Franklin Elementary School

420 Tully Road, San Jose, CA 95111

Franklin Elementary School - Master Planning Evaluation

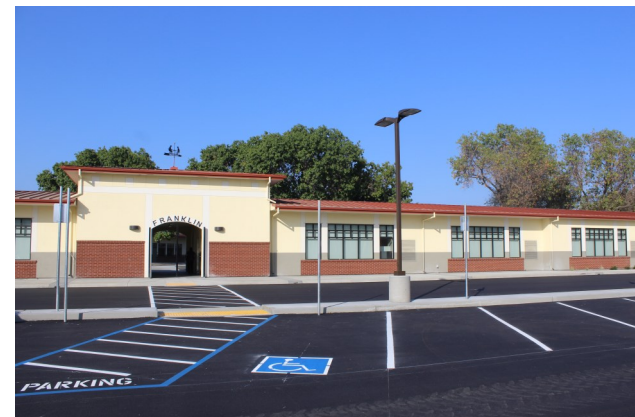
1. Parking and Traffic

During the modernization of this campus, the older existing parking lot was slurried and re-striped to function as a back-up or secondary parking lot to the new larger drop off parking lot that was added to the new front side of this campus. There is a large expanse of compacted base rock at the rear of the campus that is

used for overflow parking during large events and to allow for additional funding for the local schools by charging a fee to allow motorists to use this overflow as an alternate choice of parking for the next-door county facilities. The overflow parking is not paved.

The existing bus drop off area is original and there were not enough funds in the original modernization budget to address the flow of busses and the automobile flow of traffic.

It is recommended that the bus drop off area be redesigned to work better with the new parking lot. The rear overflow parking area should be paved.

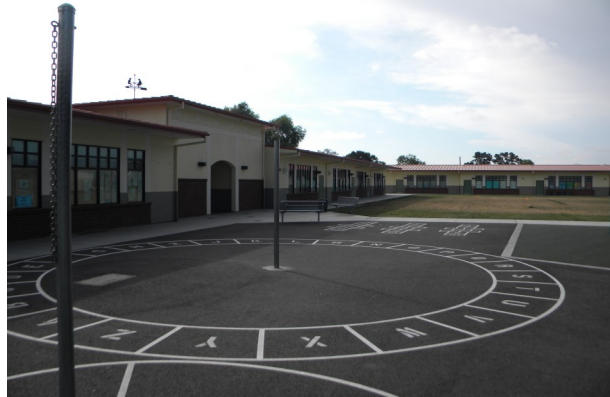
4. Paved Play Area

Although the paved area are mostly new, the upper paved play area and kindergarten play area were not repaved during the modernization due to the lack of funds.

It is recommended that the upper play area and the kindergarten play area be repaved.

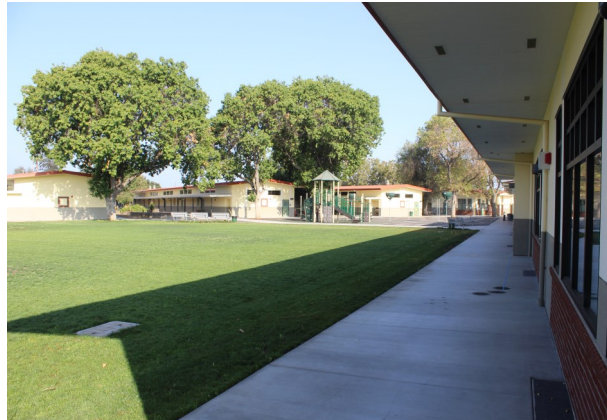
5. Turf Play Area and Synthetic Track

During the modernization, the grass area took a lot of abuse during the construction. The lawn was reseeded and watered to return close to its original condition. Due to a lack of funds, the lawn area was not replaced. There is currently no walking or running track at this site.

It is recommended that a new walking track be added to this site. The lawn should be removed and replaced with new sod and irrigation.

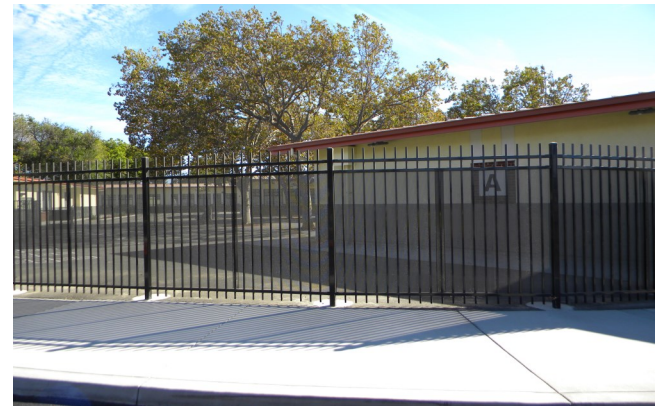
7. Fencing and Security

New decorative fencing was added at the perimeter of the entire campus. There have been a number of events where security has become a regular problems at the rear of the campus affronting the county property. Strangers to the campus often destroy district or county property and gain access to the campus.

It is recommended that a more secure fence be installed at the county side of the campus.

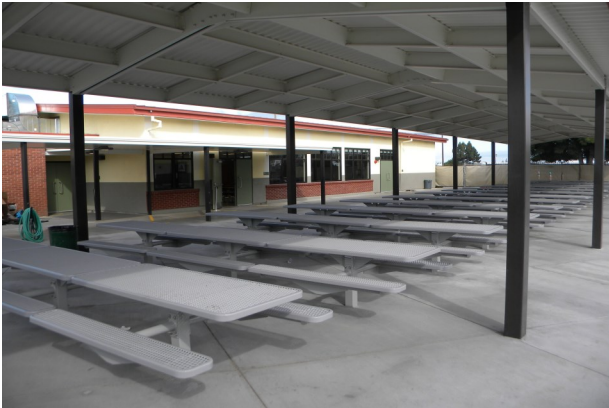
44. Cafeteria/Kitchen/Gymnasium/Music/Weight Room

The biggest challenge for the new modernization was that the community wished and desired for a new larger cafeteria complex. Funding was not available as the prioritization of the most important functions at this campus pushed this desire down the list on the priorities. As a

compromise, the District removed the stage area and expanded the larger space within the existing shell of the building. Also, an outdoor covered area adjacent to the large cafeteria allows for the students to “spill out” of the cafeteria. The kitchen and cafeteria were fully renovated, however, there are complaints that the sneeze guard is mounted too high and the serving counter is too low.

It is recommended that the issue in the serving line at the kitchen be altered and fixed.
