Hellyer Elementary School

725 Hellyer Avenue, San Jose, CA 95111

Hellyer Elementary School - Master Planning Evaluation

Evaluation Summary

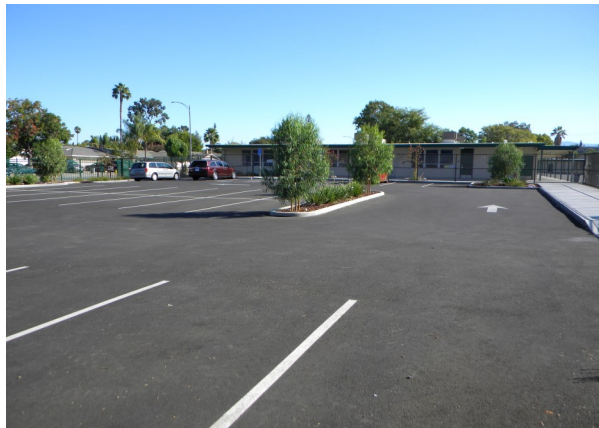
1. Parking and Traffic

The front parking lot was expanded in 2012. It has not been updated since. A secondary staff

and visitor parking area was added at the back-side of the campus in 2017.

It is recommended that the large front parking lot be slurried and painted in the next few years.

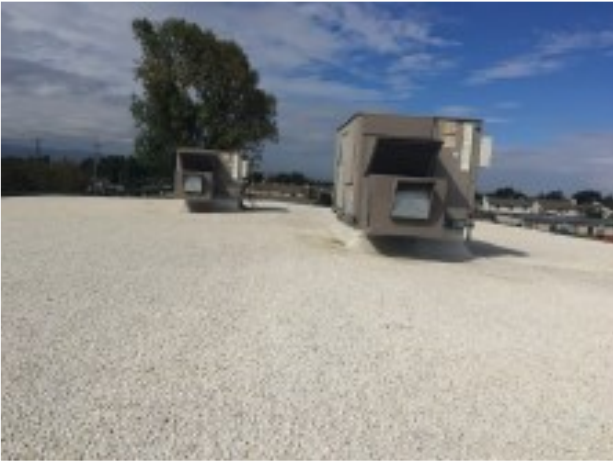
22. Roofing

Based on the roofing report, the existing roof is in very good condition as it was installed in 2012.

The roofing report recommends some maintenance such as unclogging gutter and cleaning.

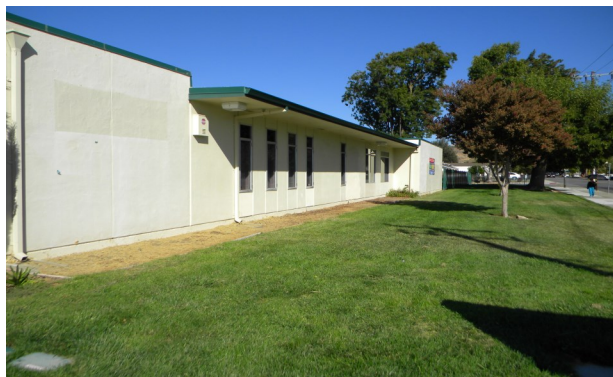
23. Exterior Painting

This campus is in need of exterior painting.

It is recommended that all exterior features be repainted including the existing decorative fencing.

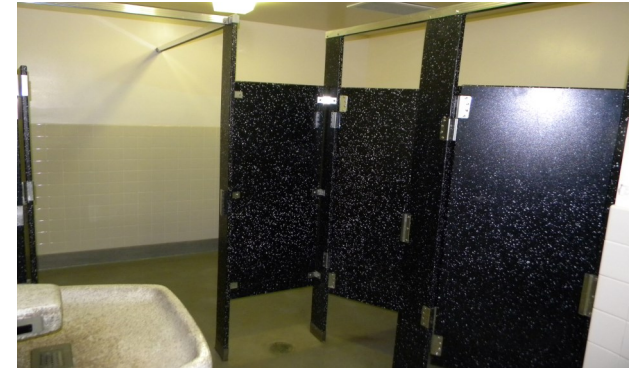
26. Restrooms/Partitions/Fixtures

All existing restrooms at this campus are in good condition. It has been reported that many of the cleanouts in the bathrooms were unknowingly buried on the wall and need to be discovered.

It is recommended that all existing hidden cleanouts be opened and made flush to the existing wall finishes.

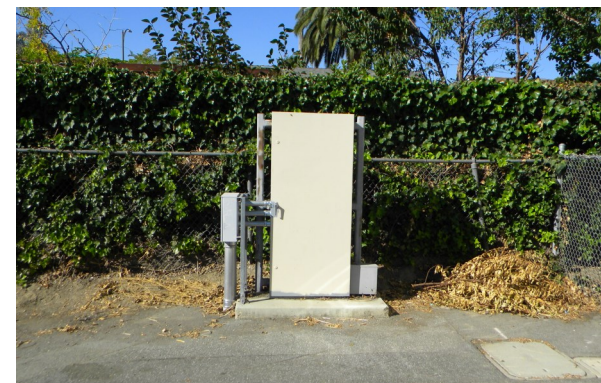
36. Data Network

The FMSD has been adding overhead projector at all of their classrooms over the years. This campus does not have overhead projectors. The cafeteria has 2 IDF's where the kitchen is the master and the custodial closet is the secondary. The WAP is not a one to one ratio at this time.

It is recommended that overhead projectors be installed at all classrooms. The 2 IDFS should be reversed and all rooms be equipped with WAP.

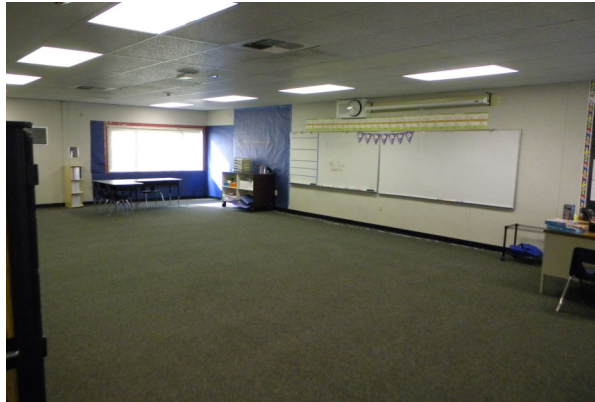
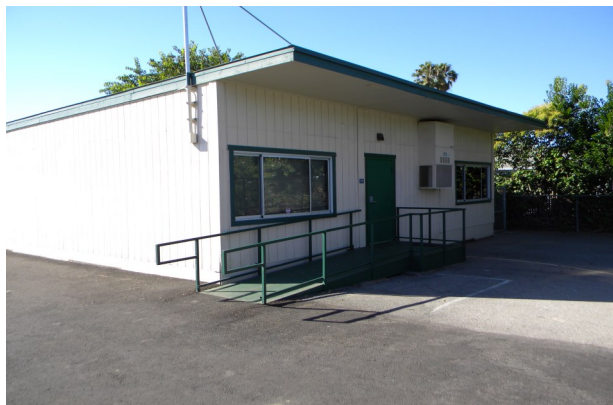
41. Relocation of Existing Portable Buildings

There is a large portable building housing two smaller classrooms which do not meet the minimum size requirements for a classroom.

It is recommended that all existing large portable classroom complex and all existing porta-

bles classrooms be removed from this campus. A new permanent classroom building should be constructed to replace all portable classrooms.

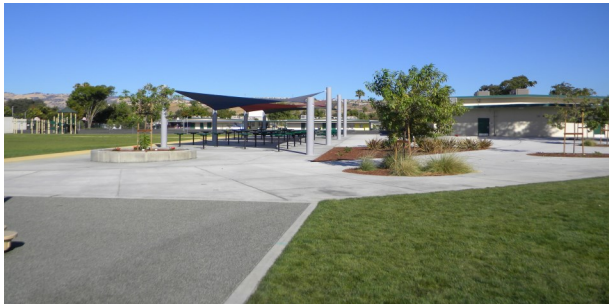
56. Covered Eating Structure or Outdoor learning

The existing covered and outdoor learning spaces are sufficient in size and meet the needs of the campus. The District Standard is to provide a shade structure of the kindergarten play structure for which this school does not have.

It is recommended that a new shade structure be installed over the existing play structure at the kindergarten area.
