Robert F. Kennedy School

1602 Lucretia Ave., San Jose, CA 95122

Robert F. Kennedy Elementary School - Master Planning Evaluation

Evaluation Summary

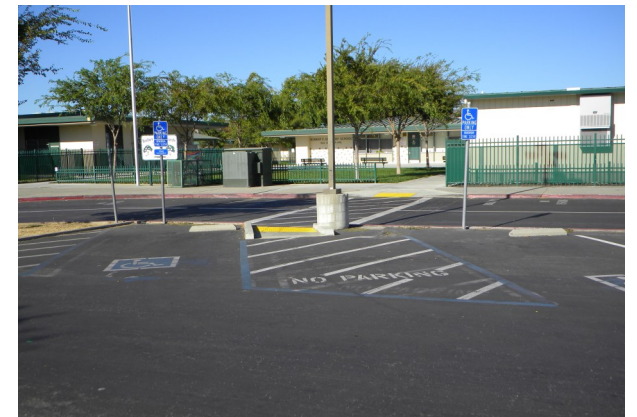
In the past, the parking lot was expanded and restriped for staff. The parking lot at the front area is mostly used by the neighboring charter school. The staff parking lot is decaying and is in need of repair.

It is recommended that the parking lots get slurry sealed to hide existing striping and then get

re-stripped. It is recommended that signage be replaced with new signage.

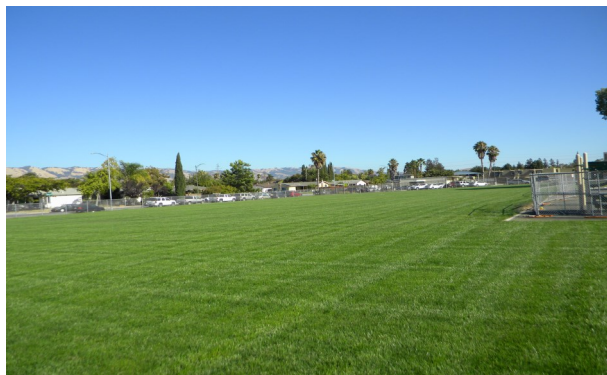
The turf area was replaced in 2016 and is in good condition. The irrigation was repaired and brought to district standard. The grass area

under the solar panels structures get unusually muddy during inclement weather as it does not receive much sunlight. This campus does not have a walking track.

It is recommended that a new walking track be added to this campus. The area under the solar panels should be paved or receive a more permanent ground material.

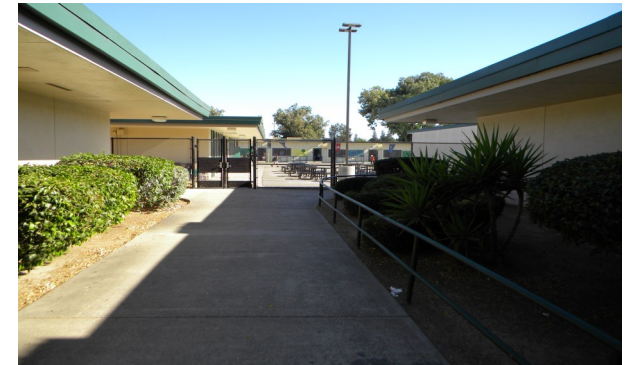
Planting areas have been maintained well throughout the years. The interior courtyard area is not currently landscaped and not meeting the District standards.

It is recommended that irrigation and landscaping be added to the interior courtyard area.

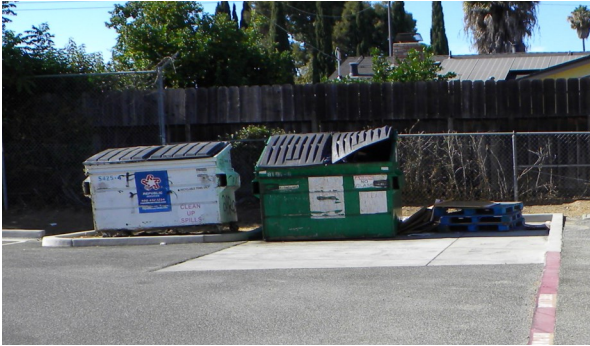
Neither the Kennedy campus nor the adjacent Charter school has a dedicated garbage enclosure.

It is recommended that a new block wall enclosure with a roof and a hose bib be added to the Kennedy Campus and the adjacent Charter school.

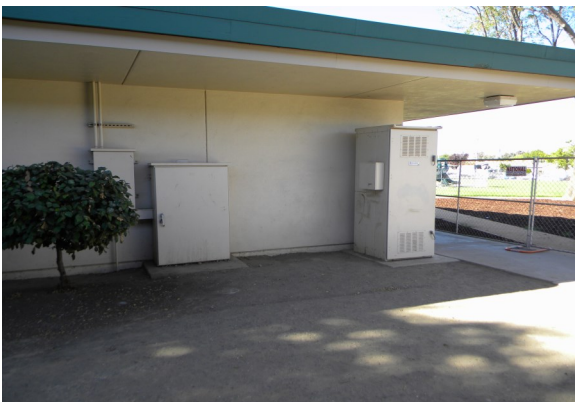
Underground utilities supplying gas and water to the site are over 40 years in age. The existing sewer system is composed of an antiquated clay piping system which allows tree roots to grip and break existing underground piping. These underground utilities have surpassed

their intended service life. Replacing the underground utilities will drastically reduce the need for ongoing maintenance of these systems.

It is recommended that all existing underground utilities older than 40 years be replaced with new utility systems. Underground water, storm, sewer and gas lines should all be replaced entirely at this site.

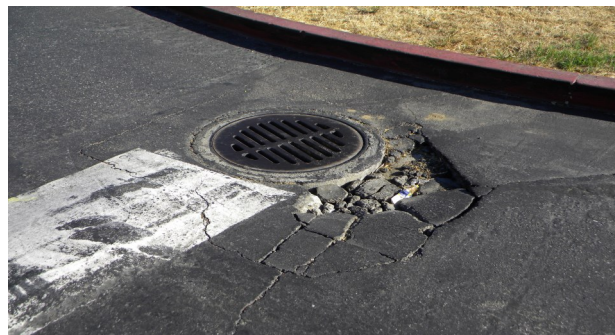
There are no reported issues at this site related to storm drainage. However, the base of the

existing rain water leaders do not meet the district standard clean out.

It is recommended that the existing rain water leaders be altered at their bases with new District Standard clean-outs.

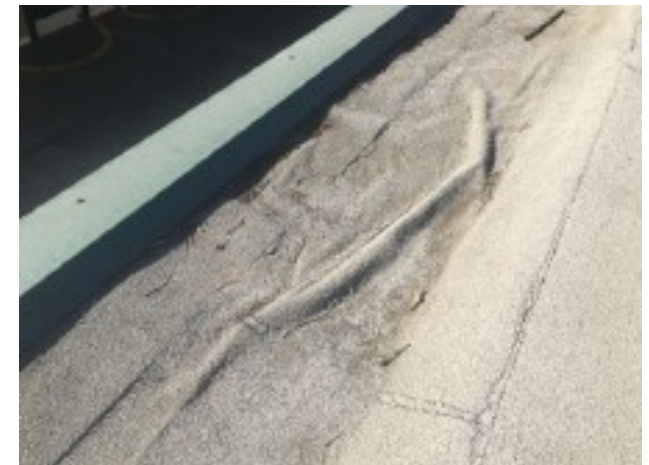
Based on the roofing report, the roof for the entire campus was replaced in 2008. The perimeter and the field condition of the built up roofing is developing blisters. There is some deterioration of the perimeter flashing.

It is recommended that the membrane ridges and valleys that have blistered be coated with a special roofing product as recommended by the roofing report.

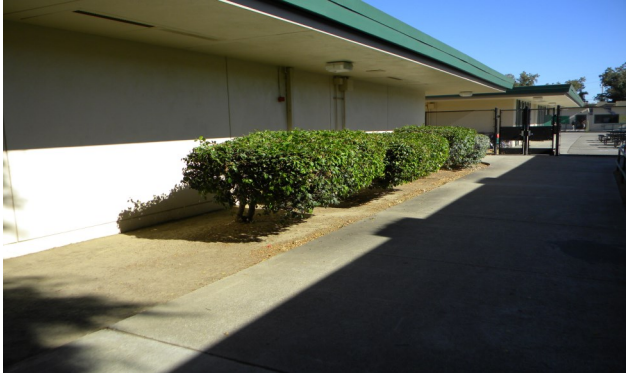
The existing exterior of this campus is in poor condition and has exceeded its expected lifecycle.

It is recommended that the entire campus be painted in the next few years.

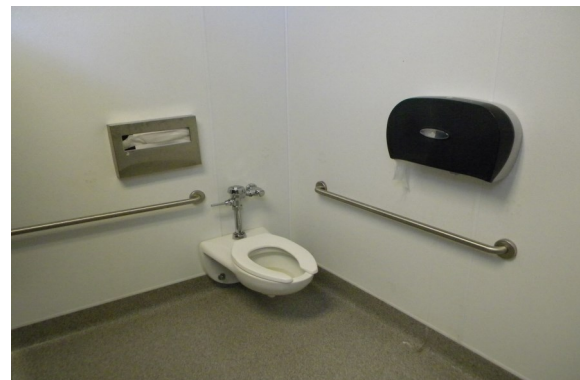
The existing bathrooms are in good condition however the terrazzo or epoxy flooring in the bathrooms have been patched over the years from prior renovations.

It is recommended that all restroom flooring be removed and replaced with new flooring that meets the District Standards.

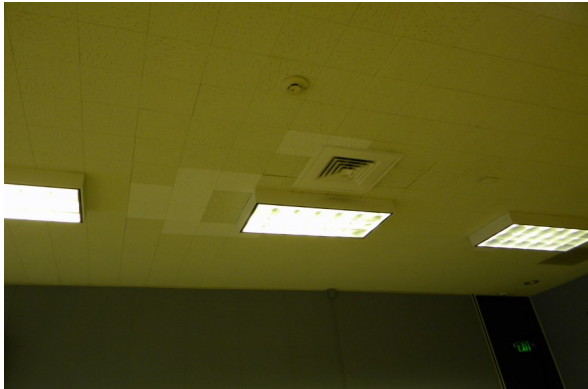
All suspended ceilings are in need of new ceiling tiles at several locations. There are areas of ceilings where interior modifications or roof leaks have occurred. Hard lid ceilings are discolored from moisture or modest vandalism.

It is recommended that all ceiling tiles be replaced and the grid be painted. It is recommended that all hard lid ceilings be painted.

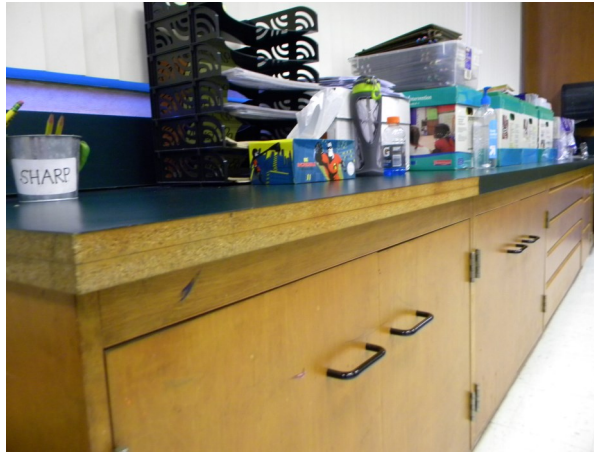
All cabinetry is over 15 years old as there are signs of abuse, vandalism and heavy wear and tear at some various locations. Cabinet tops are beginning to delaminate.

It is recommended that all cabinetry be replaced entirely throughout the campus. Teach-

ing walls should be a priority to meet District Standards.

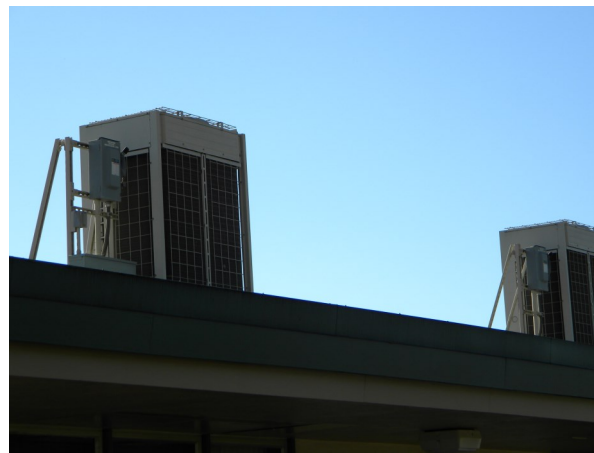
The existing HVAC system is in fair condition. Although these units have not yet surpassed

their useful lifecycle, it has been reported that several units at this campus are in need of constant repair and alterations. The existing units may no longer be useful as the demand for maintenance is exceeding their usefulness.

It is recommended that all units at this campus be replaced with a new system that meets the District standards.

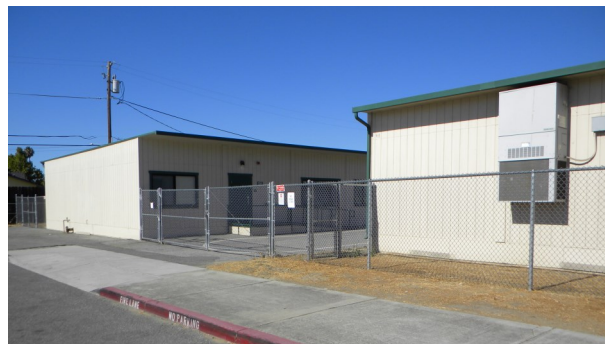
The existing portable classrooms are in good condition. There are visible signs of slight deterioration to the walls and past patchwork that should be redone.

It is recommended that the small amounts of patchwork and dry rot be repaired.
