# Los Arboles Elementary

455 Los Arboles Avenue, San Jose, CA

## Los Arboles Literacy & Technology Academy - Master Planning Evaluation

### Evaluation Summary

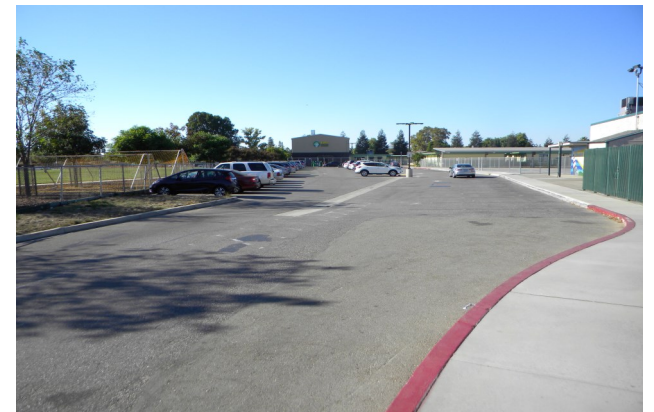
In the past, the parking lot was expanded twice to elongate the landlocked parking area at the side and rear of the campus. The front parking lot was altered to accommodate a better flow of visitor parking. In the recent past, a Charter School was constructed at the back of the existing school district property impacting the park-

ing area. The Charter parents began using the already impacted parking area now used by both campuses. The District is seeking a resolution with the Charter School to see what other options are possible toward a better parking situation.

It is recommended that the kindergarten portable buildings be removed at the front of the school to allow for a larger expanded parking

lot and drop off area at the front of the school. A new kitchen can be constructed at the side of the existing cafeteria and the modular classrooms be incorporated into a new permanent classroom building.

It would be desirable to coordinate an expanded parking lot for the Charter School adjacent to the Charter school at the back of the campus.

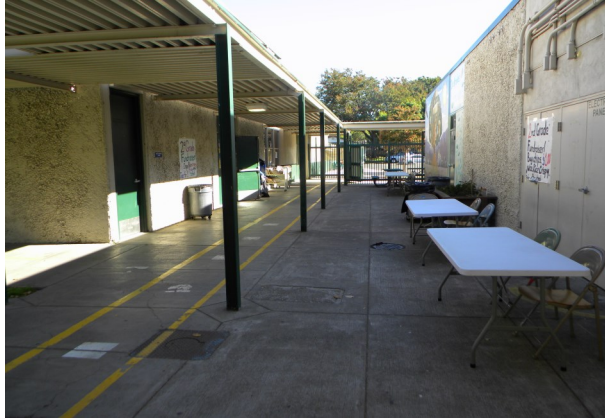
Some flatwork and walkways were upgraded in adjacent to the expanded parking area. There are several locations where the concrete walkways have cracked and lifted.

It is recommended that all concrete walkways be replaced with new concrete walkways to allow for a path of travel to all classroom and student support service areas.

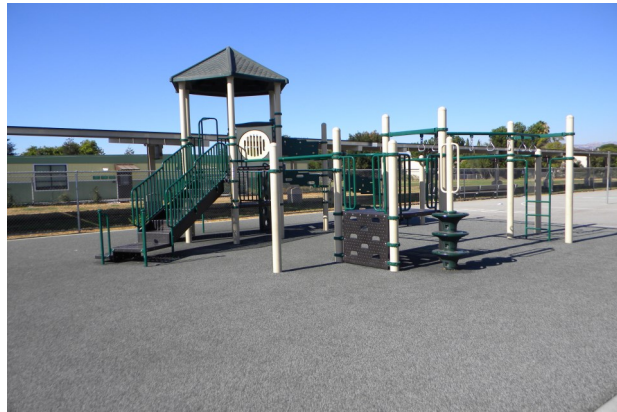
All play equipment is in good condition at this campus. The Head Start fall protection is deteriorating.

It is recommended that the Head Start play surface be removed and replaced.

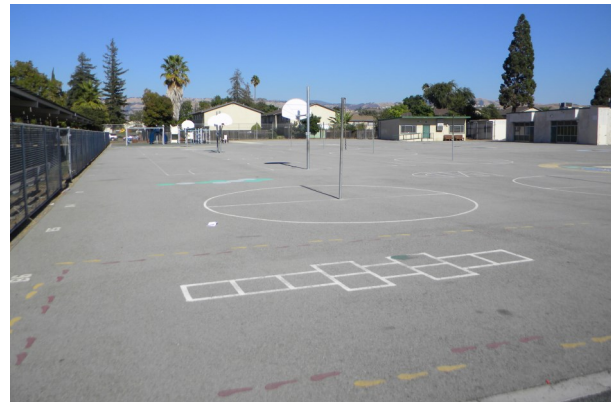
The existing paved play area is in poor condition.

It is recommended that the entire paved play area be slurry sealed and striped as soon as possible.

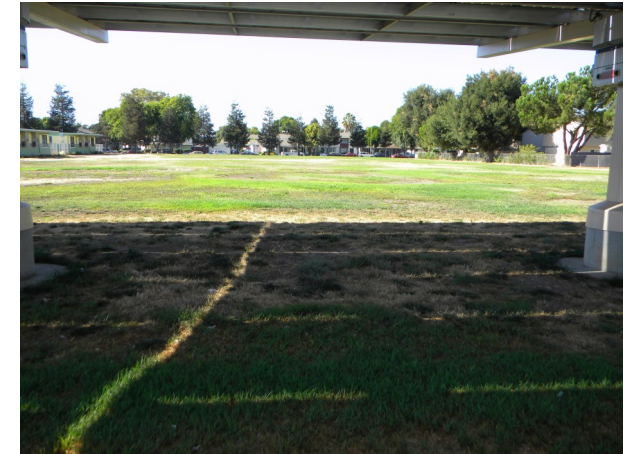
The existing turf is in poor condition. The District has been installing walking tracks at most of their campuses. This campus does not have a track.

It is recommended that the turf fields be up-

graded with new turf. A new DG walking track should be installed in the play area.

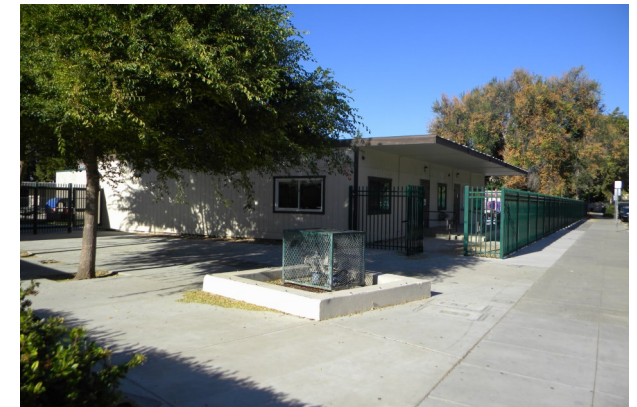
New decorative fencing was added at the perimeter of the entire campus. The fence that separates the grass area from the paved play area is no longer needed for security.

It is recommended that the existing fence be removed between the paved play area and the grass area.

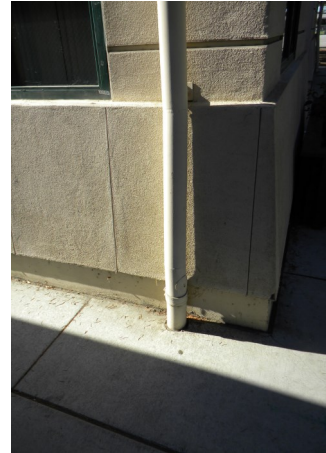
Several rain water leaders are not properly specified for vandal resistance and do not have the District Standard clean-outs. There are no known drainage issues at this campus.

It is recommended that the existing rain water leaders be altered at their bases with new District Standard clean-outs.

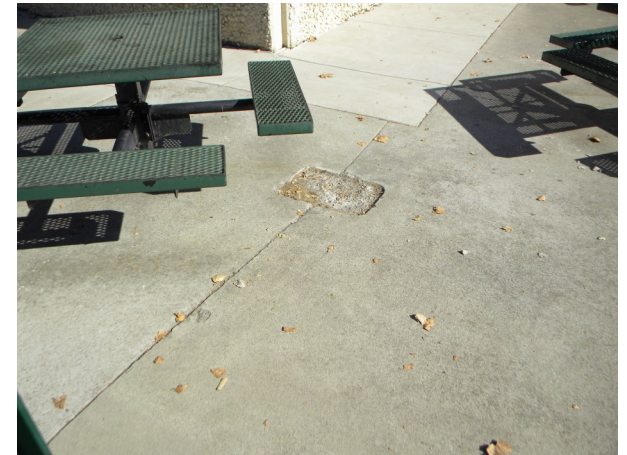
The existing concrete walkway system appears to handle foot traffic well at the site; however, several areas of the existing walkways have cracks and other signs of deterioration. There have been several trenching projects whereas the concrete has a lot of patching.

It is recommended that large cracked areas of the walkways be replaced to the nearest expansion joint. It is also recommended that entire walkways are removed where patching has occurred in the past.

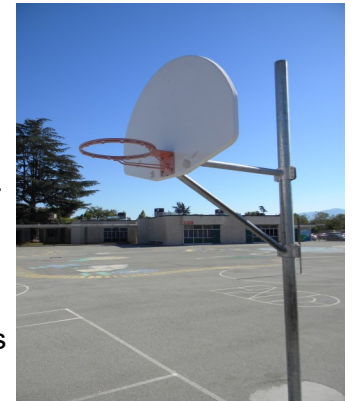
The existing basketball backstops, rims and chains are missing or are inadequate. There are currently no ball walls available at this site.

It is recommended that all basketball backstops be replaced with new rims and chains.

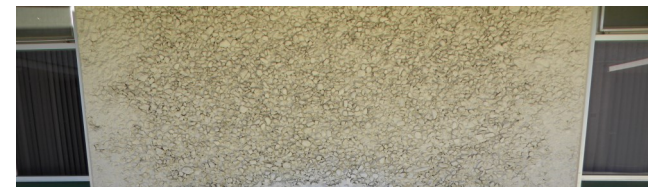
This campus was constructed using a heavily textured aggregate surfacing material which is not easy to maintain. Some of the frontage ag-

gregate material was covered over with cements plaster and painted to achieve a better appearance at the front of the campus.

It is recommended that all existing exposed aggregate surfaces be covered over with cement plaster and then painted.

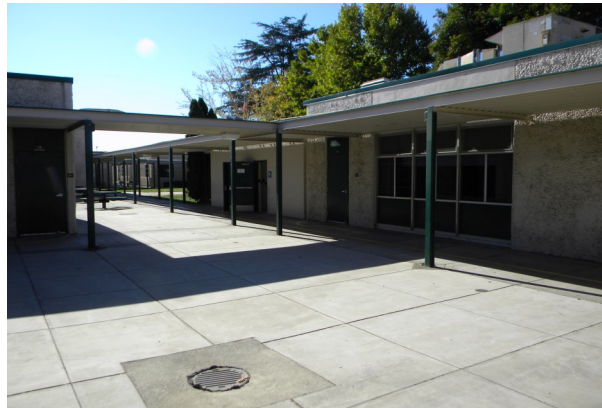
There existing covered walkways are in poor condition.

It is recommended that all covered walkways be replaced with new prefabricated covered walkways.

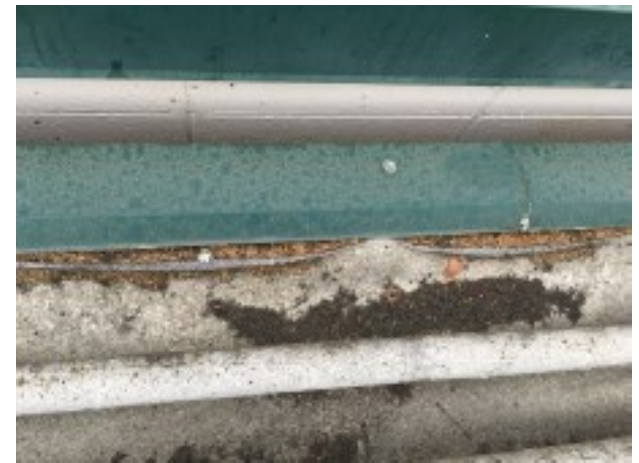
Based on the roofing report, this campus was re-roofed in 2002. The general condition of this roofing is in good condition. According to the report the perimeter flashing is failing along the covered walkways. There is maintenance required and recommended.

It is recommended that maintenance be performed on this roof as reported by the roofing report and the perimeter flashing be repaired.

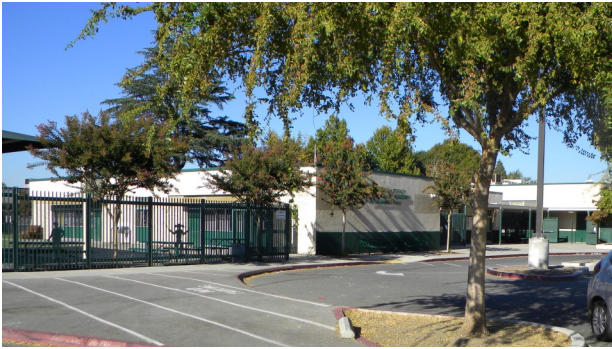
The existing exterior of this campus is beginning to show signs of wear.

It is recommended that this entire campus be painting in the next two years.

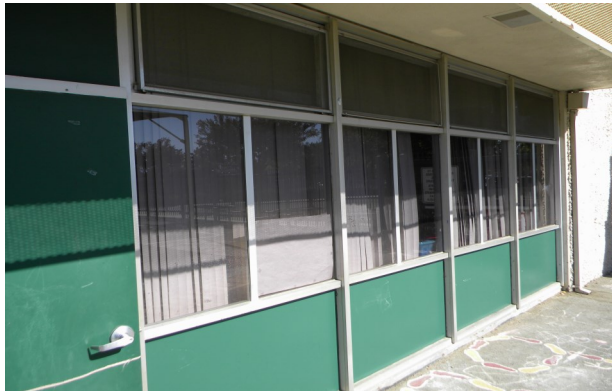
The original campus buildings were constructed in an era when natural resources such as natural gas and electricity were inexpensive. Windows are single glazed throughout and insulation does not currently meet new construction standards. The windows blinds need to be replaced.

It is recommended that insulation be added to

all exterior walls and added to all ceiling cavities. Windows should be replaced with double glazed window systems. It is recommended that new window blinds replace all of the existing window blinds throughout this campus.

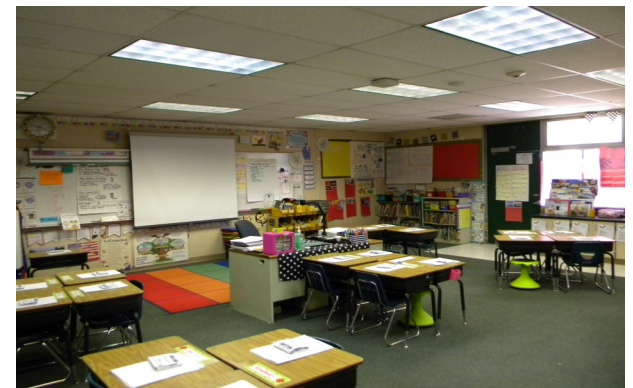
Many of the walls are a vinyl wall covered that has surpassed its expected lifecycle as many wall seams are fraying.

It is recommended that all new interior wall finishes be replaced with new durable wall materials throughout the campus.

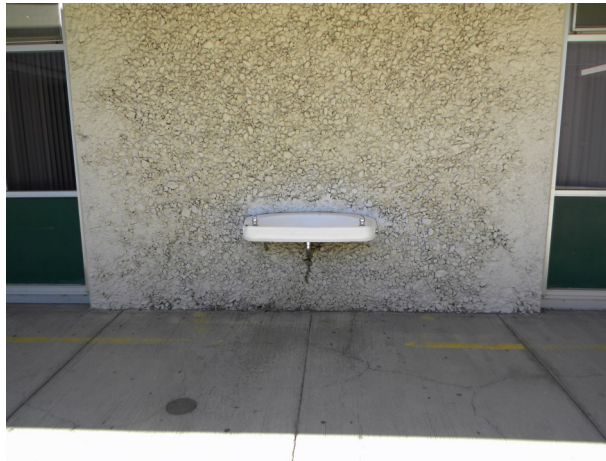
Exterior drinking fountains have been upgraded or replaced to meet ADA requirements. There are still some drinking fountains that have not been upgraded and some of the newer style ADA compliant drinking fountains are in need of replacement.

It is recommended that a bottle filler drinking

system be installed in the cafeteria building. It is also recommended that two of the exterior drinking fountains be updated to current ADA requirements.

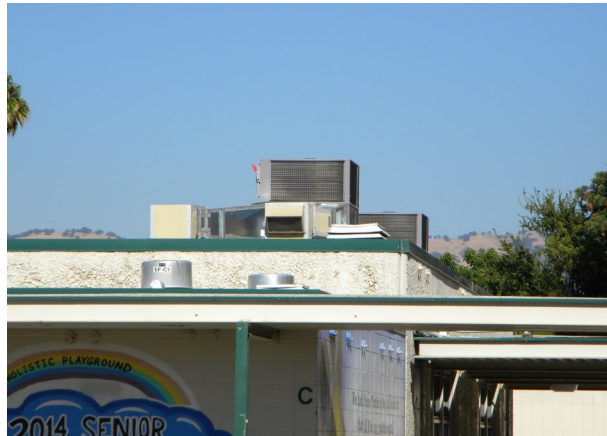
The existing HVAC system has been replaced at the entire campus in 2002. HVAC units have a normal lifecycle of 15 years. The mechanical units were installed on the roofs visible to the eye.

It is recommended that the HVAC units be replaced with new mechanical screening.

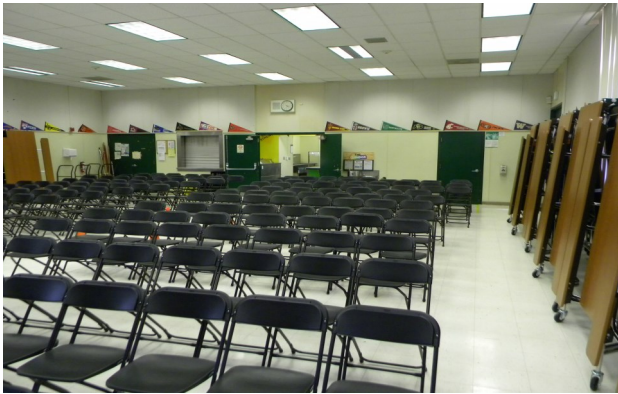
The existing cafeteria space is in poor condition. The serving line needs to be modified.

It is recommended that the cafeteria receives new finishes throughout. It is recommended that the serving line area be reconfigured for better usage.
