# McKinley Elementary

## McKinley Elementary School - Master Planning Evaluation

### Evaluation Summary

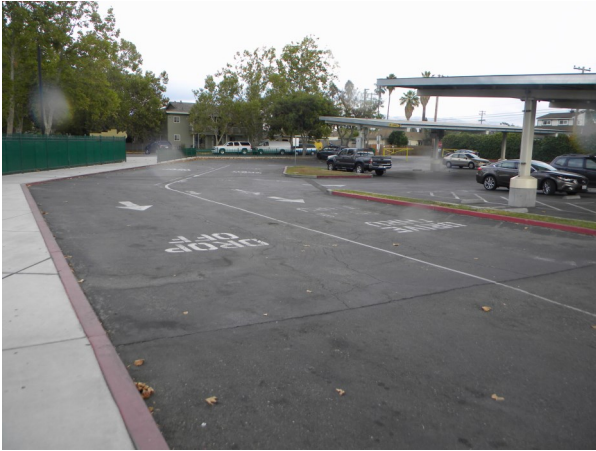
lot next to the front main parking lot of the campus where the Headstart picks up and drops off, behind the two story building and there is a parking lot for staff at the back of the campus. The main parking lot and the Headstart parking lots are in good condition. The back staff parking lot was a result of a quick solution to pave an area where the teachers were already parking. The quick results of paving this staff parking lot resulted in a ineffective and inefficient design.

It is recommended that the staff parking lot at the back of the campus be completely reconfigured to allow for a better flow of traffic.

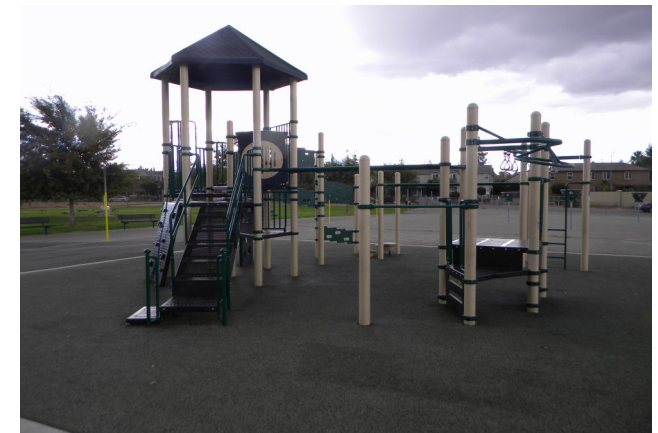
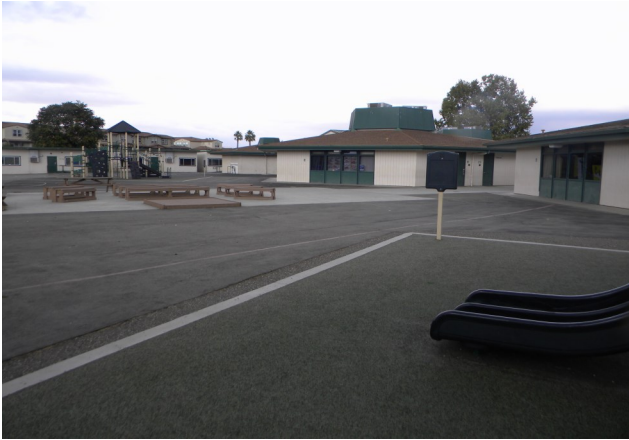
The play structures meet the needs for the campus. The matting is beginning to decay and will need to be patched or replaced in the future. There is an old obstacle installed in the play area that is a tripping hazard.

It is recommended that the matting at the play structures be replaced in the next five years.

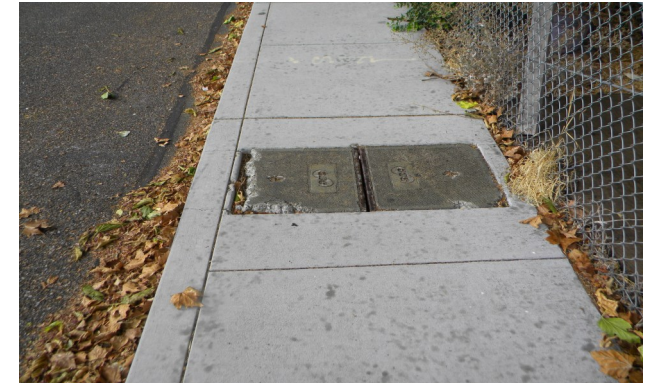
Underground utilities supplying gas and water to the site are over 40 years in age. The existing sewer system is composed of an antiquated clay piping system which allows tree roots to grip and break existing underground piping. These underground utilities have surpassed their intended service life. Replacing the underground utilities will drastically reduce the need for ongoing maintenance of these systems.

It is recommended that all existing underground utilities older than 40 years be replaced with new utility systems. Underground water, storm, sewer and gas lines should all be replaced entirely at this site.

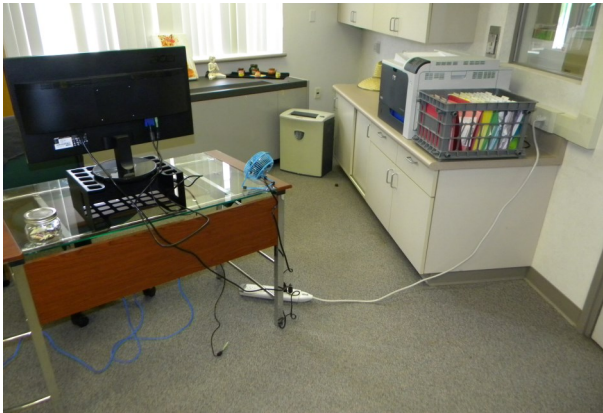
There are not currently enough electrical outlets in the classrooms or other student service areas. There are several locations where loose

wiring is hanging from the roof and walkways. It is recommended that some additional electrical outlets be provided at select areas of this campus. All loose wiring should be removed.

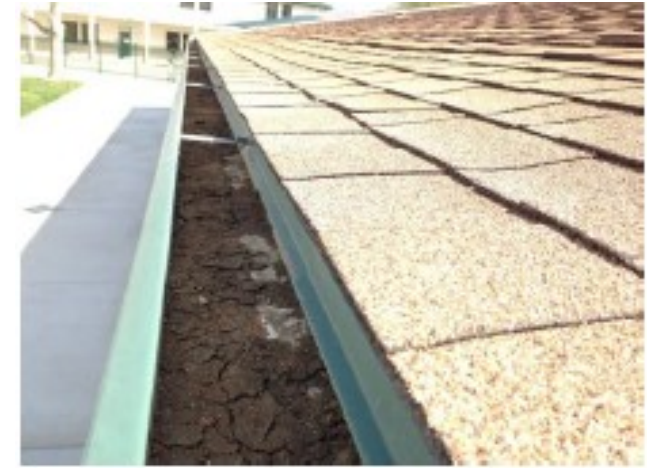
Based on the roofing report, the built up roof portions of this campus have ponding water. The portables are reported to be showing signs of rust corrosion and seam deterioration. The existing shingle roofing is showing signs of UV deterioration.

It is recommended to replace and slope the existing built up roofing areas of the campus. The existing shingles should be replaced with metal roofing in the next five years. All roof penetrations should be caulked and maintenance is needed at several locations as noted in the roofing report.

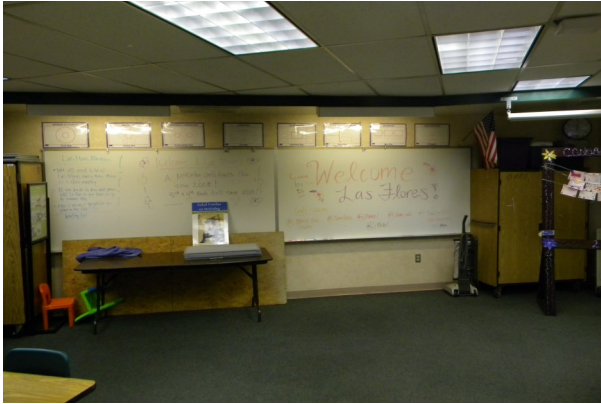
All suspended ceilings are in need of new ceiling tiles at several locations. There are areas of ceilings where interior modifications or roof

leaks have occurred. Hard lid ceilings are discolored from moisture or modest vandalism.

It is recommended that all ceiling tiles be replaced and the grid be painted. It is recommended that all hard lid ceilings be painted.

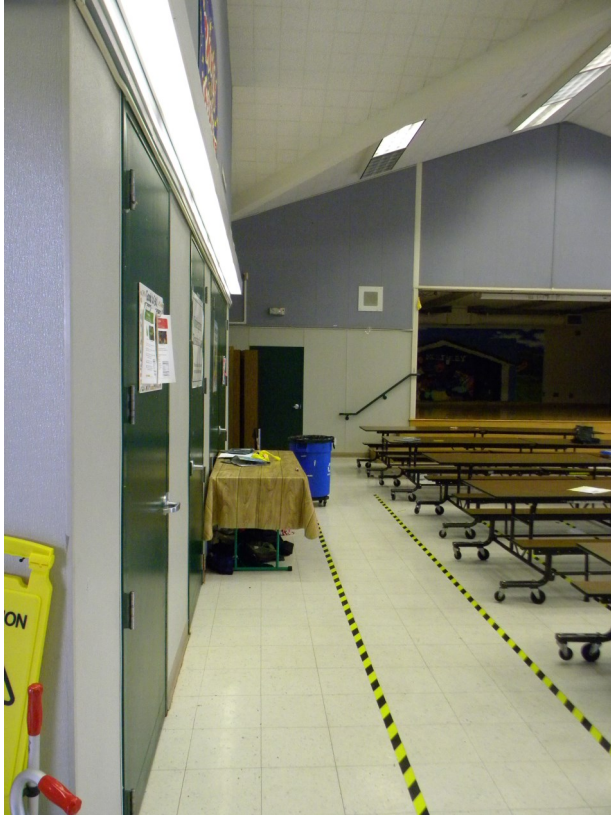
The existing cafeteria and kitchen is located in a manner that blocks the natural flow of parking and fire lane to the rear of the campus. This cafeteria is too small for this campus and does not meet the needs of the ongoing educational

needs. The existing cafeteria is in great need of renovation. The custodial closet reportedly has ongoing drainage issues. The existing storage area is poorly laid out.

It is recommended that the entire building be demolished and rebuilt for this campus, located in more desirable location.
