1250 Taper Lane, San Jose, CA

Jeanne R. Meadows Elementary School - Master Planning Evaluation

Evaluation Summary

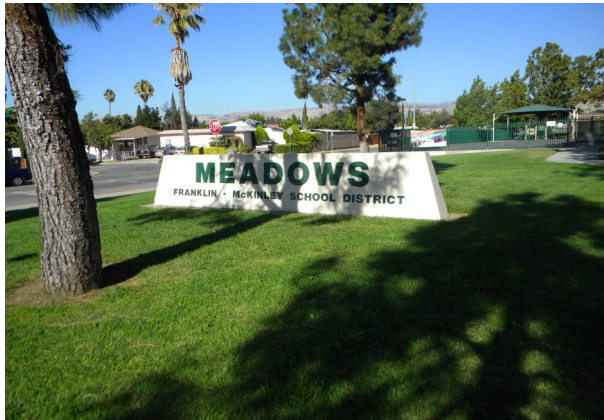
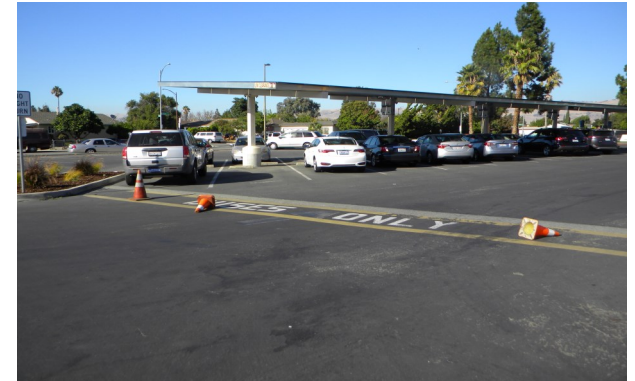
1. Parking and Traffic

additional parking and is on the side of the campus. This parking lot is in good condition. The original front parking area is in fair condition but does not serve as a sufficient drop off zone.

It is recommended that the existing front parking lot be redesigned to be more effective to meet the needs of the District.

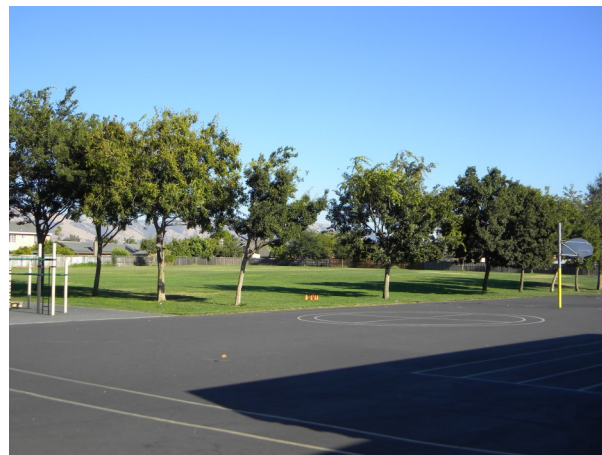
4. Paved Play Area

The existing paved play area is in good condition.

It is recommended that the play area be slurry sealed and restriped in the next five years.

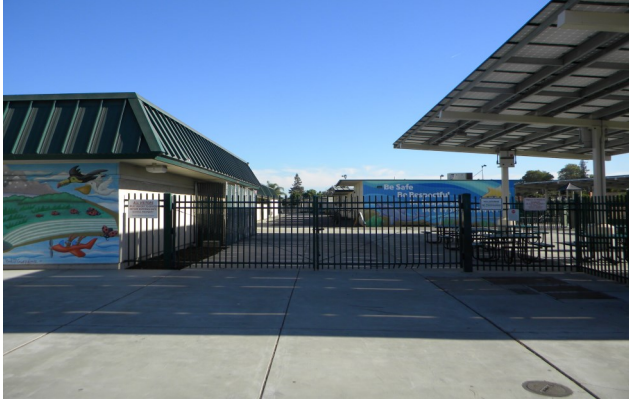
7. Fencing and Security

New decorative fencing was added at the perimeter of the entire campus in the past. The kindergarten fence at the front of the school has

open rails which is not to District Standard. The concrete retaining wall at the kindergarten area is failing.

It is recommended that the existing kindergarten fence be altered with new perforated panels similar to other kindergarten play areas in the District. The existing concrete retaining wall is recommended to be removed and replaced.

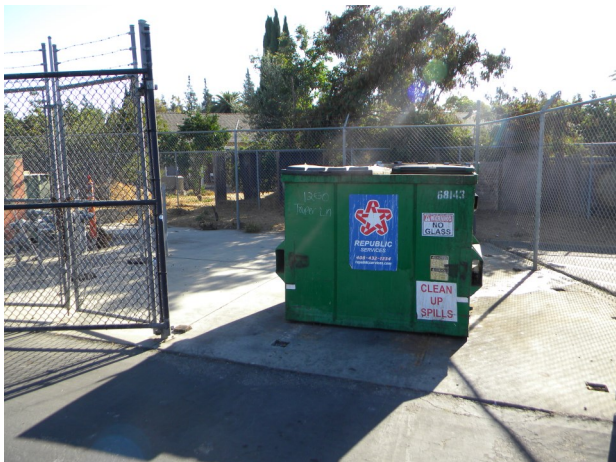
8. Trash Enclosure

The existing trash enclosure does not meet the District standards.

It is recommended that a new block wall enclosure

sure with a top and a hose bib be added for the existing garbage enclosure.

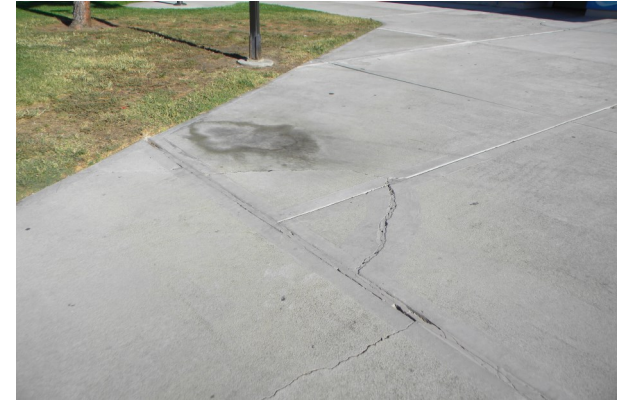
13. Concrete Walkways

The existing concrete walkway system appears to handle foot traffic well at the site. There have been several trenching projects whereas the concrete has a lot of patching.

It is recommended that large cracked areas of the walkways be replaced to the nearest expansion joint. It is also recommended that entire

walkways are removed where patching has occurred in the past.

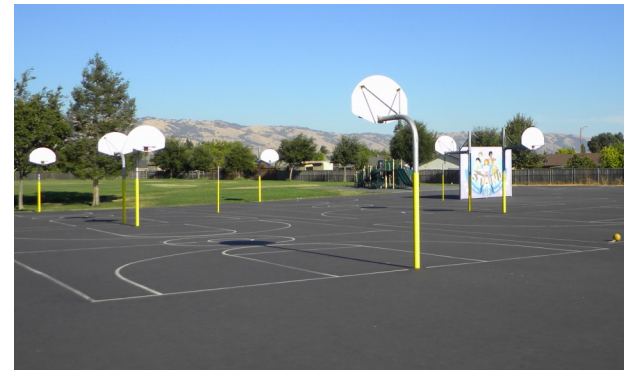
14. Basketball Backstops/Ball Walls/ Misc. Play Apparatus

The existing basketball backstops, rims and chains are missing or are inadequate.

It is recommended that all basketball backstops be replaced with new rims and chains.

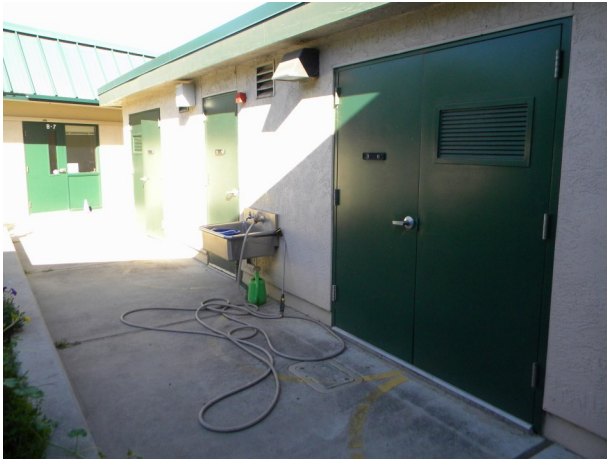
15. Quality of Exterior Siding/Material

This campus was constructed using cement plaster when it was originally constructed. The roofing report indicates that the cement plaster is failing at several locations.

It is recommended that the existing cement plaster be removed and replaced with a new water resistant membrane and new durable waterproof siding.

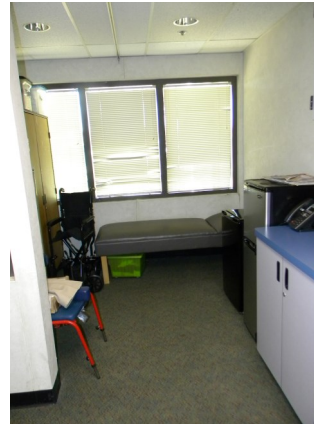
28. Tackable Walls

The tackable walls are in fair condition. As this school is 30 years old, the tackable walls will need to be replaced soon.

It is recommended that the tackable walls be replaced during the next significant modernization to the classrooms.

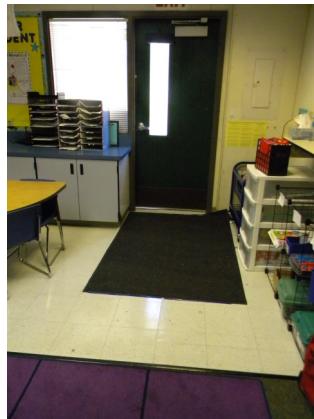
29. Interior Wall Finishes

All other interior walls without tackable walls are showing signs of wear.

It is recommended that all new interior wall finishes be repainted or stripped of the existing vinyl and replaced with new durable wall surfaces.

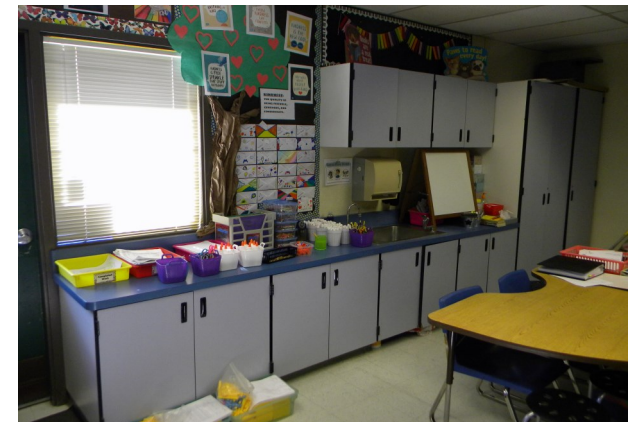
31. Cabinetry

The existing cabinetry is original to this school. There is wear and tear at some various locations. The cabinetry has surpassed its normal useful lifecycle however this campus has kept it in good condition.

It is recommended that during the next significant modernization that all cabinetry be replaced and reconfigured to meet the District Standards.

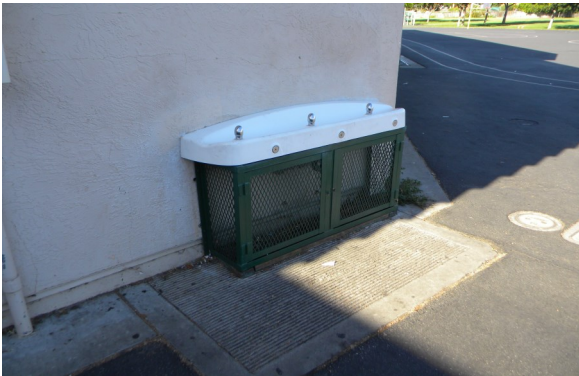
32. Drinking Fountains

Exterior drinking fountains have been upgraded or replaced to meet ADA requirements over the years, however there are still some drinking fountains that have not been upgraded and some of the newer style ADA compliant drinking fountains are in need of replacement.

It is recommended that a bottle filler drinking system be installed in the cafeteria and a minimum of two of the exterior drinking fountains be updated to current ADA requirements.

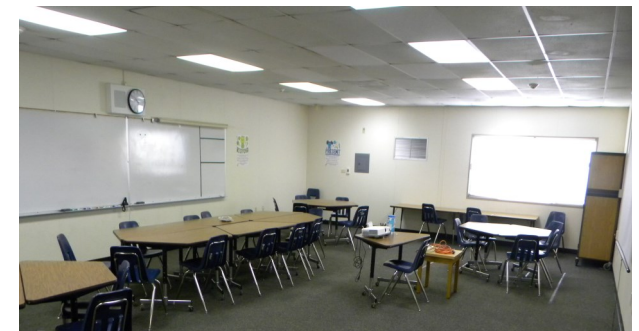
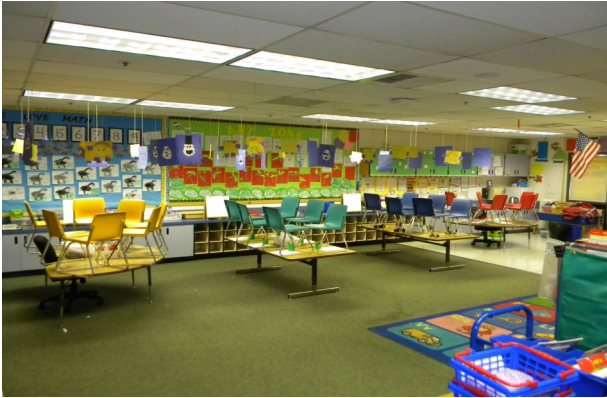
40. Alteration of Existing Portable Buildings

The existing portable classrooms are in good condition however there appears to be some exterior dry rot wood trim and siding. The bath-

room building is in need of new finishes.

It is recommended that the bathroom portable building be completed renovated and that all dry rot wood trim and siding be replaced and painted.
