# Ramblewood Elementary

1351 Lightland Road, San Jose, CA

## Ramblewood Elementary School - Master Planning Evaluation

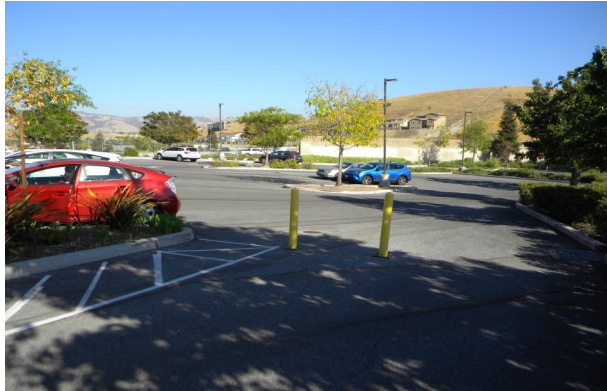
#### 1. Parking and Traffic

The parking lot is too small. There have been

complaints about the flow of traffic at this campus. Unfortunately, this campus has no land for creative reworking of the existing parking lot. The existing pavement is in good condition.

It is recommended that the existing parking lot be slurry coated and restriped in the next five years.

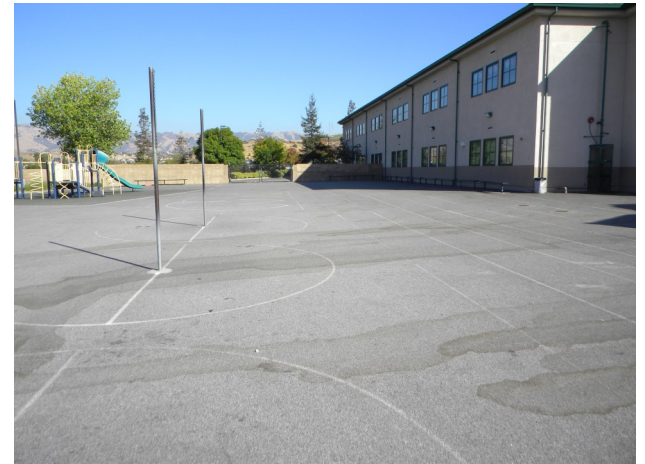
#### 3. Play Equipment

A new play structure was added summer 2019. This new play structure is one of the first of its kind in the bay area whereas more students

with special needs can use this play apparatus. The existing play structures are adequate.

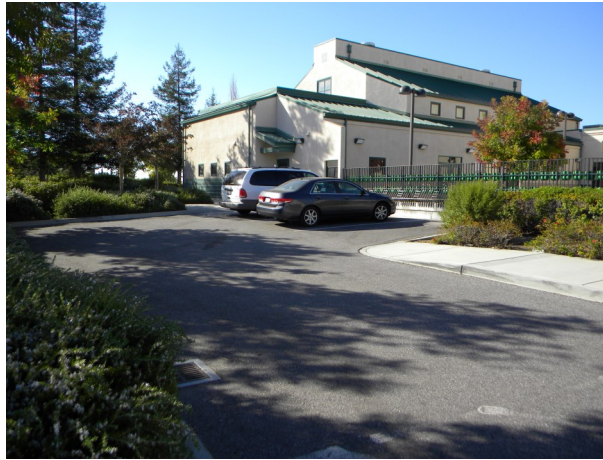
#### **6. Landscaping and Irrigation**

The existing planting and irrigation is in good condition. There is a need for a water source for the vegetable garden.

It is recommended that a source of water be

added to the vegetable garden area.

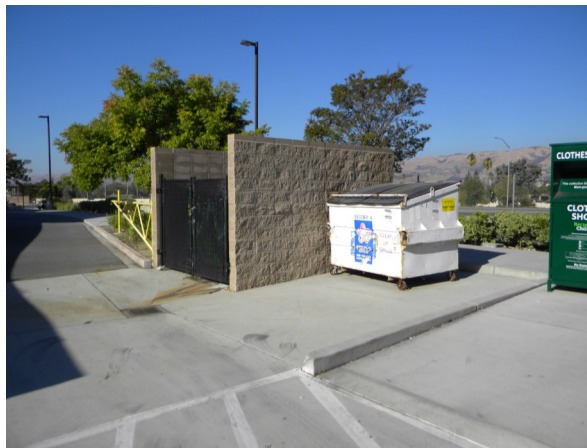
#### **7. Fencing and Security**

This campus is currently enclosed with fencing and visitors must pass through the main entrance when school is session. There are several locations where gaps occur on the decorative fencing adjacent to the CMU. The fencing along the park does not meet security needs of this campus.

It is recommended that the fencing along the park be reinstalled with new District standard

black vinyl fencing and the gaps at the decorative fencing be replaced and repaired.

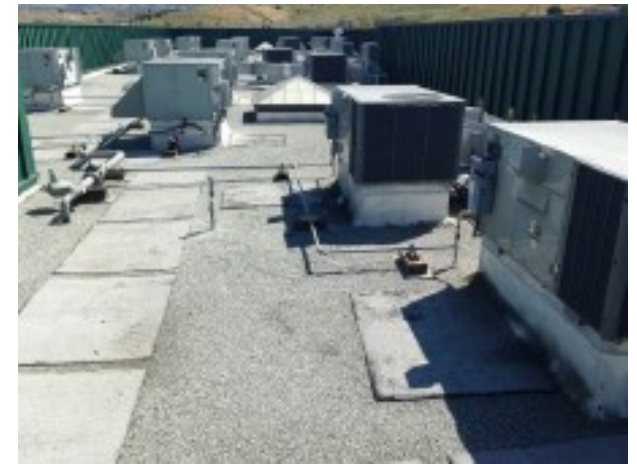
#### **22. Roofing**

Based on the roofing report, the condition of the roofing is in fair to poor condition. The flashing around the perimeter and roof penetrations have begun to deteriorate. The caulking and

sealant around the exposed duct units have also begun to fail. The general roofing is in fair condition, however minor area of ponding water and granule loss is evident.

It is recommended that maintenance begin on the existing originally installed built up roofing system. It is recommended that all pipes and penetrations be sealed and that all curbs, corners and lap joints on the perimeter be repaired.

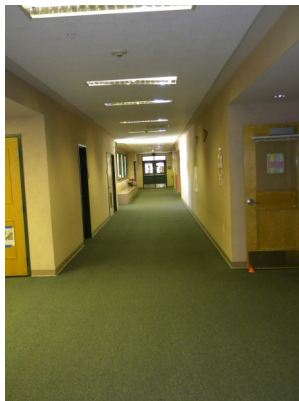
## **27. Flooring**

The flooring throughout this campus is being maintained and is in fair condition.

It is recommended that the flooring be replaced in five years.

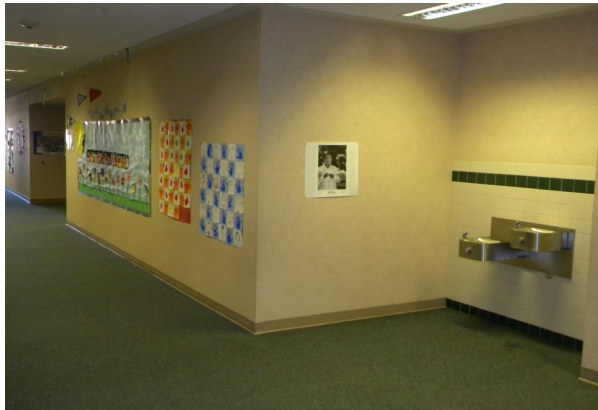
## **29. Interior Wall Finishes**

Interior wall finishes are mostly covered with vinyl wall covering. Vinyl tends to pull off and tear over the years.

It is recommended that walls be stripped of vinyl wall material and be replaced with other optional wall materials such as impact resistant paintable surfaces.

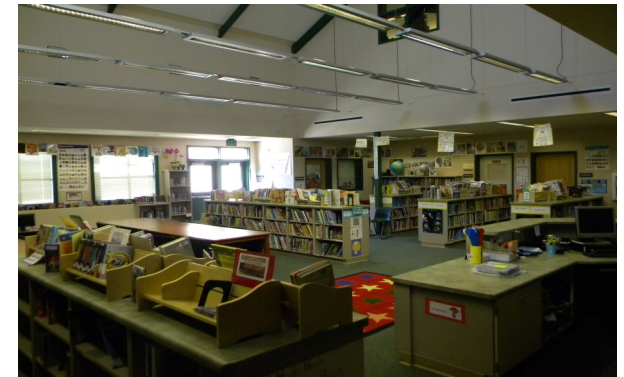
### **42. Library**

The current Library space is adequate and meets the minimum size for the Franklin-McKinley School District. The use of computer labs and library spaces for school functions have changed. Library space is now a more social learning space and computer labs are not a function of a classroom space.

It is recommended that the existing book storage shelving be rearranged to be housed along

the perimeter of the existing space whereas the old library becomes transformed to become a more desirable open space with clusters of seating spaces more conducive of the “new” library.
