Santee Elementary

1351 Lightland Road, San Jose, CA

Santee Elementary School - Master Planning Evaluation

Evaluation Summary

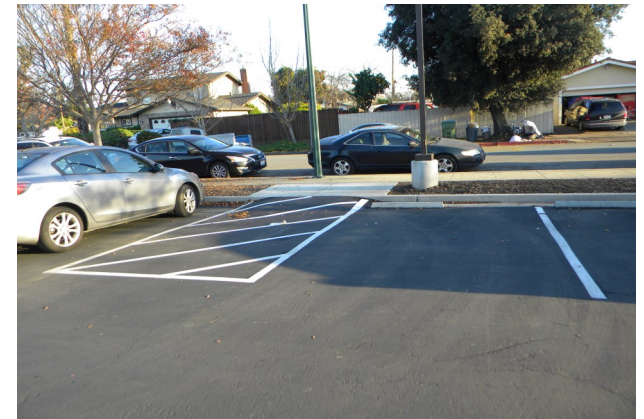
In the past, the parking lot was expanded with additional parking. The Educare complex has minimal parking at the front of that campus and a fire lane had to be maintained. It was concluded that the existing parking to Santee had

to be expanded to allow for additional parking for the Educare facility. The existing parking pavement is in good condition.

It is recommended that the existing parking lot be slurry sealed and restriped in the next five

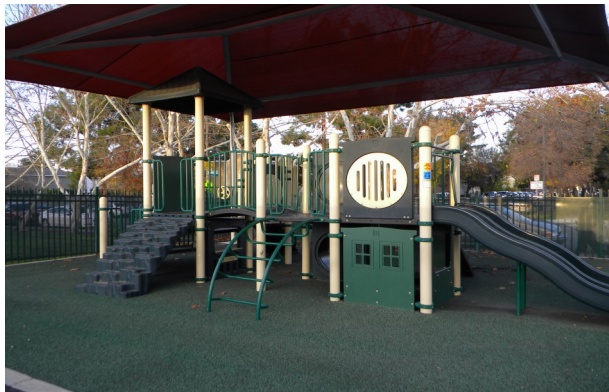
This play equipment is all in good condition in general. The fall protection matting is in good

condition at the kindergarten area.

There is no replacement or repair needed in the kindergarten poured in place matting.

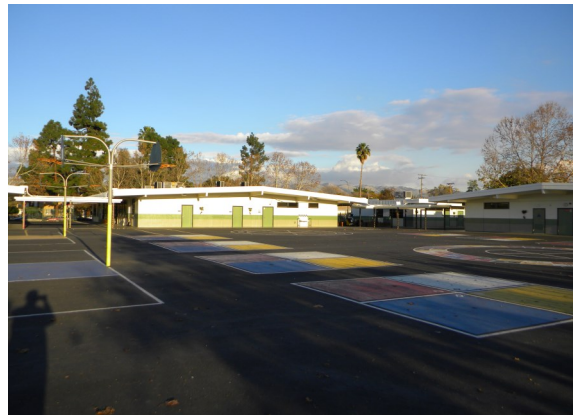
Santee's existing paved play area is in fair condition.

There is no need for repair to the black top at this time.

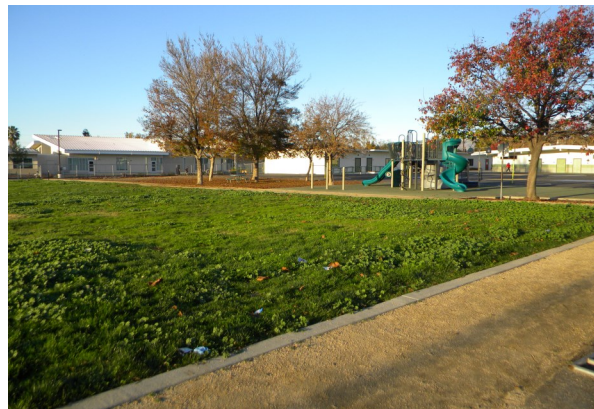
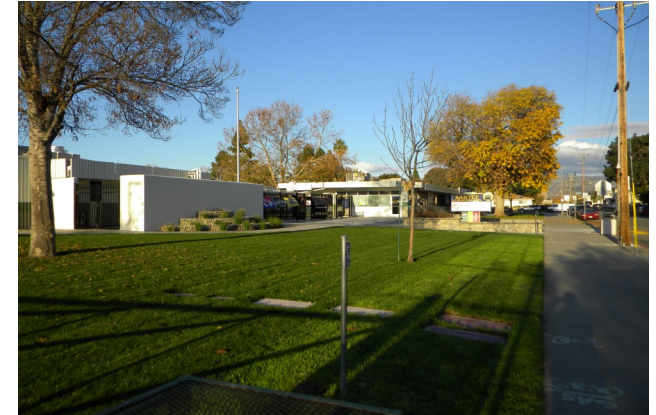
The turf area is in good condition. A walking track was added to this campus in 2018.

There are no upgrades needed to the turf area or the track at this time.

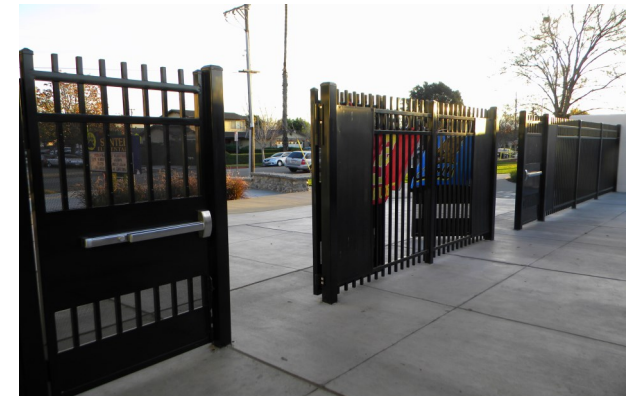
New decorative fencing was added at the perimeter of the entire campus. There is no need for upgrades to the existing fencing at this time.

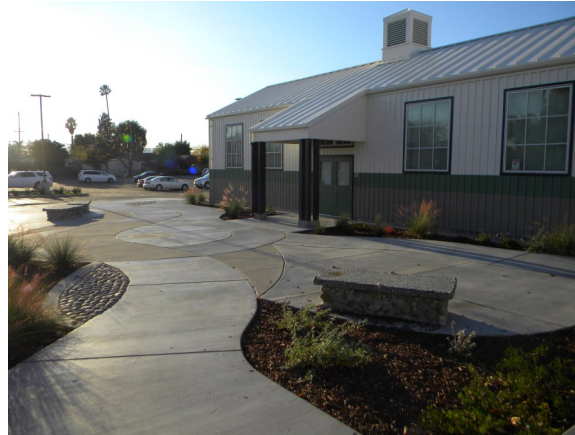
The existing concrete walkway system appears to handle foot traffic well at the site. Most of the

concrete at the front of the school was replaced and redesigned in the last two years.

There is no known concrete that needs to be replaced or upgraded at this time.

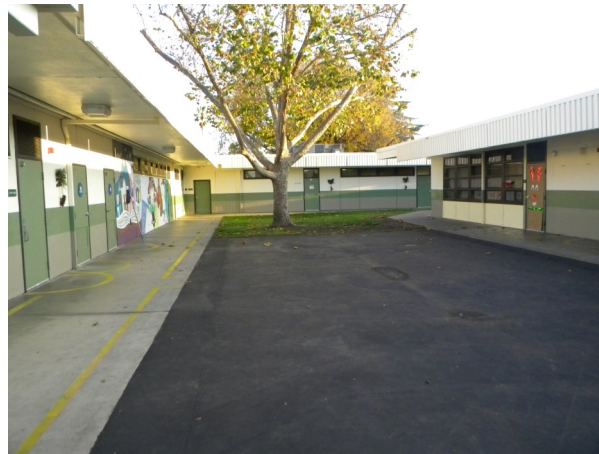
The original campus buildings were constructed in an era when natural resources such as natural gas and electricity were inexpensive. Windows are single glazed throughout and insulation does not currently meet new construction standards.

It is recommended that insulation be added to all exterior walls and added to all ceiling cavities. Windows should be replaced with double glazed window systems.

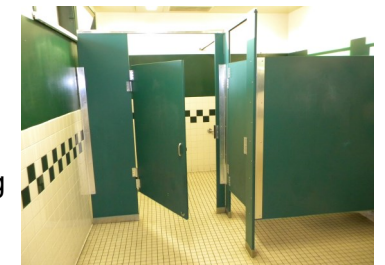
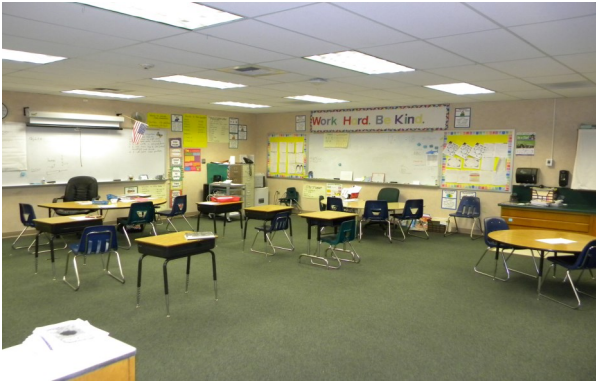
Most of the flooring is getting older.

Floor carpeting can last for about 15 years. All carpeting at this site is approaching its useful lifecycle.

It is recommended that all floor carpeting and associated VCT be replaced in the next three years.

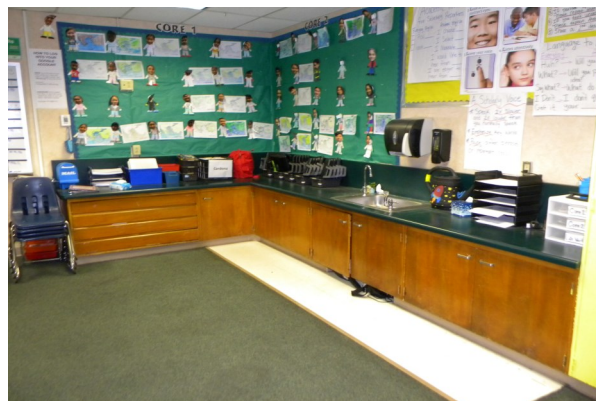
All cabinetry has surpassed its expected life cycle.

It is recommended that all cabinetry be replaced with new cabinetry meeting the district standards included new Teaching wall units at each classroom.

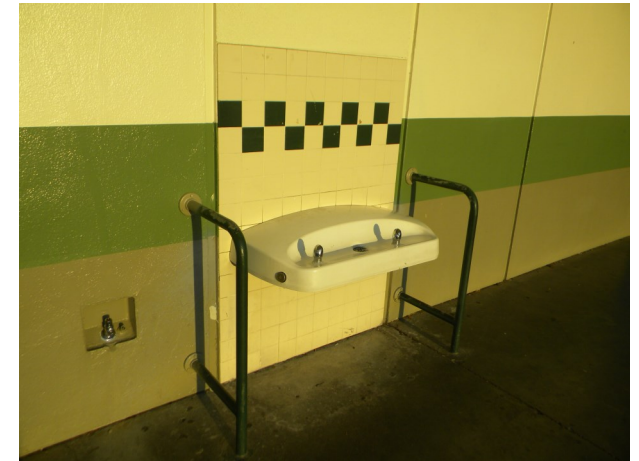
Exterior drinking fountains have been upgraded or replaced to meet ADA requirements. The

new standard for the District and ADA is a combination high and low drinking fountain with a bottle filler. All of the drinking fountains met the ADA requirements at the time of installation but no longer meet current code.

It is recommended that at least two High and Low drinking fountain be installed at the exterior locations in the future.

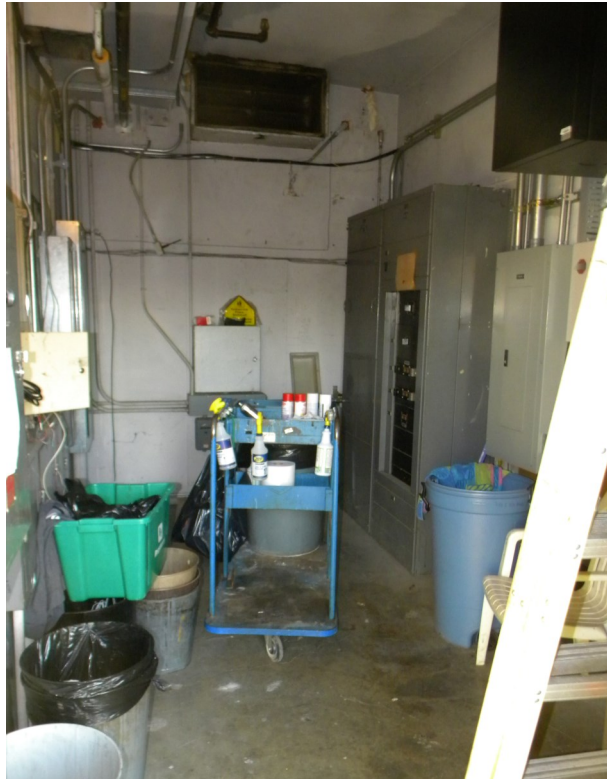
It has been reported that the MDF is used as storage which does not meet the District standards. It does not currently have air conditioning in the MDF room. The lighting in the MDF roof

is insufficient.

It is recommended that the MDF room be converted not be used as a storage room and that the lighting and HVAC be added to this dedicated room.
