Shirakawa Elementary

665 Wool Creek Drive, San Jose, CA

Shirakawa Elementary School - Master Planning Evaluation

Evaluation Summary

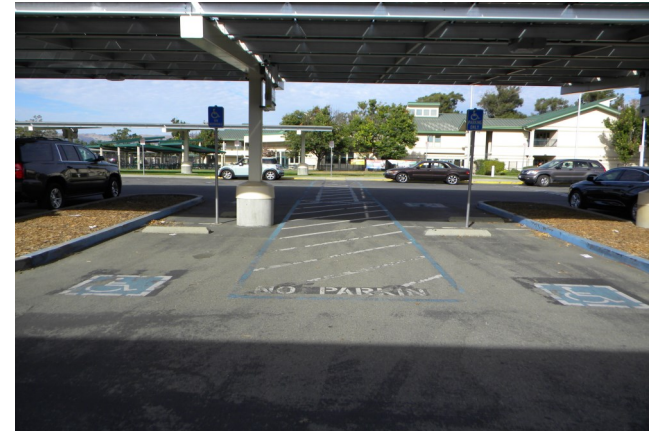
The school shares a large parking lot with the neighboring District Service Center. There is a separate bus drop off area at the side of the school in between the school buildings

and the paved play and grass areas. Both parking and drop off areas are in fair condition.

It is recommended that the parking lot be altered to include a better layout for the drop off area. It is also recommended that the bus drop off area be relocated and paved to expand the paved play area while altering the security fencing along a different location. The parking area should be slurry sealed and restriped in the next year.

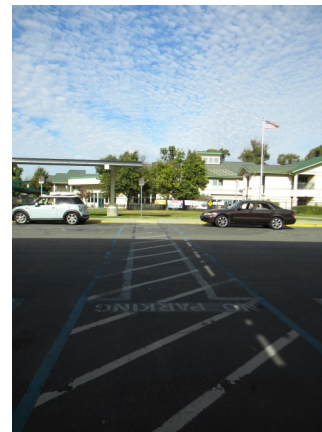
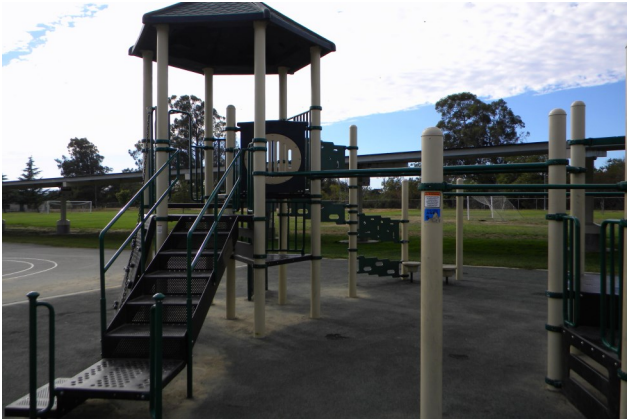
equipment for older students. The play structures are in good condition however the safety matting has surpassed its lifecycle.

It is recommended that the safety matting be replaced with new poured in place safety matting.

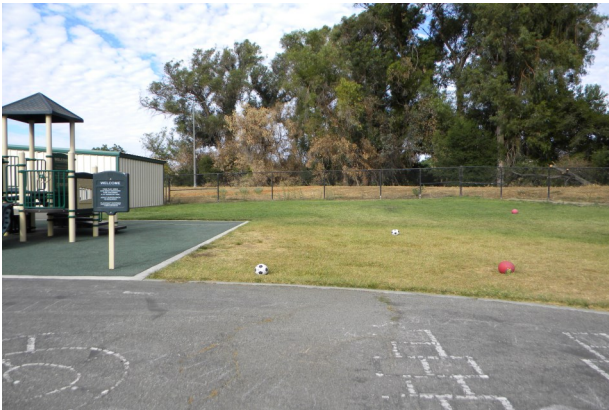
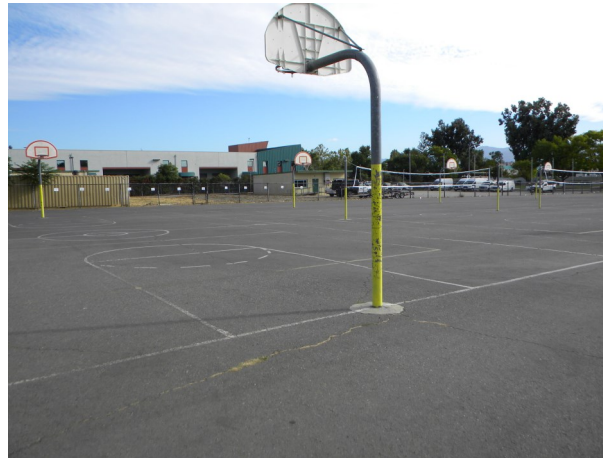
The existing pavement is in fair condition.

It is recommended that the upper grade paved play area be expanded and striped with relocation of basketball backstops in the new expand-

ed area. The existing pavement should be slurry sealed and restriped.

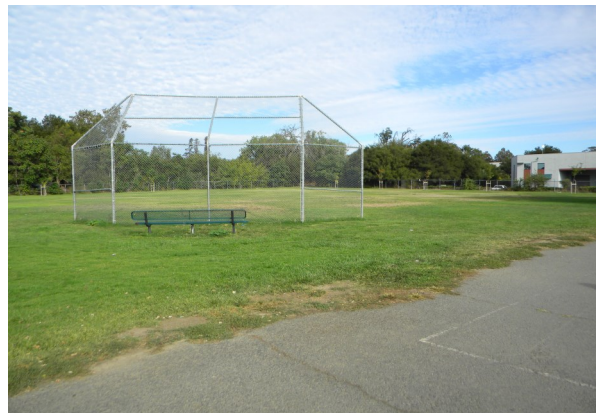
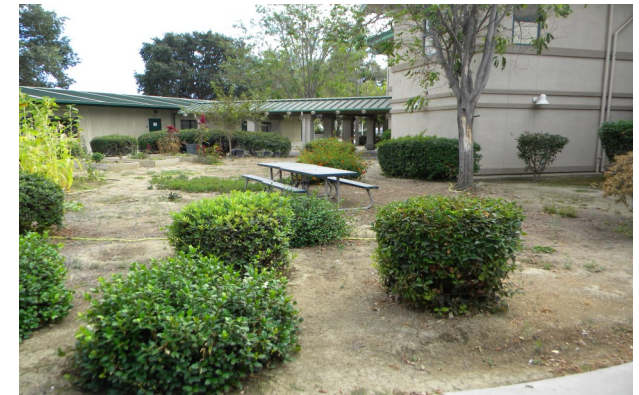
The turf area is in poor condition. This K-8 school should have a synthetic track installed similar to the other middle schools in the District.

It is recommended that the turf area be regraded, irrigated and reseeded to provide new grass area at the existing turf area. It is recommended that a new synthetic track be installed at this campus.

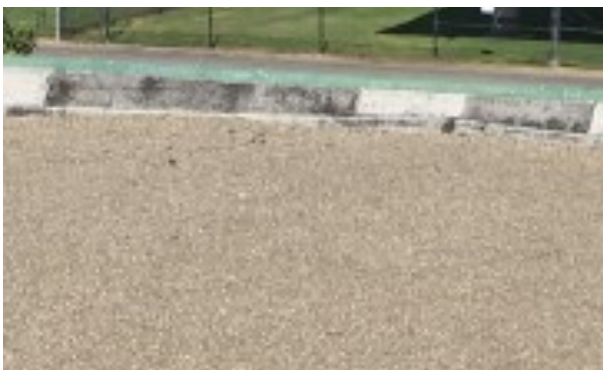
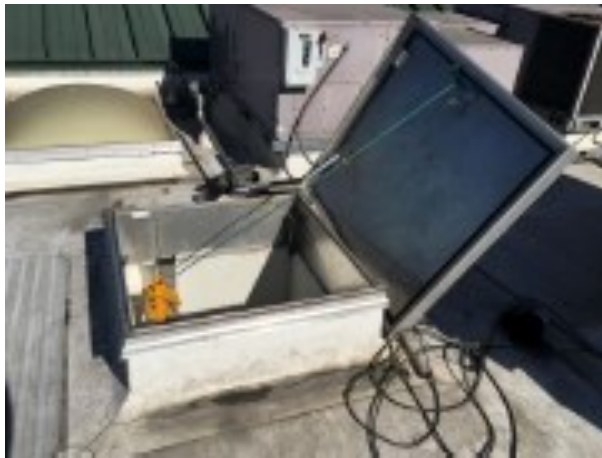
Based on the roofing report, the existing metal roofing is in good condition. There are some maintenance issues such as a perimeter flashing deterioration, a broken roof hatch and other issues that need attention at this campus. The built up roofing was installed in 1998 and is in poor condition.

It is recommended that the built-up roofing be replaced in the next few years and maintenance be performed on the roof hatch and perimeter issues as described in the roofing report.

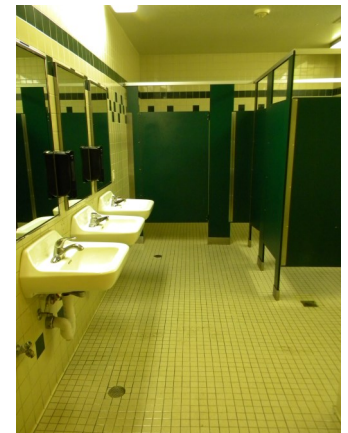
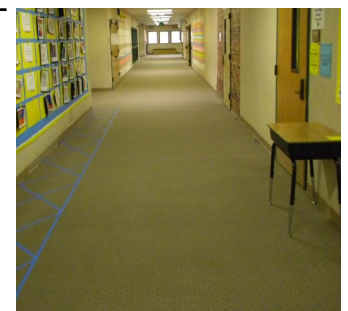
The carpeting in the classrooms is a woven product that is still in good condition. The hallways flooring is in bad condition and is in need of replacement. The existing rubber flooring material is failing in the stairwells.

It is recommended that the hallway flooring be replaced throughout the cam-

pus. The flooring material should be replaced with a more permanent flooring material in all of the stairwells.

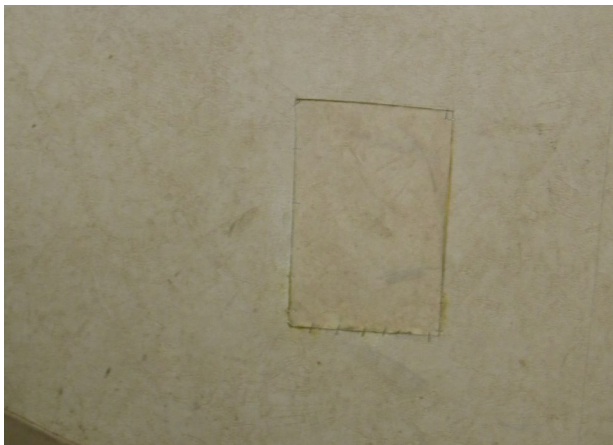
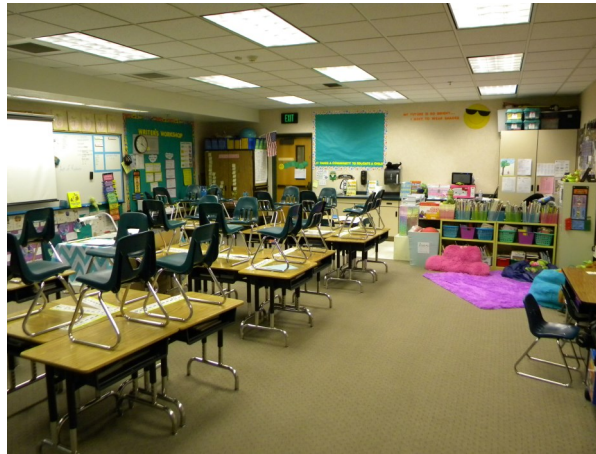
The existing vinyl wall coverings throughout this

campus are showing wear especially in the hallways where a large quantity of vinyl wall coverings is tearing from the walls.

It is recommended that the all of the vinyl wall coverings be replaced with a more durable wall surface material in the future.

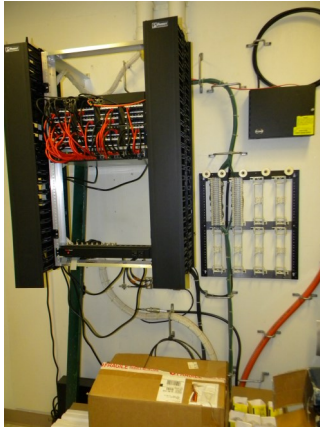
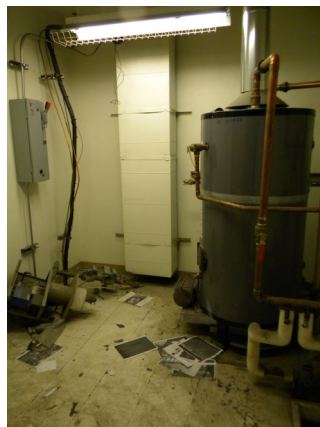
The existing IDF's are open rack and need to be converted to closed racks. The IDF room across from the library near room 106 is always warm as there is a transformer and a water heater sharing this room. It is reported that the IDF in the A wing is in a poor location and should be relocated.

It is recommended that all open racks be reinstalled into closed racks. A new air conditioner should be installed at the existing IDF room near the library and the IDF in

the A wing should be relocated.

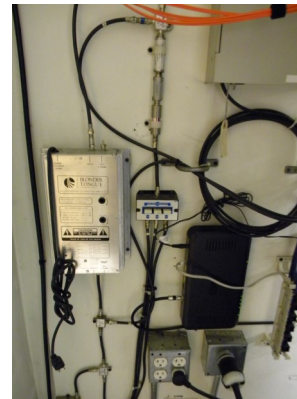
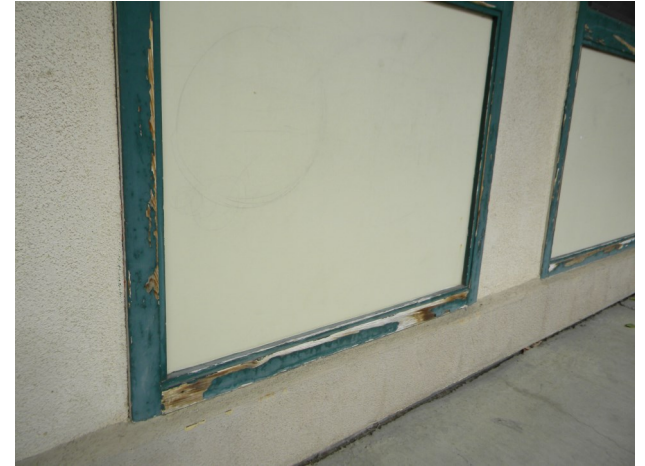
The existing portable buildings are permanent modular buildings. The older cluster of modular classrooms have trim that is separating and failing.

It is recommended that the existing trim at the existing modular buildings be upgraded.

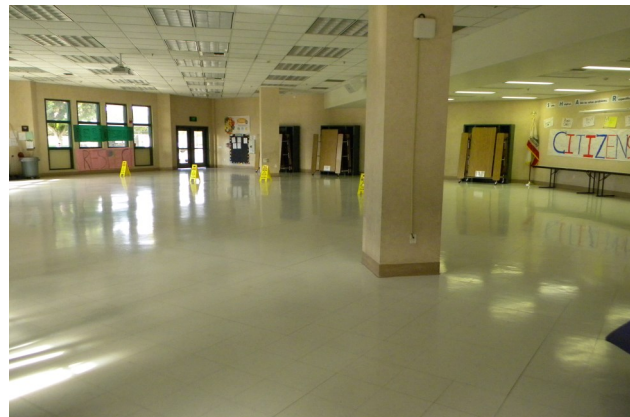
The existing kitchen and cafeteria are too small and should be expanded. The flooring is failing in this room. The serving area is using a speed line in lieu of a serving line.

It is recommended that the cafeteria and kitchen be renovated in the next five years.
