Stonegate Elementary

2605 Gassman Drive, San Jose, CA

Stonegate Elementary School - Master Planning Evaluation

Evaluation Summary

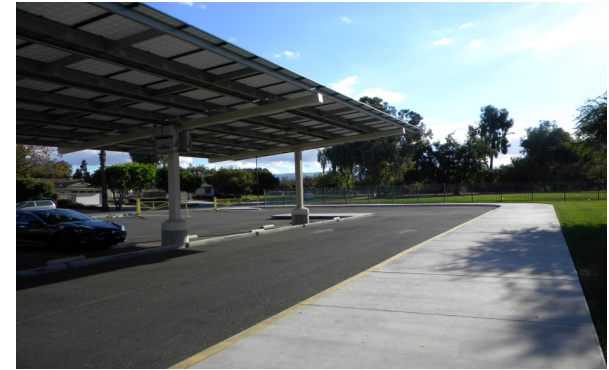
The staff parking lot shows signs of cracking and damage likely due from heavy vehicle trucks because of the trash enclosure location and kitchen loading area.

It is recommended that the staff parking lot be resurfaced and overlaid with new AC pavement and striping in the next two years.

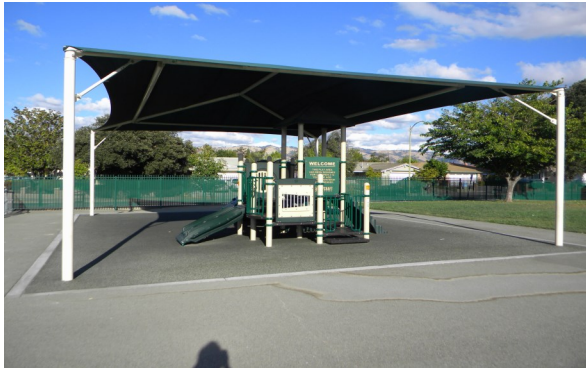
All three play structures on site were installed in 2014 and meet the district standards. They are starting to show signs of age from typical wear and tear.

It is recommended that the poured in place matting at the play structures be removed and replaced with new poured in place matting.

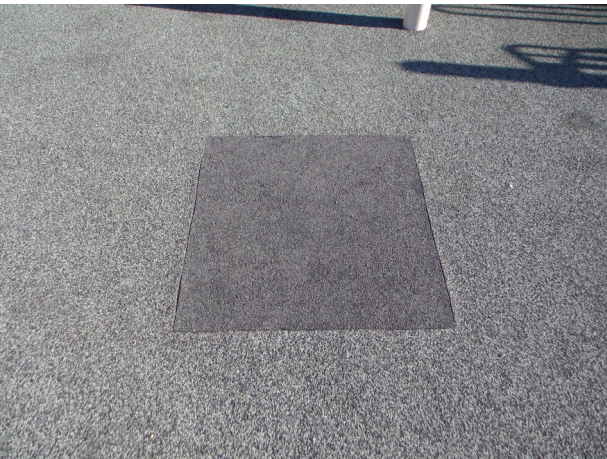
Overall there is ample paved play area at this site. The upper playground was expanded in 2014 and the remaining play area was not addressed at that time and is showing signs of failure from water intrusion. The lower playground is in in good shape.

It is recommended that the entire play area be replaced and restriped in the next 10 years.

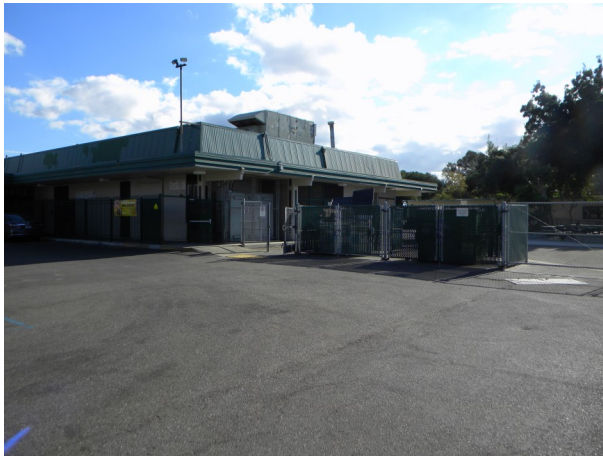
Underground utilities supplying gas and water to the site are over 40 years in age. The existing sewer system is composed of an antiquated clay piping system which allows tree roots to grip and break existing underground piping. These underground utilities have surpassed their intended service life. Replacing the underground utilities will drastically reduce the need for ongoing maintenance of these systems.

It is recommended that all existing underground utilities older than 40 years be replaced with

new utility systems. Underground water, storm, sewer and gas lines should all be replaced entirely at this site.

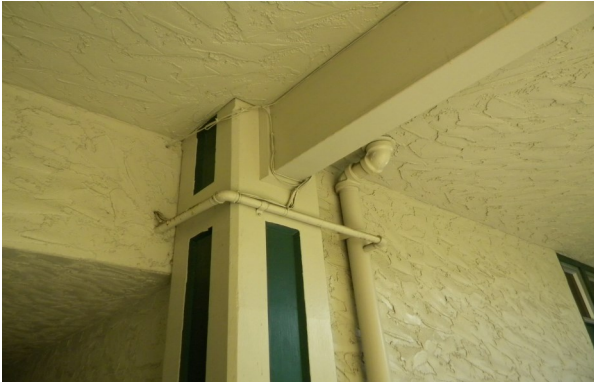
This campus was finished with a rough skip trowel plaster texture during its original construction. Walls facing the playground have signs of damage from ball impacts and general wear and tear. The existing trowel pattern is worn, dated and has surpassed its intended lifecycle.

It is recommended that all of the exterior walls at Stonegate be upgraded with new exterior stucco surfaces.

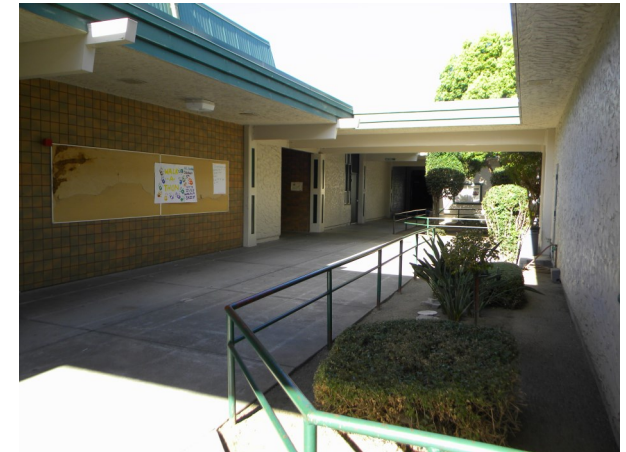
The covered walkways are extremely dark and should have the light upgraded or skylights installed.

It is recommended that new covered walkways be installed to connect all outlying classroom clusters with the main campus buildings. New skylights and lighting should be installed in all existing corridors and covered walkways.

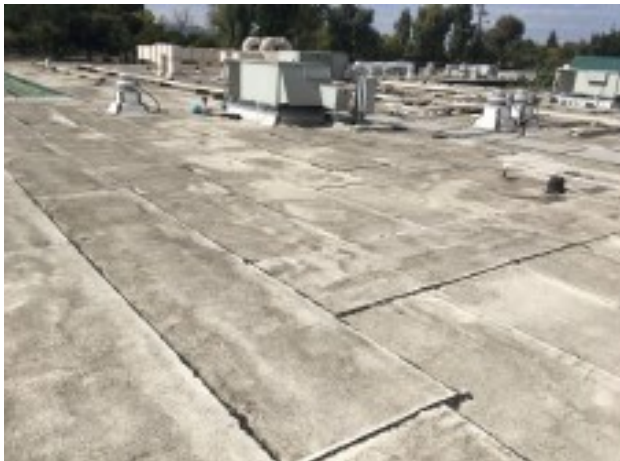
Based on the roofing report, it is reported that the roof surface throughout this campus has developed blistering which are beginning to crack and should be repaired right away. The existing curb flashing and seams have some deterioration.

It is recommended that preventative maintenance and repairs recommended by the roofing report be initiated.

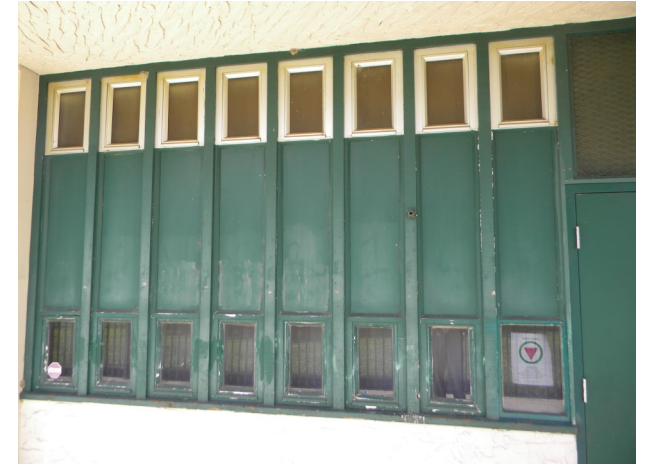
The original campus buildings were constructed in an era when natural resources such as natural gas and electricity were inexpensive. Windows are single glazed throughout and insulation does not currently meet new construction standards. The existing windows at this campus give the campus a negative appearance.

It is recommended that insulation be added to all exterior walls and added to all ceiling cavities. Windows should be replaced with a new fresh look that enhances the appearance of this campus.

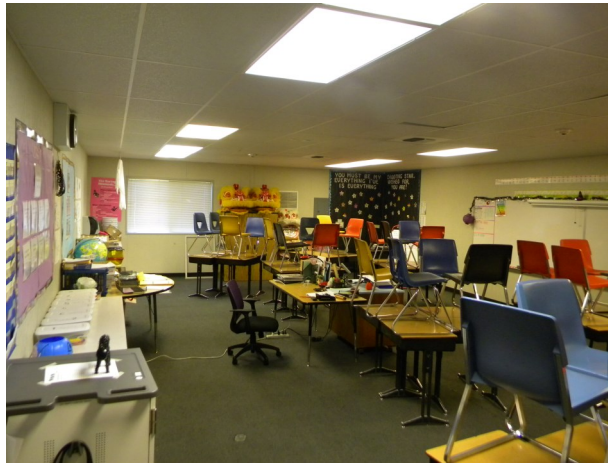
Most of the interior walls have vinyl wall coverings. Many walls tear or discolor at the seams or edge conditions.

It is recommended that walls be stripped of vinyl wall material and be replaced with other op-

tional wall materials such as impact resistant paintable surfaces.

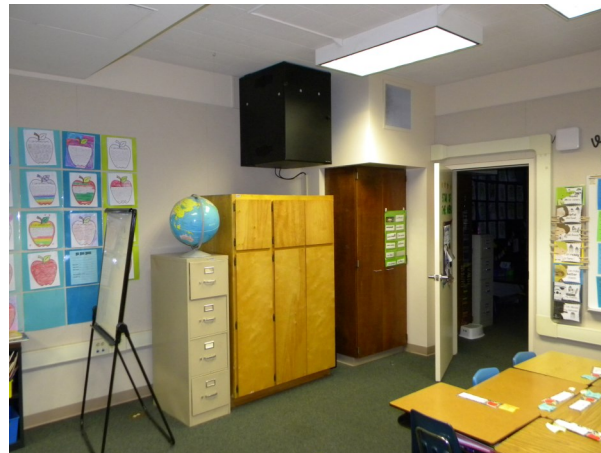
It is reported that the MDF is in a room without air conditioning.

It is recommended that air conditioning be added to the MDF room.
