Sylvandale Middle School

653 Sylvandale Avenue, San Jose, CA 95111

Sylvandale Middle School - Master Planning Evaluation

Evaluation Summary

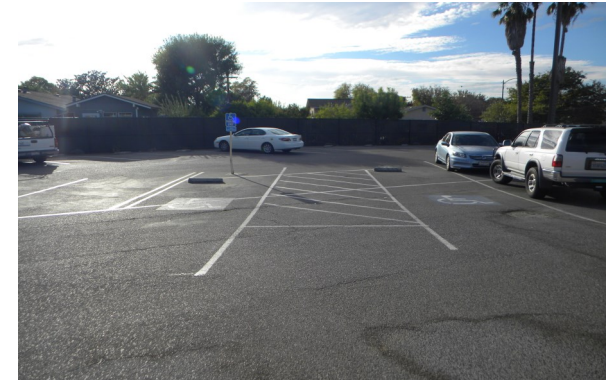
The parking lot at the rear of the campus near

the gymnasiums is not used. The entrance has been gated off, it lacks lighting and the landscape is generally over grown.

The main staff parking lot is small, narrow and long but does appear to be adequately sized for the staff count. It does have signs of damage from water intrusion and heavy vehicle usage. At some point the parking lot received an overlay but the storm drain inlets and vaults were

It is recommended that the front drop off parking lot be expanded toward the existing buildings to allow for more visitor parking and increase the number of much needed parking spaces at this campus. The rear parking lot is not currently being used and there is no obvious resolution. The main parking lot should be slurry sealed and restriped.

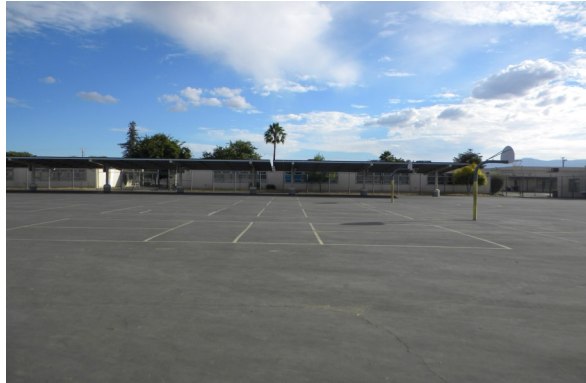
Sylvandale existing paved play area is in fair condition. It was re-slurried and striped in 2017.

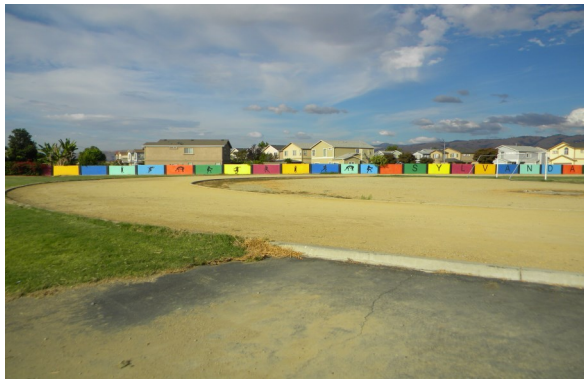
The existing sports play field is natural grass. The existing track is constructed of decomposed granite.

For a middle school, it would be desirable to upgrade the standards of the track to a synthetic track and synthetic turf.

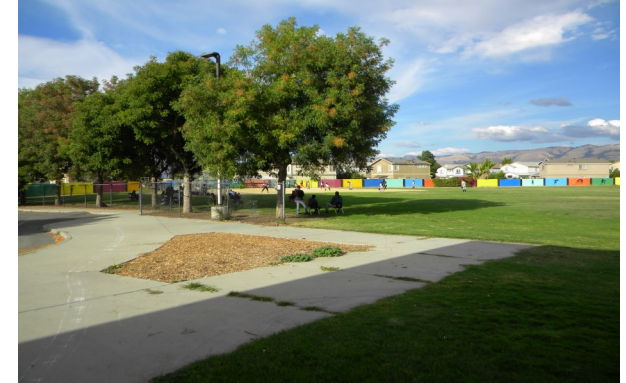
The front of the school has grass fed by domestic water. The rear play field is fed by a city supplied reclaimed water system.

A feasibility study should be completed to deter-

mine if all locations can be converted to reclaimed water system.

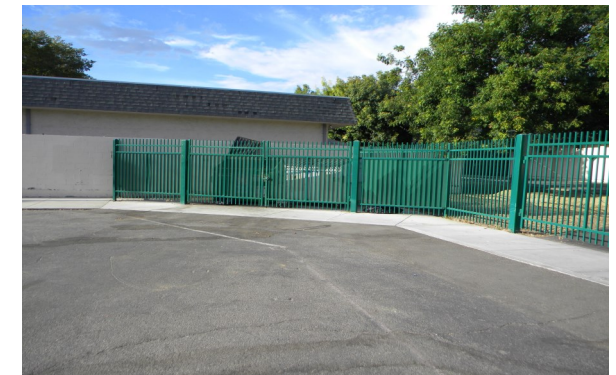
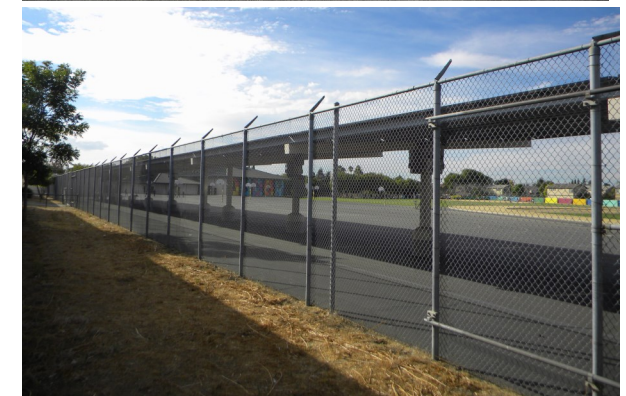
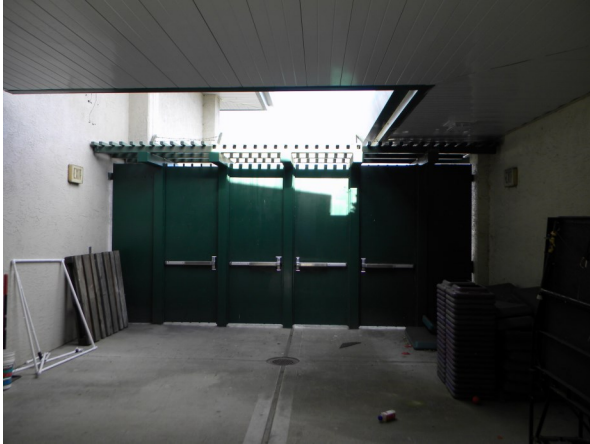
rimeter of the entire campus. There are areas at the existing gymnasium whereas exiting out has been locked from the outside which could create a safety issue. The existing fencing at the play area shows the old cleats that used to hold barbed wire.

It is recommended that because there are still existing exit gates that are locked from the outside which can create an exiting issue, a new way of existing out from the Gym needs to be added. The cleats should be removed from the existing fencing.

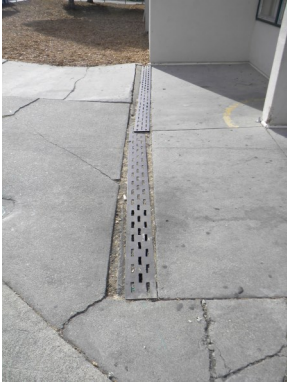
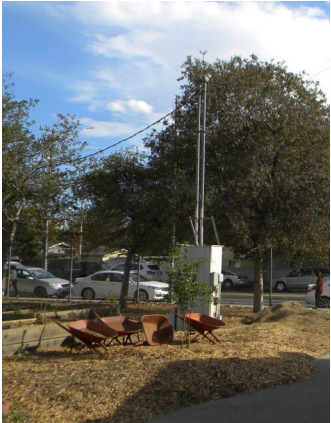
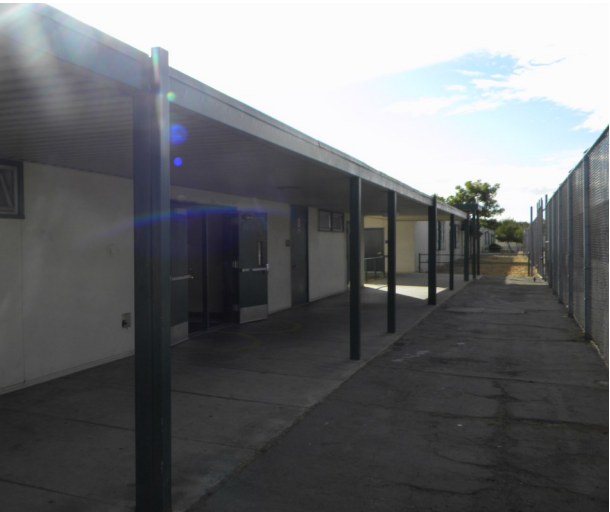
The existing concrete walkway system appears to handle foot traffic well at the site; however, several areas of the existing walkways have cracks and other signs of deterioration. There have been several trenching projects whereas the concrete has a lot of patching.

It is recommended that large cracked areas of the walkways be replaced to the nearest expansion joint. It is also recommended that walkways are removed where patching has occurred in the past.

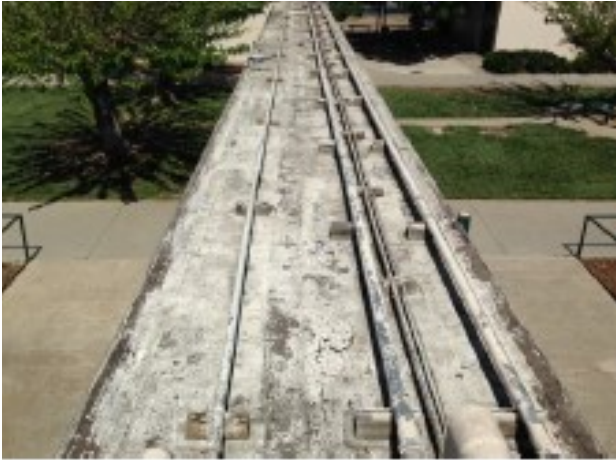
According to the roofing report, the existing roofing at this campus was installed in 1998. The roof is in poor condition. The covered walkway roof surfaces are deteriorating. The curbs and flashing are showing signs of deterior-

ration. The only roofing that is in good condition is the metal roof at the Gym.

It is recommended that the entire campus be reroofed with a new built-up roof with new flashing and gravel.

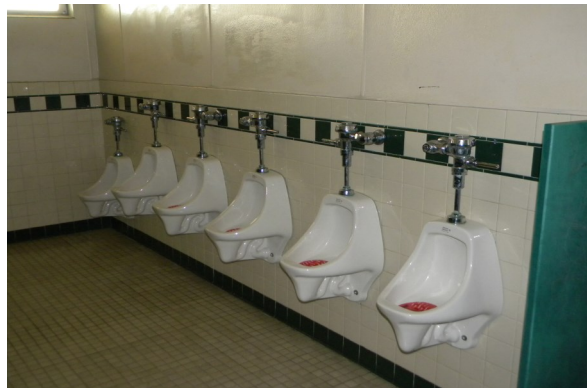
The existing restroom finishes were modernized in 2004.

It is recommended that all toilet partitions be replaced within the next 5 years as they are approaching their useful lifecycle. It is recommended that the floor grout be acid washed or steamed to remove cumulative coatings.

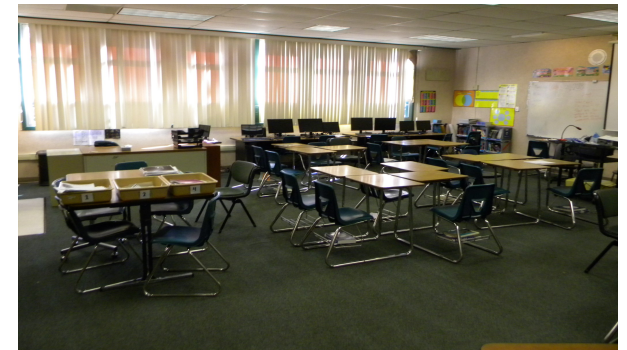
The flooring is older but has been well maintained. Floor carpeting can last for about 15 years. All carpeting at this site is approaching its useful lifecycle. The VCT flooring in corridors is in good shape but the rubber base is damaged in several locations from what appears to be insufficient backing at the wall to floor joint.

It is recommended that all existing flooring be replaced with new flooring throughout the campus.

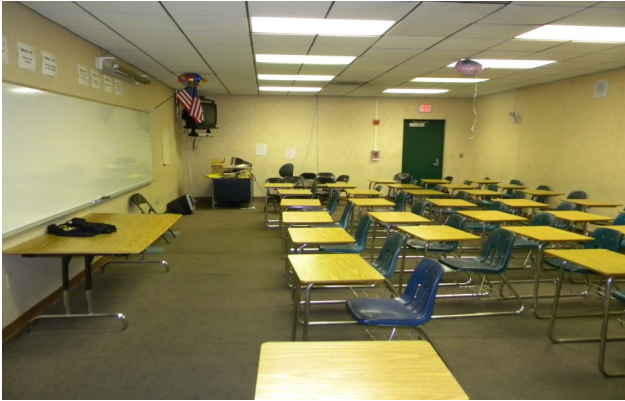
Many of the existing wall surfaces have vinyl wall coverings which are showing wear and beginning to peel away from the walls.

It is recommended that all new interior wall finishes be repainted and all existing vinyl walls be stripped and replaced with a new durable wall surface.

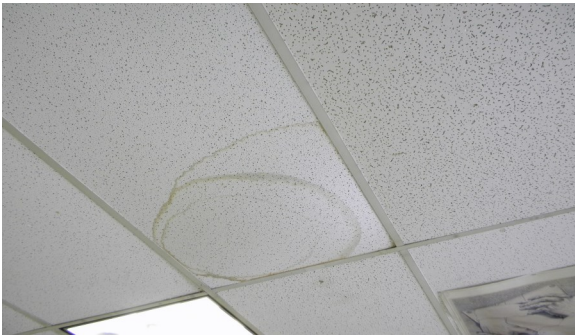
All suspended ceilings are in need of new ceiling tiles at several locations.

It is recommended that all ceiling tiles be replaced and the grid be painted. It is recommended that all hard lid ceilings be painted.

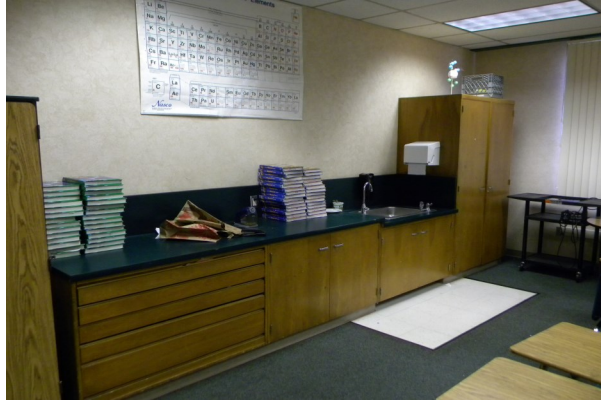
Although the counter tops were replaced in 2008 the cabinetry body and doors themselves are original. There are signs of abuse, vandalism and heavy wear and tear at some locations.

It is recommended that all cabinetry be replaced entirely throughout the campus and new District Standard teaching walls be added to all of the classrooms.

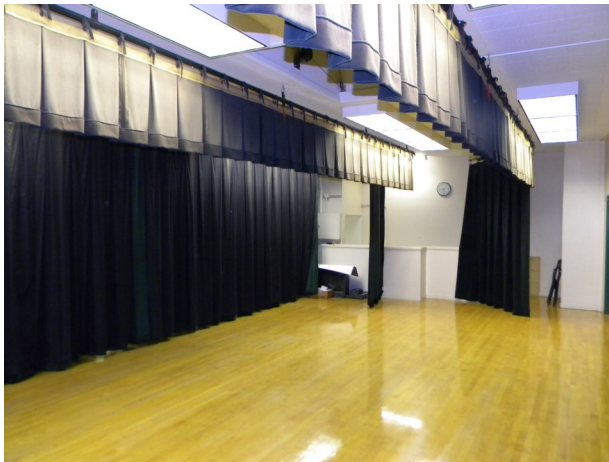
The Gymnasium is in satisfactory condition other than the older skylight system which is decaying and discoloring.

The cafeteria is adequate but should have its finishes upgraded. There have been complaints that there is no storage for the cafeteria space.

It is recommended the Gymnasium skylight be replaced, weight room / fitness center be upgraded and the cafeteria be upgraded with new

finishes. The curtain at the stage should be replaced with a new curtain. A new storage area should be added to the cafeteria.
