# Windmill Springs School

2880 Aetna Way, San Jose, CA 95121

## Windmill Springs School - Master Planning Evaluation

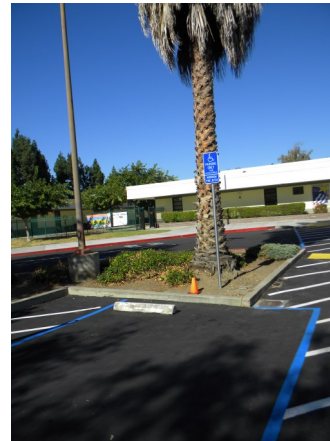
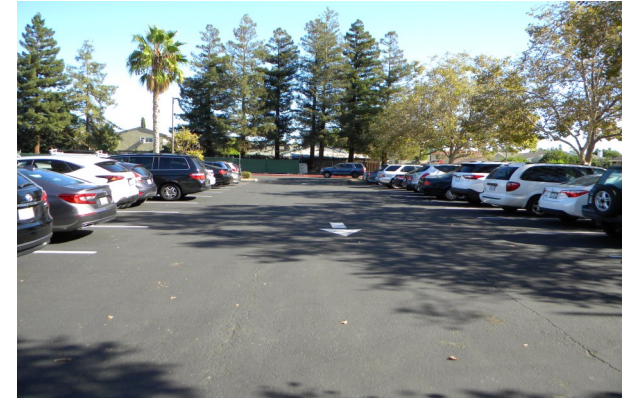
The parking lot was slurry coated and resealed during the 2018 modernization. Entry gates were added. Stalls have been restriped and labeled. Signage was upgraded.

The parking lot was not replaced and there are signs of water damage. It is recommended that the parking lot be completely removed and replaced in the next 10 years.

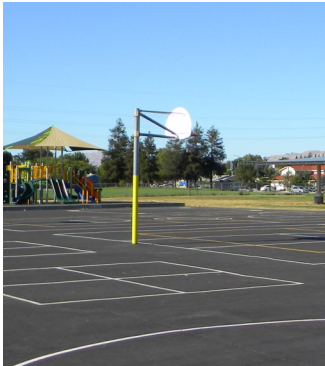
The entire play area was resealed and re-stripped during the modernization. Previous jagged edge transitions and sunken utility trenching were repaired, however some of the pavement was not completely replaced and there are signs of water damage. It should be completely removed and replaced in the next 10 years.

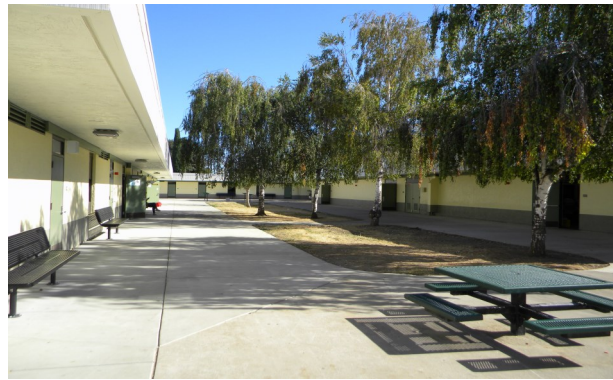
The existing turf is in fair condition. The base of the turf area is uneven with several holes and

tripping hazards. The decomposed granite walking track has deteriorated.

It is recommended that the turf be leveled, removed of vermin, and replaced with new sod. The DG walkway should be replaced or at a minimum a new binding agent and sealant provided.

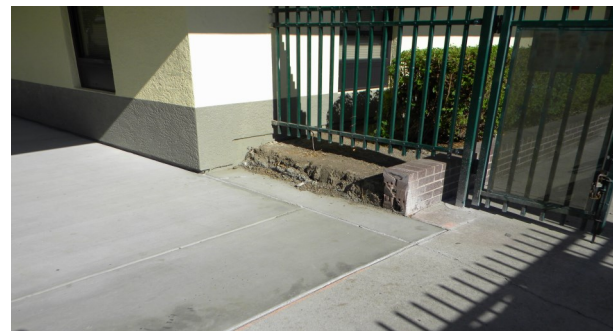
Landscaping for the interior courtyard have been replaced by synthetic turf and are in good condition. The kindergarten play field area has no irrigation and is in need of replacement.

The irrigation controller is outdated and should be replaced.

It is recommended that irrigation system be replaced with new zones identified.

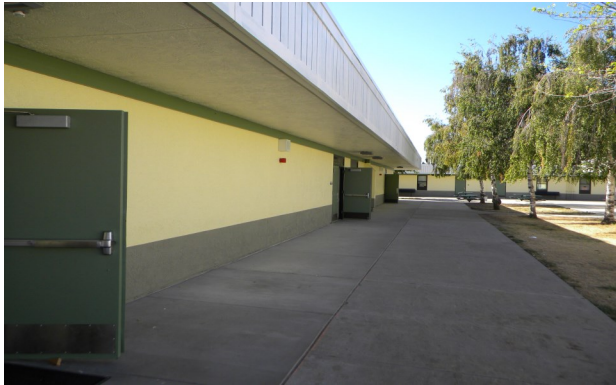
Although most of the exterior lighting has been

upgrade some of the existing exterior lighting is inadequate at the rear of the campus.

It is recommended that new site lighting be added as necessary to make the campus safer at night.

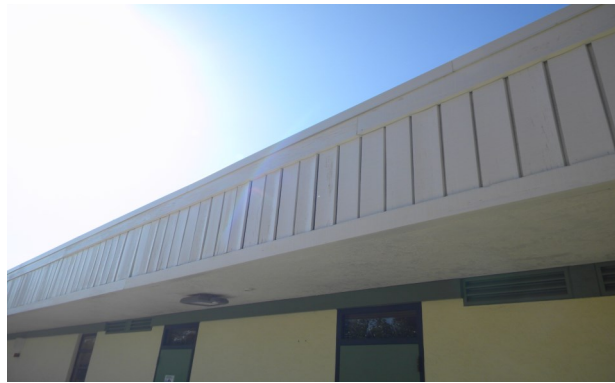
The stucco and paint are overall in good condition. The wood fascia was replaced and painted during the modernization. Wood siding is not a long lasting material.

It is recommended that the upper wood siding fascia be replaced with a long lasting material

throughout the campus.

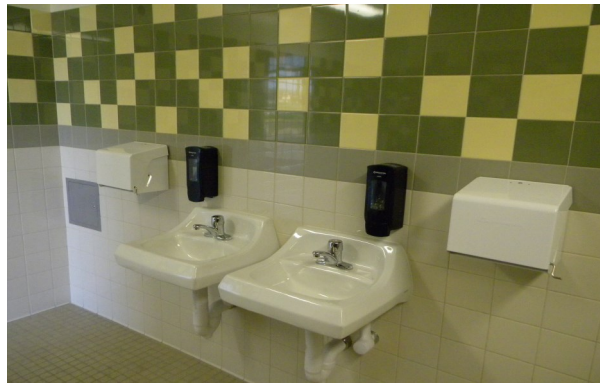
There was one staff single accommodation restroom that was not included in the modernization that should be upgraded.

It is recommended that the single staff toilet room be fully modernized.

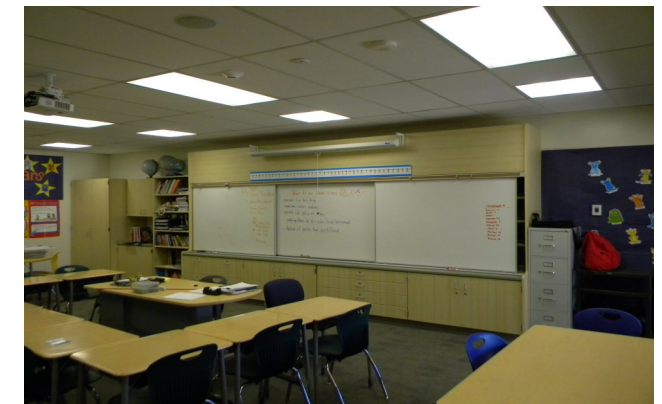
All cabinetry at this campus were replaced in the 2018-2019 modernization with the exception of the staff lounge casework and the mail slots.

It is recommended that the mail slot and all cabinetry in the staff lounge area be replaced with new cabinetry.

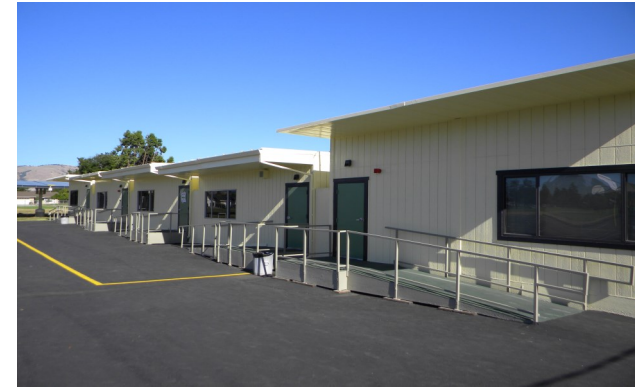
This campus has six existing portable classroom buildings at this campus. Two of the portables are 20 years old and the others average 15 years old. They are aging well but are approaching their life expectancy.

It is recommended that all portable classrooms be replaced with permanent classroom buildings.

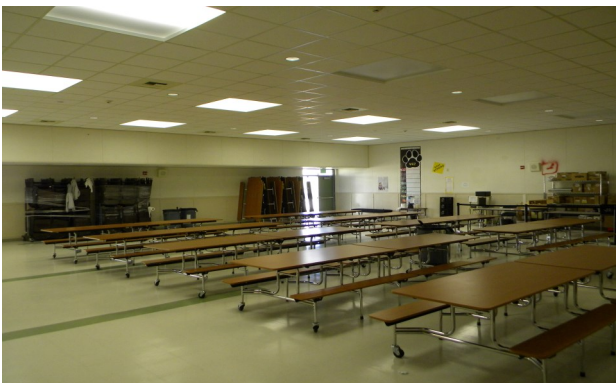
The kitchen and cafeteria were renovated during the 2018-2019 modernization.

It is recommended that in the future, the walls in the cafeteria be surfaced with a more durable material.
