# Brooklyn City School District – Facilities Renovation Studies

June 2023

# High School Facility Assessment

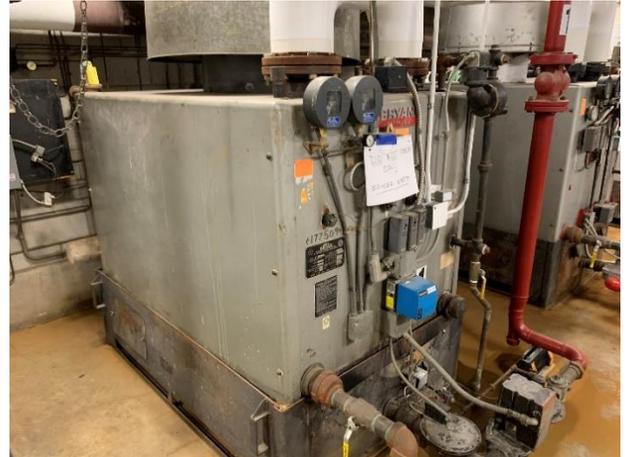
The original facility along, with all additions except the 2015 addition, are heated from 3-Bryan boilers that are over 40 years old and in poor shape. These boilers provide heating hot water to cabinet unit heaters, unit heaters, unit ventilators, convectors, heating only air handling units and other miscellaneous type heating devices.

Bryan Boilers

Provide overall new heating systems including air conditioning, in all areas except the 2015 addition. Provide funding for upgrading the non-ducted system to a ducted system in the original 1958 areas served by the unit ventilators.

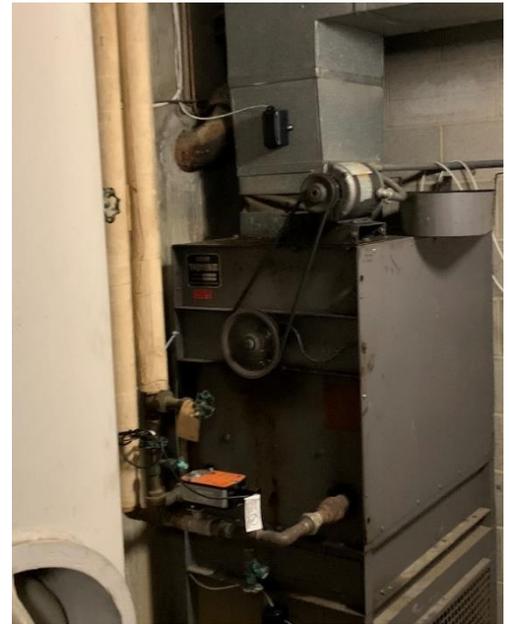
The Northwest Gym is served by 2 indoor, heating only air handling units that are approximately 4 years old and in good shape. The basement level locker rooms and wrestling room is also served by indoor, heating only air handling units located in the basement mechanical room. The band and choir rooms have indoor, air handling units that also have DX cooling coils and outdoor condensing units. Smaller roof top HVAC units were installed around 10 years ago and serve the second-floor computer room, board offices, and administrative offices. These roof top units are approaching the end of their useful life and should be replaced.

Heating only AHU serving Basement

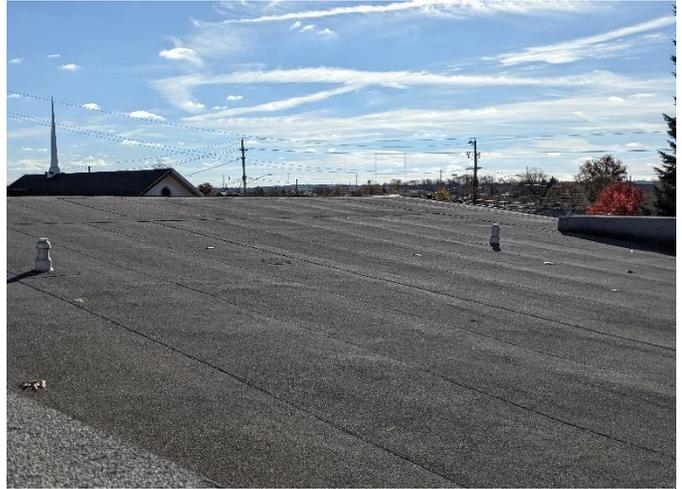
The roof over the Original Construction is a TPO membrane and built-up asphalt system. The TPO membrane was installed in 2015 and 2020, and is in good condition. The installation of the built-up asphalt roof is unknown, and it is in fair condition.

Roofing over Original Construction

The built-up asphalt roofs require replacement to meet Ohio School Design Manual guidelines for age of system. This is currently in the roof maintenance plan but will be accounted for in the costings.

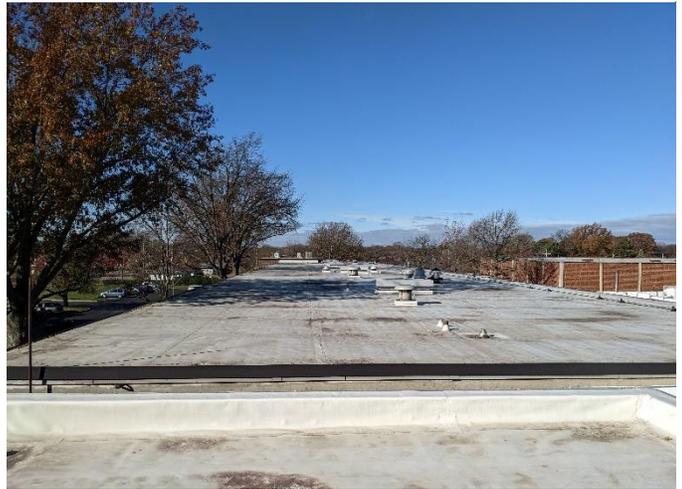
The roof over the 1957 Addition is a TPO membrane system that was installed in 2015 and 2020, and is in good condition.

Roofing over 1957 Addition

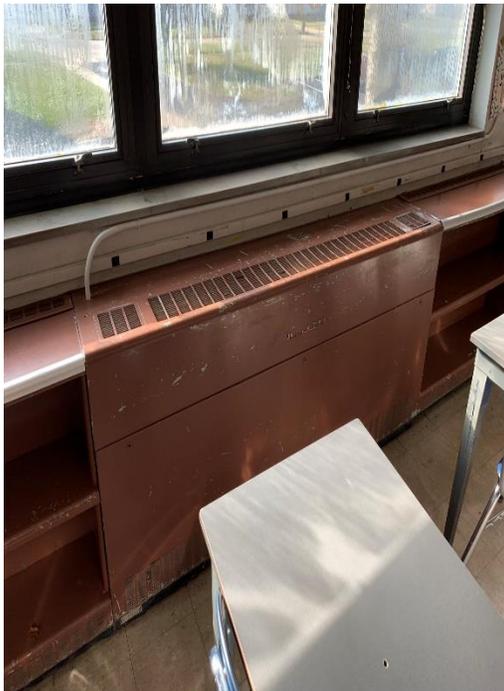
Unit Ventilator without AC

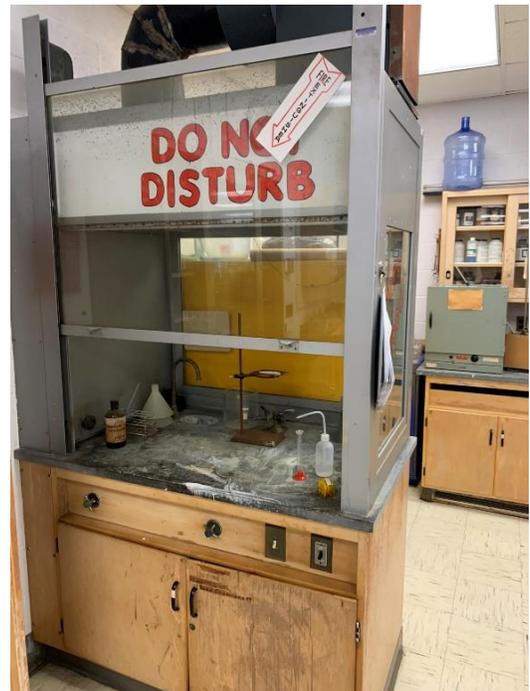
The art room has a kiln, and it has the proper exhaust. The scene shop does not have a dust collection system and one should be present. There are 3 science rooms, and 1- art room that does not have a general exhaust and should. The chemistry room has a very old lab hood that should be replaced. All these areas fall within the original 1958 portion of the facility.

Lab Hood

- Add dust collection system to the scene shop.
- Add 4 general room exhaust fans with controls.
- Add new chemistry lab hood to chemistry lab.

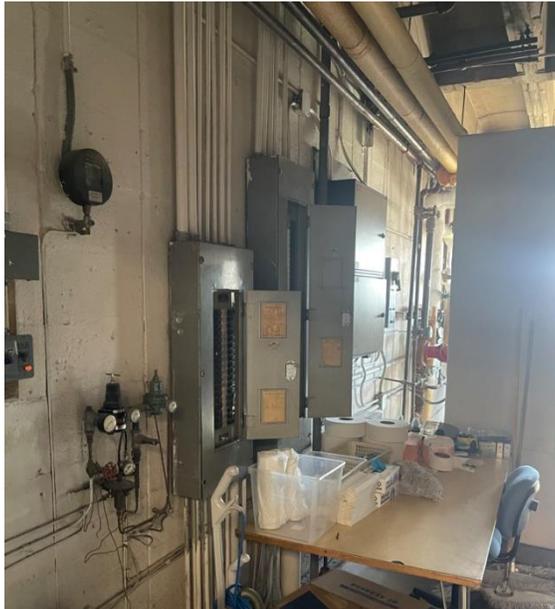
Electrical Panels

The entire electrical system in the 1951, 1957, 1958, and 1962 portions of the building requires replacement due to condition and age, and for lack of capacity for additional circuits required in Classrooms. The distribution panels are obsolete and new breakers are not available.

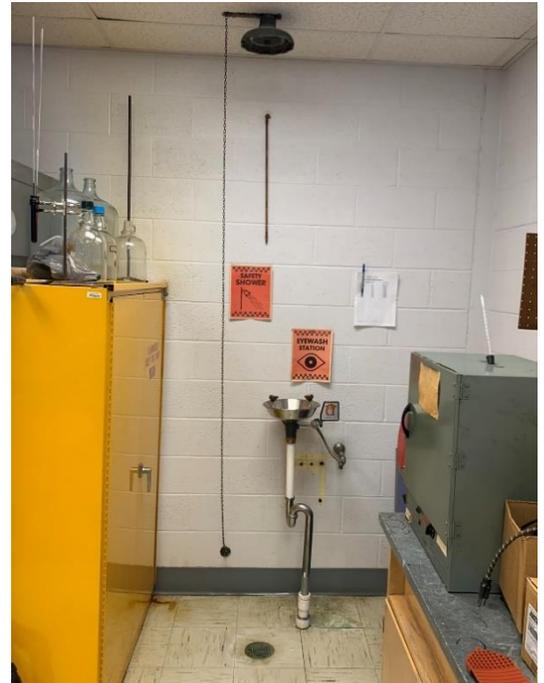
Emergency Eyewash/shower

- Replace 2 Domestic Water Heaters
- Replace 21 water closets due to age and condition.
- Replace 6 urinals due to age and condition.
- Replace 29 lavatories due to age and condition.
- Replace 8 electric water coolers.
- Add one emergency eyewash / shower combination.

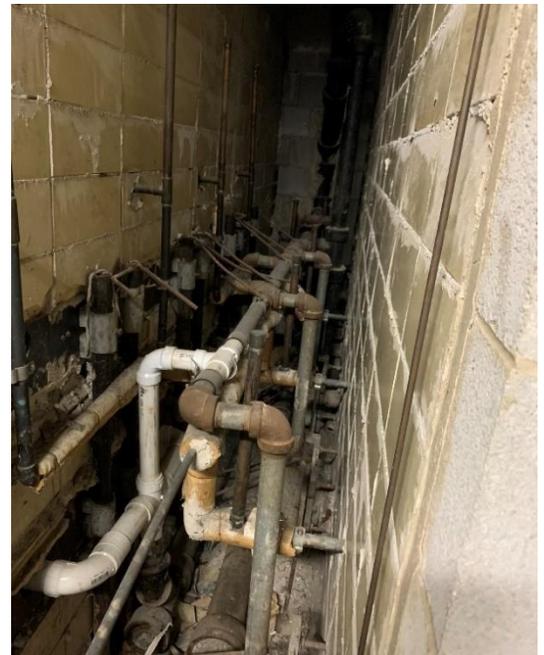
Plumbing chase

Replace all the domestic water piping in the 1958 original facility.  
 Add acid waste piping to the chemistry room.

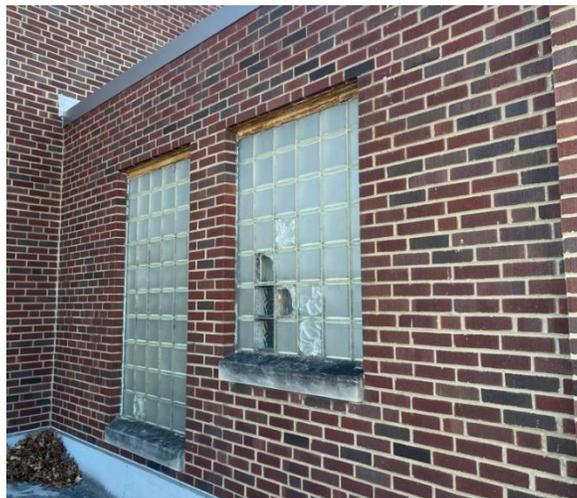
Glass block windows

Replace the existing glass block in overall facility with a new insulated window system to match existing insulated system and comply with Ohio School Design Manual requirements. Replace skylights in the 1958 Addition.

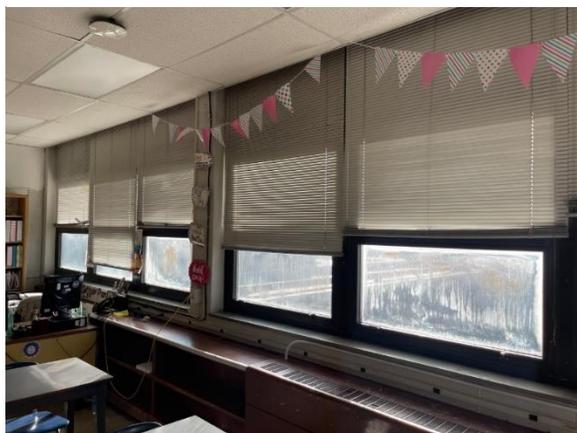
Typical windows with broken seals

Provide a new insulated window system with integral blinds due to condition and to meet with Ohio School Design Manual requirements. Replace storefront window system. Add electric blinds in high school reception due to window orientation for interior comfort.

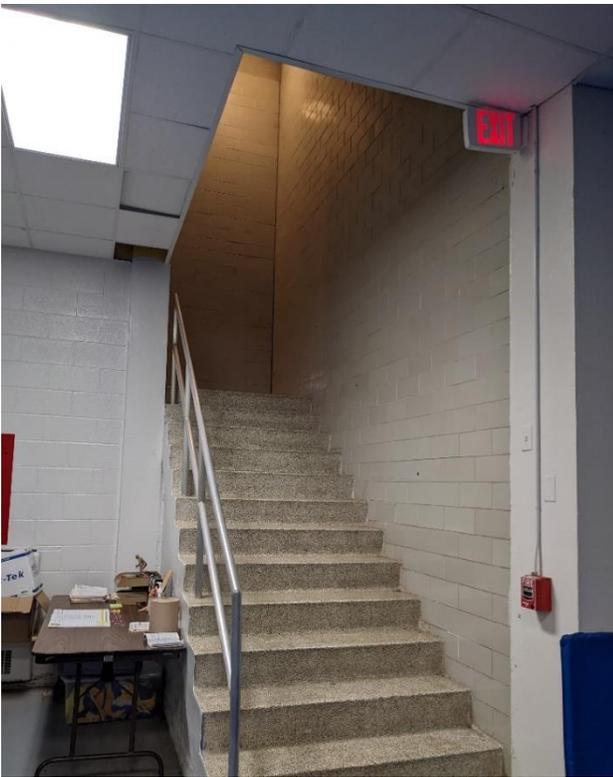
Wall where leaking previous occurred

Provide sprayed on membrane waterproofing system in basement location.  
 Provide drainage tile system at the basement in conjunction with the waterproofing to prevent any future flooding.

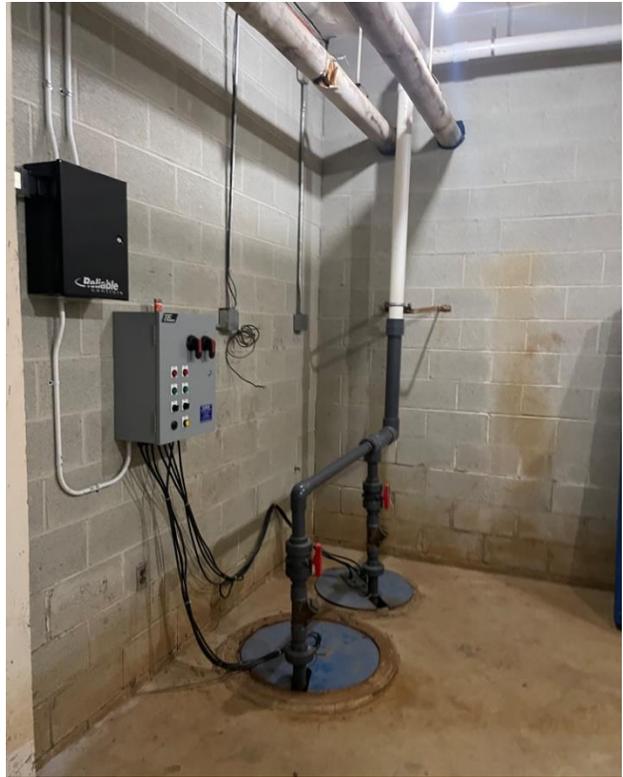
Pumps for basement

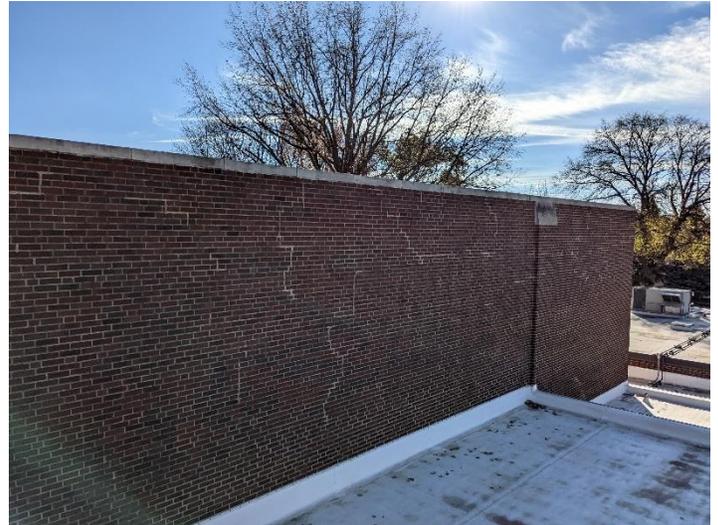
The exterior masonry has not been cleaned and sealed in recent years, and shows evidence of mortar deterioration. The District has tuckpointed in several locations throughout the building, but all remaining locations show deterioration and should be tuckpointed.

Wall needing tuckpointing

Provide tuckpointing in all areas of mortar deterioration as required through the overall facility.

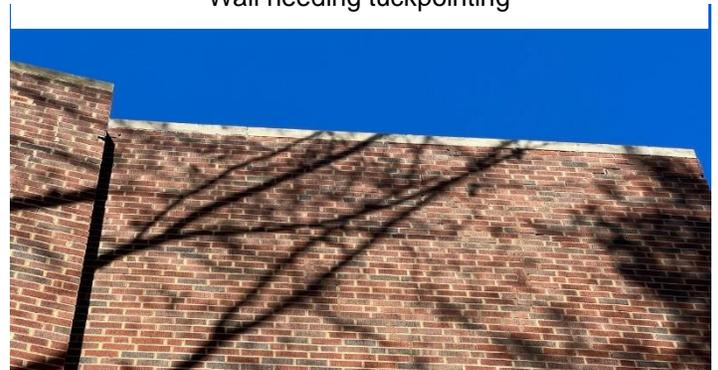
The overall facility has a brick veneer on load bearing masonry wall system, which displayed locations of deterioration, and is in fair and poor condition throughout. Primary areas of wall deterioration occur in the original construction at the auditorium. Significant masonry deterioration was documented at the parapet in this area.

Parapet needing re0built

Provide for masonry reconstruction of walls in original construction that were noted to be significantly deteriorated.

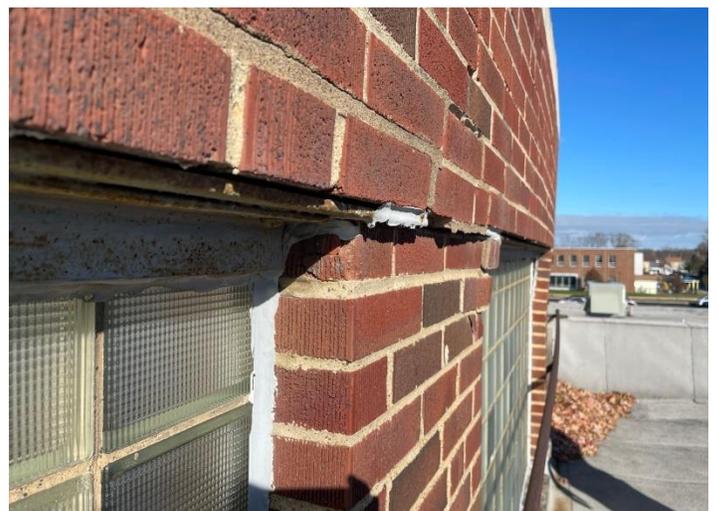
The window sills are stone, and are in fair condition. The exterior lintels are steel, and are sagging and rusting in several areas. Chimneys

Shifting parapet over lintel

Prep and paint exposed steel lintels through the overall facility. Replace delaminating steel lintels where required. Provide for the cleaning and repainting of exterior soffits.

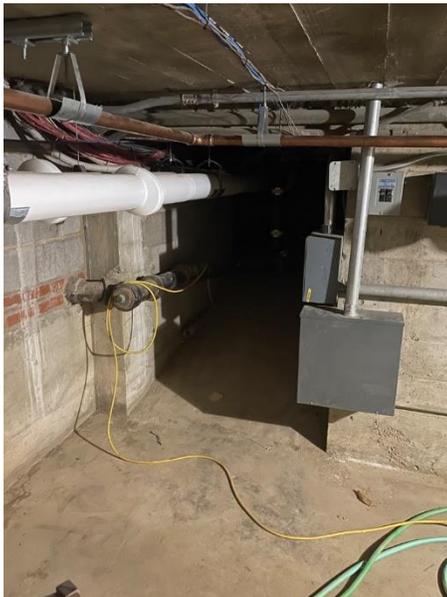
Crawlspace in Original Construction

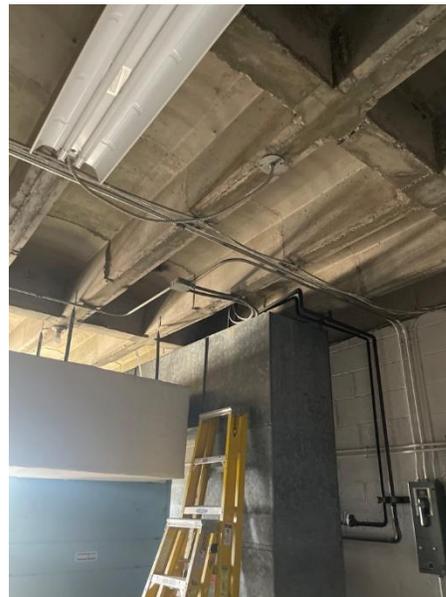
Precast concrete planks

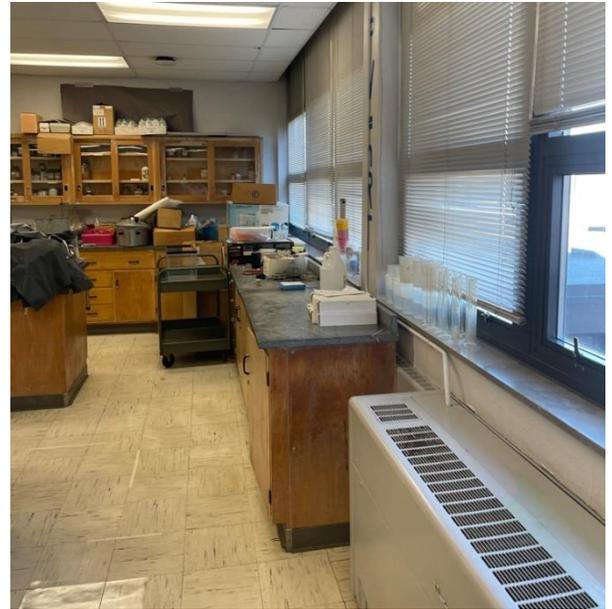
Science classroom casework is wood type construction with epoxy resin tops, is adequately provided, and in fair to poor condition. Science classroom typically had VCT floor finish in poor condition.

Science classroom finishes

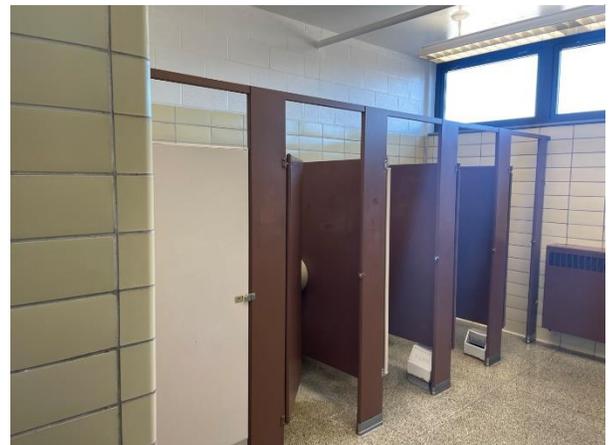
The 1957, 1958, and 1962 Additions have Restrooms with terrazzo type flooring, plaster type ceilings, as well as glazed block type wall finishes, and they are in fair but dated condition. Toilet partitions are metal, and are in poor condition. The restroom finishes and partitions in large group restrooms will be replaced under the ESSER program.

Restroom finishes

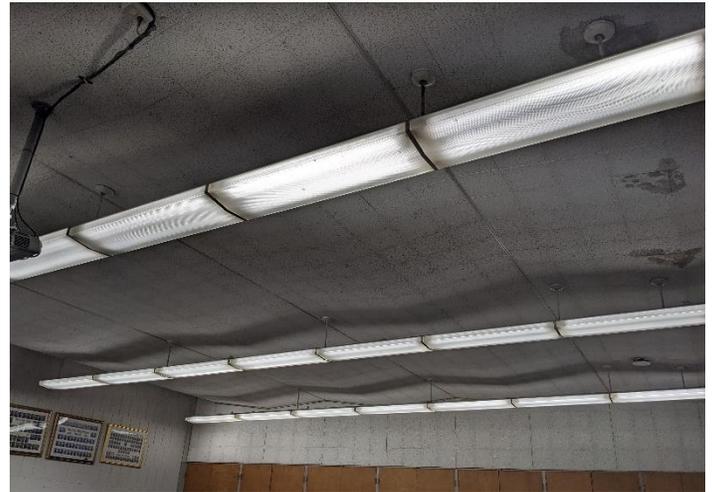
Fluorescent light fixtures

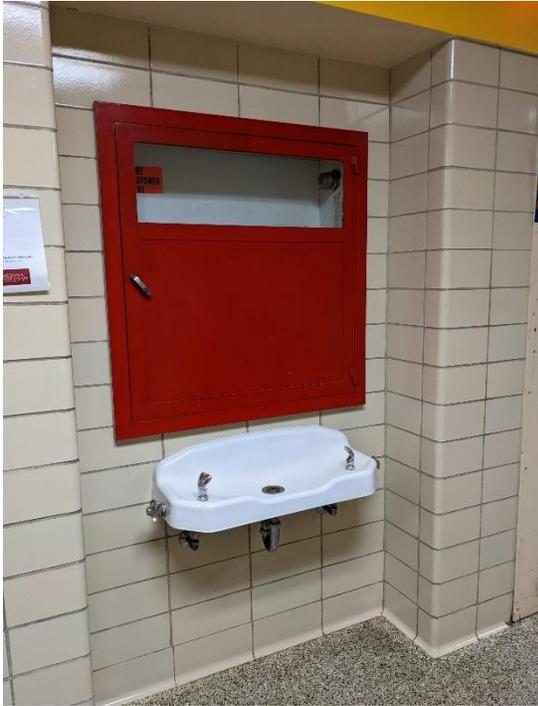
Inaccessible drinking fountain

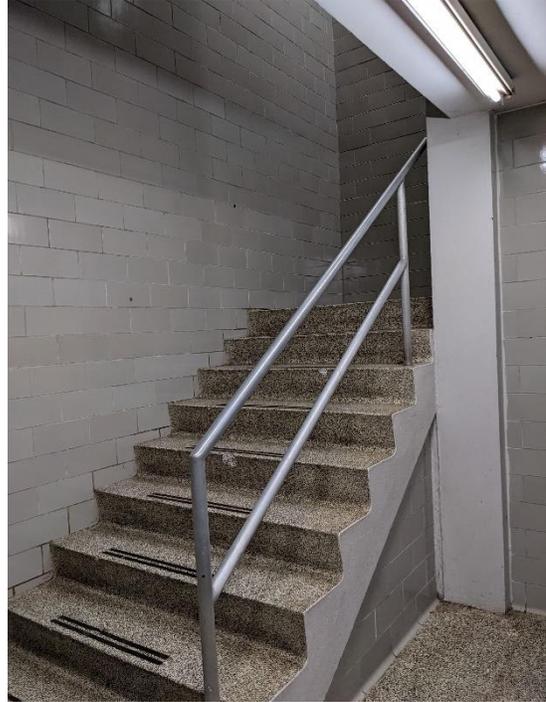
No ADA access to basement

Provide ADA-compliant signage, elevators for areas inaccessible, and doors and frames in the overall facility to facilitate the school's meeting of ADA requirements. Provide ADA compliant toilet partitions and toilet accessories per each level of the school building for staff and/or

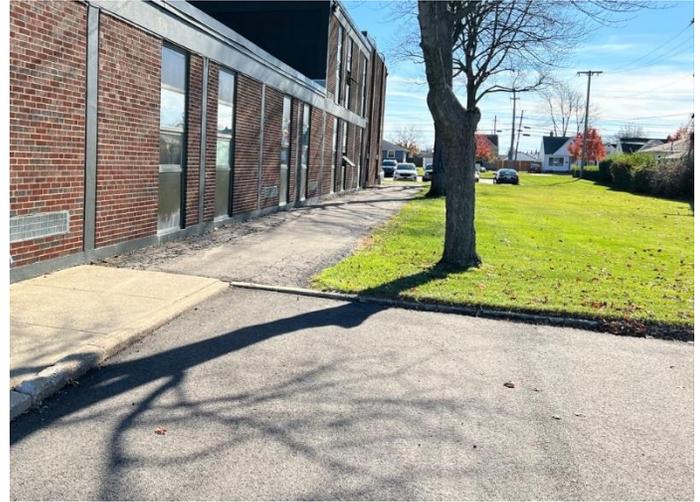
Sidewalk, curb, and asphalt condition

Provide for the replacement of curbs, concrete sidewalk, concrete in courtyards, and asphalt due to condition.

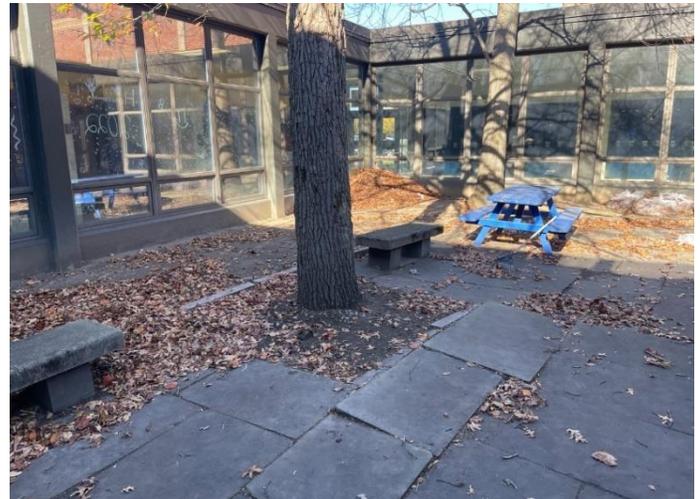
Courtyard condition

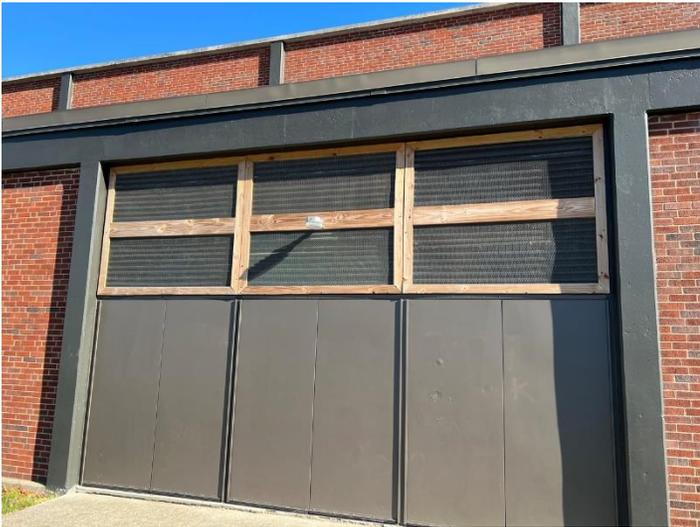
Exterior hollow metal doors

Replace all exterior doors to comply with Ohio Building Code, ADA, and Ohio School Design Manual guidelines.

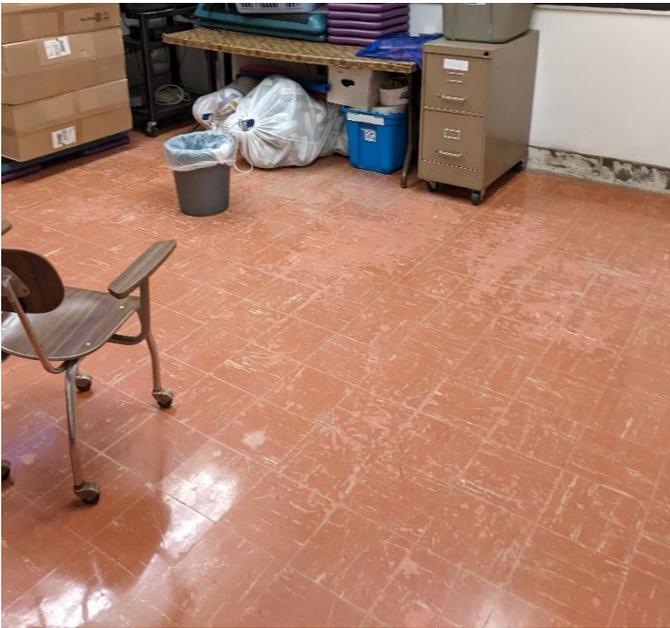
Asbestos floor tile

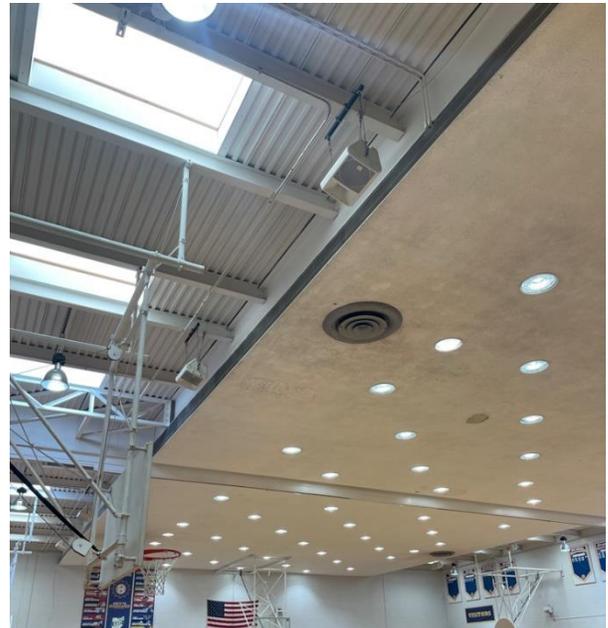
Gym soffit reported to contain asbestos

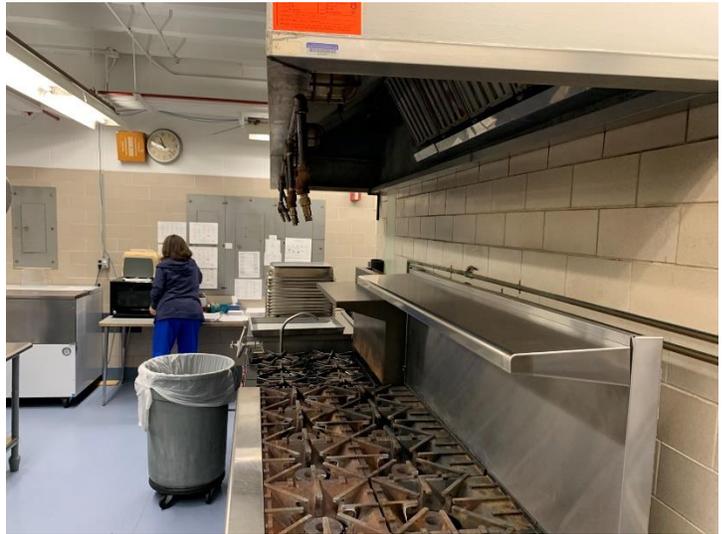
Non-conforming Type I kitchen hood

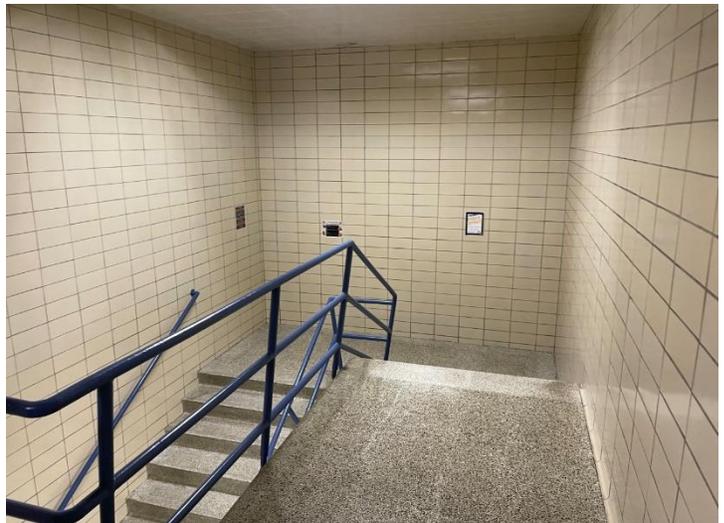
Non-rated stairwell
