FACILITY CONDITION ASSESSMENT

Ann Arbor Public Schools
2555 South State Street
Ann Arbor, Michigan 48104
Jim Vibbart

March 19, 2018

ALLEN ELEMENTARY SCHOOL
2560 TOWNER BOULEVARD
ANN ARBOR, MICHIGAN 48104

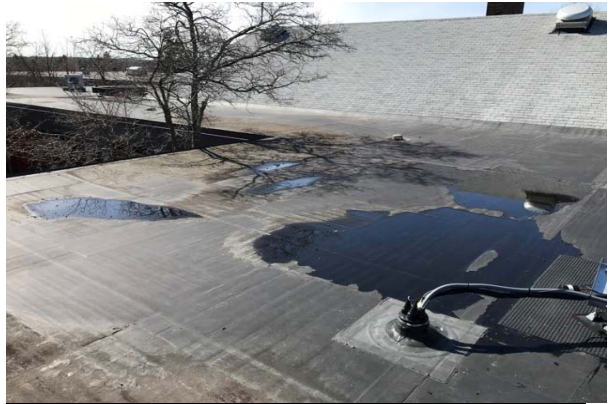
#8: FLAT ROOF, ISOLATED MINOR PONDING

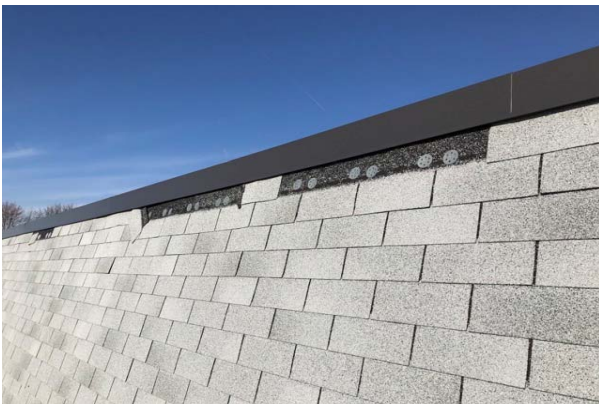
#11: MISSING ASPHALT ROOF SHINGLES AT MANSARD ROOF

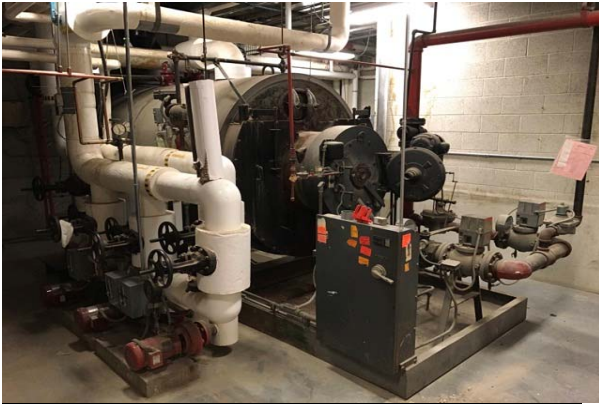
- Boiler #1 is significantly past its EUL, as it is original the building's initial construction. However, the unit is reportedly still functional. The boiler will likely require replacement with a more modern unit within the term.

#37: BOILER #1 (ORIGINAL)

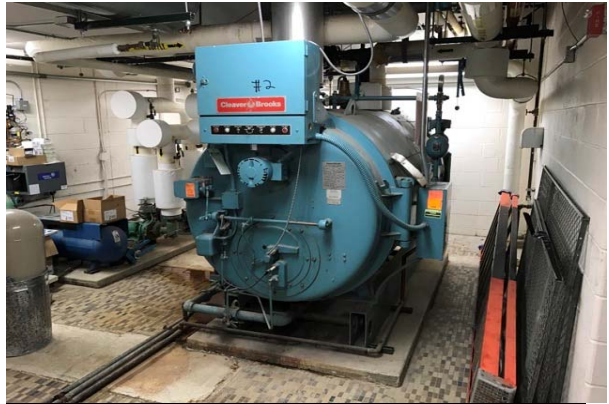
- Boiler #2 is past its EUL, but is reportedly still functional. The boiler appears to be leaking slightly, as water was observed on the floor of Mechanical Room B adjacent to the unit. The leak should be further investigated and repaired, and the boiler will likely require replacement within the term.

#38: BOILER #2 (NEWER)

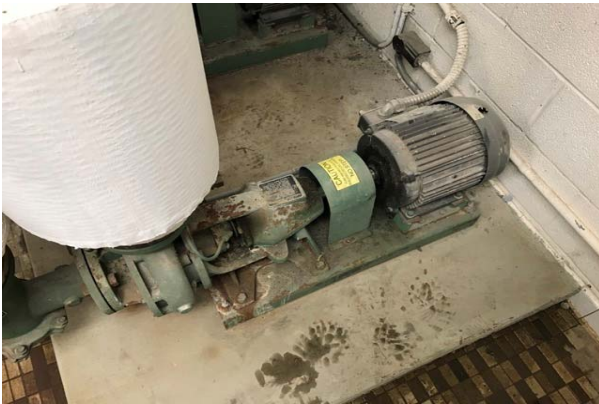
- The heating water distribution pumps appear to be past their EULs, but are reportedly still functional. Replacements will likely be required during the term.

#39: DISTRIBUTION PUMP, HEATING WATER

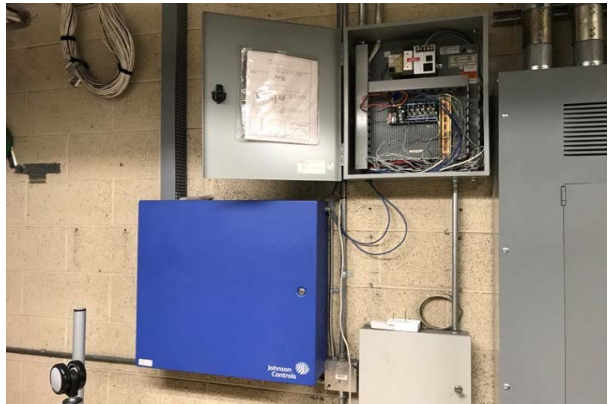
- The facility HVAC appeared to be at least partially controlled using an outdated pneumatic system supplied by an air compressor. For modernization, reliability, and increased control, full conversion to a web-based direct digital control (DDC) platform is highly recommended.

#40: BUILDING AUTOMATION SYSTEM

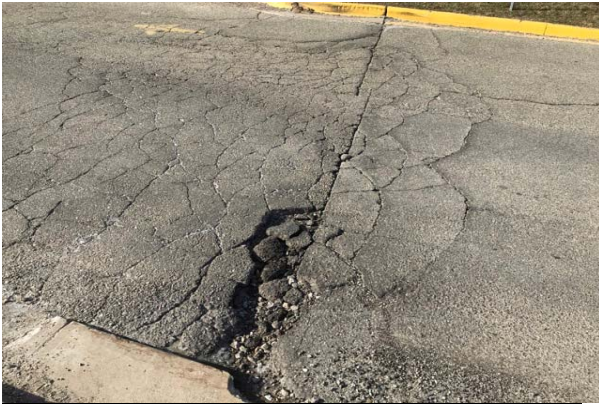
Site : The property's site is generally in good to fair condition, with isolated areas of damage and deterioration at the parking lots and sidewalks. The majority of other site components are in sound condition.

#49:	CRACKED AND DAMAGED PAVING AT DRIVE AISLE
------	---

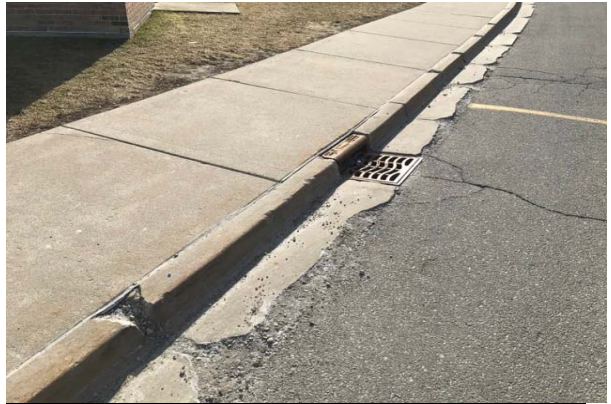
#50:	CONCRETE CURB DAMAGE
------	----------------------

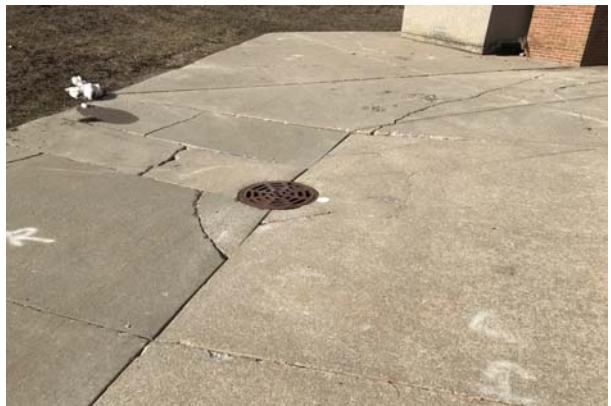
#52:	CRACKED CONCRETE SIDEWALK
------	---------------------------
