FACILITY CONDITION ASSESSMENT

Ann Arbor Public Schools
2555 South State Street
Ann Arbor, Michigan 48104

June 28, 2018

BRYANT ELEMENTARY SCHOOL
2150 SANTA ROSA DRIVE
ANN ARBOR, MICHIGAN 48108

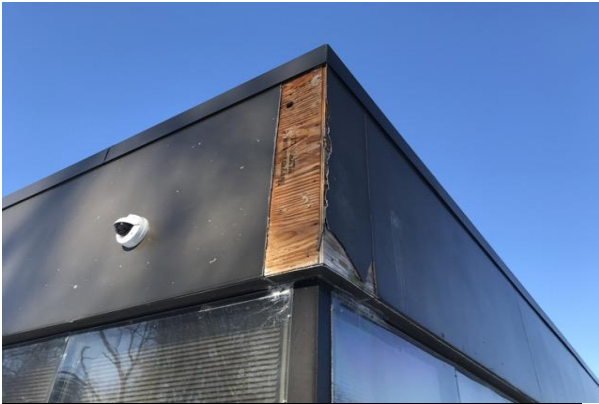
- The metal siding has significant areas of dented, damaged, and missing siding along the south and east elevations of the building. The damaged siding must be replaced.
- Isolated portions of the mortar joints along the brick veneer are cracked on all elevations of the building. The damaged mortar joints must be cleaned and re-pointed.

#7:	ALUMINUM SIDING, REPLACE
-----	--------------------------

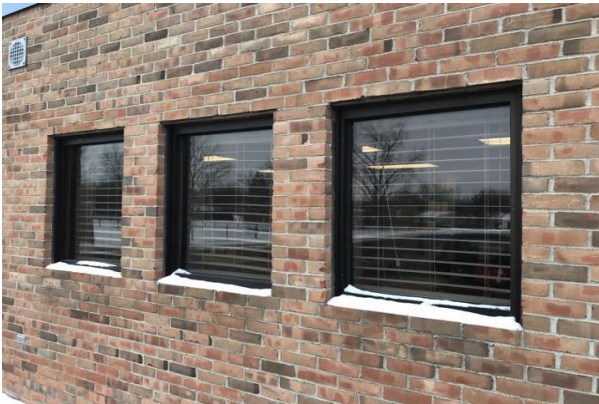
#9:	EXTERIOR WINDOWS, REPLACE
-----	---------------------------

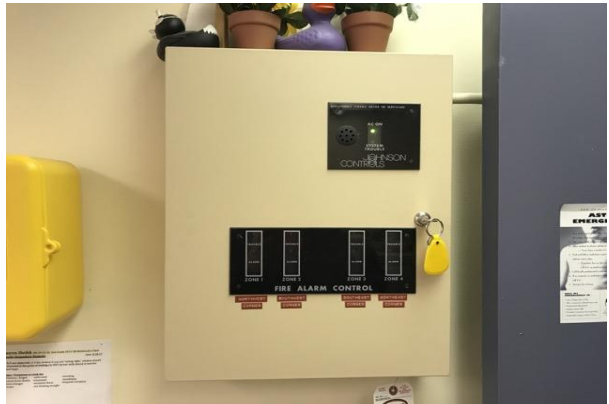
#10:	FIRE ALARM PANEL, REPLACE
------	---------------------------

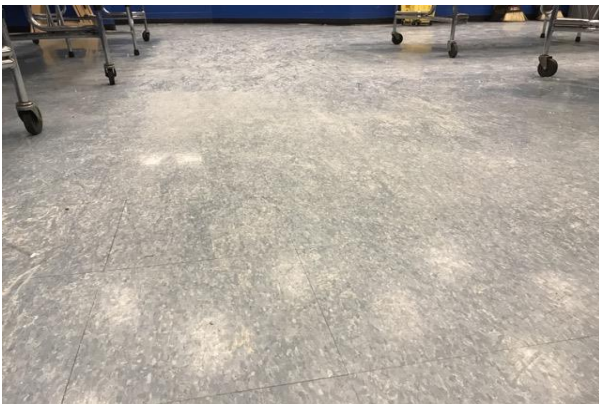
#11:	VINYL CUT TILE (VCT), REPLACE
------	-------------------------------

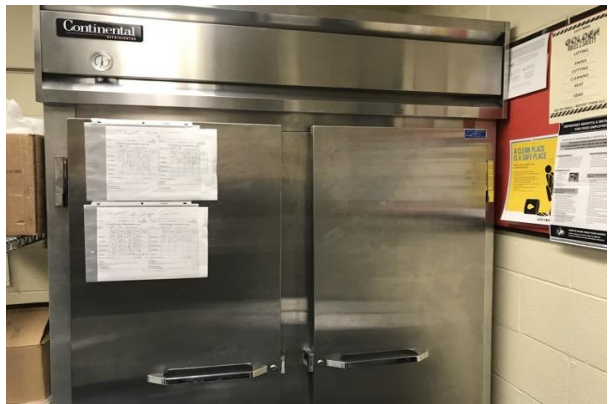
#12:	REACH-IN REFRIGERATOR, REPLACE
------	--------------------------------

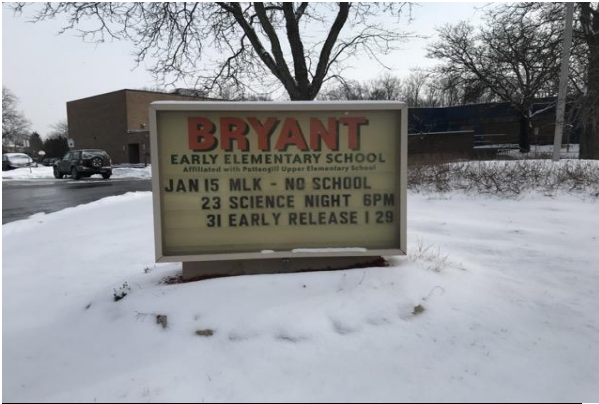
#13:	SIGNAGE, REPLACE
------	------------------

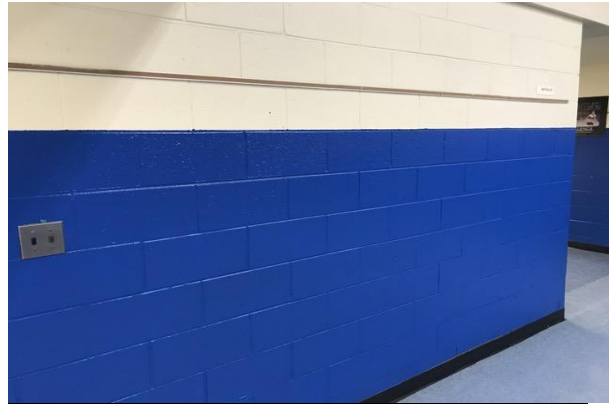
#14:	CMU BLOCKS, PREP AND PAINT
------	----------------------------

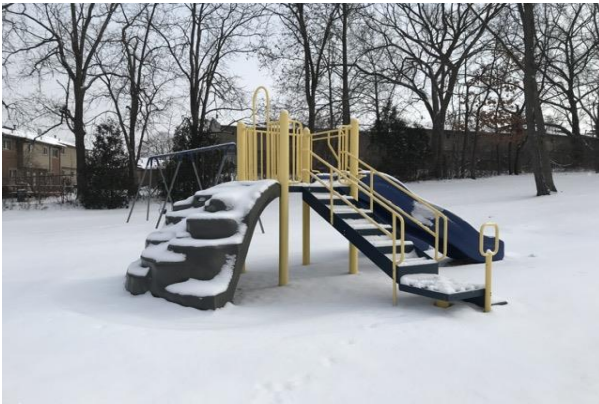
#15:	PLAY STRUCTURE, REPLACE
------	-------------------------

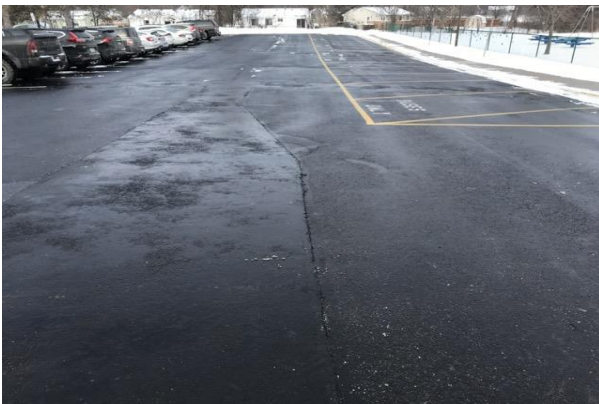
#17:	PARKING LOT, ASPHALT, SEAL AND STIPE
------	--------------------------------------

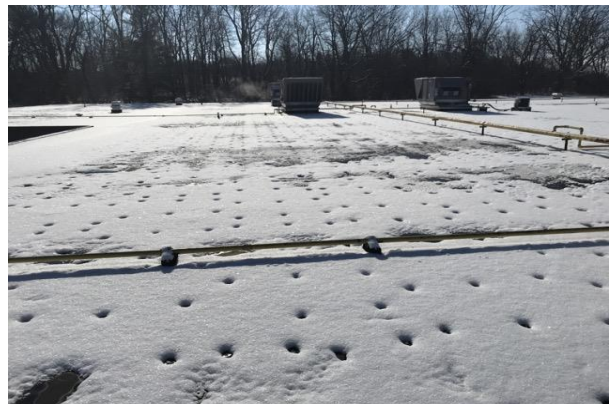
Architectural : The roof and roof decking is in poor condition. Multiple leaks have been repaired on the roof and the staff reported one area that repeatedly leaks. The roof decking was weak in multiple laocations and needs to be replaced..

- The roof finishes appear to be more than 20 years old. Information regarding roof warranties or bonds was not available. The roofs are maintained by an outside contractor. The roof was covered with snow during the site visit.
- Roof leaks have occurred in the past year. The leaks have since been repaired, and no active roof leaks are evident.
- The roof substrate and insulation should be inspected during any future roof repair or replacement work. Walking on the roof revealed multiple weak areas of excessive deflection.

#18:	ROOF, BUILT-UP MEMBRANE, REPLACE
------	----------------------------------

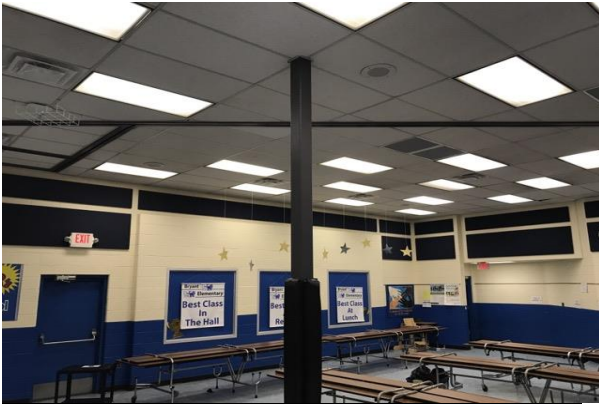
#19:	INTERIOR LIGHTING, REPLACE
------	----------------------------

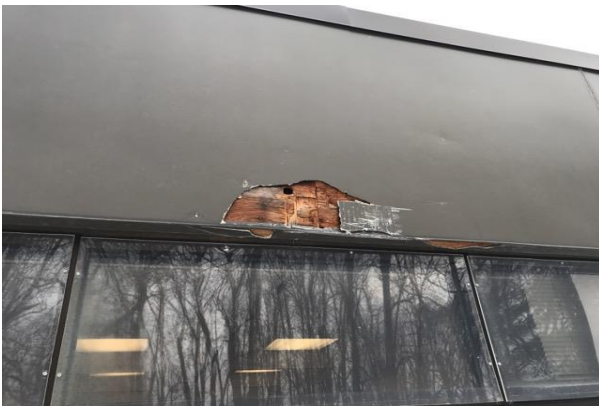
#21:	ALUMINUM SIDING, REPLACE
------	--------------------------

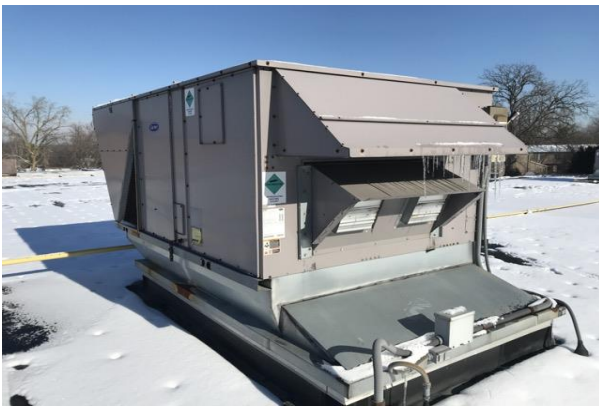
MEPF : The HVAC maintenance staff reported that multiple heat exchangers have been replaced in the package RTUs because the VAV boxes are not communicating with the RTU, causing the heat exchangers to overheat. All of the poackage RTUs should be replaced with units designed to operate with VAV boxes and incorporating modulating burners to ensure the heat exchangers do not overheat.

#27: PACKAGE UNIT, ROOFTOP, REPLACE

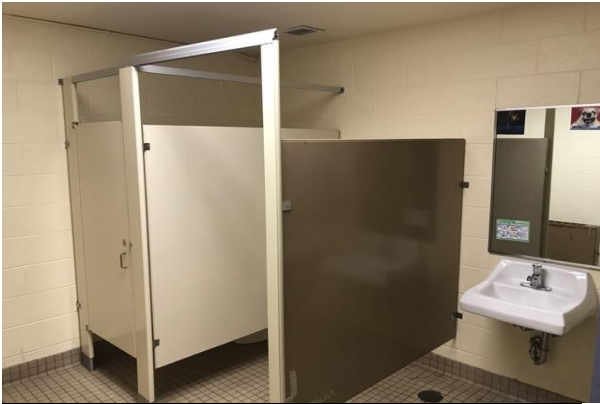
#31: TOILET PARTITIONS, METAL, REPLACE

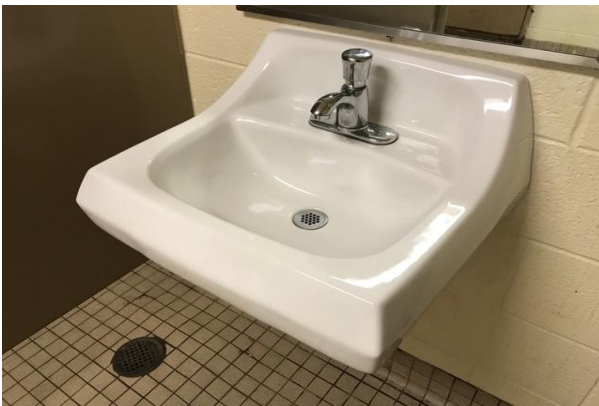
#39:	SINK, VIRTUOUS CHINA, REPLACE
------	-------------------------------

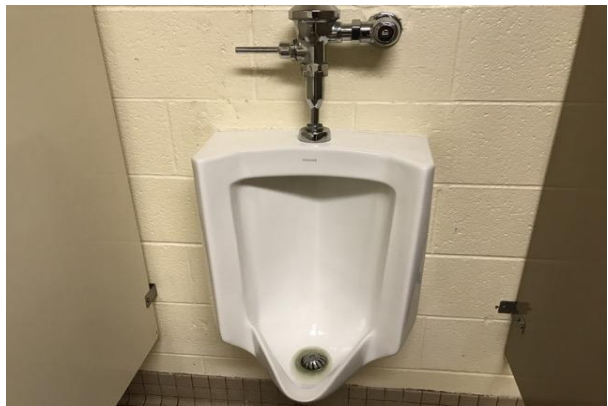
#40:	URINAL, VIRTUOUS CHINA, REPLACE
------	---------------------------------

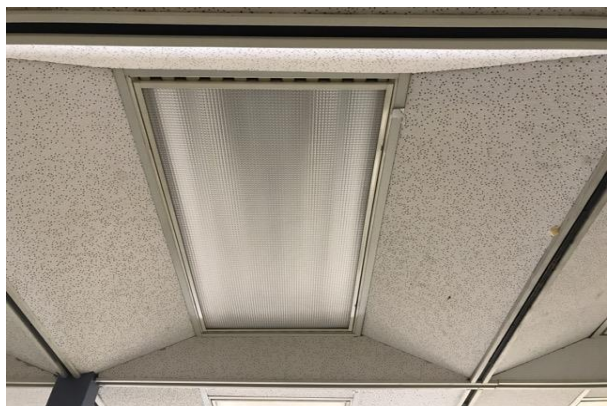
#42:	SUSPENDED ACOUSTICAL CEILING TILE (ACT), REPLACE
------	--

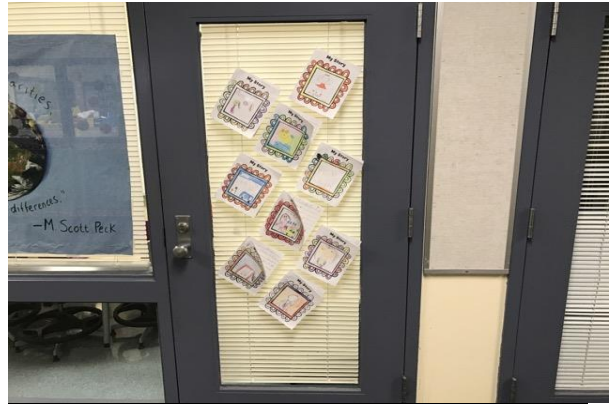
#44:	INTERIOR DOOR, FULLY GLAZED, REPLACE
------	--------------------------------------

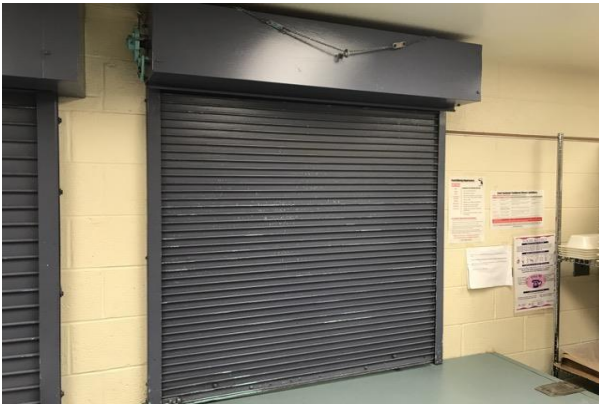
#45:	ROLL-UP DOOR, REPLACE
------	-----------------------

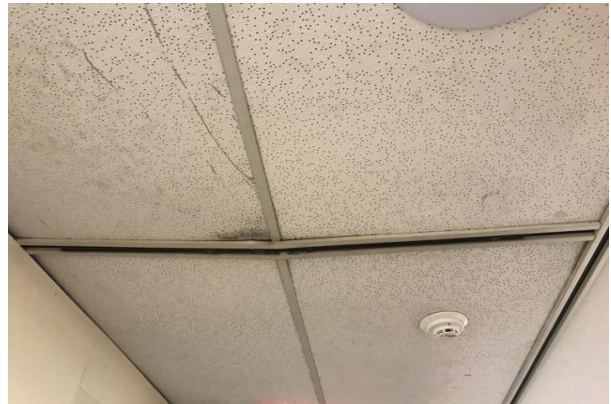
#46:	SUSPENDED ACOUSTICAL CEILING TILE (ACT), REPLACE
------	--

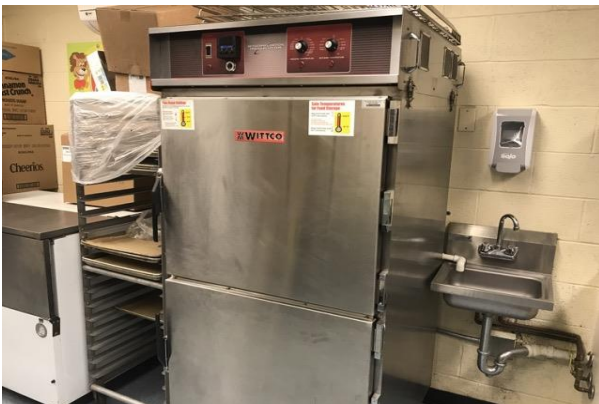
#47:	FOOD WARMER, REPLACE
------	----------------------
