# FACILITY CONDITION ASSESSMENT

*June 28, 2018*

FACILITY CONDITION ASSESSMENT

BURNS PARK ELEMENTARY  
1414 WELLS STREET  
ANN ARBOR, MICHIGAN 48104

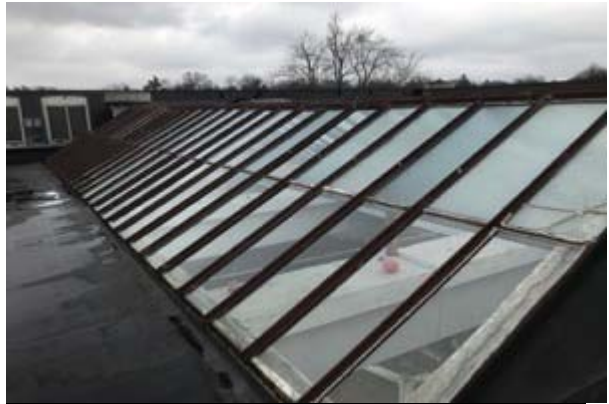
#26: SKYLIGHTS

- The skylights are rusted, cracked and leaking. The skylights require replacement.

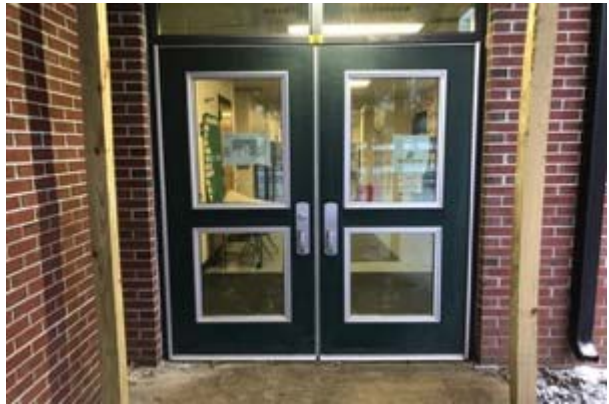
#28: EXTERIOR DOORS

- There are a significant number of damaged, delaminated, inoperable exterior doors and door frames. The damaged doors and frames must be replaced.

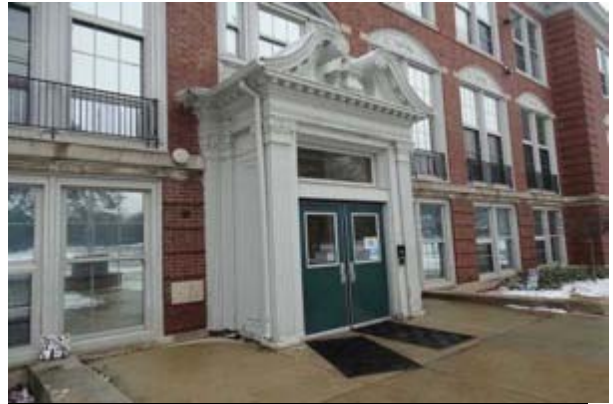
#32:	EXTERIOR WALL
------	---------------

- The wood trim shows signs of damage and is rotted in sections. The wood trim requires replacement. The repair cost is relatively insignificant, and the work can be performed as part of the property management’s routine maintenance program.
- The brick around the flag pole is cracked, missing sections and is damaged. The brick around the flagpole requires replacement.
- The soffit wood shows signs of water damage. The damaged soffit wood requires replacement. A budgetary cost is included.
- The front entrance wooden wall shows sign of cracking and paint is chipping. The front entrance wooden wall requires painting.
- The front entrance wooden molding shows sign of deterioration and damage. The front entrance wooden molding requires replacement.

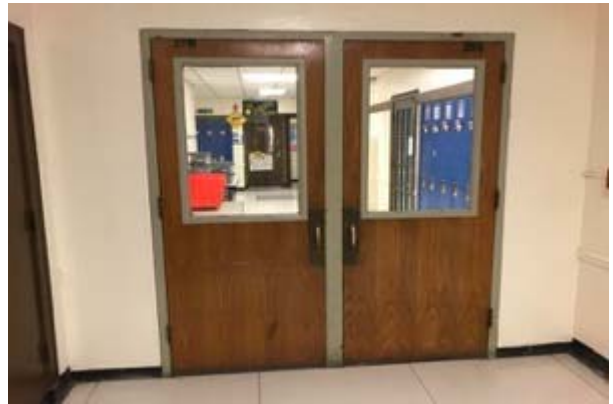
#34:	INTERIOR DOORS
------	----------------

- There are a significant number of damaged, antiquated, inoperable interior doors and door frames. The damaged doors and frames must be replaced.
- The walls have significant portions that are faded. The affected portions of the walls must be painted.

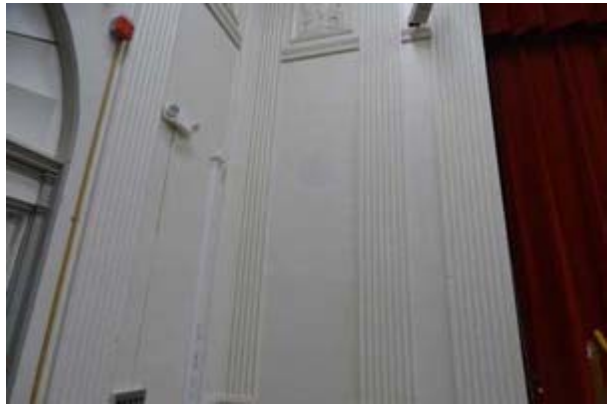
#40:	INTERIOR WALL FINISH
------	----------------------

- There are isolated areas of acoustical wall tiles that show signs of water damage. The damaged acoustical wall tiles require replacement.
- The restroom partitions are damaged and antiquated. The damaged restroom partitions require replacement

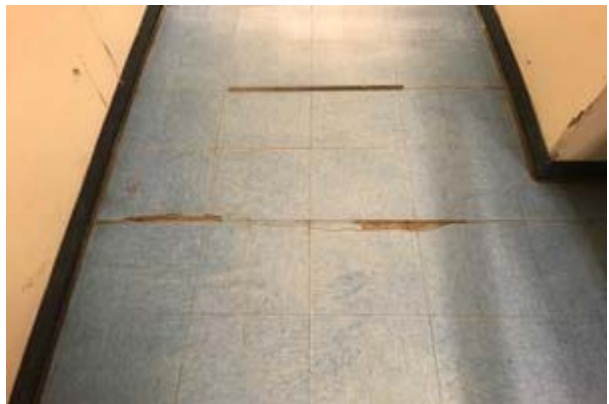
#42:	VINYL TILE (VCT)
------	------------------

- The ceilings have significant portions that are peeling, cracked and faded. The affected portions of the ceilings must be painted.
- The vinyl floor tiles are antiquated, damaged and cracked. The vinyl floor tiles require replacement.

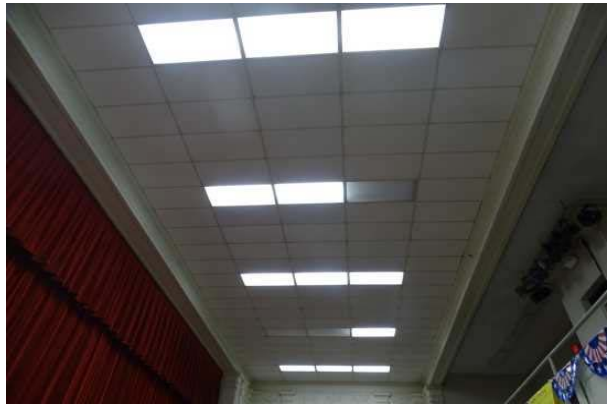
#46:	SUSPENDED ACOUSTICAL TILE (ACT)
------	---------------------------------

- The hard tile ceilings are antiquated and show signs of damage. The damaged hard ceiling tiles are recommended for replacement.
- There are isolated areas of acoustical ceilings tiles that show signs of water damage. The damaged acoustical ceiling tiles require replacement.

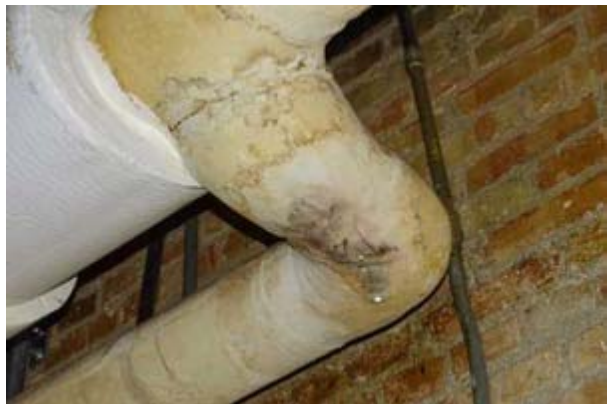
#54:	POSSIBLE ASBESTOS CONTAINING MATERIAL
------	---------------------------------------

- The drinking fountains are damaged and unusable. The damaged drinking fountains must be replaced.
- The piping is in poor condition and may contain asbestos. Asbestos is suspected throughout the building since the building was constructed in 1923. A professional engineer must be retained to analyze the existing condition, provide recommendations and, if necessary, estimate the scope and cost of any required repairs. The cost of this study is included in the cost tables. A cost allowance to repair and/or replace these deficient attributes is included in the cost tables.

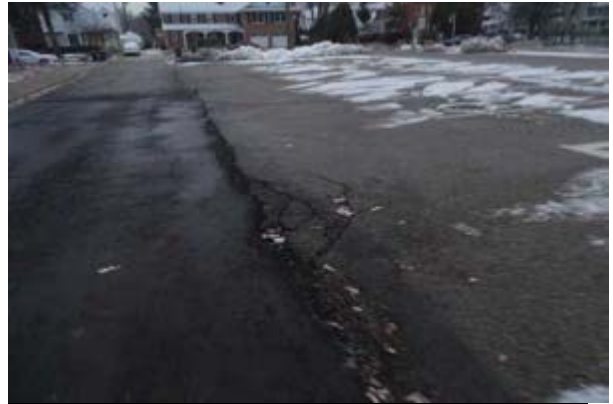
#98:	PARKING LOT
------	-------------

**Site:** The parking lot has multiple cracks from erosion. A cost allowance to repair and/or replace these deficient attributes is included in the cost tables.
