FACILITY CONDITION ASSESSMENT

129010.18R000-009.354

June 28, 2018

CARPENTER ELEMENTARY
4250 CENTRAL BOULEVARD
ANN ARBOR, MICHIGAN 48108

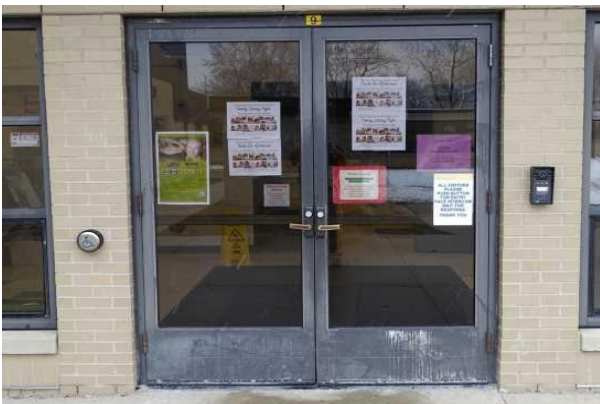
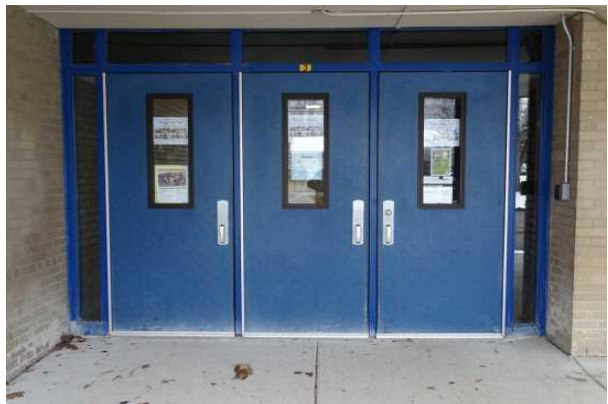
- There are a significant number of damaged, delaminated, inoperable exterior doors and door frames. The damaged doors and frames must be replaced.

#17: EXTERIOR DOORS

#18: EXTERIOR DOORS

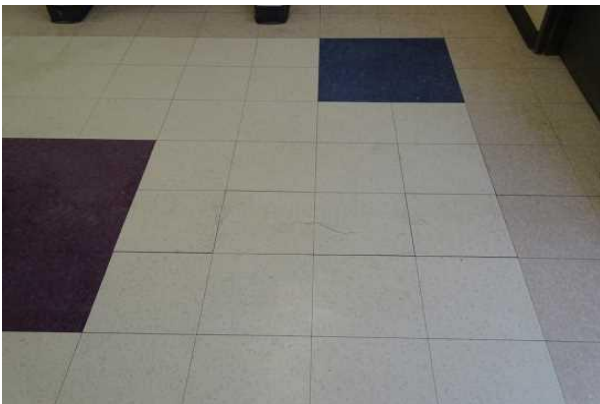
- The vinyl floor tiles are antiquated, damaged and cracked. The vinyl floor tiles require replacement.
- The ceramic tiles are antiquated, damaged and cracked. The ceramic tiles require replacement.
- The walls have significant portions that are faded. The affected portions of the walls must be painted.
- There are isolated areas of acoustical ceilings tiles that show signs of water damage. The damaged acoustical ceiling tiles require replacement.
- The restroom partitions are damaged and antiquated. The damaged restroom partitions require replacement

#23:	VINYL TILE, FLOORING
------	----------------------

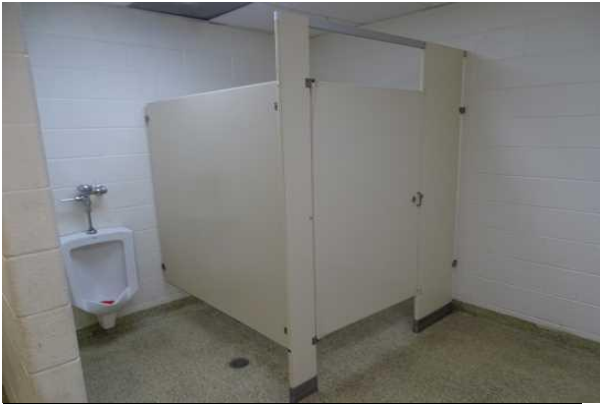
- One toilet partition is missing the door. One restroom partition is recommended for replacement.
- The restroom countertops are antiquated and in disrepair. The restroom countertops require replacement.

#25:	TOILET PARTITIONS
------	-------------------

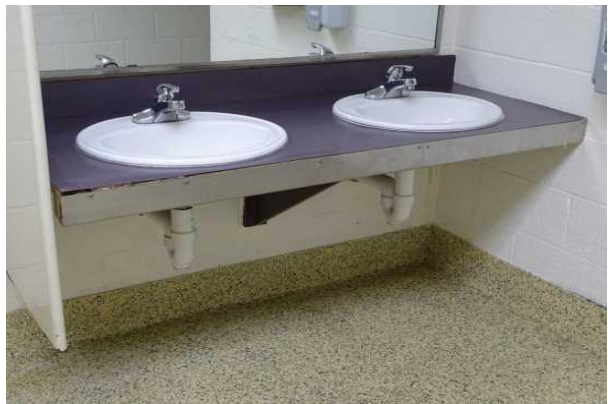
#28:	REST ROOM COUNTER AND SINKS
------	-----------------------------

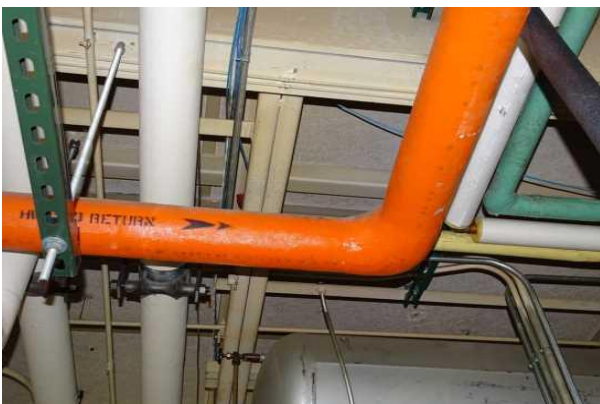
- The drinking fountains are damaged and unusable. The damaged drinking fountains must be replaced.
- The piping is in poor condition and may contain asbestos. Asbestos is suspected throughout the building since the building was constructed in 1953. A professional engineer must be retained to analyze the existing condition, provide recommendations and, if necessary, estimate the scope and cost of any required repairs. The cost of this study is included in the cost tables. A cost allowance to repair and/or replace these deficient attributes is included in the cost tables.

#29:	PIPING POSSIBLE ASBESTOS
------	--------------------------

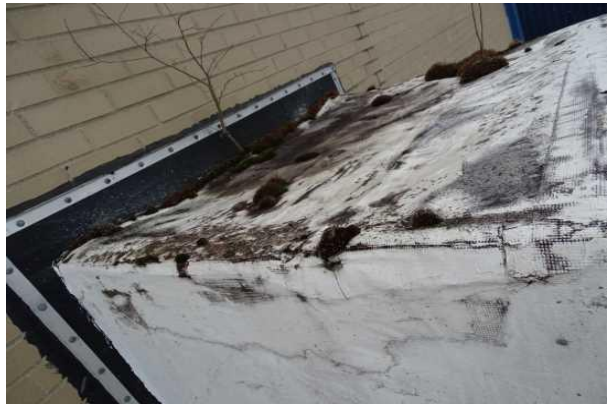
#46:	HVAC SYSTEM DUCTWORK GROWTH
------	-----------------------------

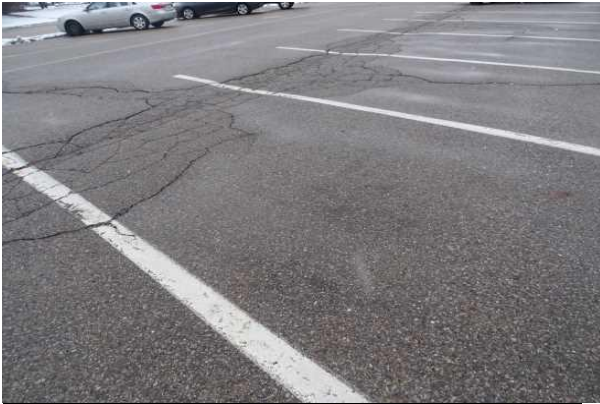
Site: The parking lot has multiple cracks from erosion. A cost allowance to repair and/or replace these deficient attributes is included in the cost tables.

#55:	PARKING LOT
------	-------------
