FACILITY CONDITION ASSESSMENT

Ann Arbor Public Schools
2555 South State Street
Ann Arbor, Michigan 48104

June 29, 2018

EBERWHITE ELEMENTARY
800 SOULE BOULEVARD
ANN ARBOR, MICHIGAN 48103

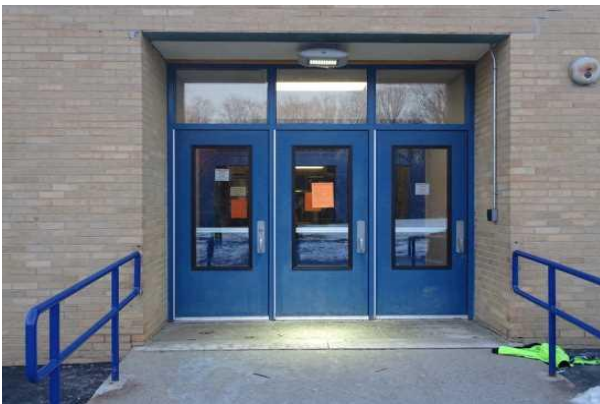
#17:	EXTERIOR DOORS
------	----------------

- There are a significant number of damaged, delaminated, inoperable exterior doors and door frames. The damaged doors and frames must be replaced.

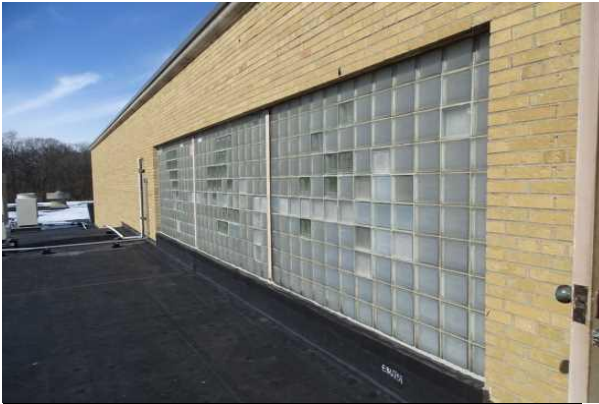
#19:	GLASS BLOCK
------	-------------

- There are significant areas of damaged glass block. The damaged glass block requires replacement.

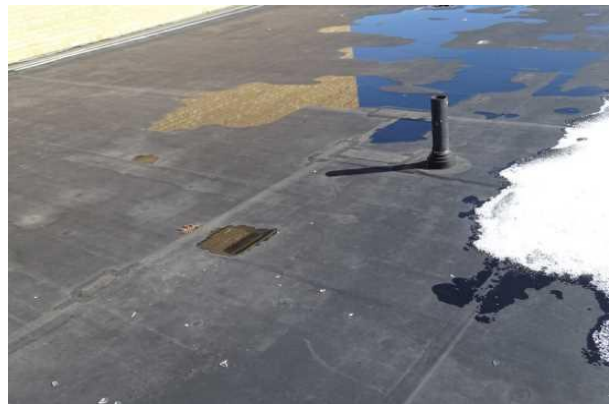
#22:	ROOF
------	------

- According to the POC, there are active roof leaks. Roof leaks have occurred in the past year. The active leaks must be repaired.
- There is no evidence of roof deck or insulation deterioration. The roof substrate and insulation should be inspected during any future roof repair or replacement work.

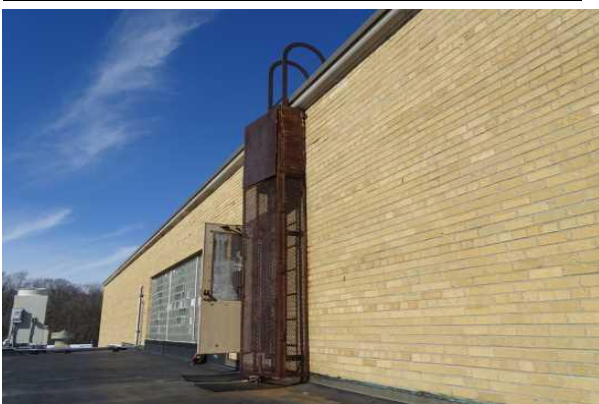
#23:	ROOF ACCESS LADDER
------	--------------------

- The attics are not accessible, and it could not be determined if there is moisture, water intrusion, or excessive daylight in the attics.
- The roof access ladders are in major disrepair and are considered a safety hazard. Metal is hanging loosely from the ladder and it is about to come apart and fall. Other sections of the roof are inaccessible safely and a mobile ladder was found on the roof to use. The roof access ladder requires immediate replacement.

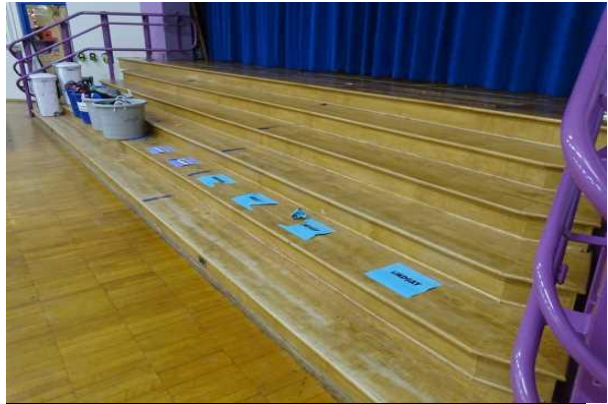
#26:	WOOD FLOORING
------	---------------

- The ceilings have significant portions that are peeling, cracked and faded. The affected portions of the ceilings must be painted.
- The vinyl floor tiles are damaged and cracked. The vinyl floor tiles require replacement.
- The restroom doors in each classroom are damaged and cracked. The restroom doors require replacement.
- There is a significant amount of ceiling tiles that show signs of water damage. The damaged acoustical ceiling tiles require replacement.
- The door hardware in the classroom restrooms are hard to open, antiquated and damaged. The door hardware requires replacement.
- The wood flooring shows signs of heavy wear and is faded. The wood flooring requires refinishing.

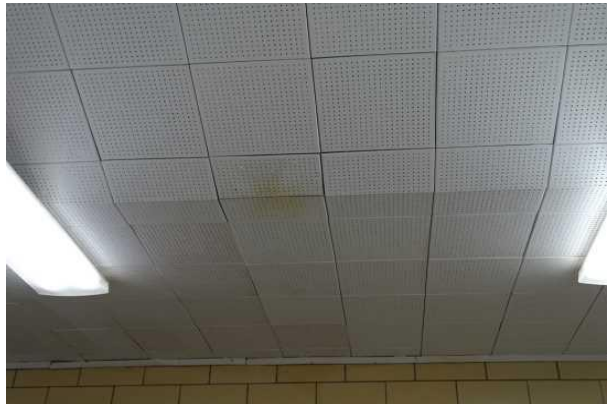
#28:	CEILING TILES
------	---------------

Architectural: The doors for the classroom restrooms need replaced. Some of the doors are antiquated, hard to open and are damaged. The ceiling tiles are stained and damaged. A cost allowance to repair and/or replace these deficient attributes is included in the cost tables.

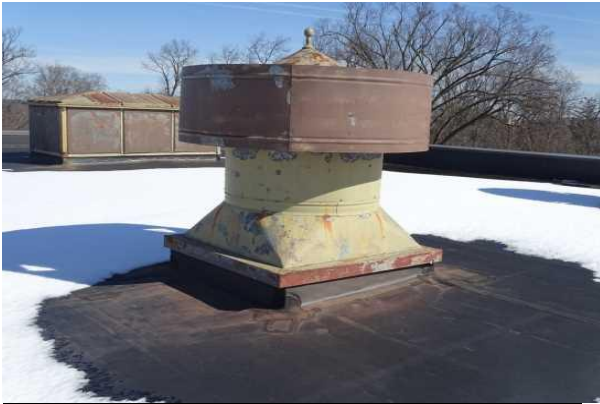
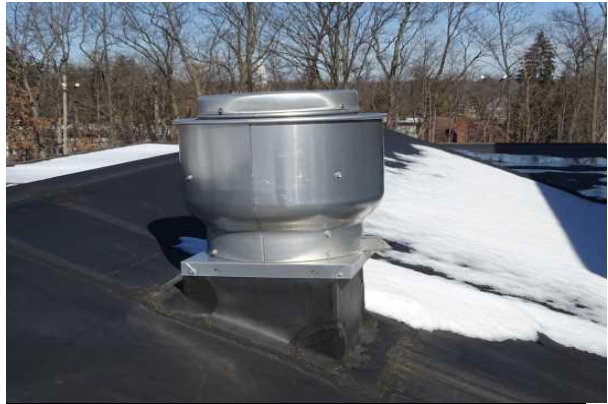
- The HVAC equipment varies in age. HVAC equipment is replaced on an "as needed" basis.
- Some exhaust fans are antiquated, in disrepair and heavily weathered. Some exhaust fans are recommended for replacement.

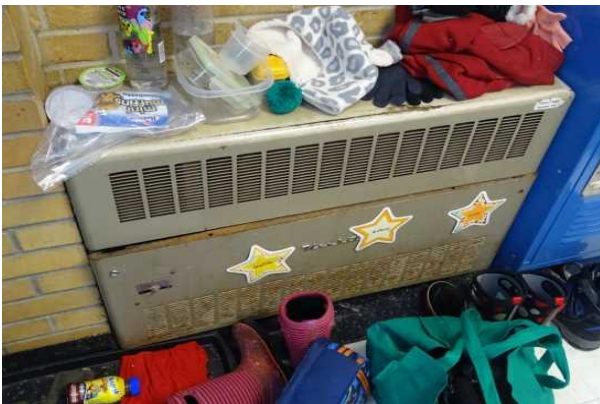
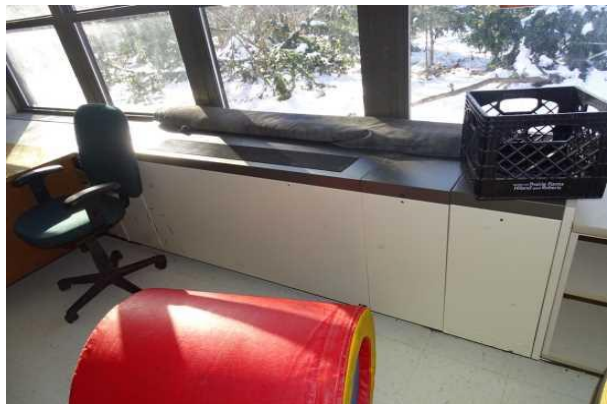
- Approximately 50% of the cabinet ventilator units are original and in poor condition. The older cabinet ventilator units are recommended for replacement.

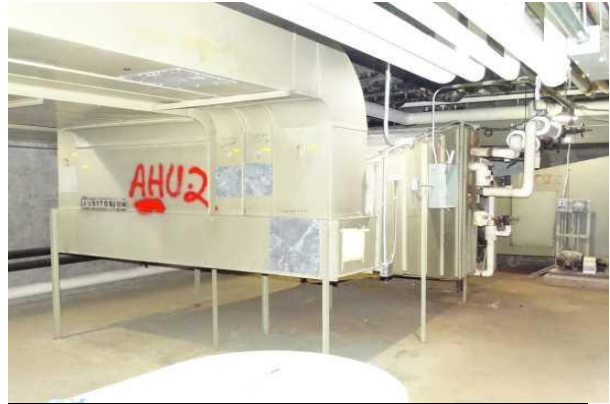
#56:	AIR HANDLER
------	-------------

- The axial fans are antiquated and in disrepair. The axial fans are recommended for replacement.
- The air handlers are original units which are rusted, antiquated and inefficient. The air handlers are recommended for replacement.

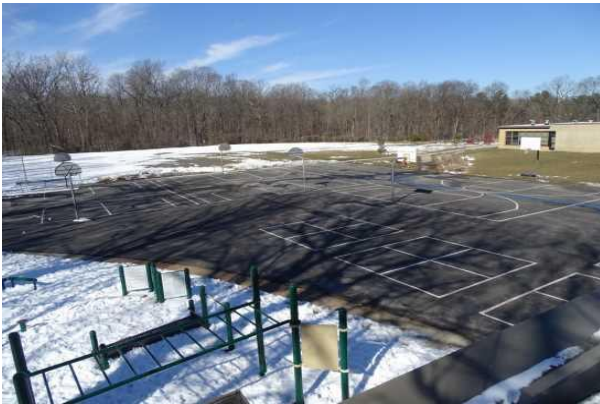
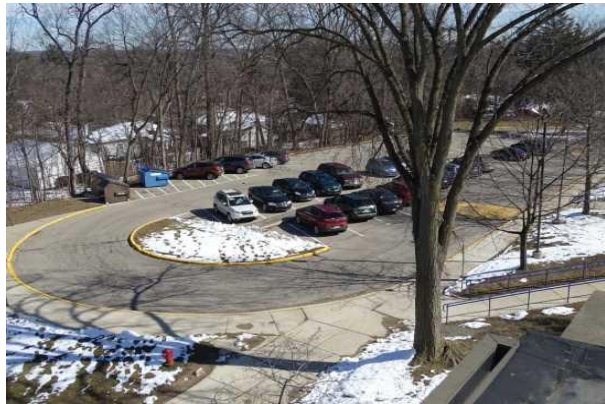
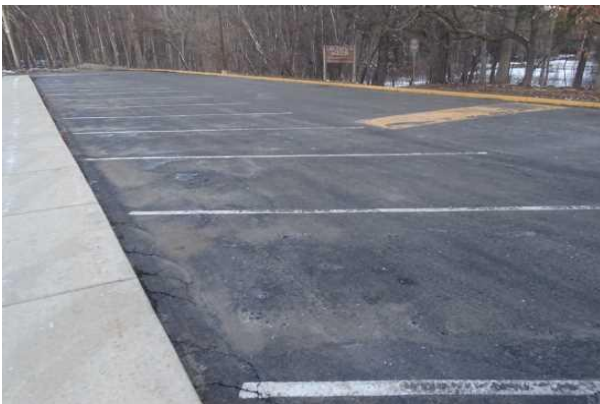
Site: The parking lot has multiple cracks from erosion. A cost allowance to repair and/or replace these deficient attributes is included in the cost tables.
