FACILITY CONDITION ASSESSMENT

February 1, 2018

MITCHELL ELEMENTARY
3550 PITTSVIEW DRIVE
ANN ARBOR, MICHIGAN 48108

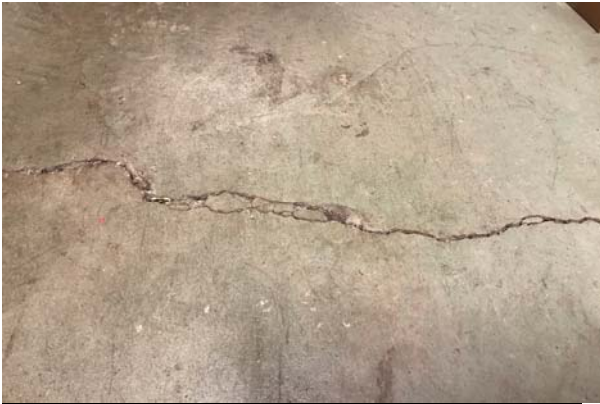
- The foundations and footings cannot be directly observed. However, there are isolated areas of cracking, movement, and vertically displaced slabs in the utility closet. Cracking of the CMU walls in the building interior indicate settling has occurred.. This condition typically indicates excessive settlement or other potential problems with the foundation system. A Professional Engineer with specific expertise in structural design and construction in this geographical area must be retained to evaluate the structure and to provide remedial recommendations consistent with local regulatory and code requirements. Although the estimated cost of repair cannot be accurately determined without the recommended study, a budgetary cost allowance to repair the affected elements is also included.

#7:	CRACKED CONCRETE SLAB-ON-GRADE
-----	--------------------------------

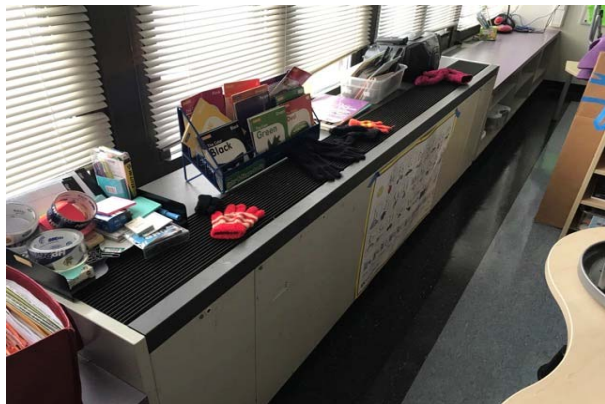
MEPF : The original fan coil units that were installed in the facility have failed and should be replaced. The BAS system is a hybrid of DDC and pneumatic and should be replaced. The facility does not have a fire suppression system, and only four certified fire extinguishers in the entire facility.

#10:	FAN COIL UNIT
------	---------------

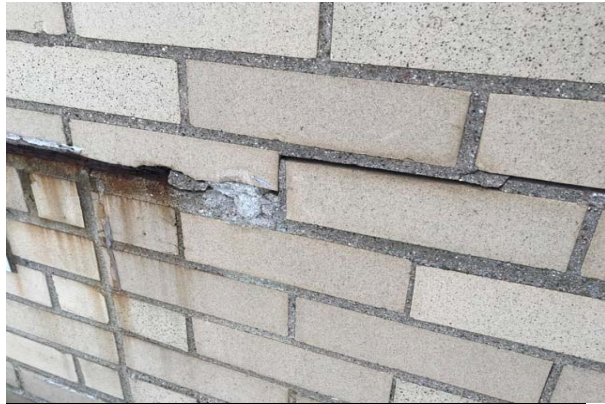
- Significant portions of the mortar joints along the brick veneer are cracked on all elevations of the facility. The damaged mortar joints must be cleaned and re-pointed.

#14:	BRICK VENEER CRACKING
------	-----------------------

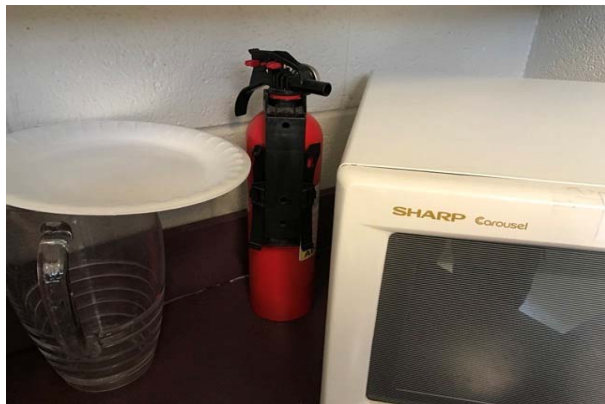
- The building is not protected by fire suppression. Due to its construction date, the facility is most likely “grandfathered” by code and the installation of fire sprinklers not required until major renovations are performed. Regardless of when or if installation of facility-wide fire suppression is required by the governing municipality, EMG recommends a retrofit be performed. A budgetary cost is included.
- Fire extinguishers appear to be missing at many locations. New fire extinguishers must be installed at all required locations immediately.

#18:	NON-CERTIFIED FIRE EXTINGUISHER
------	---------------------------------

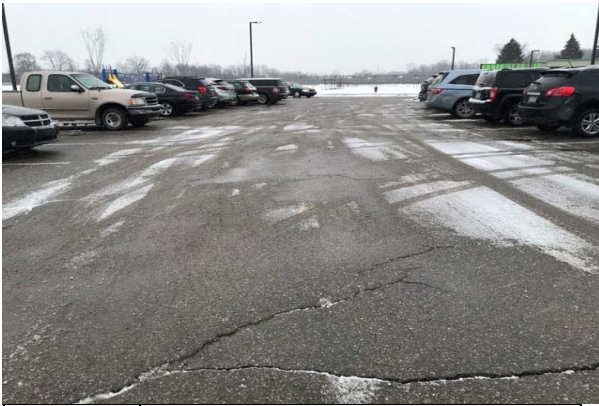
Site : The parking lot and drive way need to be milled and overlaid with new asphalt. The playground equipment shows signs of corrosion.

#21:	PARKING LOT
------	-------------

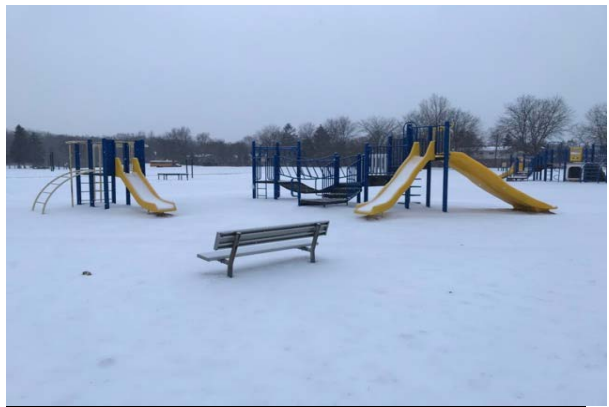
#24:	PLAY STRUCTURE
------	----------------

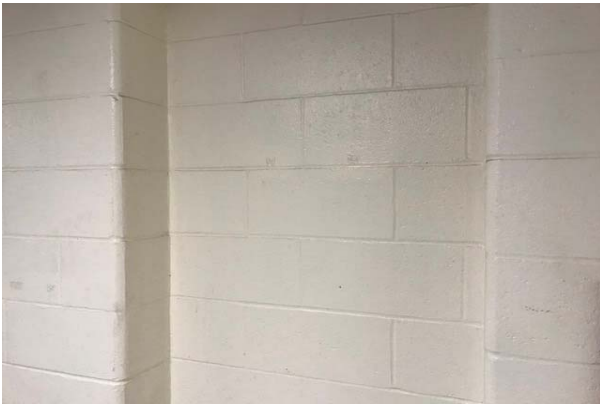
- The superstructure is exposed in some locations, which allows for limited observation. There is isolated evidence of deflection and movement illustrated by cracks in the CMU wall. A Professional Engineer with specific expertise in structural design and construction in this geographical area must be retained to evaluate the structure and to provide remedial recommendations consistent with local regulatory and code requirements.

#27:	STRUCTURAL WALLS, CMU
------	-----------------------
