FACILITY CONDITION ASSESSMENT

July 2, 2018

PATTENGILL ELEMENTARY
2100 CRESTLAND DRIVE
ANN ARBOR, MICHIGAN 48104

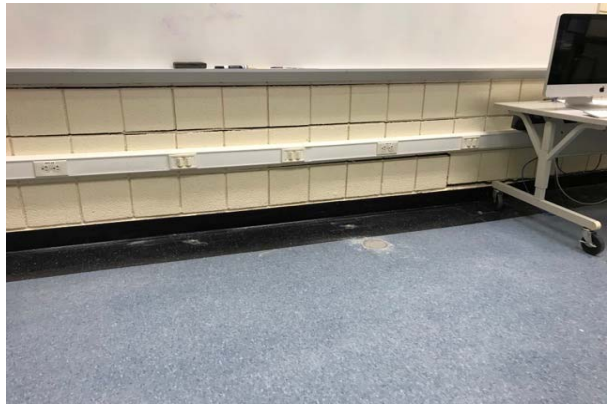
- The foundations and footings cannot be directly observed. However, there are isolated areas of cracking, movement, and vertically displaced slabs throughout the orchestra room, girls bathroom, computer lab, and vocal lab. This condition typically indicates excessive settlement or other potential problems with the foundation system. A Professional Engineer with specific expertise in structural design and construction in this geographical area must be retained to evaluate the structure and to provide remedial recommendations consistent with local regulatory and code requirements. Although the estimated cost of repair cannot be accurately determined without the recommended study, a budgetary cost allowance to repair the affected elements is also included.

#4:	CRACKED WALL
-----	--------------

- Structural study
- Structural repairs

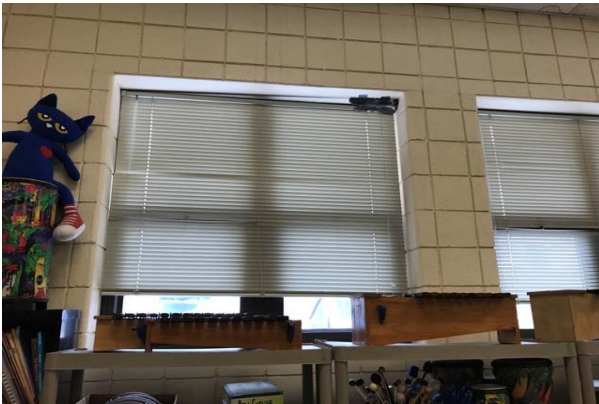
- The windows display significant evidence of leaks, condensation throughout the entire building. The damaged windows must be replaced.
- There are a significant number of damaged, delaminated, deteriorated, rusted doors and door frames. The damaged doors and frames must be replaced.

#9:	WINDOWS
-----	---------

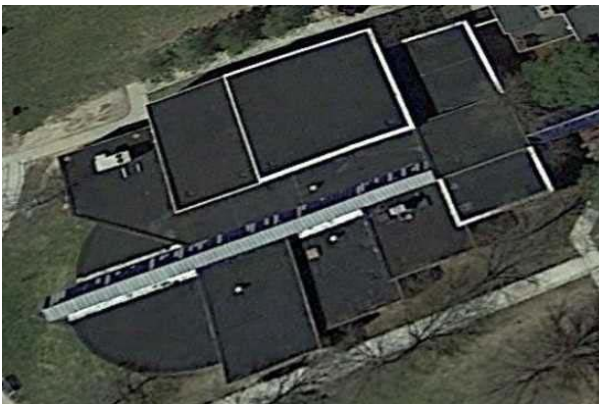
- The roof finishes appear to be more than 17 years old. Information regarding roof warranties or bonds was not available. The roofs are maintained by an outside contractor.
- The modified bituminous roofs have significant areas of heavy membrane wear on the east roof. Replacement is recommended. A cost allowance for this work is included.
- Roof leaks have occurred within the past year, and some of these leaks remain active. The leaks occur throughout the building. All active leaks must be repaired.
- There are ponding stains and build-up of debris at some of the drain locations throughout the entire roof. The affected drains must be cleaned and cleared and debris must be removed from the roof surfaces. Overhanging tree branches must be cleared from the perimeter of the roof.

#11:	ROOF
------	------

- Observed hanging limbs that protrude onto the roof. These must be cleared..

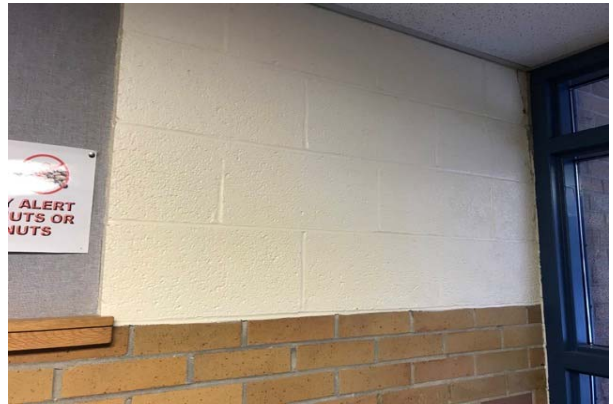
Architectural : The CMU is in poor condition. The concrete block in Orchestra room, girls bathroom, computer lab, and vocal lab observed cracks throughout these rooms. Surveillance system is antiquated. Some ceiling repairs are required.

#16:	CMU WALLS
------	-----------

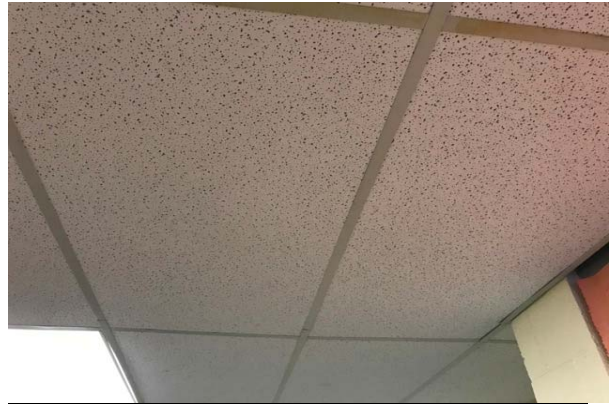
- It appears that the interior finishes are original.
- The ceiling tiles have isolated areas of water-damaged ceilings throughout the property. The damaged ceiling tiles need to be replaced. A cost allowance for this work is included.
- There are isolated areas of faded wall finishes throughout the property. The damaged wall areas need to be repainted. A cost allowance for this work is included.

#20:	SUSPENDED ACOUSTICAL TILE (ACT)
------	---------------------------------

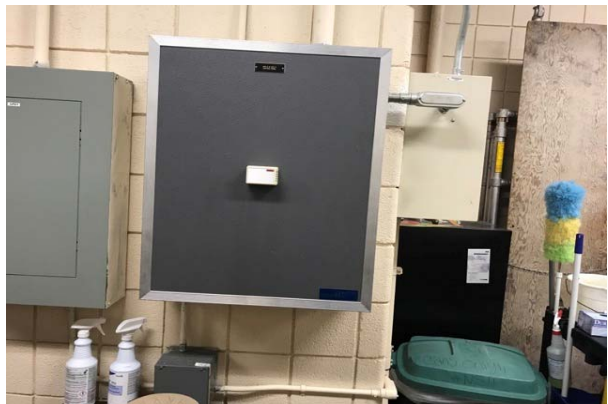
- The facility HVAC is controlled using an outdated pneumatic system supplied by an air compressor. For modernization, reliability, and increased control, full conversion to a web-based direct digital control (DDC) platform is highly recommended.

#30:	BUILDING AUTOMATION SYSTEM (HVAC CONTROLS)
------	--

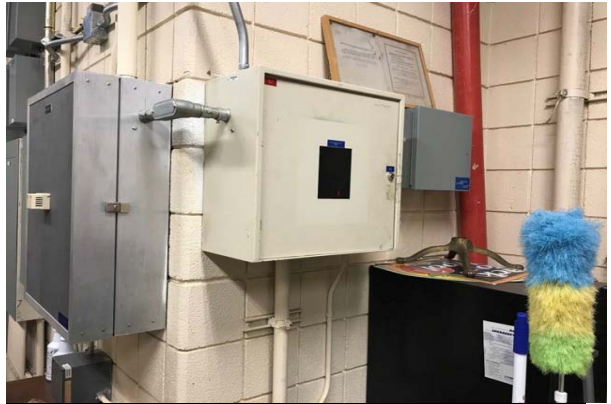
#32:	BUILDING AUTOMATION SYSTEM (HVAC CONTROLS)
------	--

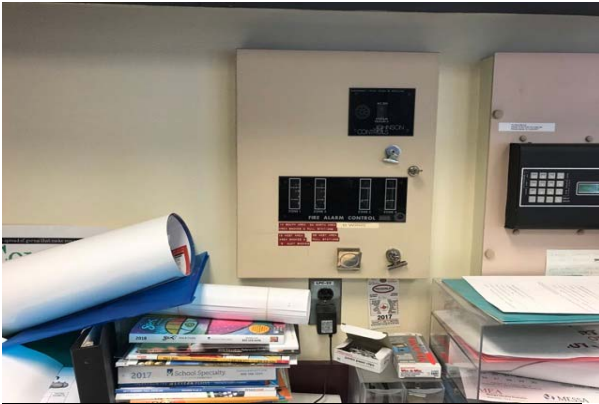
- The fire alarm systems appear somewhat antiquated and not up to current standards. Due to the age of the components and apparent shortcomings, a full modernization project is recommended. A budgetary cost is included.

#37: FIRE ALARM CONTROL PANEL

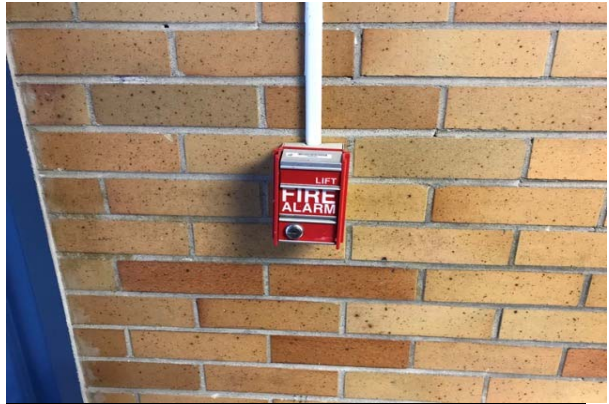
#38: FIRE ALARM SYSTEM, SCHOOL
