FACILITY CONDITION ASSESSMENT

July 2, 2018

PITTSFIELD ELEMENTARY
2543 PITTSFIELD BOULEVARD
ANN ARBOR, MICHIGAN 48104

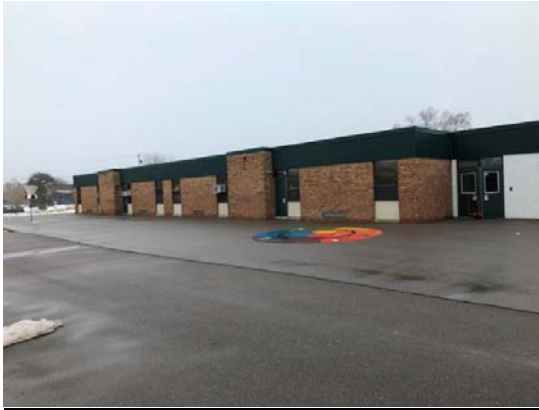
PHOTO #1: WEST ELEVATION

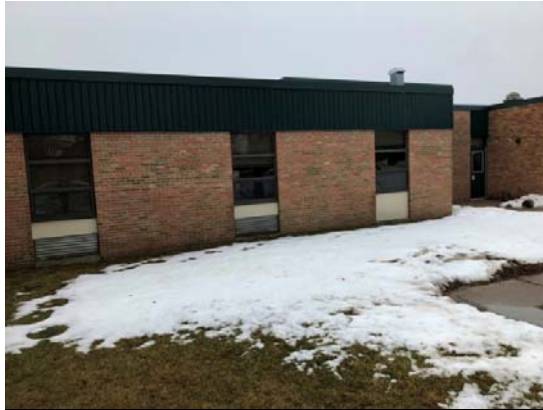
PHOTO #2: NORTH ELEVATION

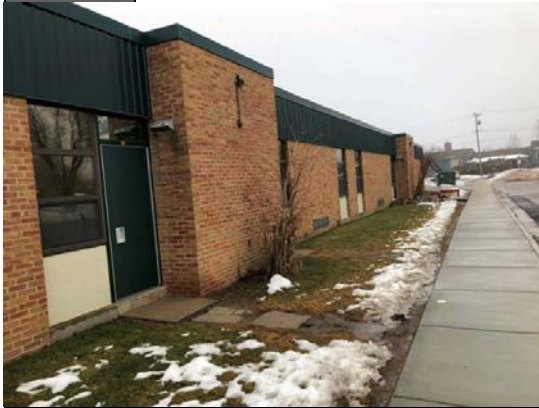
PHOTO #3: EAST ELEVATION

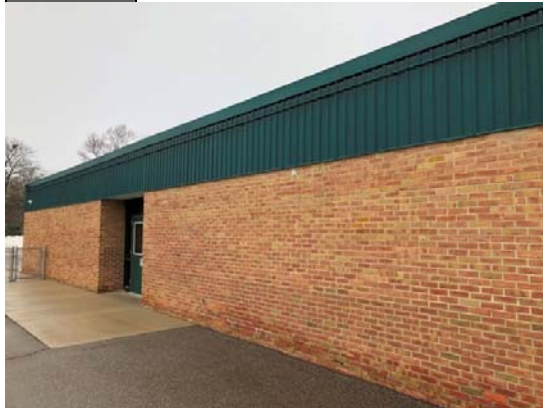
PHOTO #4: SOUTH ELEVATION

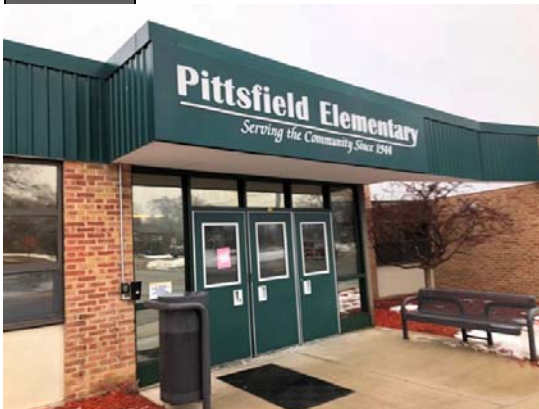
PHOTO #5: MAIN ENTRANCE DOORS

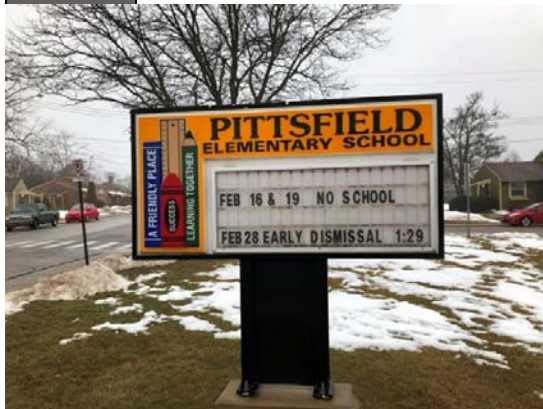
PHOTO #6: PROPERTY SIGNAGE

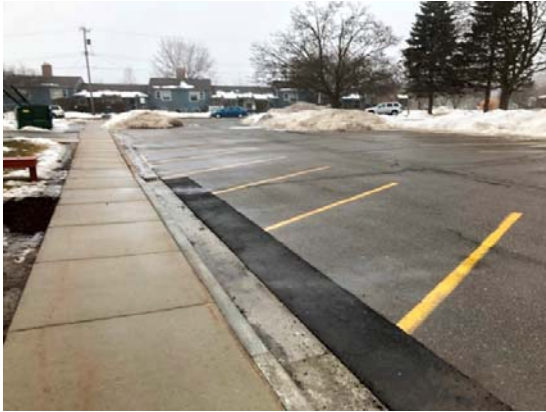
Site : Areas of asphalt pavement show signs of deterioration.

PHOTO #7: CONCRETE SIDEWALKS AND ASPHALT PAVEMENT

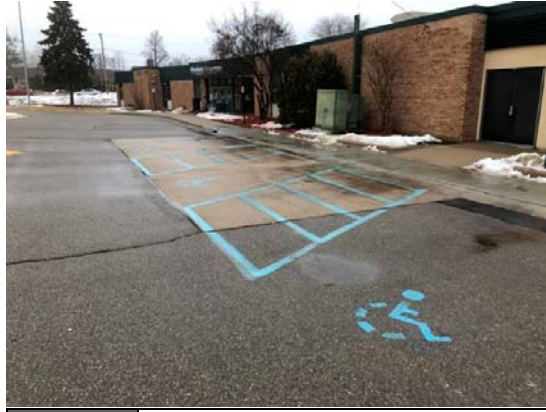
PHOTO #8: ADA PARKING AREA

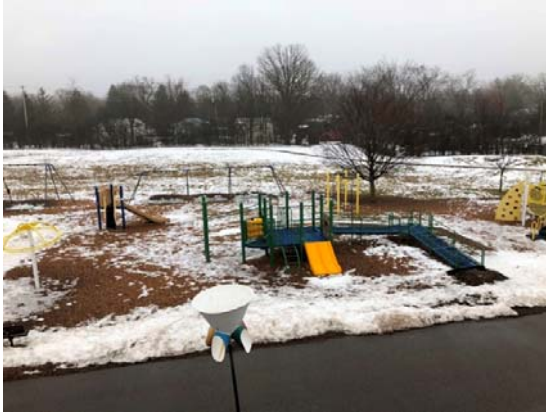
PHOTO #9: PLAYGROUND

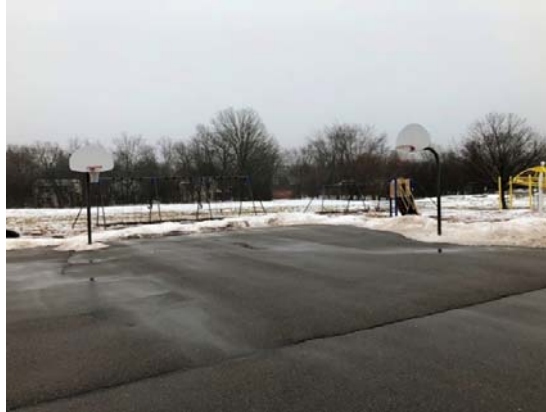
PHOTO #10: BASKETBALL COURT

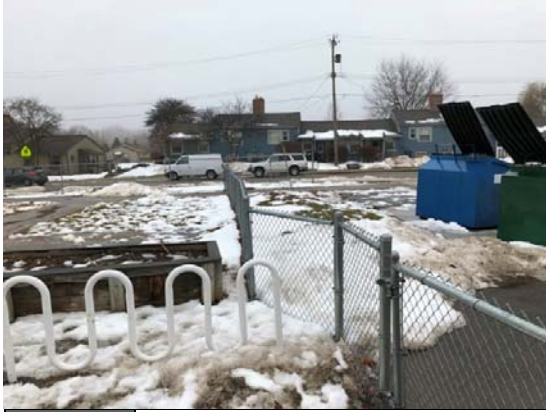
PHOTO #11: CHAIN LINK PERIMETER FENCING

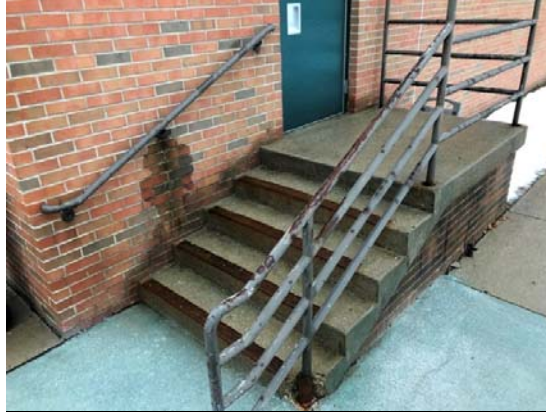
PHOTO #12: CONCRETE STAIRS

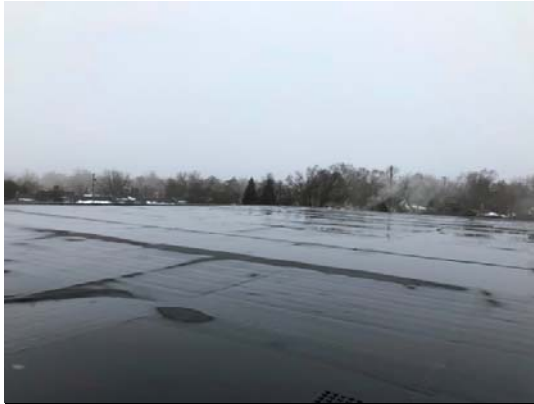
PHOTO #13: SINGLE-PLY ROOFING

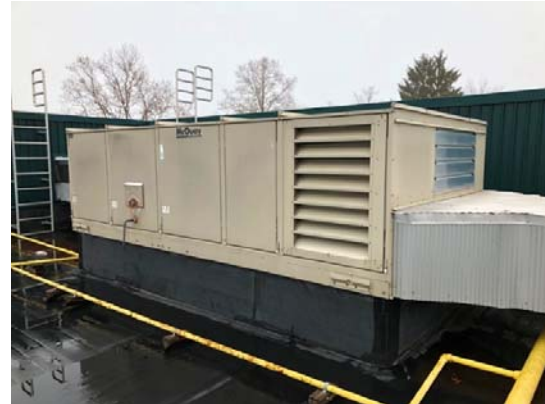
| Location | Component | Component Description | Quantity | Unit | Condition | Action | RUL | Est. Cost |
|---|---|---|---|---|---|---|---|---|
| Roof | Packaged Unit (RTU) | 5 Ton | 1 | EA | Poor | Replace | 0 | 11,239 |

PHOTO #14: ROOFTOP UNIT

| Location Name | EMG Renamed Item Number | ID | Cost Description | Quantity | Unit | Unit Cost * | Subtotal | Deficiency Repair Estimate * |
|---|---|---|--|---|---|---|---|---|
| Pittsfield Elementary | 5 | 859200 | Packaged Unit (RTU), 5 Ton, Replace | 1 | EA | \$12,925.18 | \$12,925 | \$12,925 |

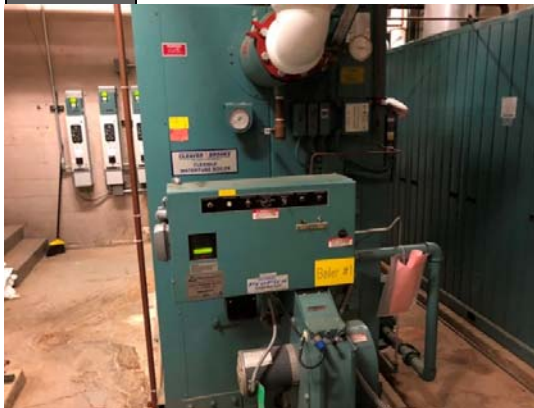
PHOTO #15: HVAC BOILER

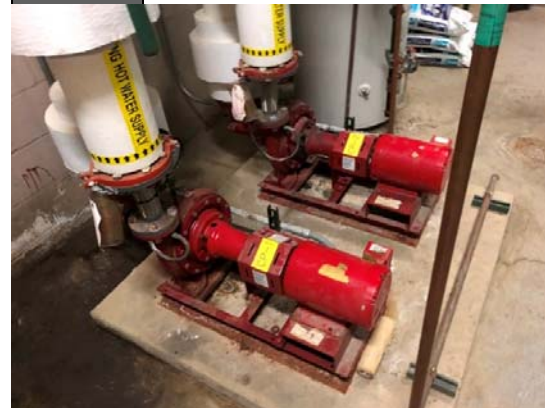
PHOTO #16: CIRCULATION PUMPS

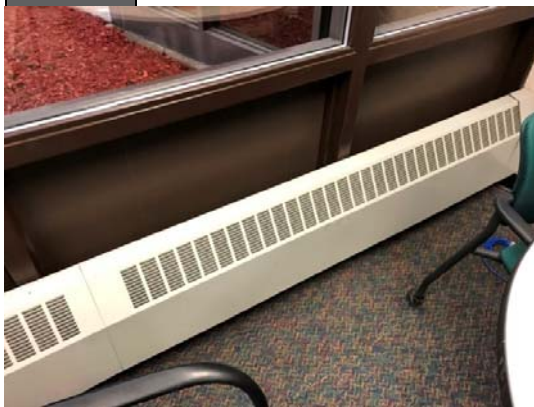
PHOTO #17: HYDRONIC TERMINAL UNIT

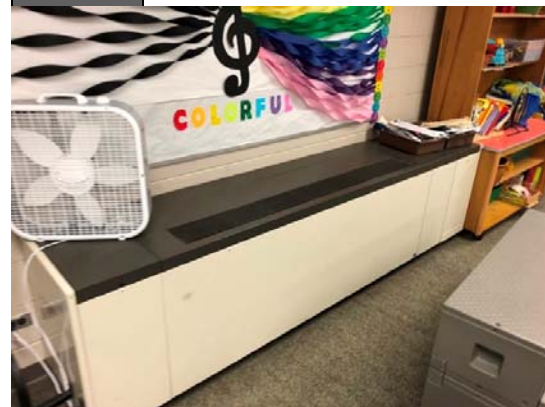
PHOTO #18: CLASSROOM UNIT VENTILATOR

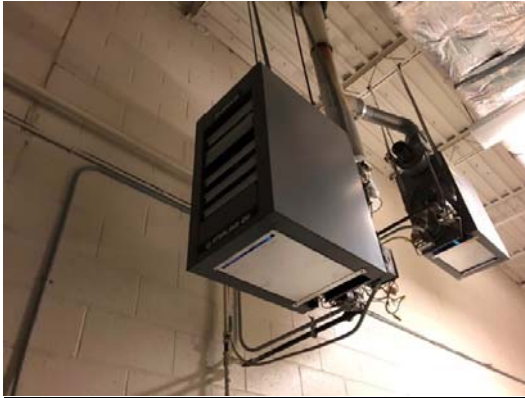
PHOTO #19: SUSPENDED UNIT HEATERS

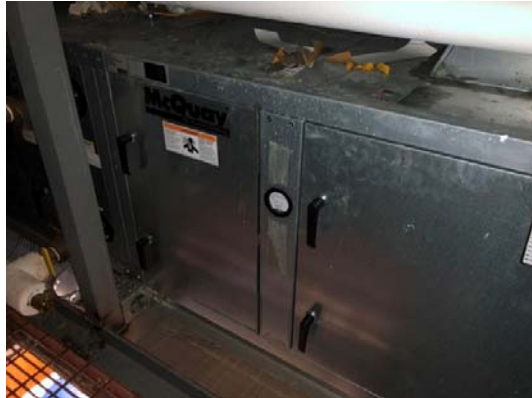
PHOTO #20: AIR HANDLER

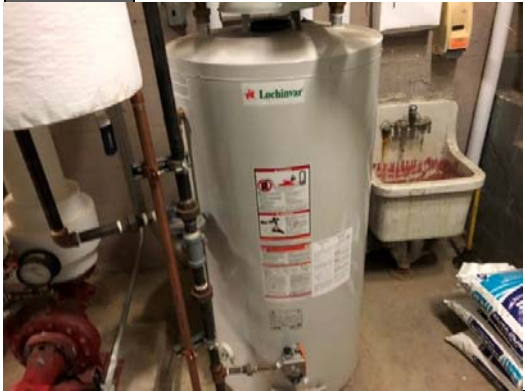
PHOTO #21: DOMESTIC WATER HEATER

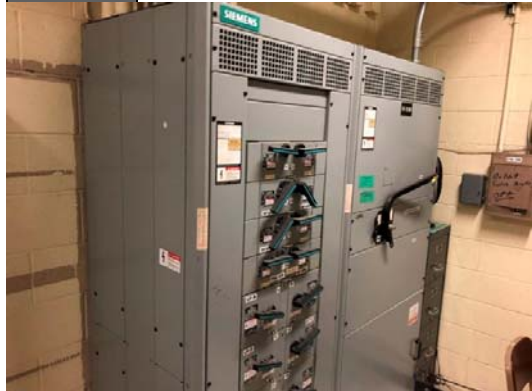
PHOTO #22: MAIN DISTRIBUTION PANEL

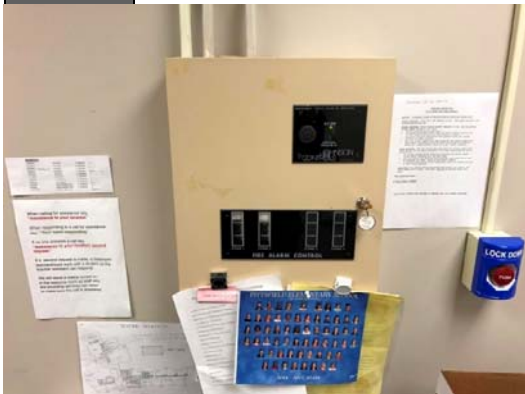
PHOTO #23: FIRE PANEL

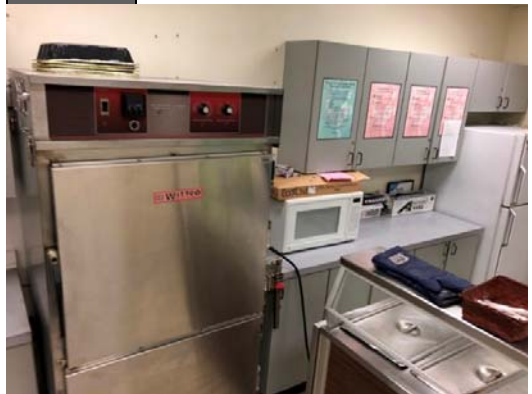
PHOTO #24: KITCHEN EQUIPMENT

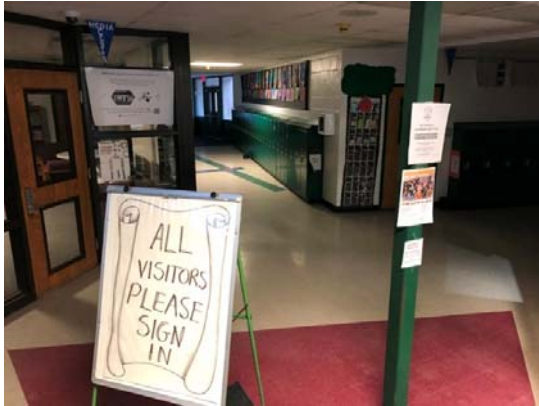
PHOTO #25: LOBBY

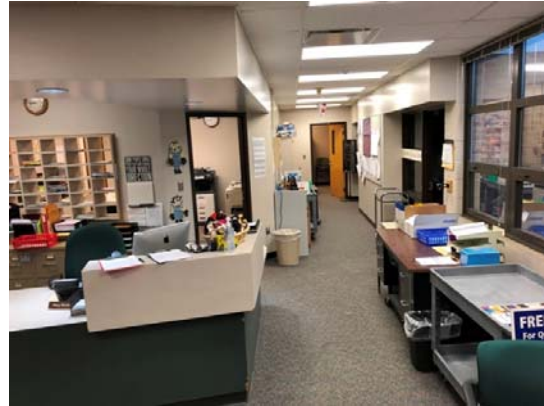
PHOTO #26: MAIN OFFICE

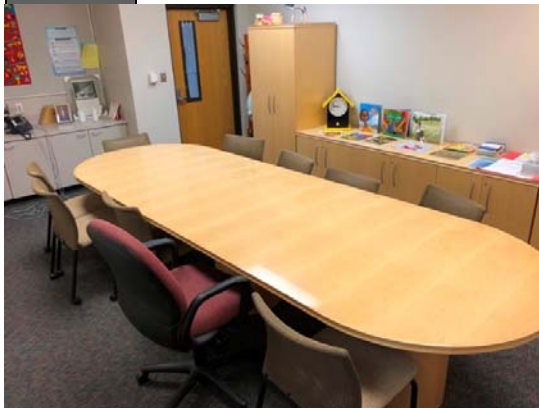
PHOTO #27: CONFERENCE ROOM

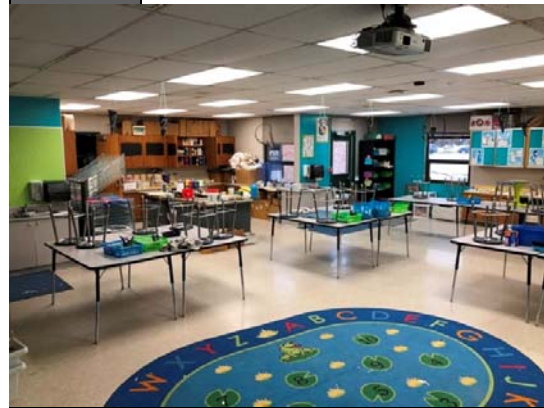
PHOTO #28: CLASSROOM

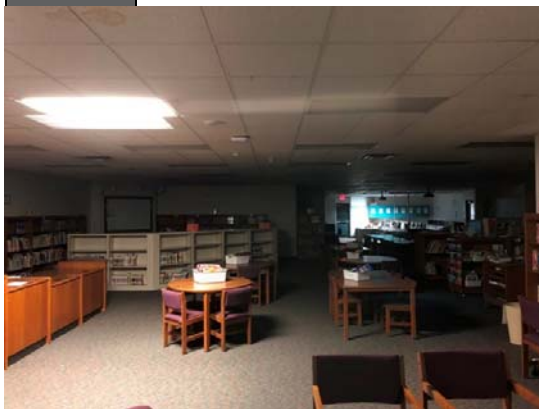
PHOTO #29: MEDIA CENTER

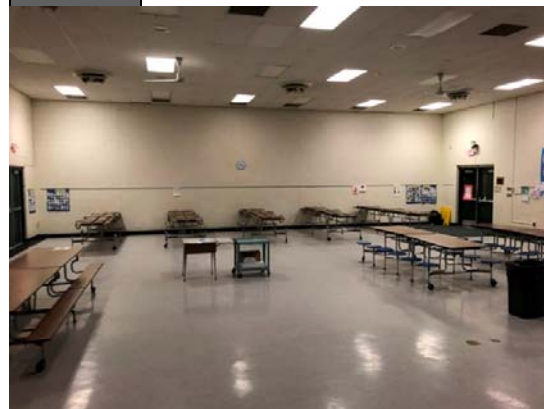
PHOTO #30: MULTI-PURPOSE ROOM

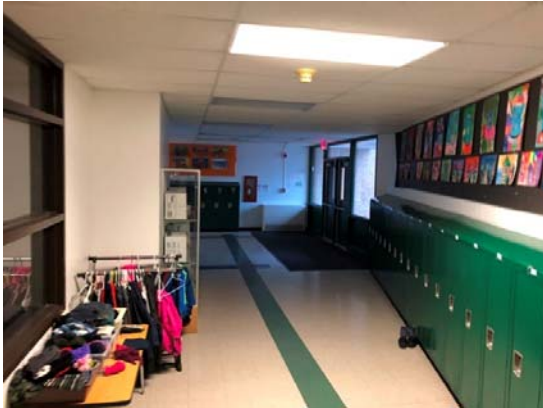
PHOTO #31: HALLWAY AND LOCKERS

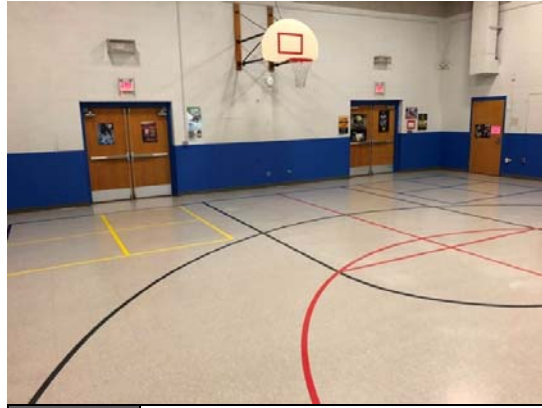
PHOTO #32: GYMNASIUM

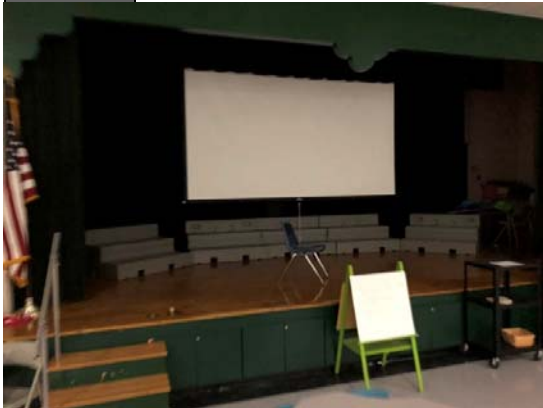
PHOTO #33: STAGE

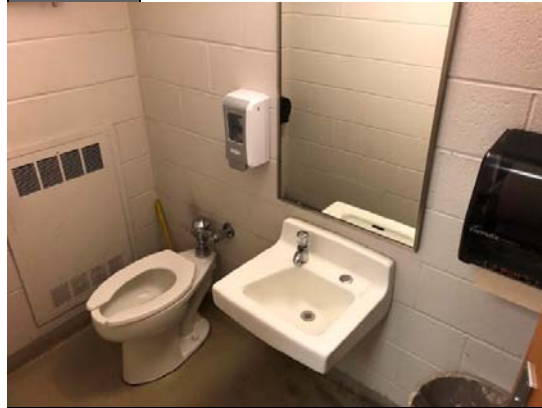
PHOTO #34: CLASSROOM RESTROOM

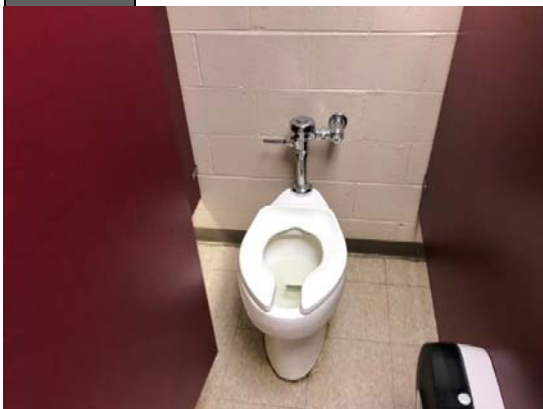
PHOTO #35: RESTROOM STALL

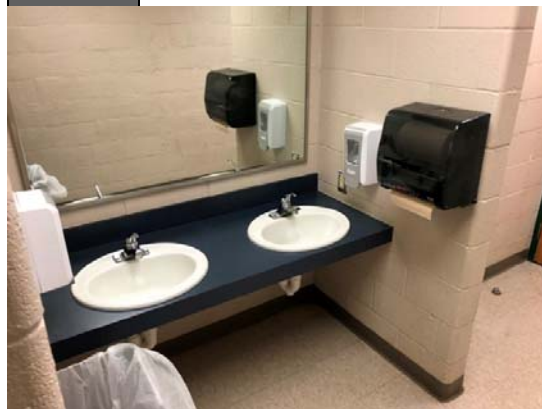
PHOTO #36: RESTROOM SINKS
