FACILITY CONDITION ASSESSMENT

July 2, 2018

THURSTON ELEMENTARY
2300 PRAIRIE STREET
ANN ARBOR, MICHIGAN 48105

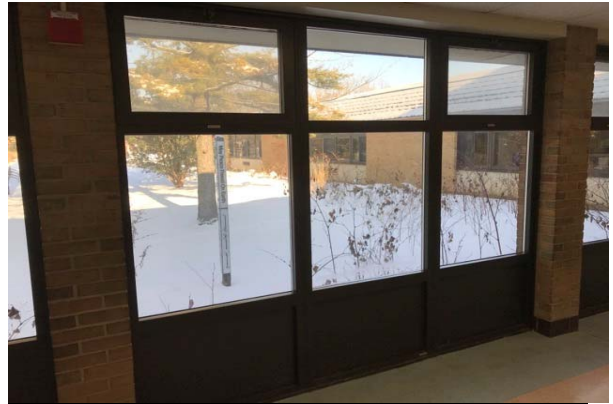
#50:	WINDOWS
------	---------

- The screens on the windows show signs of damage. The window screens require replacement.
