# FACILITY CONDITION ASSESSMENT

*R 1 Q 2018*

February 12- February 14, 2018

HURON HIGH SCHOOL, FIELD, 2 TICKET BUILDINGS  
2727 FULLER ROAD  
ANN ARBOR, MICHIGAN 48105

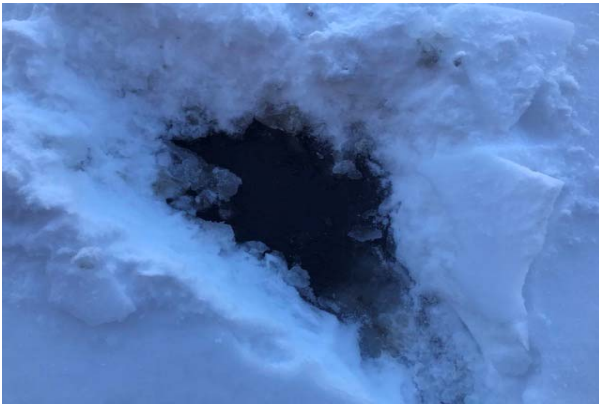
#9:	EPDM ROOF
-----	-----------

**Architectural:** Per the POC the roof leaks throughout the building. Repair damaged acoustic tiles throughout building and Clinic Room 2 due to water damage. Repair vinyl tile in Clinic Room 2 due to raising and cracking. Repair gypsum board wall in Testing Room due to cracks observed during site visit. Paint concrete walls throughout building due to age, cracking, and graffiti located in locker rooms. Repair concrete wall in Room 115 due to hole observed during site visit. Repoint brick veneer in Principal's Office due to crack observed during site visit. Replace lockers in locker rooms due to rust and damage throughout. Replace carpeting in 21 (special needs) due to isolated areas of unsanitary carpet where the children have numerously soiled the carpet.

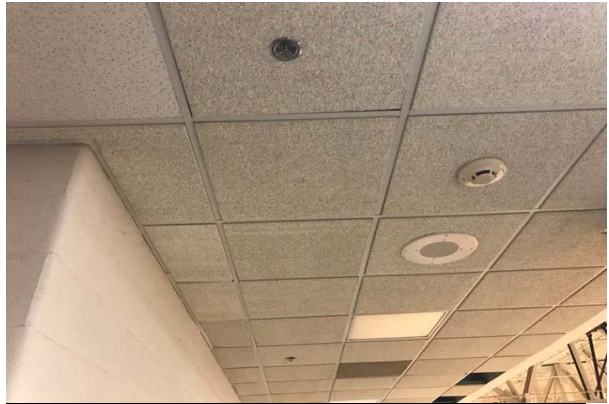
#50:	SPRINKLER HEADS
------	-----------------

**MEPF :** The vast majority of the building is not protected by fire suppression; sprinkler heads are currently limited to the gymnasium area. Due to its construction date, the facility is most likely "grandfathered" by code and the installation of fire sprinklers not required until major renovations are performed. Regardless of when or if installation of facility-wide fire suppression is required by the governing municipality, EMG recommends a retrofit be performed. As part of the major recommended short term renovations, a facility-wide fire suppression retrofit is recommended.
