# FACILITY CONDITION ASSESSMENT

February 2018

FACILITY CONDITION ASSESSMENT

PIONEER HIGH SCHOOL  
601 WEST STADIUM DRIVE  
ANN ARBOR, MICHIGAN 48105

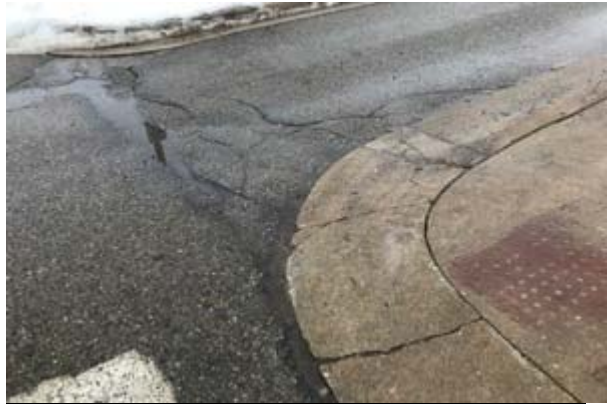
#7:	ASPHALT PARKING LOT
-----	---------------------

**Site :**  
 The Drive isles and parking lots is in poor condition. The asphalt lots and drive isles have numerous failed areas and should be repaired to prevent further degradation. A cost allowance to repair , replace the failed asphalt is also included in the cost tables

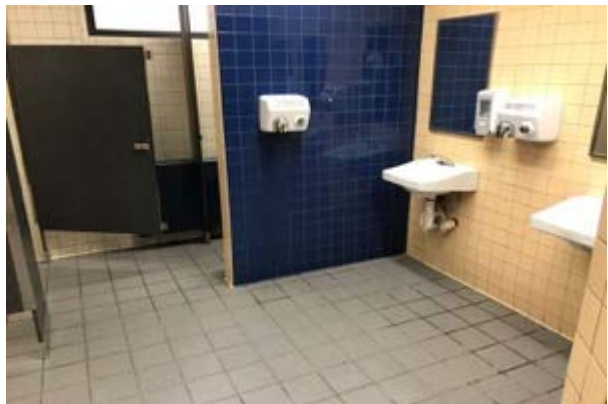
#47:	PLUMBING SYSTEM, DOMESTIC SUPPLY
------	----------------------------------

- Most of the domestic water lines are galvanized iron original to the 1956 construction. To date there has been no history of chronic leaks or water pressure problems. However, it is quite common for galvanized iron piping to develop problems due to long-term corrosion with thinning walls and/or interior mineral deposit accumulation, especially once it has aged 40 or 50 years. EMG highly encourages some easily accessible pipe sections be examined to more accurately determine the interior pipe wall conditions after nearly 62 years of use. Pending these results, consideration should be given to replacing all the plumbing supply lines with copper. A budgetary cost is included for this replacement.

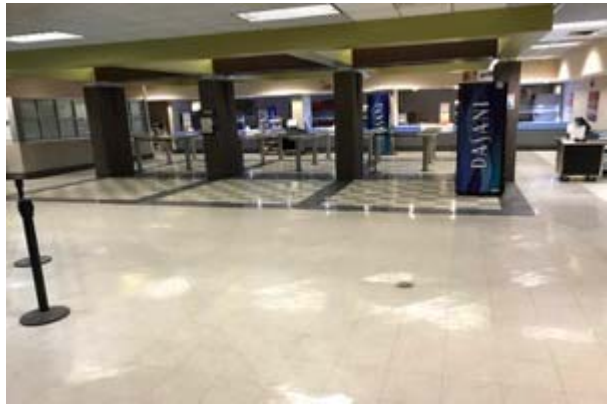
#69:	INTERIOR WALL FINISH
------	----------------------

- It appears that the interior finishes have not been renovated within the last 10 years..
- There are damaged, deteriorated sections of wall surfaces throughout the building. The damaged, finishes must be repaired. The cost to replace the wall surfaces is relatively insignificant and the work can be performed as part of the property management's routine maintenance program.
