FACILITY CONDITION ASSESSMENT

July 2, 2018

BALAS ADMINISTRATION BUILDING
2555 SOUTH STATE STREET
ANN ARBOR, MICHIGAN 48104

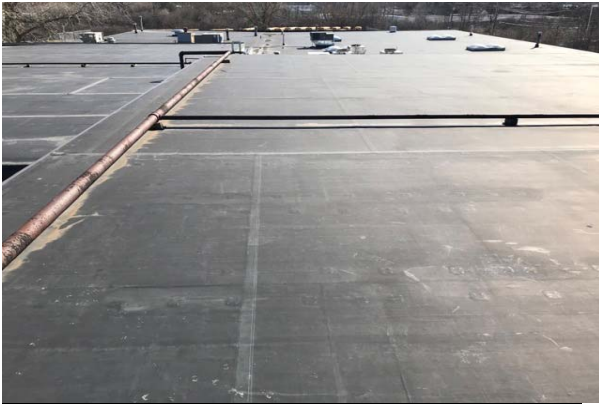
Architectural : No significant structural deterioration was observed. The roof was reported as being consistently problematic, with ongoing roof leaks in numerous areas. The aforementioned exterior wall leak into the warehouse is the only significant issue noted at the exterior walls.

#7: OVERALL ROOF

- A moisture inspection is recommended prior to or in conjunction with the roof replacement, to ensure that the reported water leaks have not created any structural issues. A cost allowance for this inspection is included.

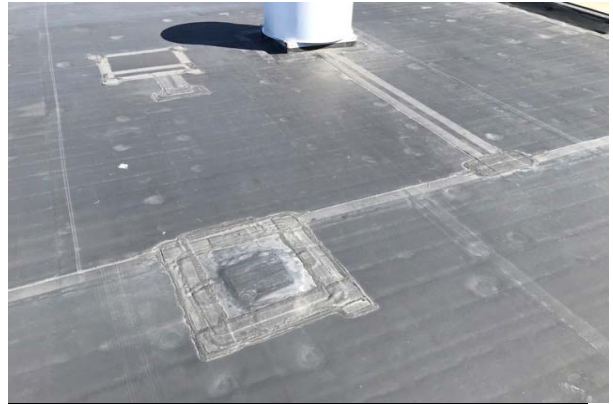
- There are no attics at the facility.
- Roof leaks have occurred within the past year, and some of these leaks may remain active. Water infiltration through the roof was reported as a chronic problem, with leakage above the IT, finance, HR, and superintendent's office being particularly problematic. The roof leaks are repaired as they arise, but overall roof replacement is recommended. All active leaks must be repaired.

#8: PATCHED AREAS OF ROOF MEMBRANE

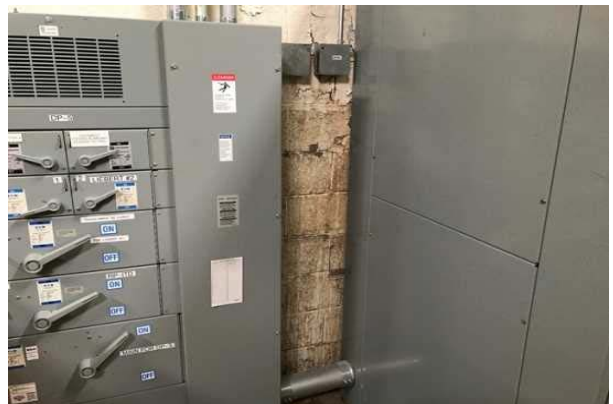
Site : The site is in generally fair condition. The asphalt paved drive aisle at the south side of the property has deteriorated due to reported heavy use by school buses, and has crushed a drainage pipe that has caused water infiltration through an exterior wall adjacent to interior electrical equipment.

- The foundations and footings cannot be directly observed. However, there are isolated areas of cracking and peeling paint, and moisture staining along the south exterior wall adjacent to a below-grade exterior door. No structural damage was reported or observed, and the issue is reportedly known, has been investigated, and has not been found to be an immediate hazard. However, remedial work should be performed, particularly considering that several large capacity electric units are located at the damp area. The root cause is reported to be a crushed drain line, which prevents water flowing down the exterior stairs toward the aforementioned exterior door from draining away from the building. Budgetary cost allowances for waterproofing of the wall, and for repairing the drain line (further discussed in section G20) are included.

#10: WATER INFILTRATION AT EXTERIOR WALL

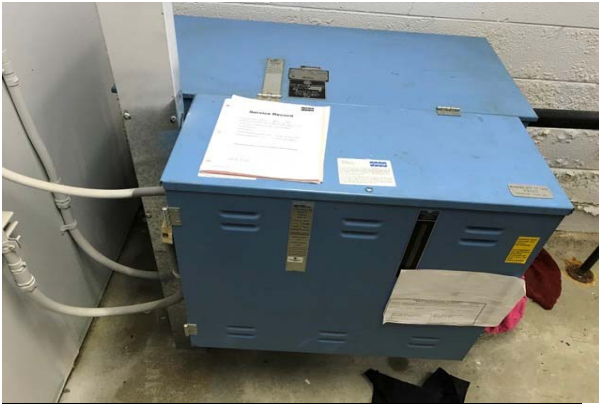
- The elevators appear to provide adequate service. The elevators are serviced by Otis on a routine basis. The elevator machinery and controls appear to be more than 20 years old.
- The elevators are inspected on an annual basis by the municipality, and a certificate of inspection is reportedly on file, but could not be found. The inspection certificates should be verified and posted in the elevator cabs.
- The emergency communication equipment in the elevator cabs appears to be functional. Equipment testing is not within the scope of the work.

#19: HYDRAULIC ELEVATOR MACHINERY

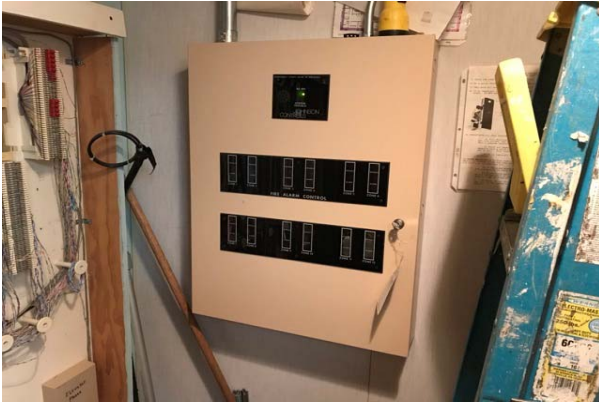
MEPF : The HVAC systems range significantly in age, but overall the facility’s heating and cooling units were reported to be functional and generally adequate. Some new units have been installed within the last three years. No major plumbing or electrical concerns were noted. The building is not sprinklered, and the fire alarm control panel appears to be past its EUL.

#27: CENTRAL FIRE ALARM PANEL

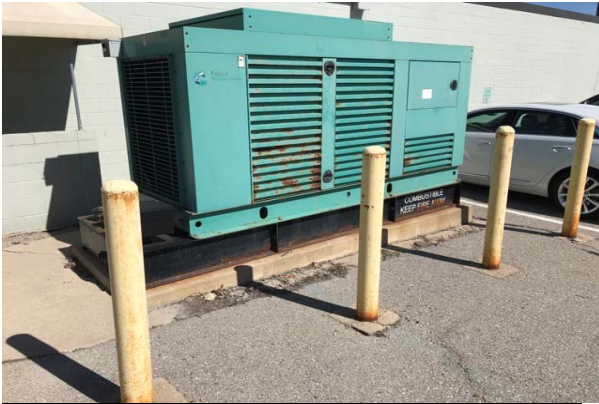
Building Emergency Systems			
Size	250 kW	Fuel	Diesel
Generator / UPS Serves	Life/safety systems	Tank Location	Beneath generator
Testing Frequency	Weekly	Tank Type	Integral ("belly") tank
Generator / UPS Condition	Poor

#31:	EMERGENCY GENERATOR
------	---------------------

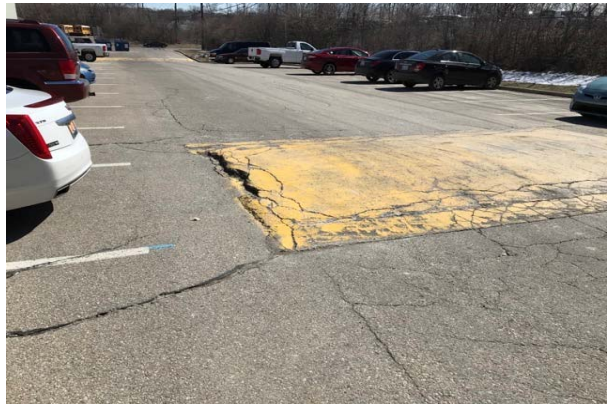
#34:	DAMAGED PAVING AT SOUTH ELEVATION DRIVE AISLE
------	--

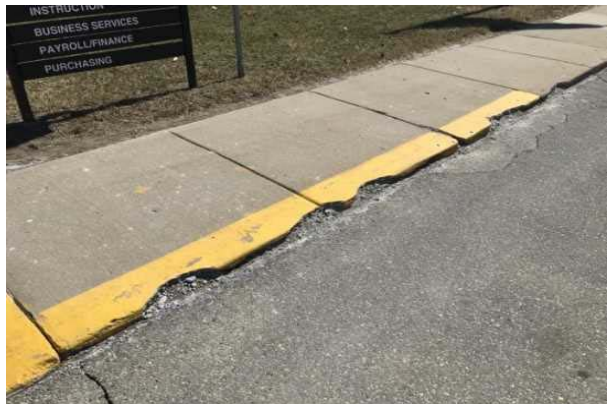
#36:	DAMAGED CONCRETE SIDEWALKS
------	-------------------------------
