FACILITY CONDITION ASSESSMENT

FREEMAN ELEMENTARY
3540 NORTH DIXBORO ROAD
ANN ARBOR, MICHIGAN 48105

June 29, 2018

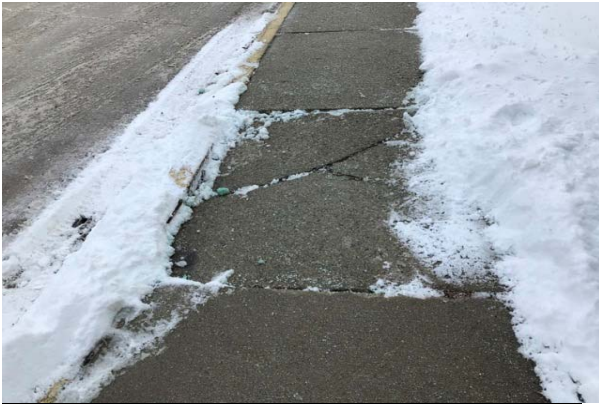
Site : The parking lot has multiple cracks from erosion. The sidewalk has major cracking and trip hazards. The fencing on the west side of the property is damaged. The site lighting is inadequate and antiquated. The site signage has minor damage. In addition the basketball backboards are distressed. A cost allowance to repair and/or replace these deficient attributes is included in the cost tables.

#7:	SIDEWALK, TRIP HAZARD
-----	-----------------------

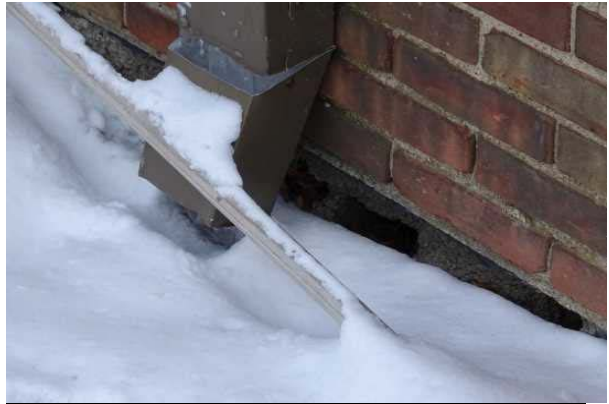
- The foundations and footings cannot be directly observed. However, there are isolated areas of cracking, movement, and vertically displaced slabs along the east side of the building. This condition typically indicates excessive settlement or other potential problems with the foundation system. A Professional Engineer with specific expertise in structural design and construction in this geographical area must be retained to evaluate the structure and to provide remedial recommendations consistent with local regulatory and code requirements. Although the estimated cost of repair cannot be accurately determined without the recommended study, a budgetary cost allowance to repair the affected elements is included.

#8:	DAMAGED FOUNDATIONS
-----	---------------------

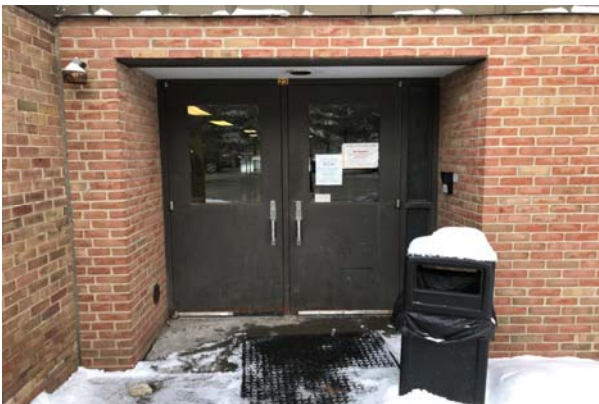
- There are a significant number of damaged, delaminated, deteriorated, rusted doors and door frames. The damaged doors and frames must be replaced.

#11:	EXTERIOR DOOR
------	---------------

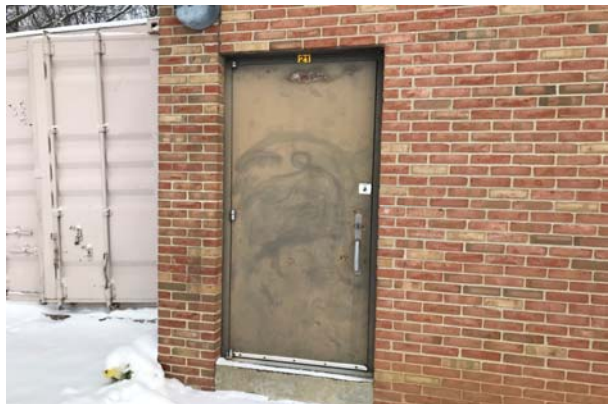
#12:	EXTERIOR DOOR
------	---------------

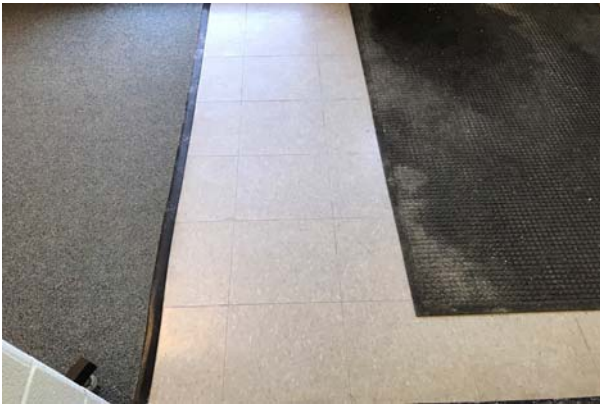
- The interior areas appear to be last renovated in 1977.
- The ceilings have significant areas of water-damaged ceilings and show signs of wear and tear throughout the building. The damaged ceiling areas need to be replaced.
- The vinyl tiles have significant areas of damage throughout the building. The damaged vinyl tile areas need to be replaced.

#15:	VINYL TILE (VCT)
------	------------------

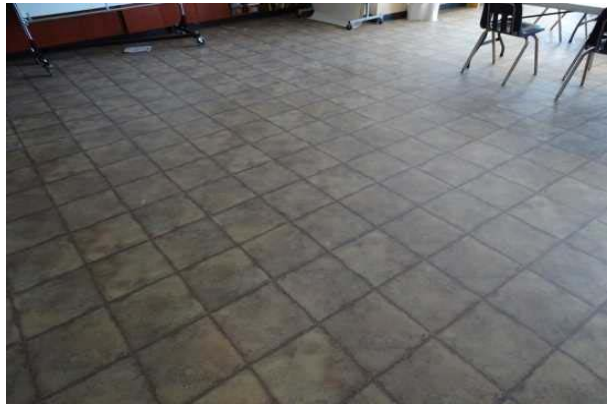
#16:	VINYL TILE (VCT)
------	------------------

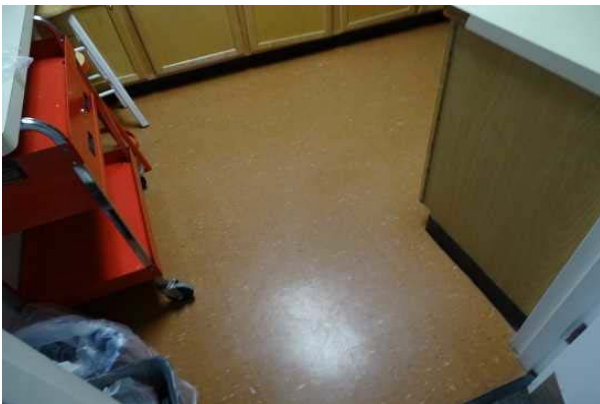
#17:	VINYL TILE (VCT)
------	------------------

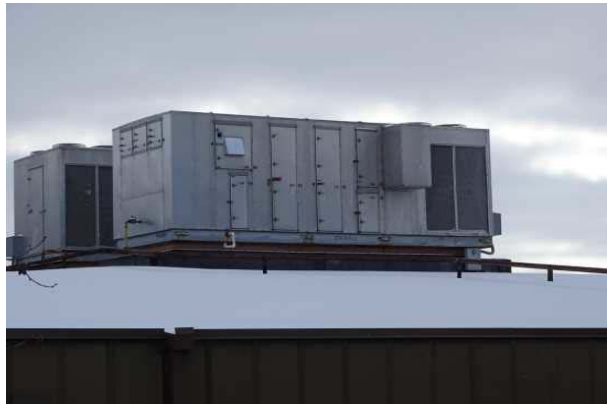
- Most of the mechanical equipment on the roof is antiquated, inefficient and shows signs of heavy use. Some of these units do not seem to be working and are physically missing panels. Most mechanical equipment on the roof requires replacement. The other mechanical equipment is near the end of its useful life. Replacement of most of the mechanical equipment within the observational term is recommended.
- The facility HVAC is controlled using an outdated electronic non programmable control system. For modernization, reliability, and increased control, full conversion to a web-based direct digital control (DDC) platform is highly recommended.

#34:	PACKAGED UNIT (RTU)
------	---------------------

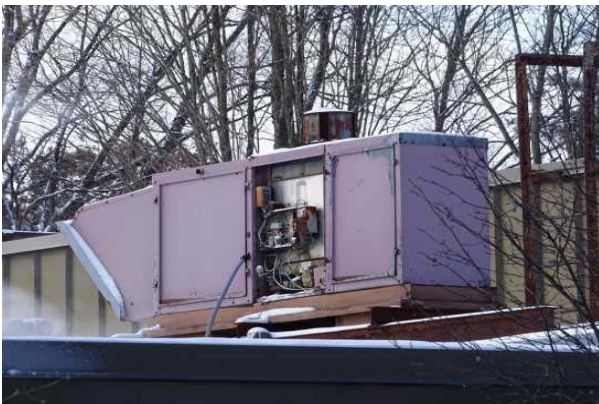
#35:	PACKAGED (RTU)
------	----------------

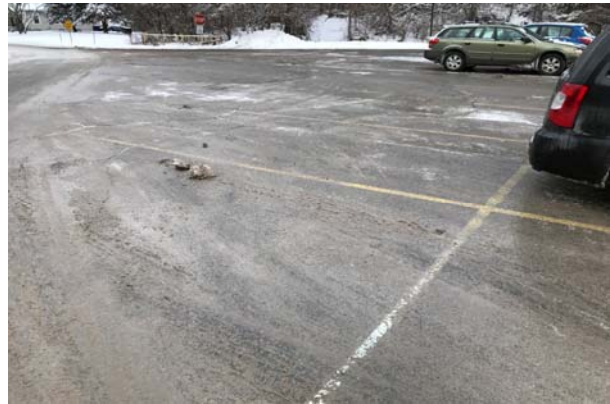
#46:	PARKING LOTS
------	--------------

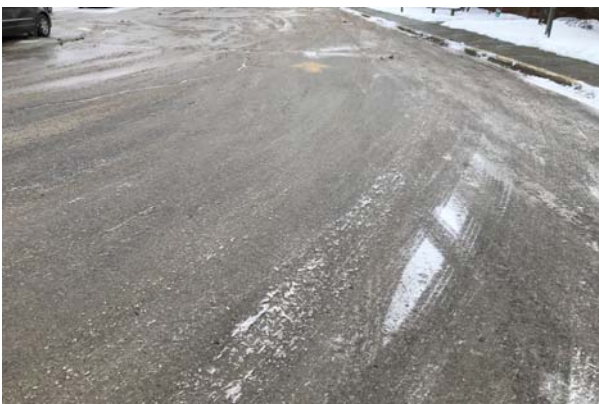
#47:	PARKING LOTS
------	--------------

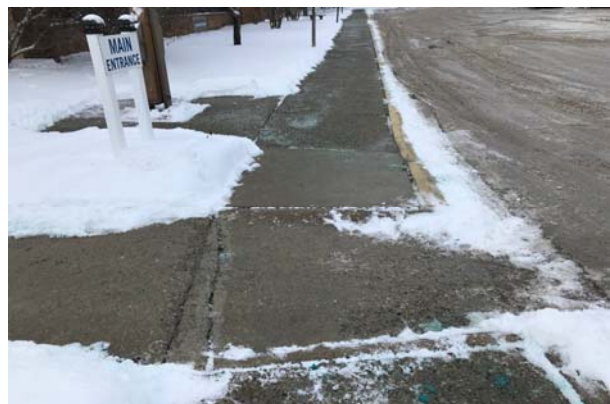
#48:	SIDEWALKS
------	-----------
