FACILITY CONDITION ASSESSMENT

129010.18R000-032.354

March 6, 2018

PRESCHOOL AND FAMILY CENTER (BALAS II AND III)
2725 BOARDWALK STREET
ANN ARBOR, MICHIGAN 48104

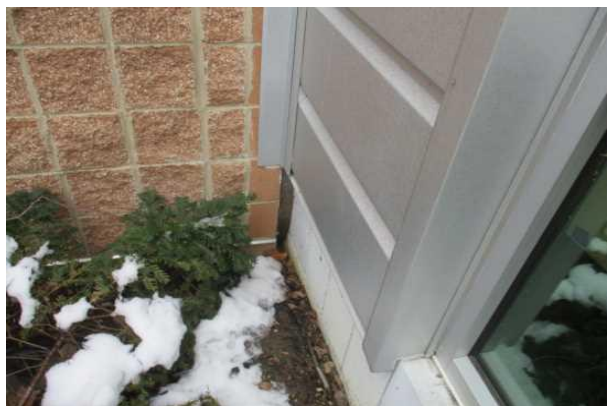
#12:	SIDING AND BRICK WITHOUT CAULKING
------	-----------------------------------

- On-going periodic maintenance, including patching repairs, graffiti removal, and re-caulking, is highly recommended. Future lifecycle replacements of the components listed above will be required.
- The metal siding has isolated areas of dented siding, north wall at the east doors. The damaged siding trim must be repaired.
- There are significant areas of missing sealant, metal wall to CMU block joints are the areas of concern. The damaged sealant must be replaced or repaired.

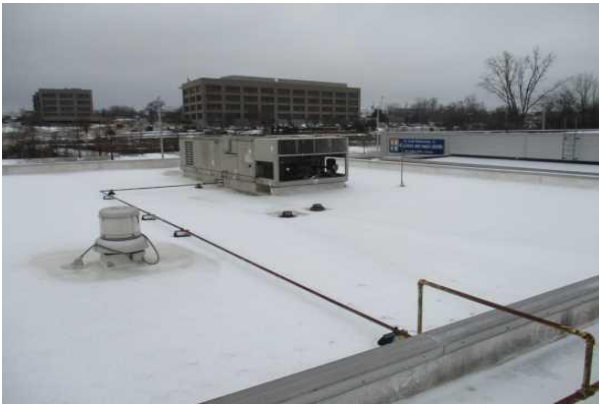
- The roof top gas piping is corroded and requires cleaning and repainting.

#15:	RTU AND GAS PIPING ON ROOF
------	----------------------------

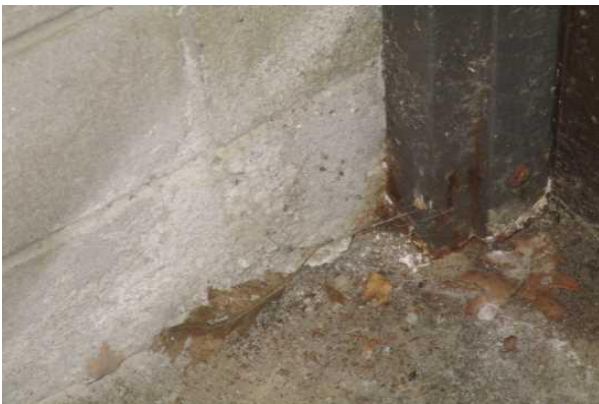
#17:	EXTERIOR DOOR FRAME DAMAGE
------	----------------------------

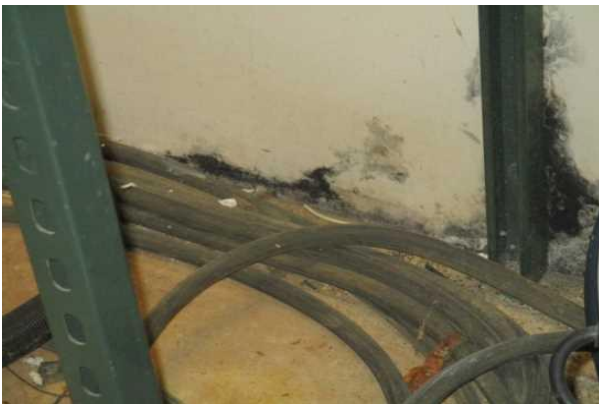
#29:	MOLD REMEDIATION
------	------------------

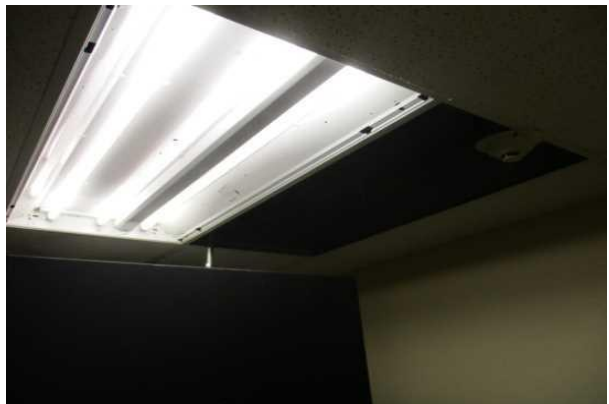
#30:	MISSING CEILING TILES
------	-----------------------

- The ceiling tiles have isolated areas of water-damaged ceiling tiles some are in C105, Yellow hallway, Media Center. The damaged ceiling tiles need to be repaired and/or replaced. The cost to replace the damaged finishes is relatively insignificant and the work can be performed as part of the property management's routine maintenance program.

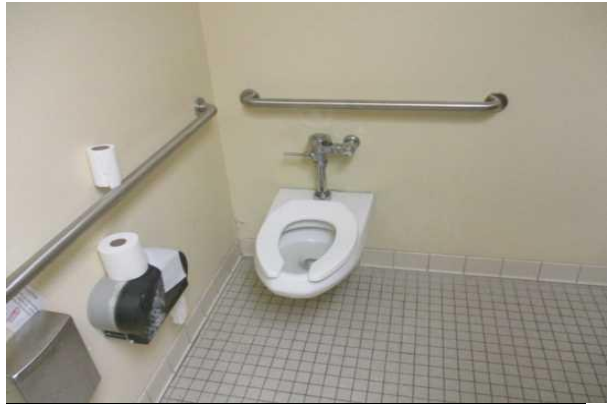
#32:	GYPSUM BOARD REPAIR
------	---------------------

- There are isolated areas of water-damaged wall finishes, plumbing wet walls, entry doors and boiler room. The damaged wall areas need to be repaired. This should include the installation of expansion joints at the cracked drywall.
