The Garland Company, Inc.

## Aberdeen School District Roof Reports

Prepared For  
Michael Pauley

October 19, 2022

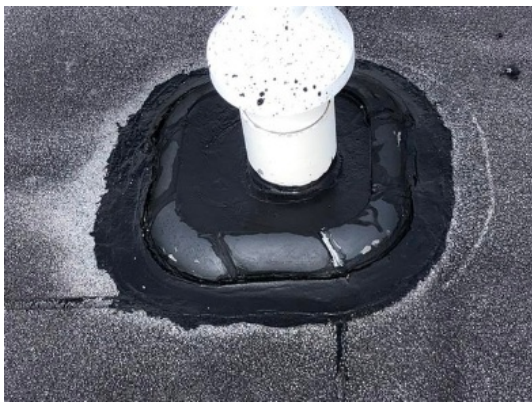
*Photo 1*

Cracked out penetration flashing

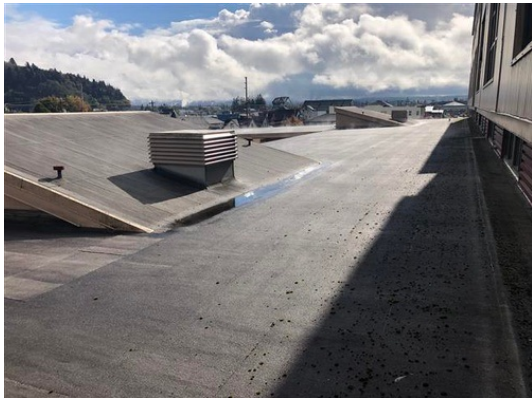
*Photo 2*

Roof section holding water - ideally this areas should have a cricket

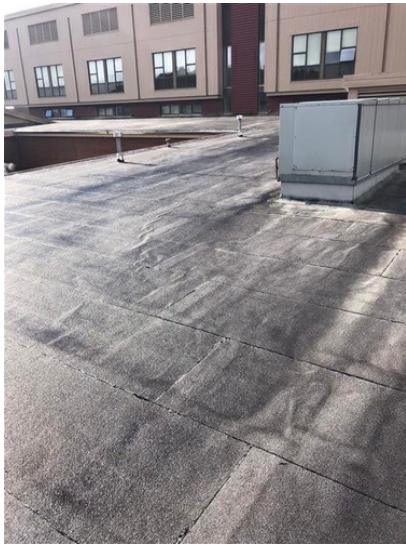
*Photo 3*

Looking out over a dirty cap sheet on the lower roof section

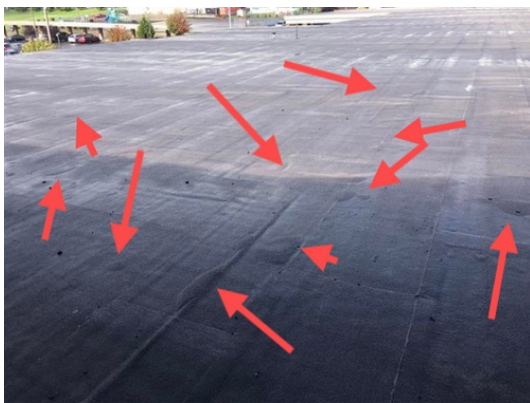
*Photo 4*

Multiple blisters are found on each roof section

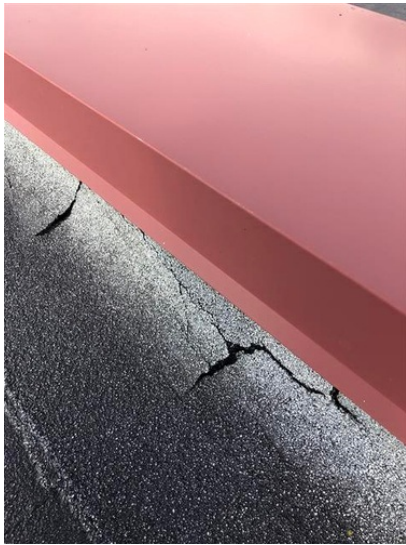
*Photo 9*

Failed base cap sheet at a flashing location - this is wide open currently

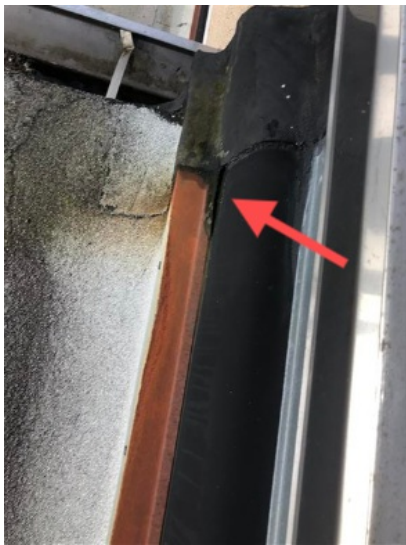
*Photo 10*

Split in the expansion joint - these are often an issue

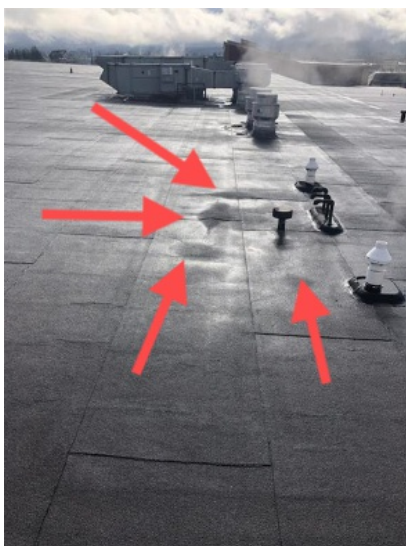
*Photo 11*

Another roof section littered with blisters

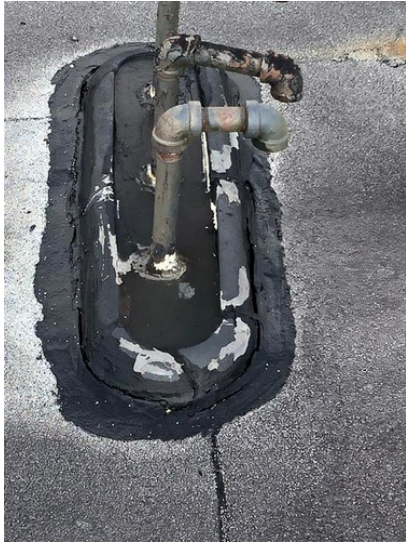
*Photo 12*

More cracking at penetration

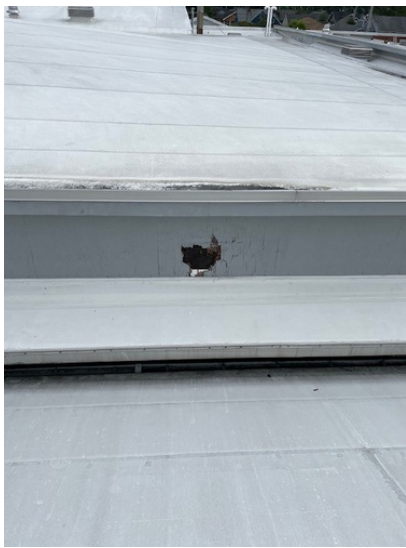
*Photo 6*

An area of siding that has been damaged and a waterproofing concern.

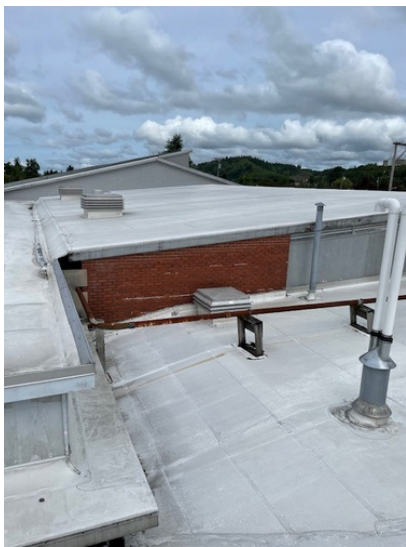
*Photo 7*

The masonry brick should be sealed at the same time of roofing work.

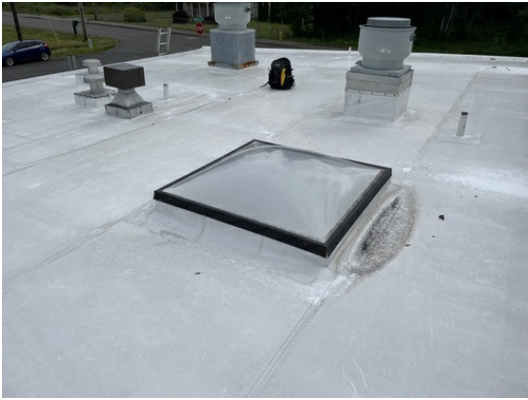
*Photo 5*

The roof top equipment such as this skylight has a very low flashing height, which would likely cause a water intrusion concern on a snow storm.

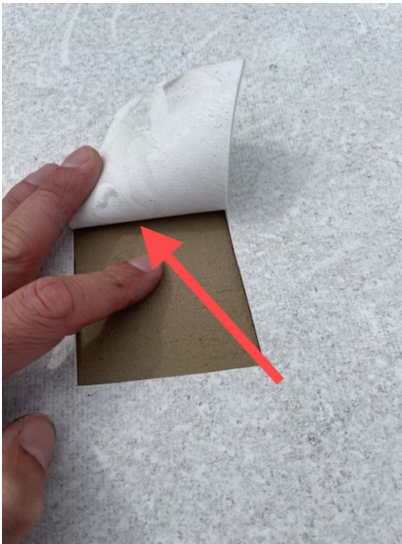
*Photo 6*

The roof was cored to determine the complete assembly. It appears that there is 3 roofs on this building and moisture was present under the most recent as highlighted in this picture.

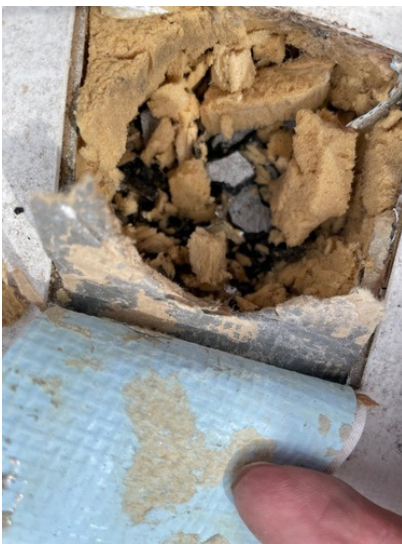
*Photo 7*

The core sample on the main building confirmed three roofs over a wood deck with a couple inches of insulation.

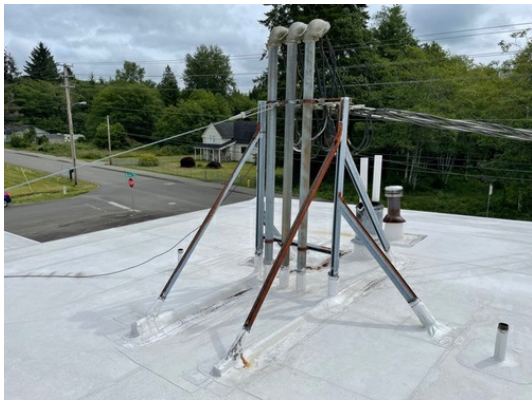
*Photo 8*

Multiple penetrations that should be correctly flashed during the next roof replacement.

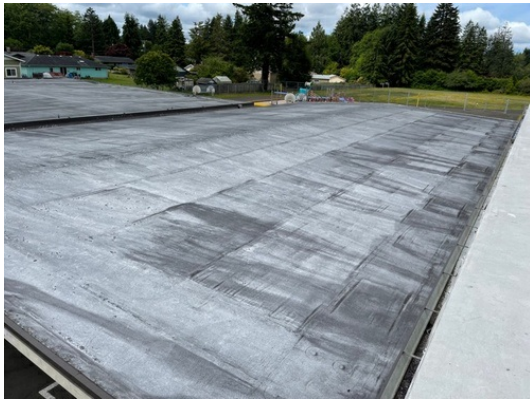
*Photo 1*

Overview of the covered play shed. The positive slope is helpful and it is believed that a repair and restoration is a possible application in this area.

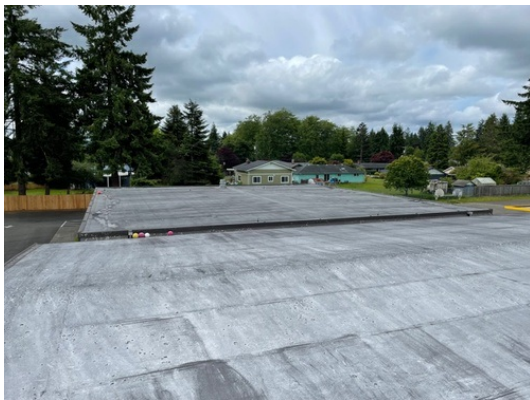
*Photo 2*

The classroom wing is the only BUR mineral cap sheet on the School. A repair and restoration option may be a 10 year solution, however if the building is anticipated to be kept by the District then a complete roof replacement should be performed.

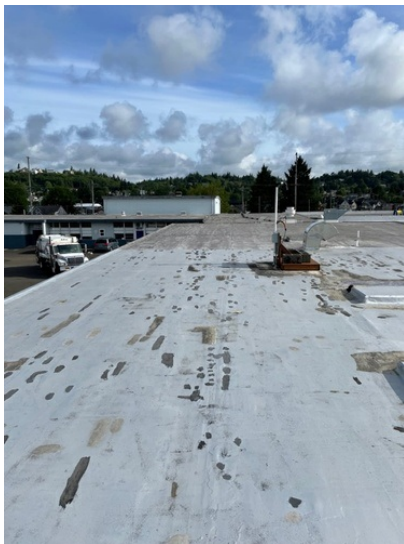
*Photo 1*

Overview showing the existing roof that appears to be been coated and patched in numerous areas.

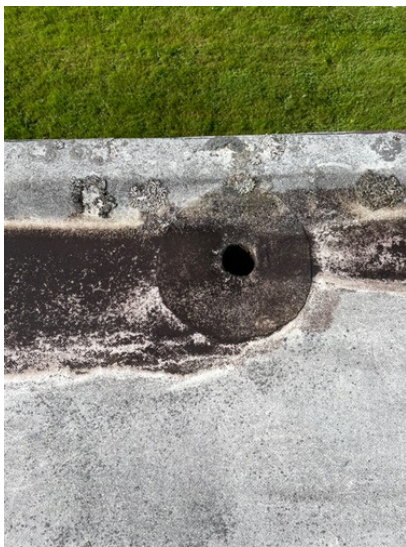
*Photo 4*

The small size of the drain, no overflow and lack of protection screen make for a concern.

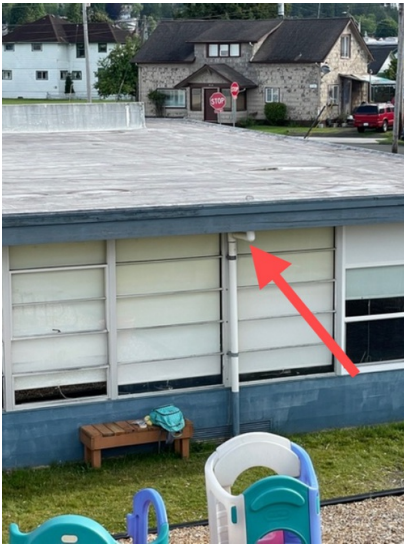
*Photo 7*

The drainage through the soffit and into a 90 are a worry. It is recommended that external gutters be added at the time of roof replacement.

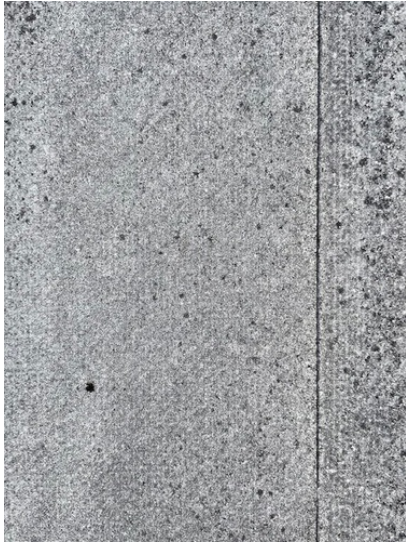
*Photo 9*

The existing single ply roof is failing due to age.

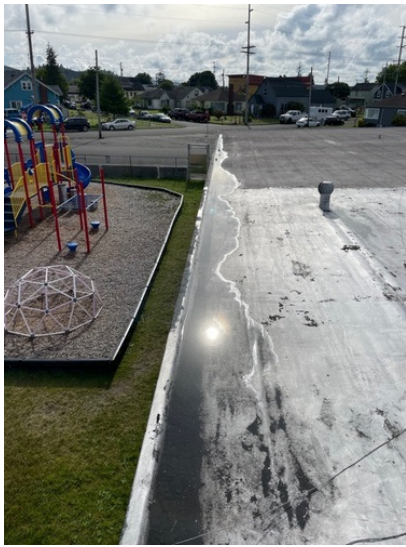
*Photo 10*

Significant ponding is found along the perimeter. Replacing the existing drainage system with external gutters will eliminate this.

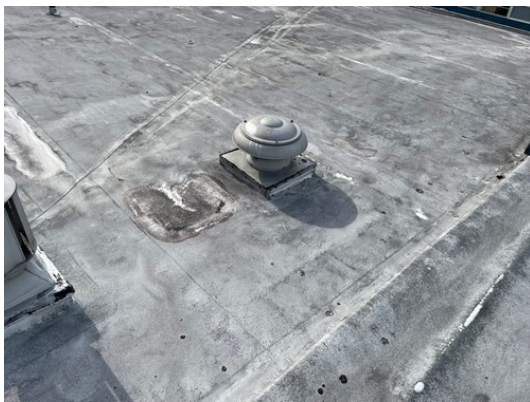
*Photo 11*

Low roof top equipment can create a risk of water intrusion. All roof top equipment should be raised 7" at the time of roof replacement.

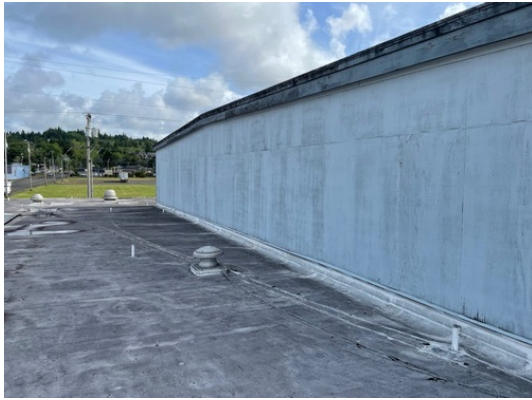
*Photo 12*

The Gym siding should be considered to be addressed at the same time as the roof.

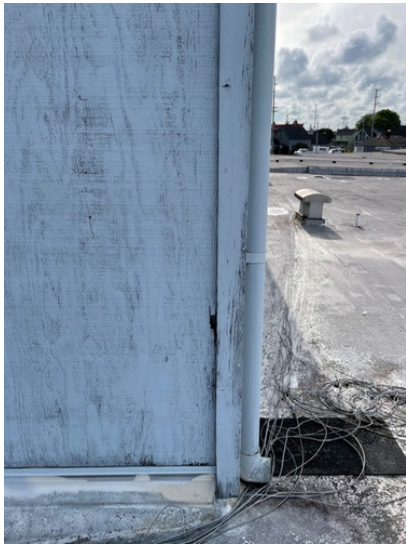
*Photo 13*

Small and frequent water related damage can be found along the Gym siding.

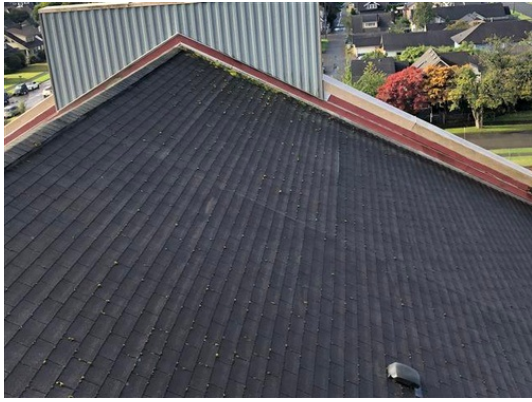
*Photo 3*

Shingles in good condition - showing minor signs of age and wear

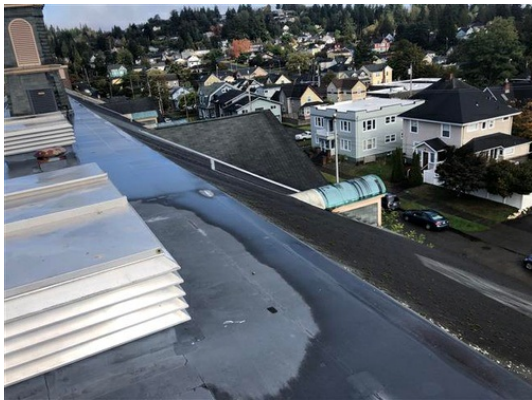
*Photo 7*

Flat center catwalk section holds some water but in relatively good condition

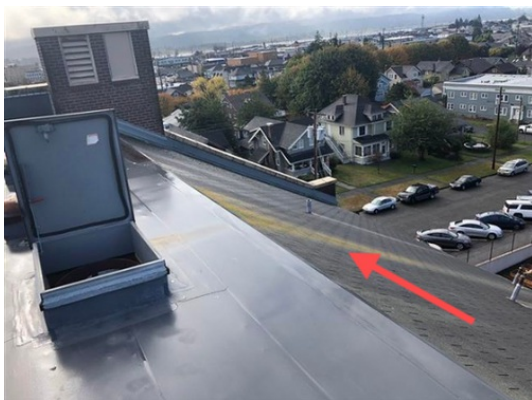
*Photo 8*

Looking at roof hatch - notice some algae growth on the shingles in the background

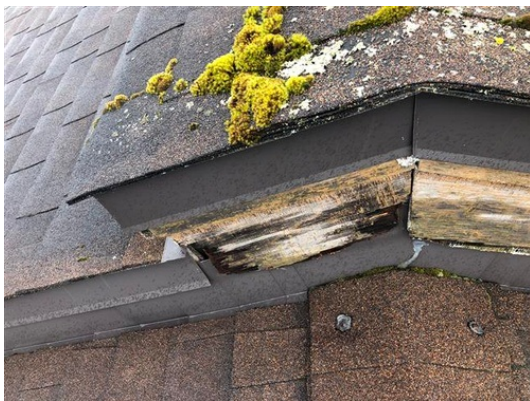
*Photo 1*

Small amount of wood rot on a piece of fascia

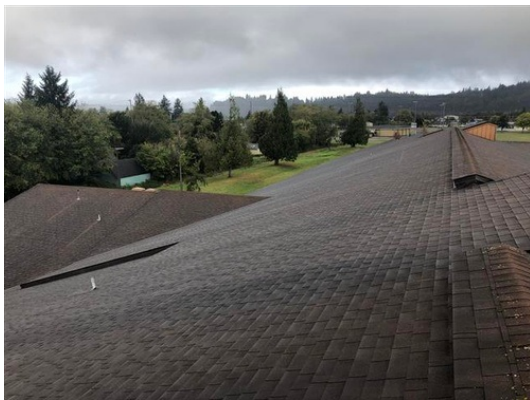
*Photo 2*

Looking out over roof section - most of the shingles have a layer of dirt and grime on them but otherwise appear to be in good condition

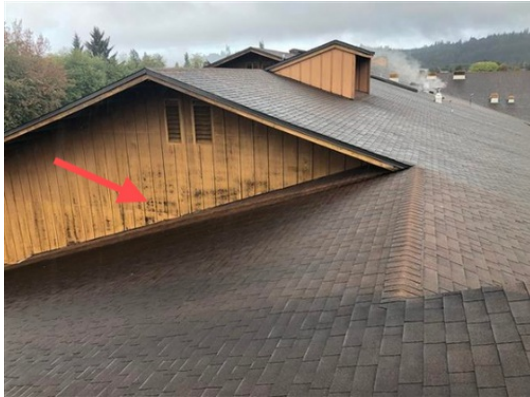
*Photo 4*

Siding on roof showing signs of wear

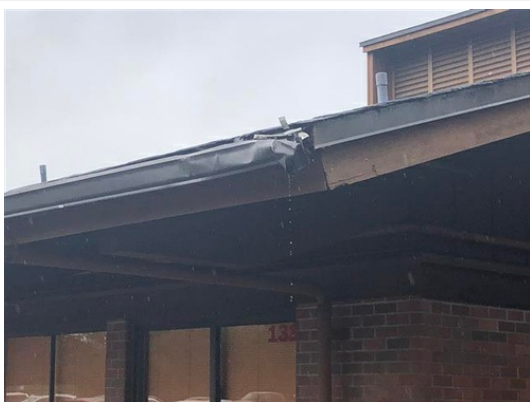
*Photo 6*

Damaged gutter

| <div>- Clean the roof to remove layer of dirt and grime</div> <div>- Repair the damaged gutter section</div> <div>- Perform repairs at misc. fascia and siding areas with water damage</div> | | | |

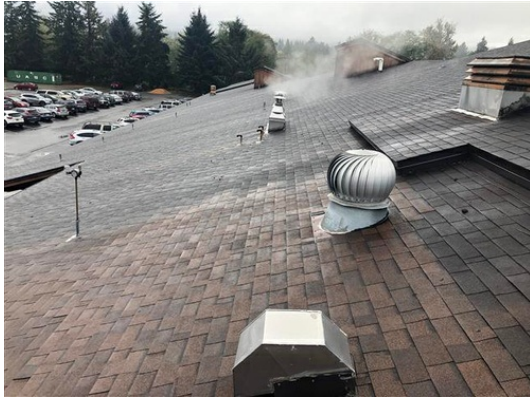
*Photo 8*

Shingles near vents have less dirt and grime on them resulting in the color difference

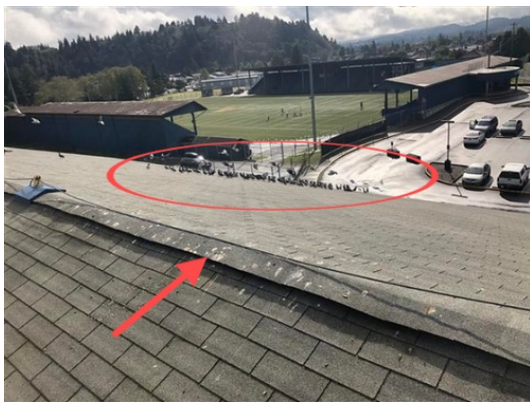
*Photo 1*

Looking down the side of the shingle roof - notice the large flock of birds and bird droppings all over the roof

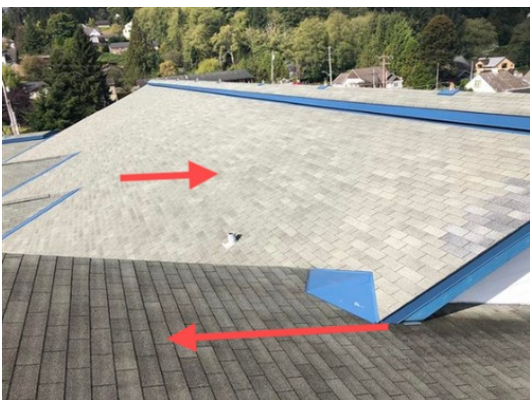
*Photo 6*

Shingles are worn differently depending on which way they lay

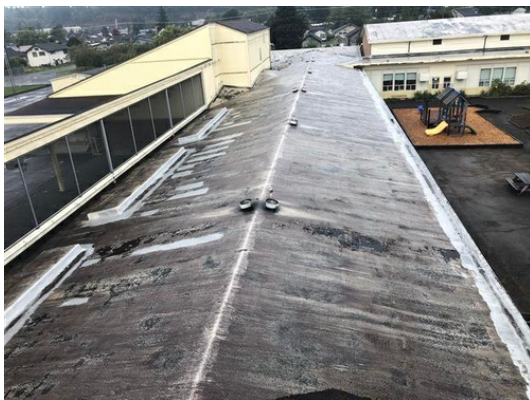
*Photo 5*

BUR with silver coating and lots algae growth- notice the cleaned areas where repairs have been done

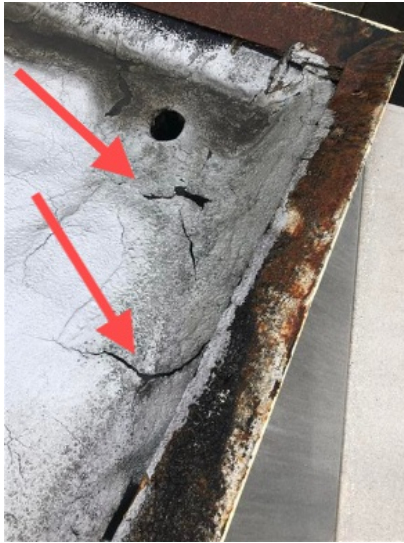
*Photo 6*

Cracks near drain

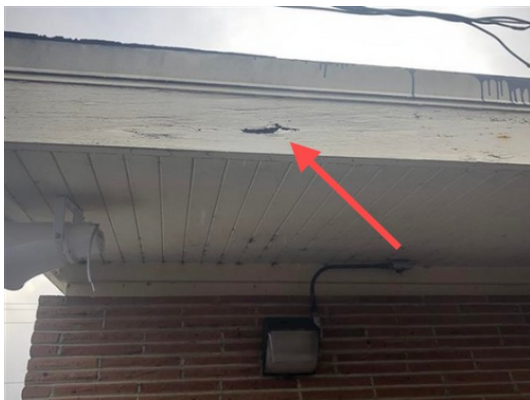
*Photo 8*

Rot in the fascia boards

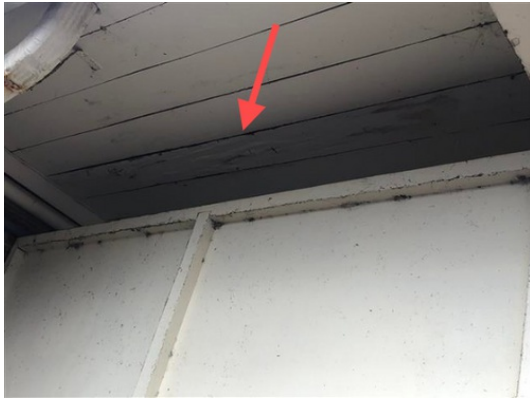
*Photo 9*

Rot in the wood decking

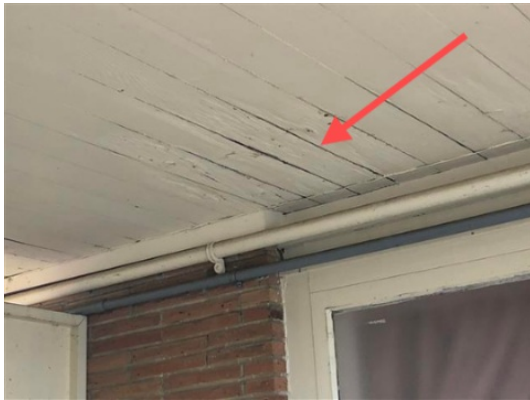
*Photo 10*

Additional rot in the wood decking

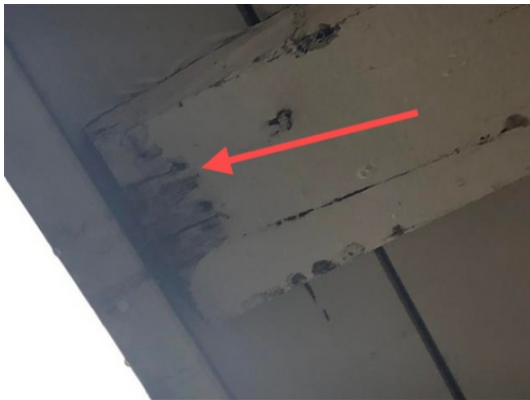
*Photo 11*

Rot on wood under deck

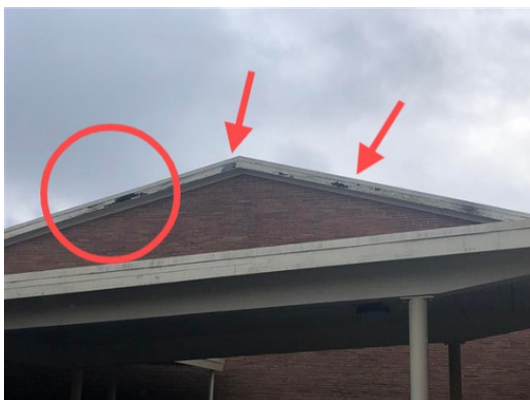
*Photo 12*

Rot in the fascia boards

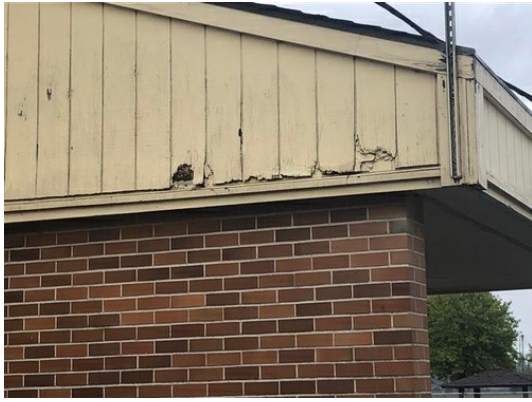
*Photo 13*

Siding with holes and deterioration

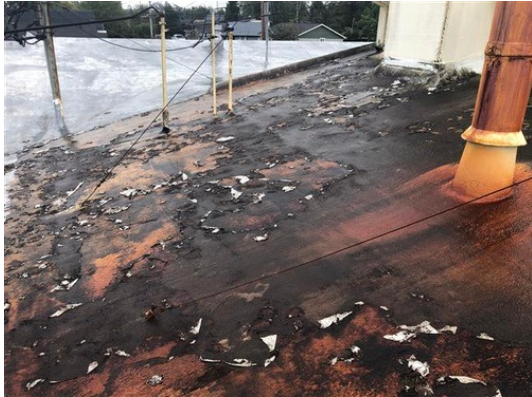
*Photo 14*

Discoloration from the vents on the BUR roof section

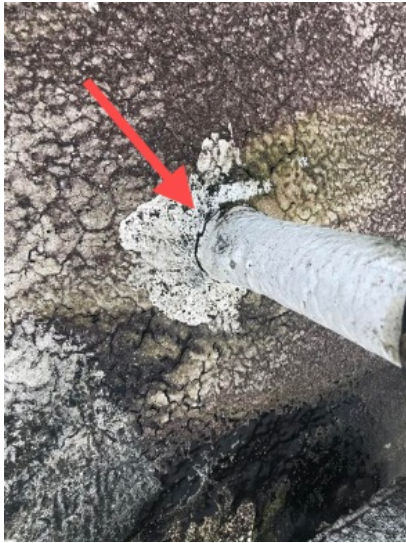
*Photo 16*

Cracking around pipe

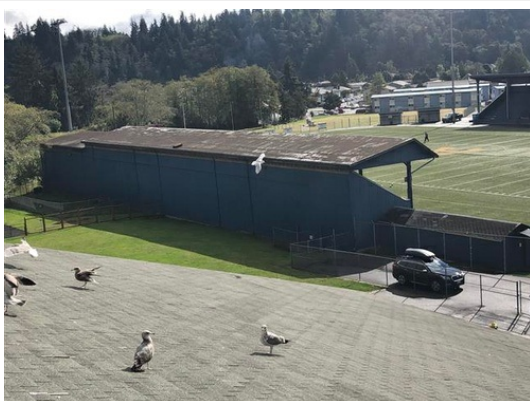
*Photo 3*

Looking down over stained and dirty single ply roof section
