Lighting System Inspection Report

Staples High School Auditorium
70 North Avenue
Westport, CT 06880

Staples High School Auditorium
Inspection Report on Stage Lighting and Stage Rigging Systems
10/18/2022

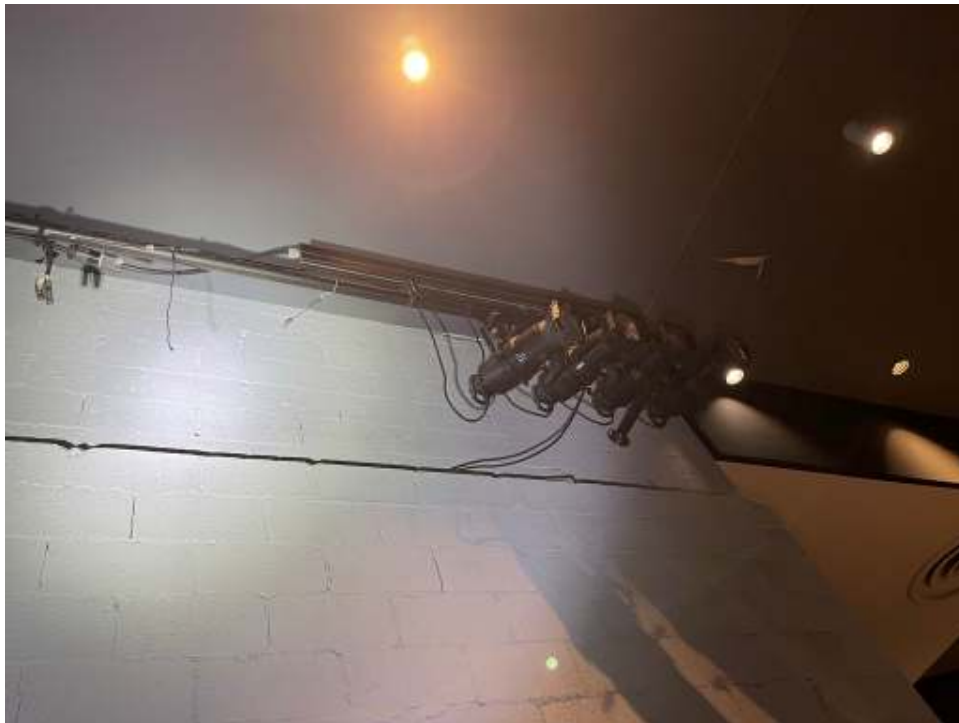
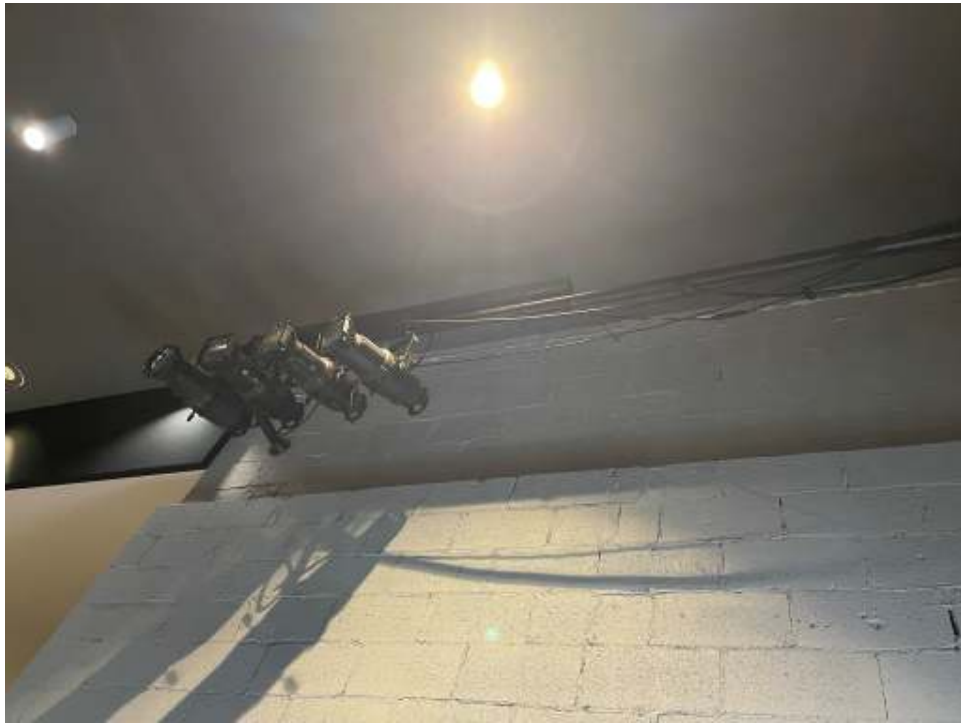
A.) Front of house (FOH)

The front of house positions are difficult to access. Lighting fixtures are hung on tormentor pipes which utilize threaded connections, which do not meet ANSI standards.

Recommendation: The front of house positions could be remounted lower for easier access. Refabricate new form pipes with welded corners and flanges. Permanent power and control wiring should be installed.

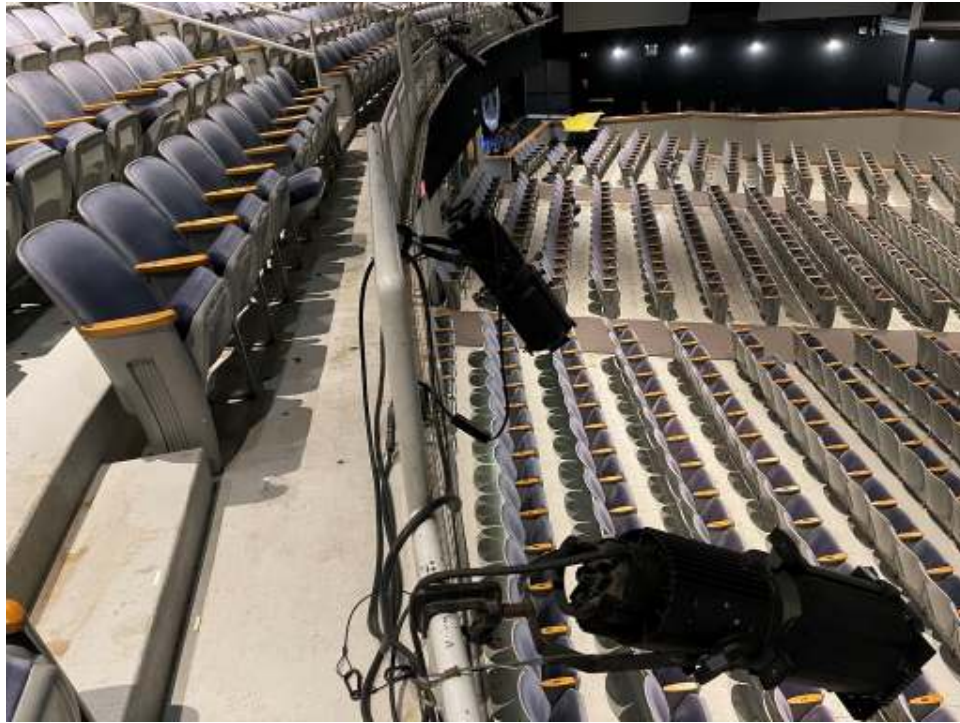
B.) Balcony Rail

Lighting is hanging from the balcony guard railing. Temporary cabling is used instead of permanent wiring for power and control. This could be hazardous to audience members during a performance. Sight lines are impacted by lighting fixtures.

Recommendation: A separate hanging position could be created 6 or 8 Inches out from rail so lights could be hung in proper orientation with the yoke mounted vertically, to keep lighting fixtures away from the audience area and out of audience sight lines. Permanent conduit and circuit boxes should be run out to the new hanging positions.

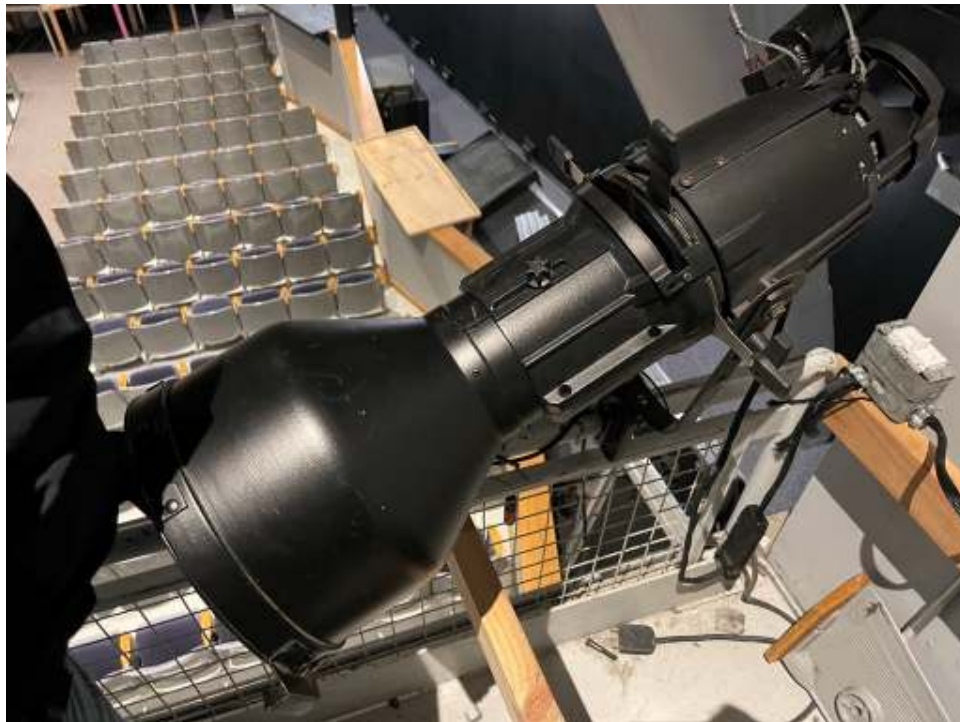
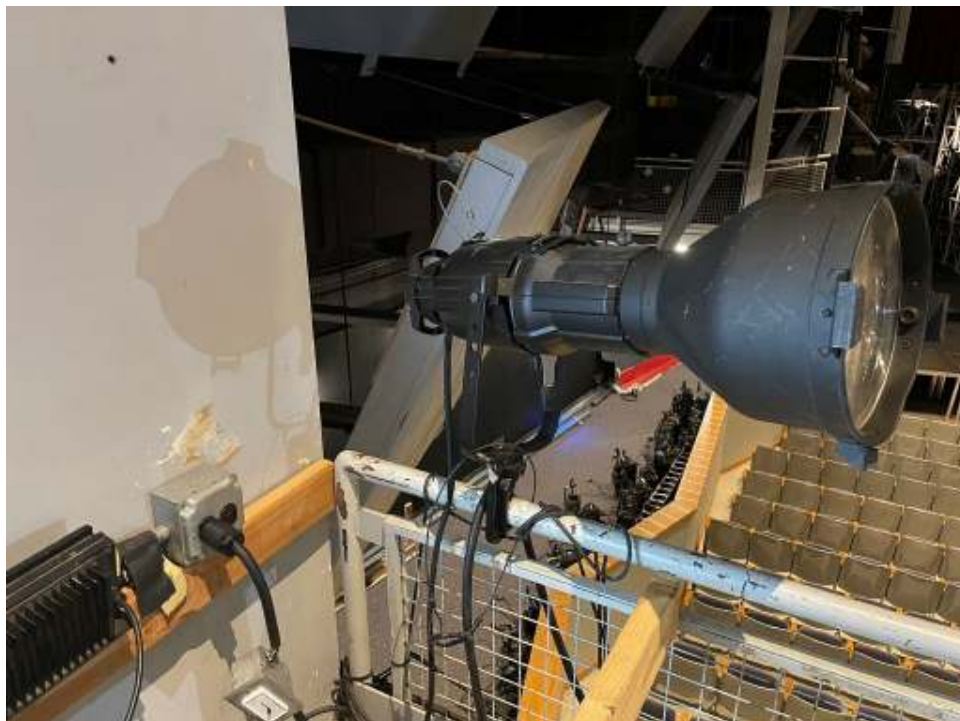
C.) Balcony Rail Follow Spot Positions

Follow spot positions are installed with inadequate add on hardware. Lighting fixtures are clamped to balcony guard railing. Power cable on homemade dimmer box is pulling out of its strain relief, and the box is missing covers, exposing sharp edges.

Recommendation: Lighting fixtures are clamped to balcony guard railing and should be mounted on follow spot stand pipe. Permanent power and control wiring should be provided. Upgrading fixtures upgraded to LED will no longer require a separate dimmer. City Theatrical offers a follow spot kit for more stable mounting, handling, and balance of the fixture.

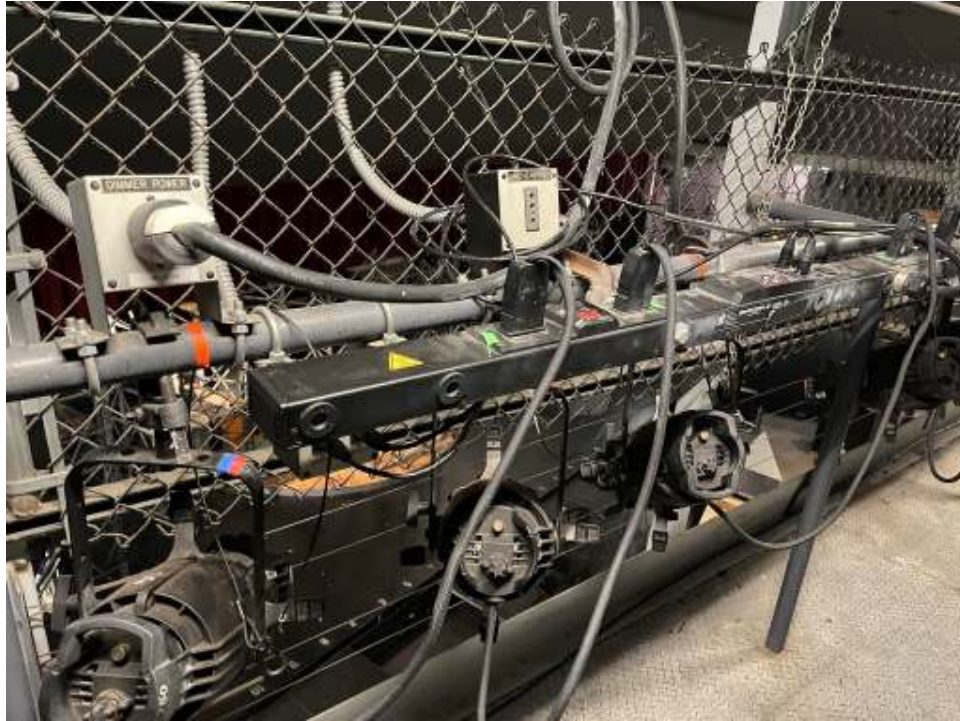
D.) FOH Catwalk

The front of house catwalk is covered with a wire mesh fencing for safety. Dimmer bars are attached to hanging rail, but extensive cabling is required to reach the lighting fixtures. Dimmer bars obstruct the lighting fixtures on the pipe.

Recommendation: The catwalk power and control distribution should be reorganized and replaced. New outlet boxes and DMX outlets should be mounted at locations across the catwalk to minimize extra cabling.

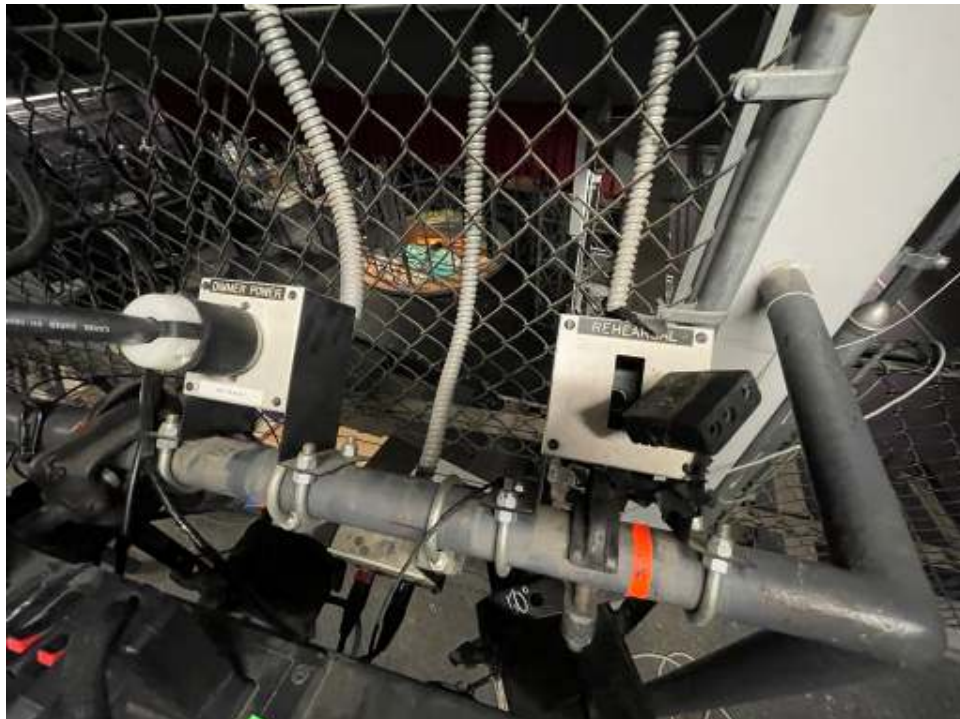
Some of the outlets are damaged or in need of repair.

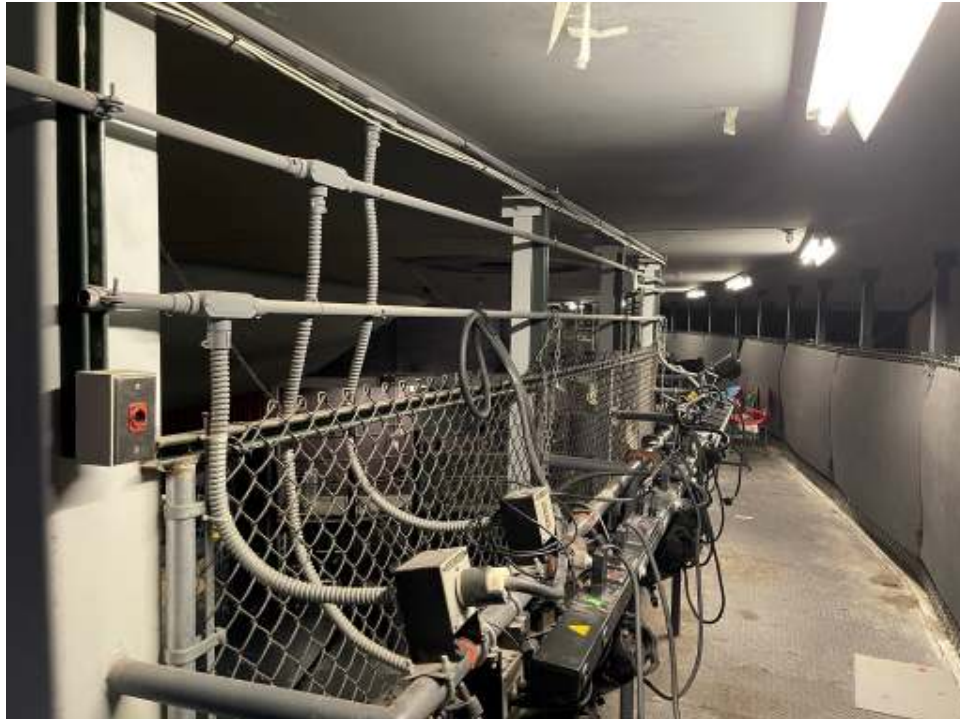
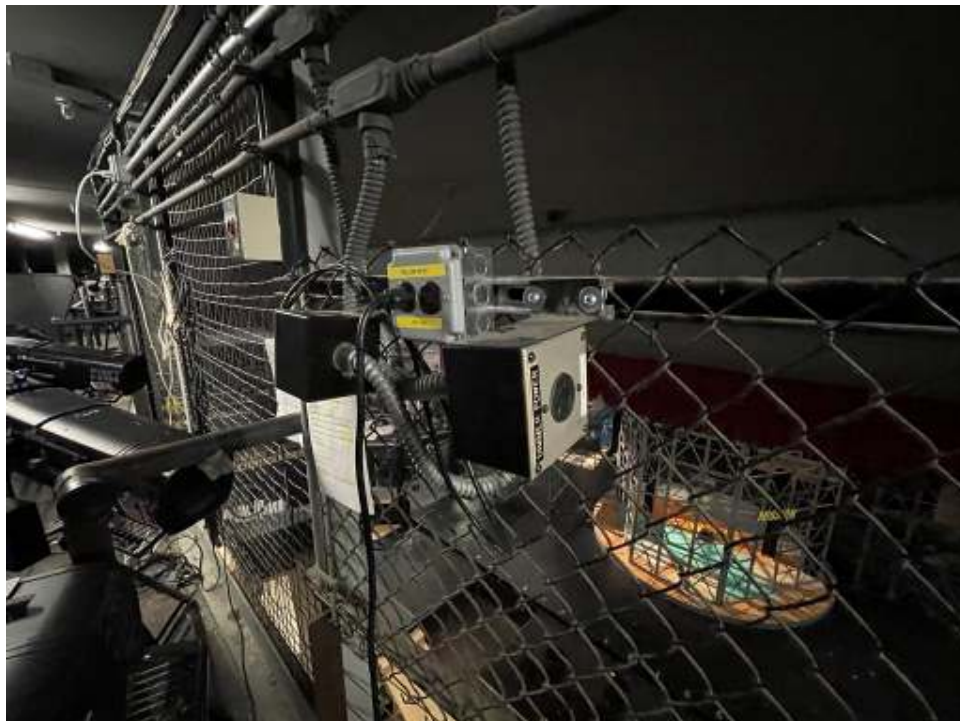
Various boxes for rehearsal lights, DMX, and dimmer power are located throughout the catwalk area, but they are disorganized and do not provide a coherent circuiting layout for lighting fixtures.

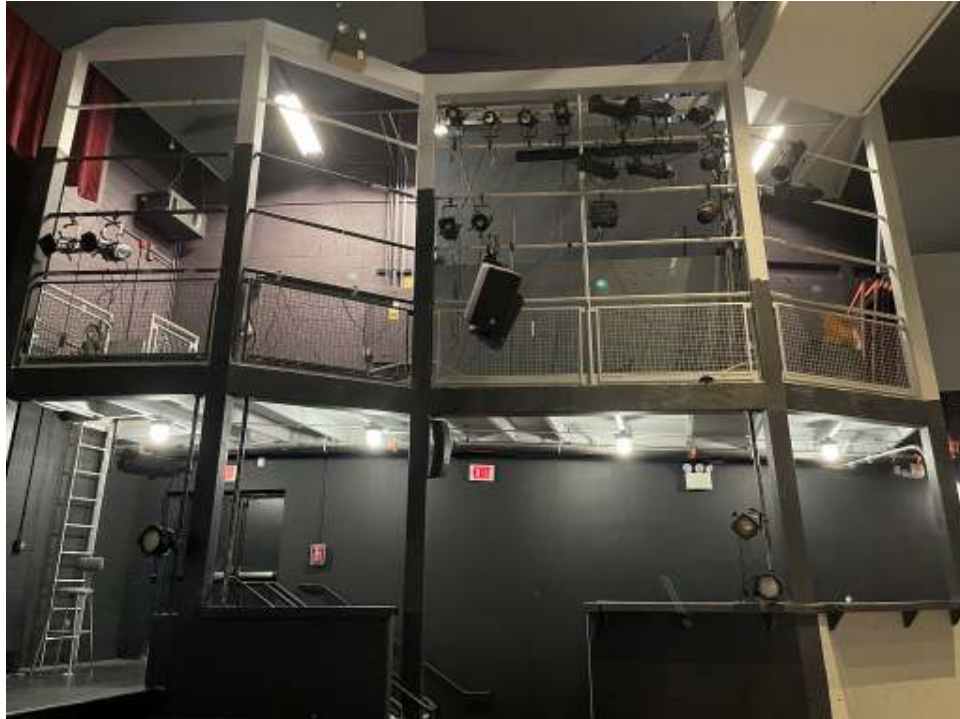
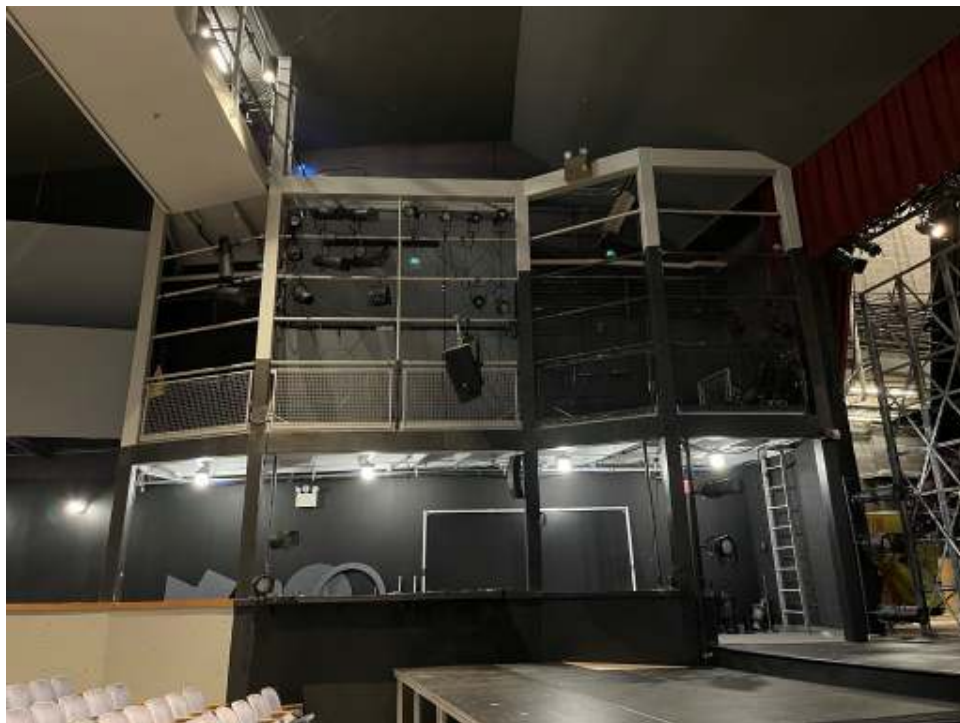
E.) Side Tormentor Positions

The side tormentor positions offer flexibility not found in most theaters. Dimmer bars at a single location necessitates having to run cables all over the position.

Recommendation: Dimmer bars should be replaced with permanent power and control wiring at multiple locations to minimize cabling all over the position.

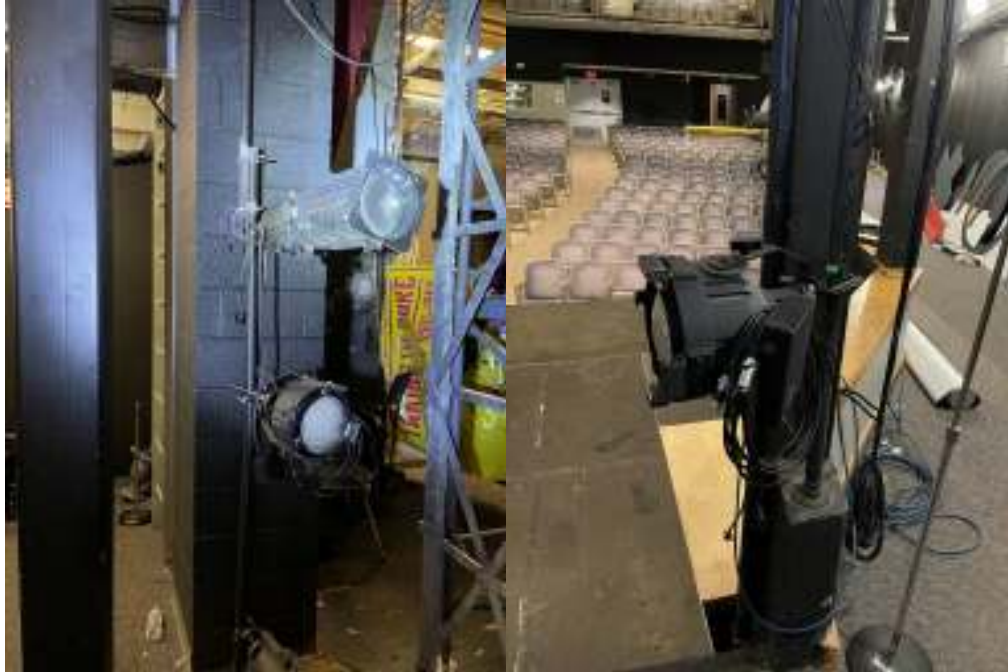
F.) Proscenium Tormentor Positions

Tormentor pipes mounted to proscenium provide a useful hanging position, but they are fabricated improperly.

Recommendation: These positions should be replaced with properly fabricated single units with welded components and mounted to the floor.

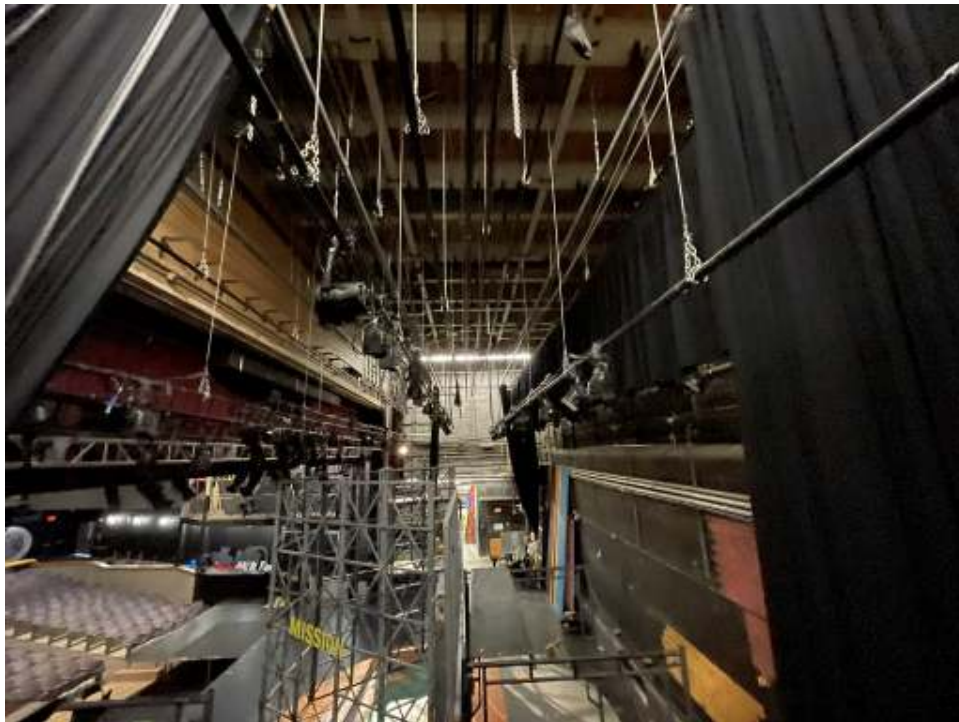
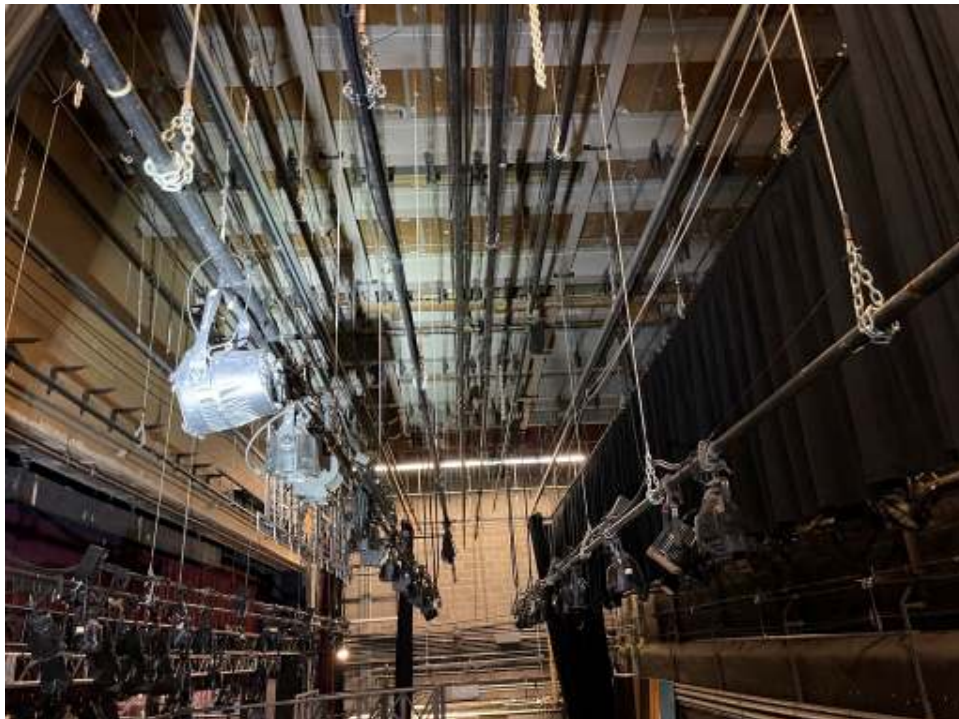
G.) Stage Electrics

The stage electrics are powered by six circuit dimmer bars located in one position on each electric. All cabling on these 56' long electrics has to be routed down the pipe to these locations. There is ineffective cable management from the ceiling which is not located at the end of the pipe. The current configuration limits the number of circuits available on each pipe.

Recommendation: Replace the distribution, cable management and multicable with new full length connector strips, providing additional circuits and DMX control across the length of the pipe. If the intent is to motorize these electrics, provide hoist systems with integrated cable management.

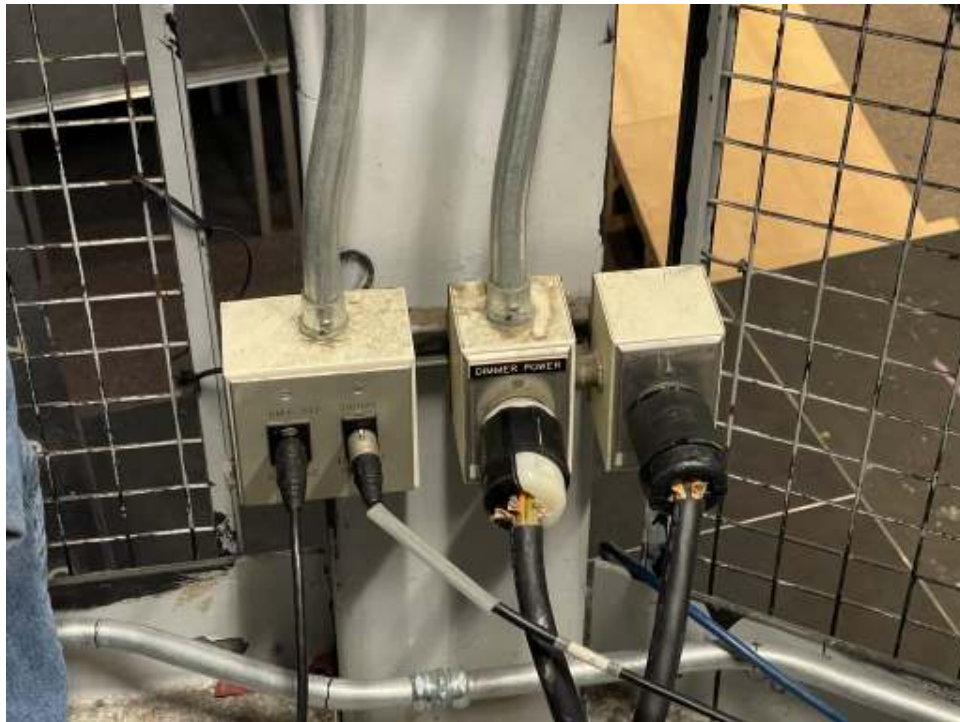
H.) Dimming System

The dimming system is designed with no central dimming, except for house light dimming (addressed below). Six circuit dimmer bars are positioned throughout the space with cabling required from most positions to reach the dimmer bars. Many of the dimmer bars have connectors with strain reliefs not correctly maintained.

Recommendation: Dimming system wiring should be replaced with adequate circuits designed for an LED system. Relay racks should be supplied to allow for LED fixtures to be turned off when not in use, conserving electricity. Power distribution should be redesigned, replaced, and configured for efficient use to minimize extraneous cabling as much as possible, facilitating and speeding up deployment of new lighting plots.

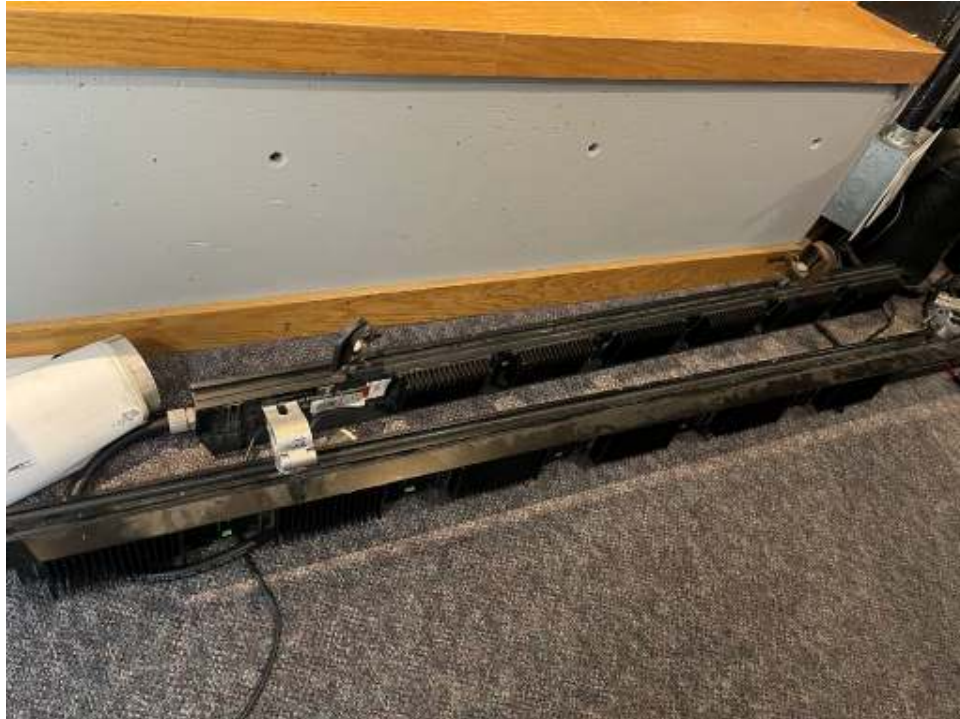
Many areas have dimmer bars that are not mounted. Many of the dimmer bars are located in areas that could be considered unsafe, either in terms of access to those areas or in terms of positioning to maintain safe operation and space for heat dissipation.

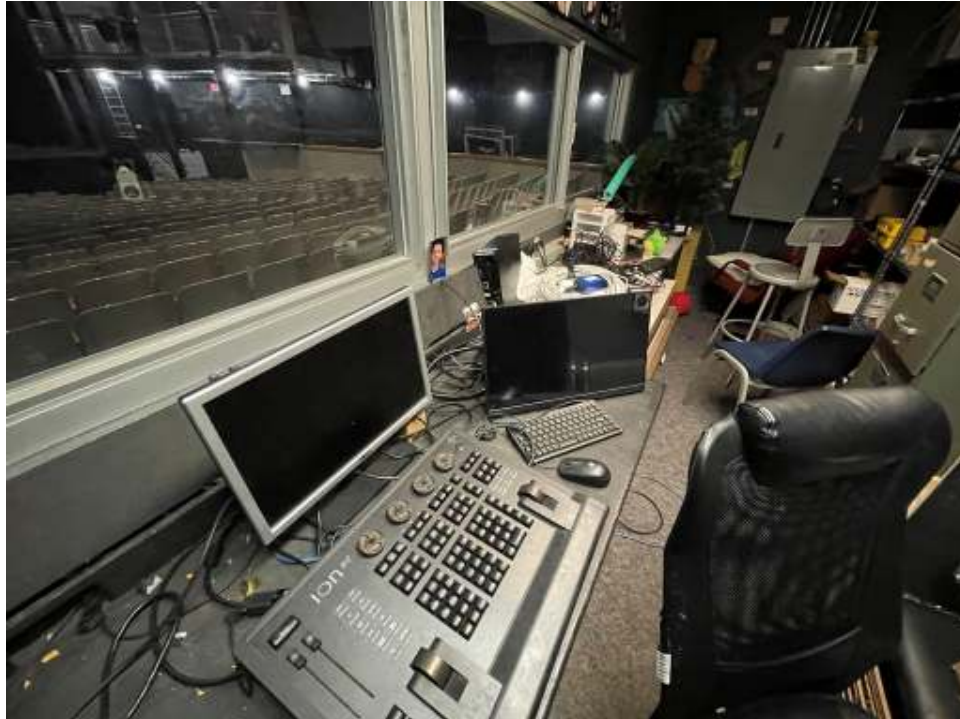
I.) Control System

Lighting control console is an ETC Ion, which is a current product, and is adequate for control of an updated LED lighting system.

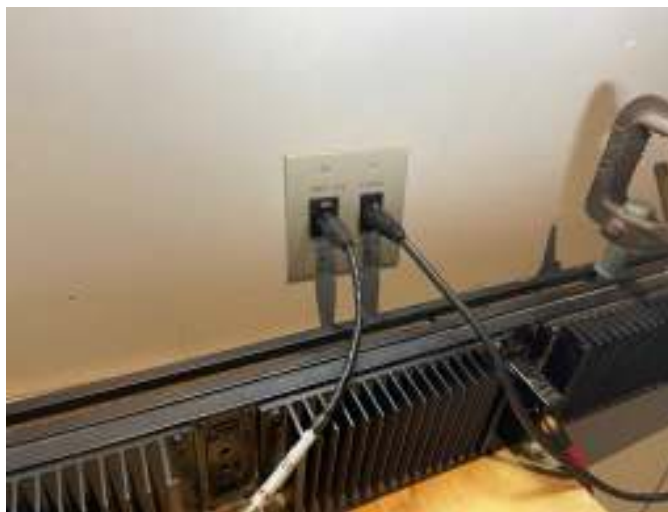
DMX distribution is outdated and not designed for the needs of a modern LED lighting system. Existing DMX outlets depend on jumping through to the next outlet to complete the run, making troubleshooting difficult.

Recommendation: Update DMX control distribution system to modern networking equipment and cabling. Provide control locations at all fixture hanging positions. Control locations should be addressable to facilitate system setup.

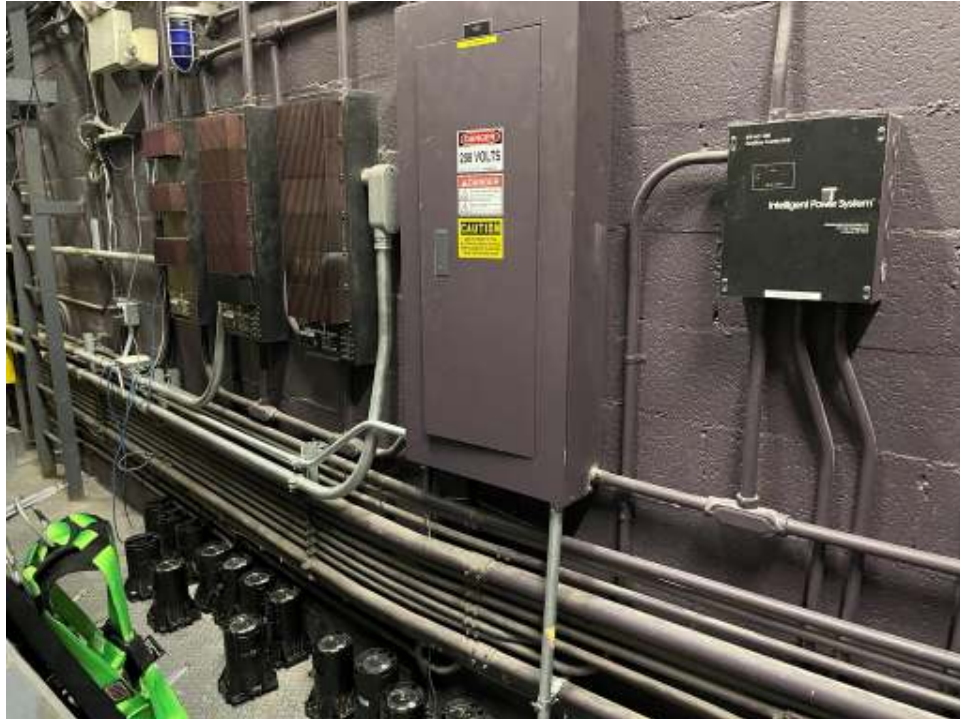
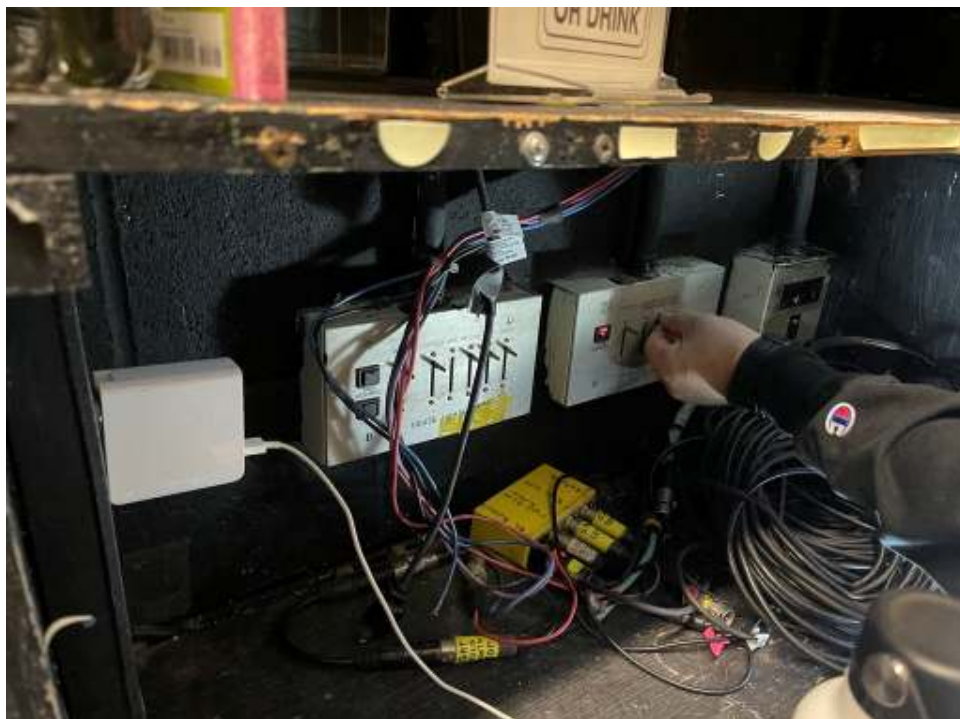
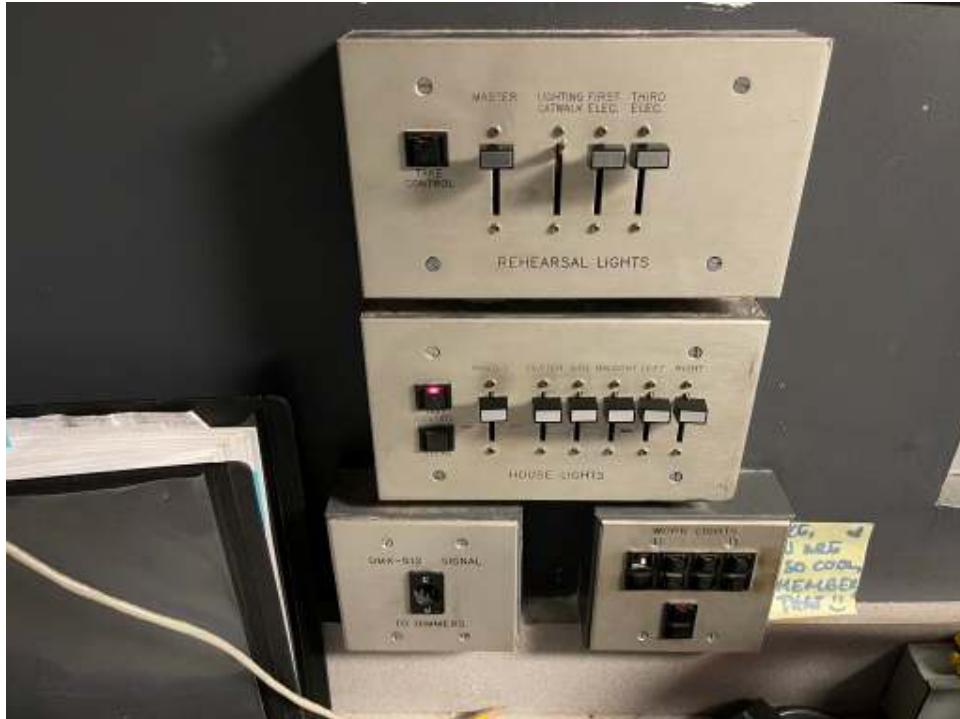
J.) House Light System

The auditorium house light system is barely functional. A number of attempts have been made to bolster the system, resulting in control issues. The house light dimming system is obsolete. Many of the control stations are inoperable.

Recommendation: The house light system should be replaced in its entirety, with the dimmer units replaced by relay panels. The house lighting fixtures should be replaced with DMX controlled LED fixtures, uniform in type throughout the space to provide adequate levels of light to maintain safe egress. Pendant winches should no longer be needed, as lamp replacement should be minimal.

New house light controls, compatible with the new house lighting system, should be provided at all entry points, and touch screens should be located in the control booth and backstage at a stage managers position to provide the ability to have limited control of the lighting without having to use the lighting control console.

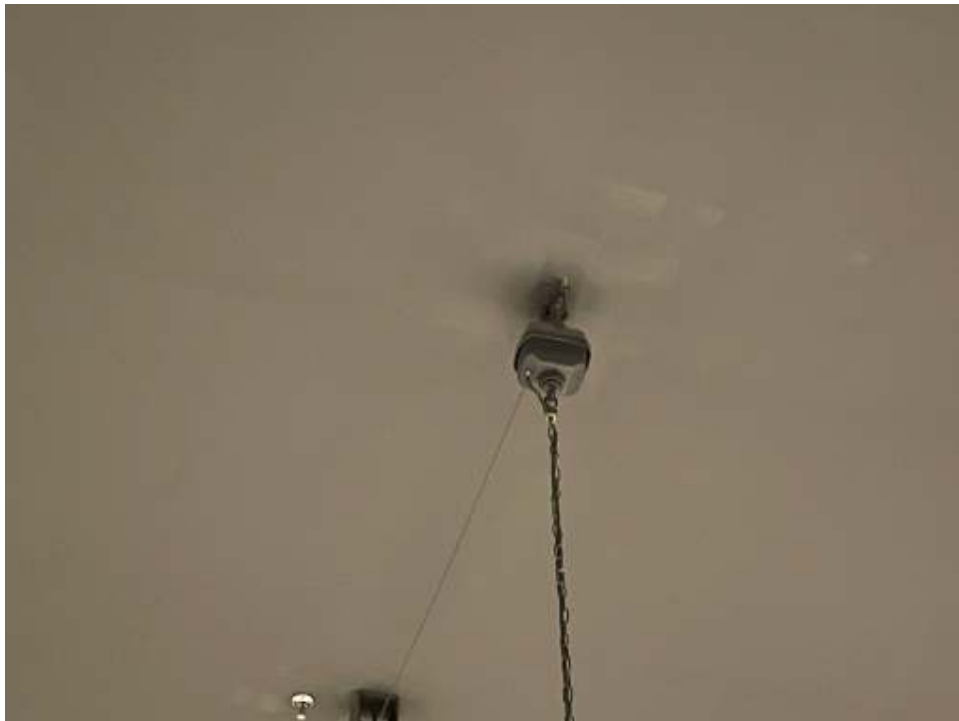
Some house light fixtures are not connected to the lighting system at all, and therefore not controllable for performances. Many of the house light fixtures need new lamps. A pendant fly system is required to reach some of the fixtures for re-lamping.

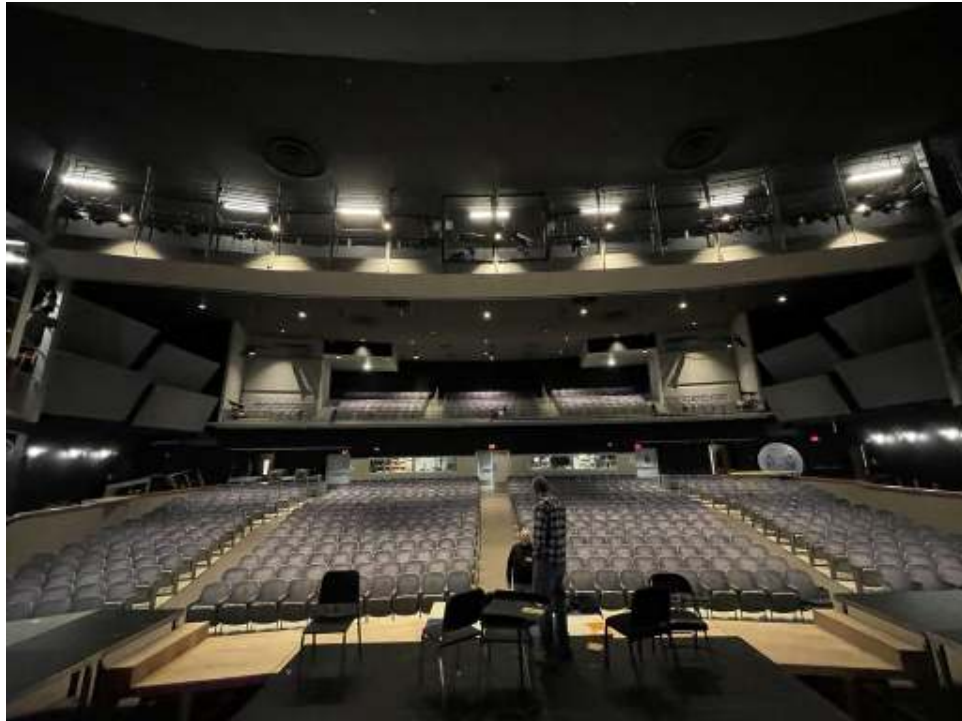
Many areas of the house are dark, because of nonfunctioning house lights.

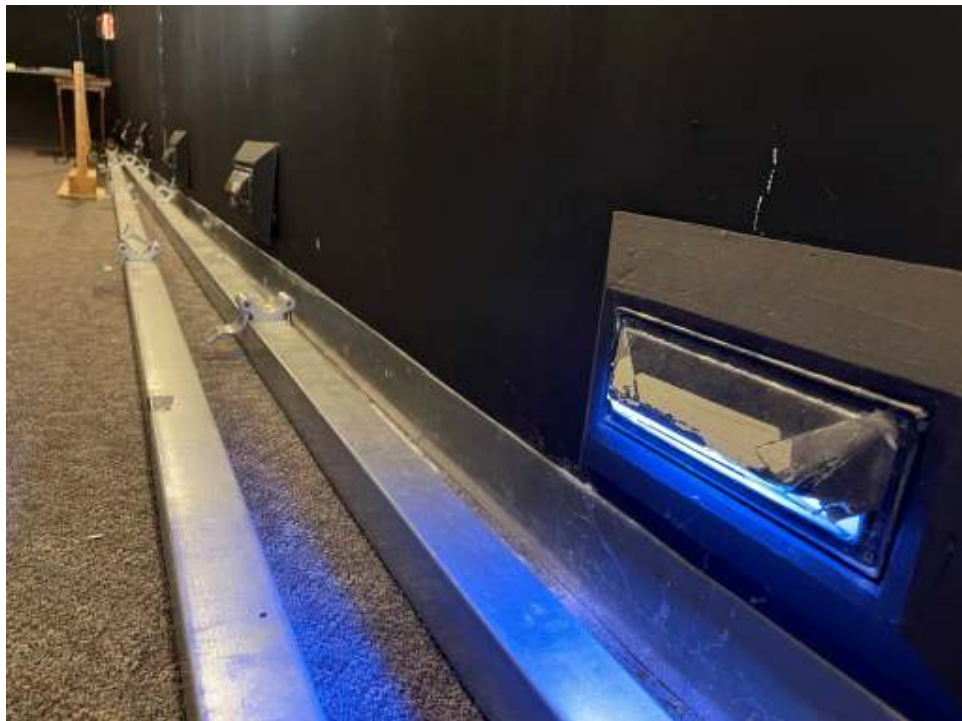
Aisle lighting and safety lighting is in disrepair or not working.

Aisle lighting and egress lighting should be updated to provide adequate access into and out of the space when the house lights are down for performance.

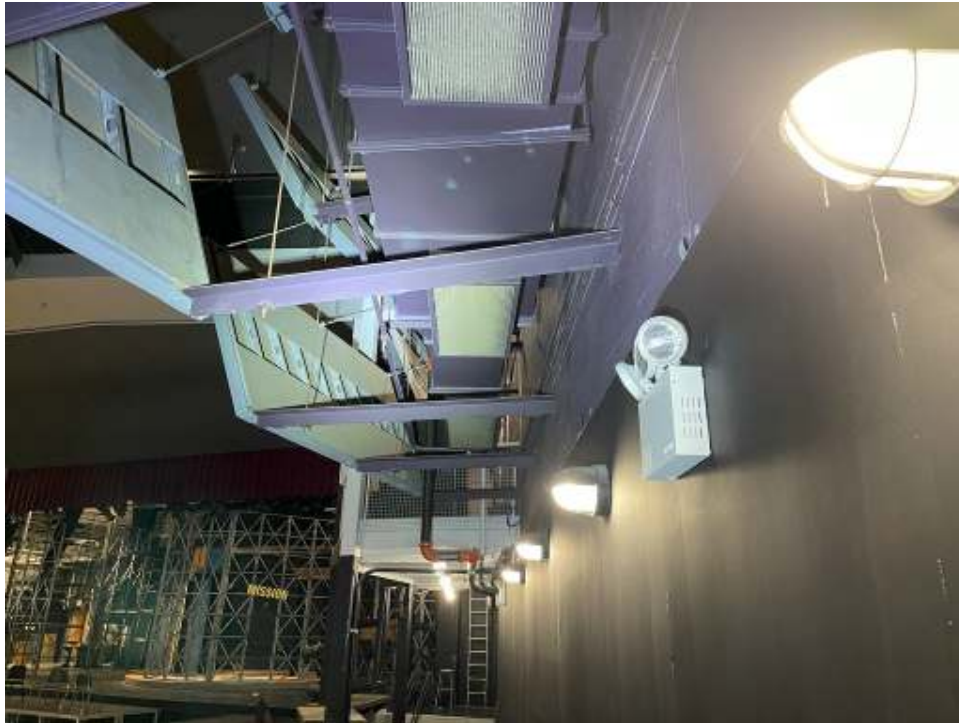
Detrimental glare from side sconces.

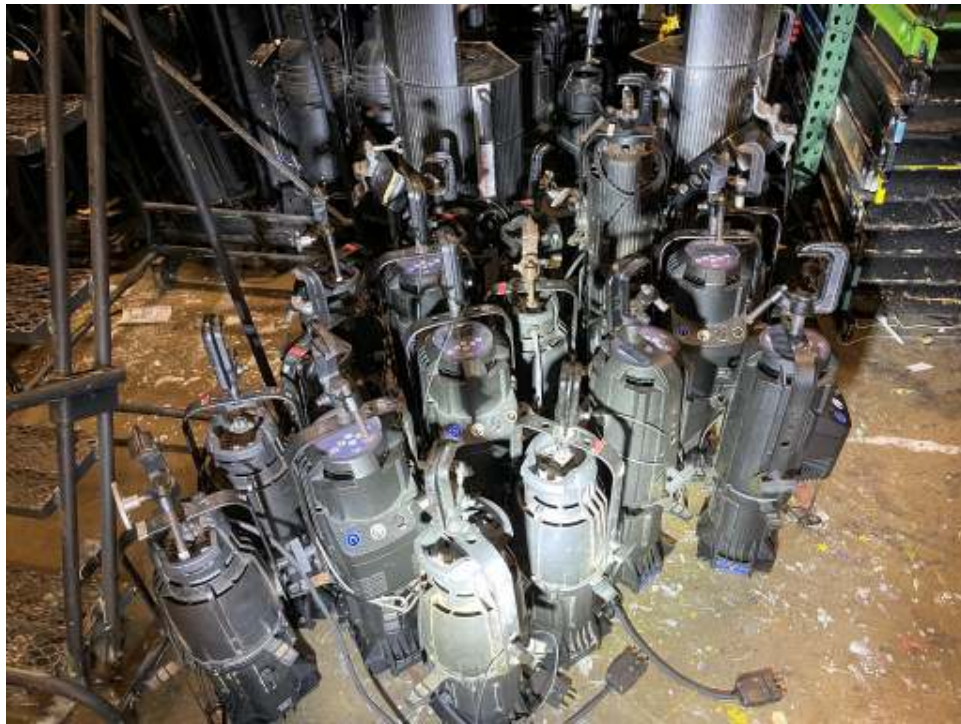
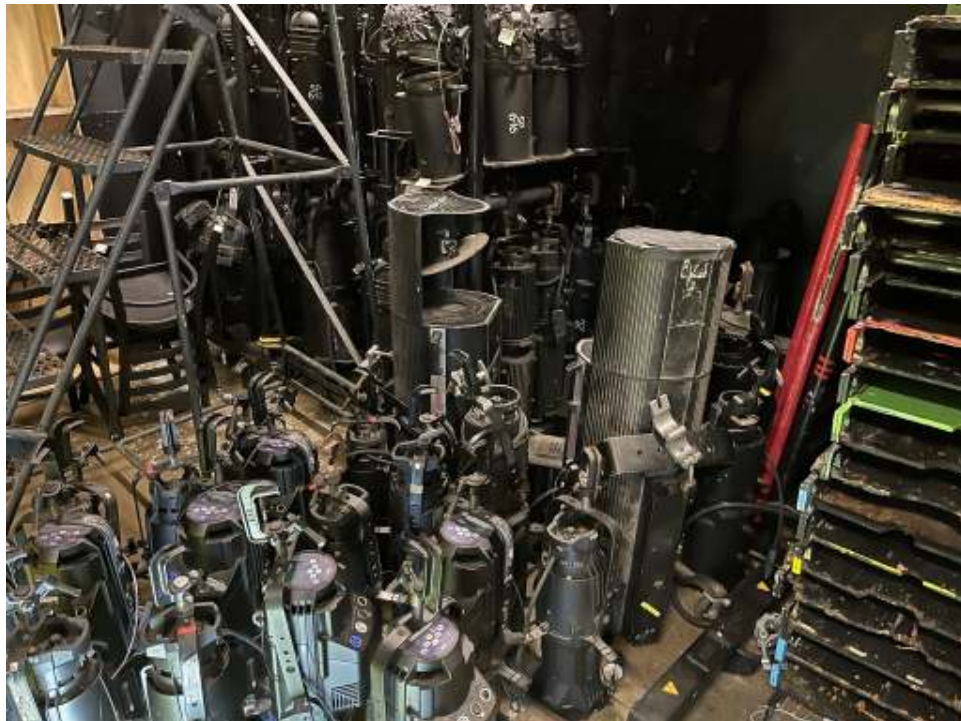
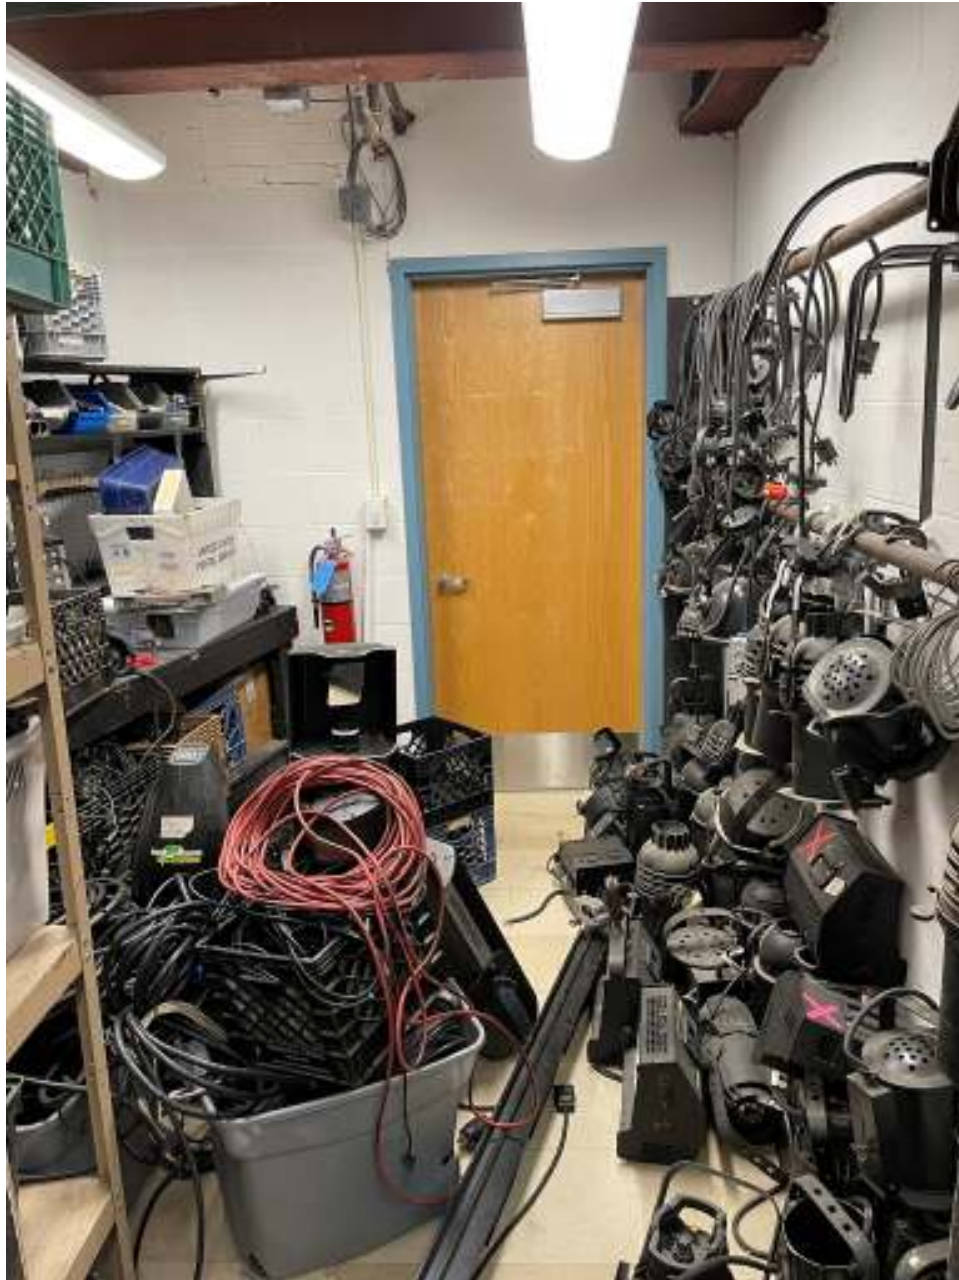
K.) Theatrical Lighting Fixtures

There is a combination of mostly conventional fixtures and some LED fixtures. Most of the conventional fixtures are approximately 15-30 years old. Many are in disrepair. With the current popularity of LED fixtures, lamps for these fixtures are being discontinued by some manufacturers, and they are getting harder to source. It is anticipated that this trend will continue into the future.

Recommendation: Replace all of the non-LED fixtures with new LED fixtures. Add some automated lighting fixtures. Provide new cabling for power and control to accommodate the new system. Inventory accessories and provide additional accessories, if needed. Add automated fixtures to improve flexibility and performance.

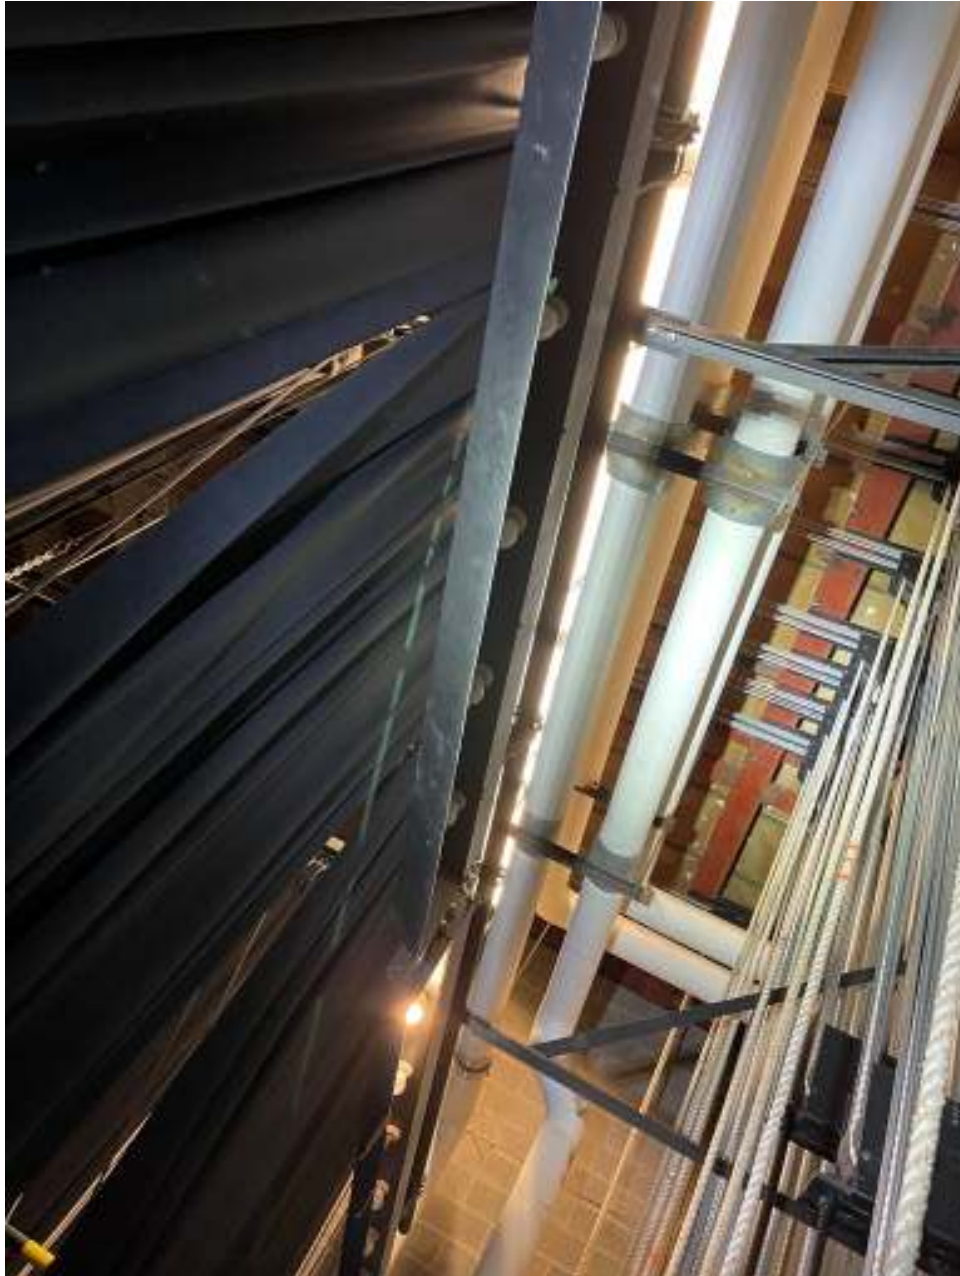
L.) Work Light

Work light over the stage is insufficient for production work. Work lights on the catwalk and side galleries need new lamps or electrical maintenance. Index lights on the fly rail have lamps burnt out or fixtures need repair.

Recommendation: Work lights should be provided on the electrics for lighting the stage area to build scenery, etc. Additional high work lights to enable visibility of the rigging would also be an improvement. Replace and /or repair work lights on the catwalk and in the tech galleries. Index lights on fly rail need replacement lamps or should be updated to LED.
