Lighting System Inspection Report

Staples High School Auditorium
70 North Avenue
Westport, CT 06880

Staples High School Auditorium
Inspection Report on Stage Lighting and Stage Rigging Systems
10/18/2022

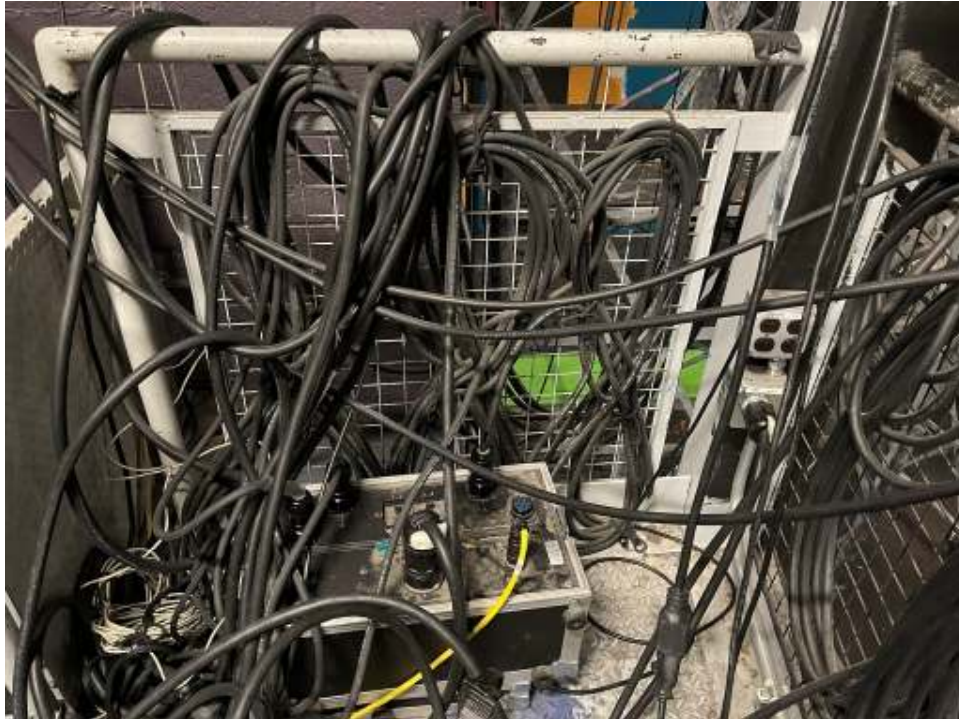
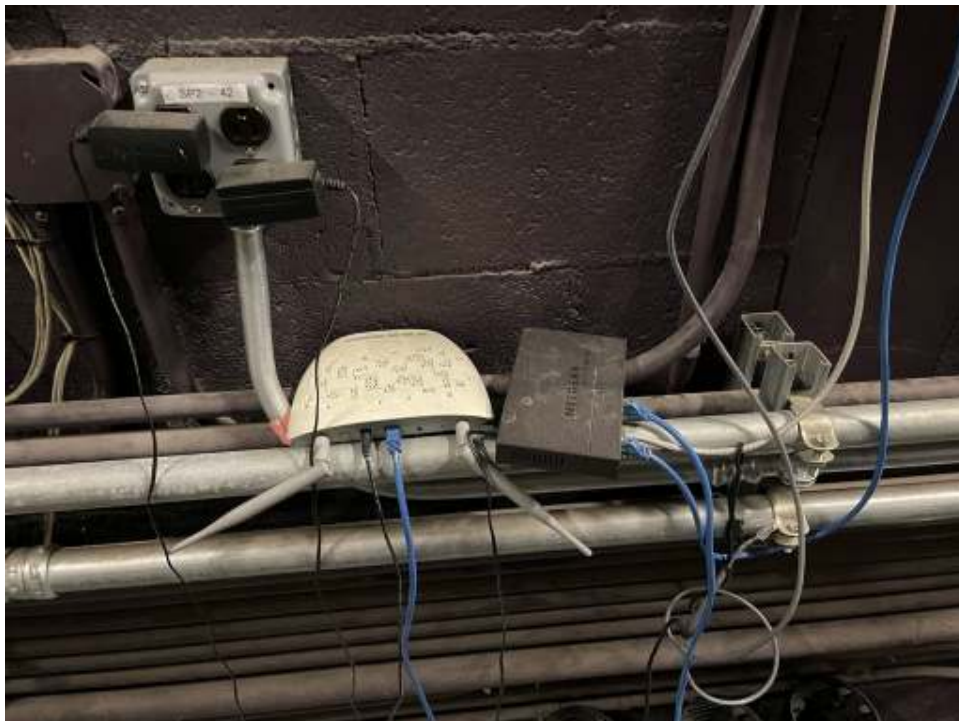
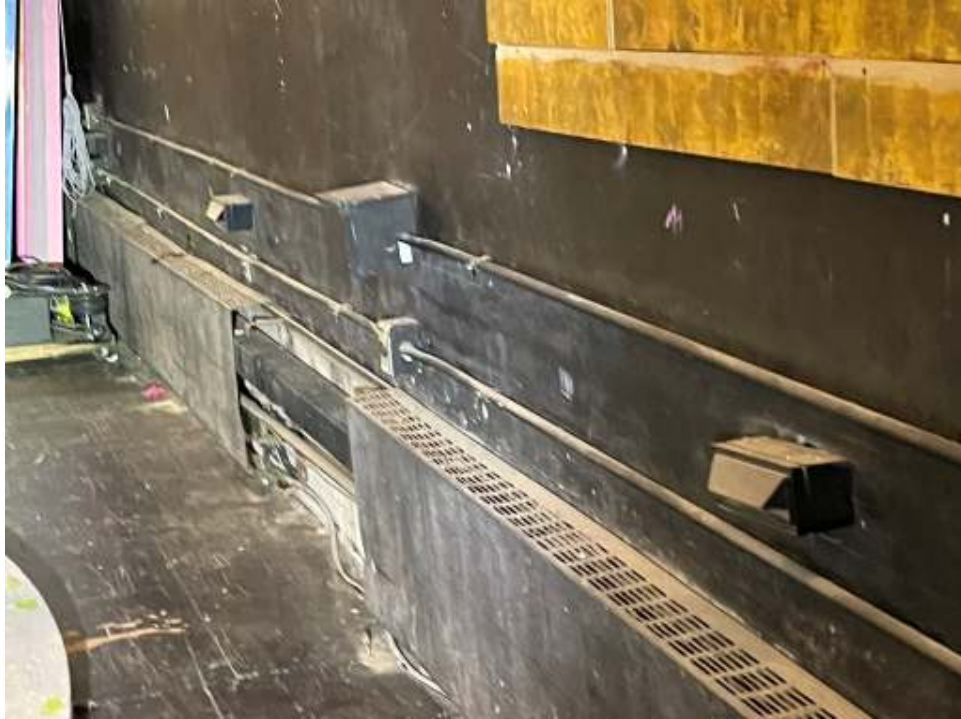
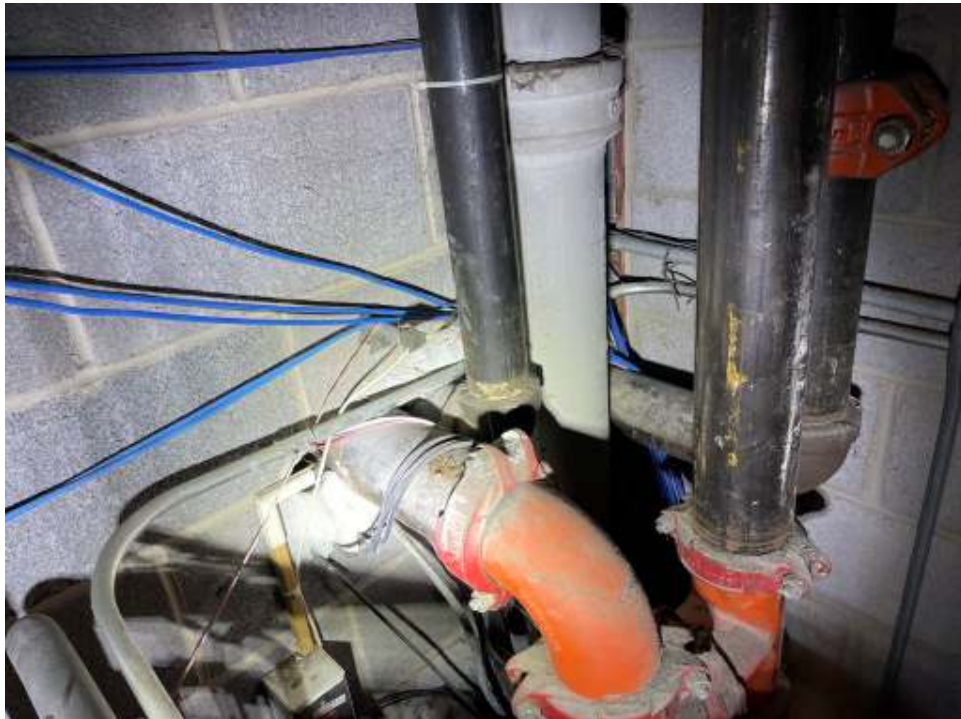
M.) Housekeeping, Safety

There are numerous housekeeping, maintenance, and code issues throughout the space.

Recommendation: The space needs a thorough cleaning and the loose equipment needs to be stored properly and inventoried. At a minimum, maintenance work for the system should be addressed as soon as possible.
