**MILLER PACIFIC
ENGINEERING GROUP**

August 4, 2017
File: 1911.034altr.doc

Re: Geotechnical Engineering Investigation
Evaluation of Liquefaction Risk and Liquefaction Induced Settlement Potential
Paden Elementary School Campus
444 Central Avenue
Alameda, California

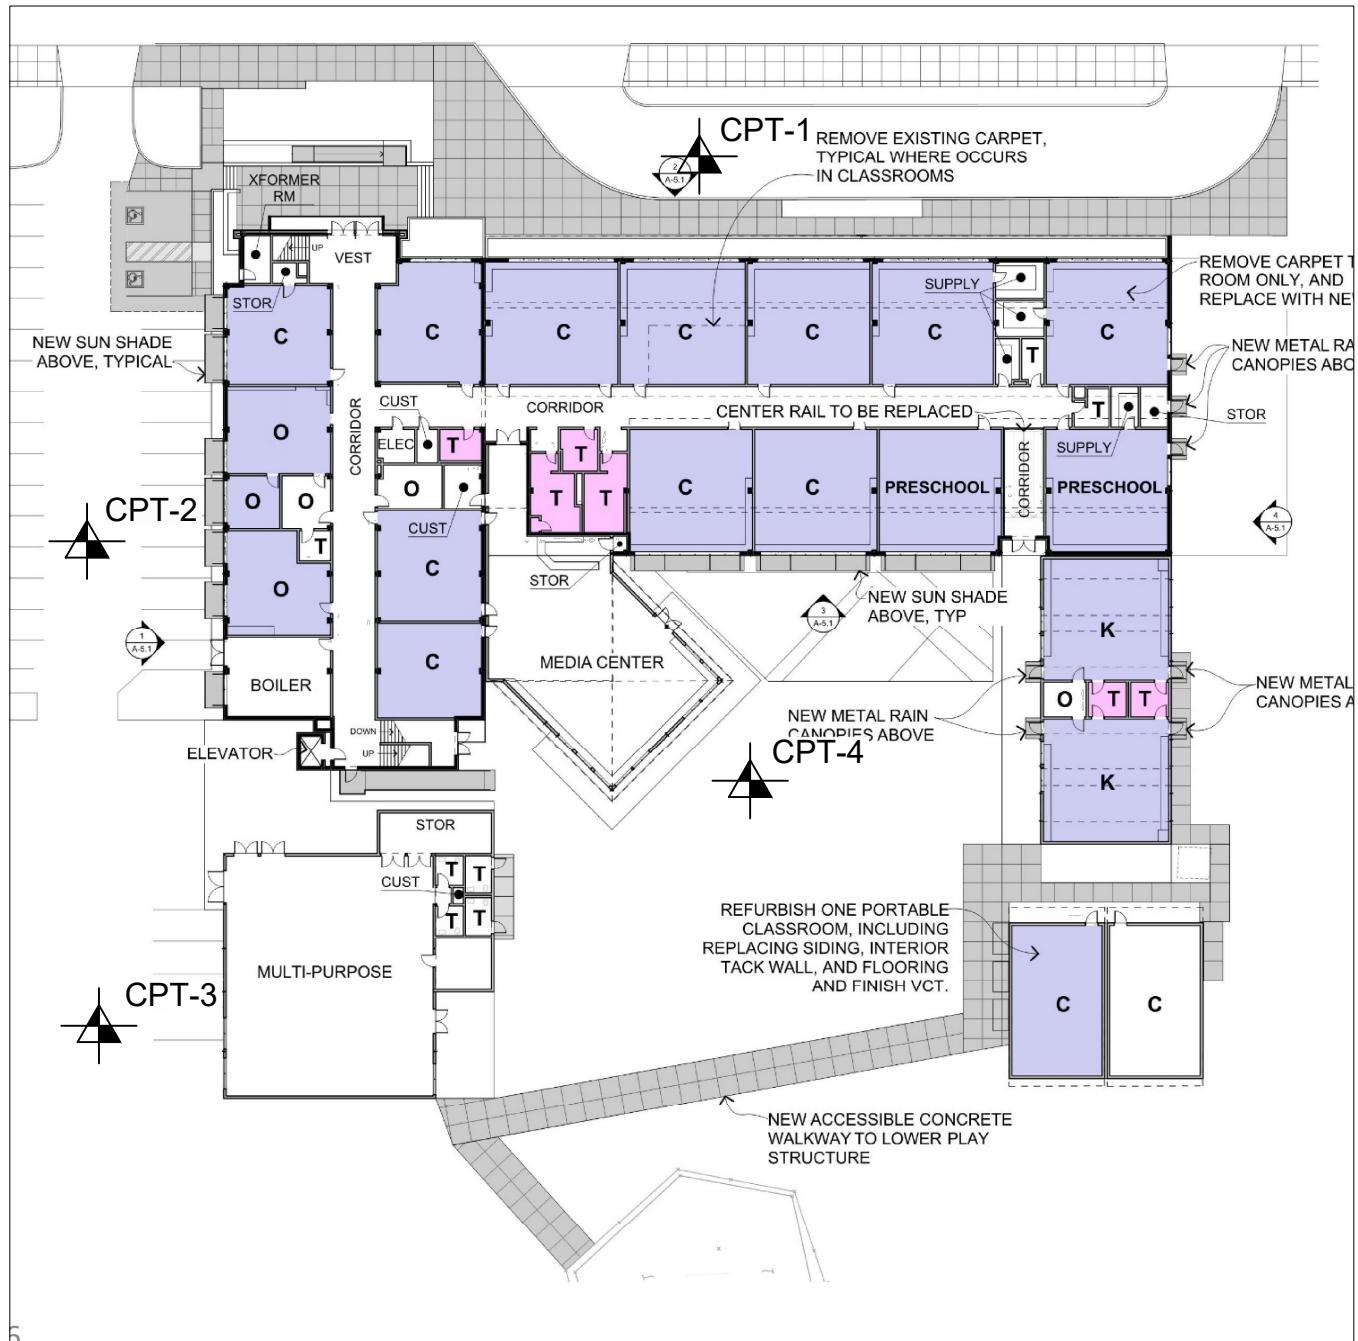
SITE PLAN

Miller Pacific Engineering Group explored the subsurface soil and groundwater conditions with four Cone Penetration Tests (CPTs) at the approximate locations shown on the Site Plan, Figure 2. The CPTs were conducted with truck-mounted equipment on April 12, 2017. The CPTs were extended to depths of about 32 feet to 60 feet below the ground surface. A schematic of the CPT apparatus is provided on Figure A-1 and a CPT Soil Interpretation Chart is provided on Figure A-2. CPT logs are shown on Figures A-3 through A-6.

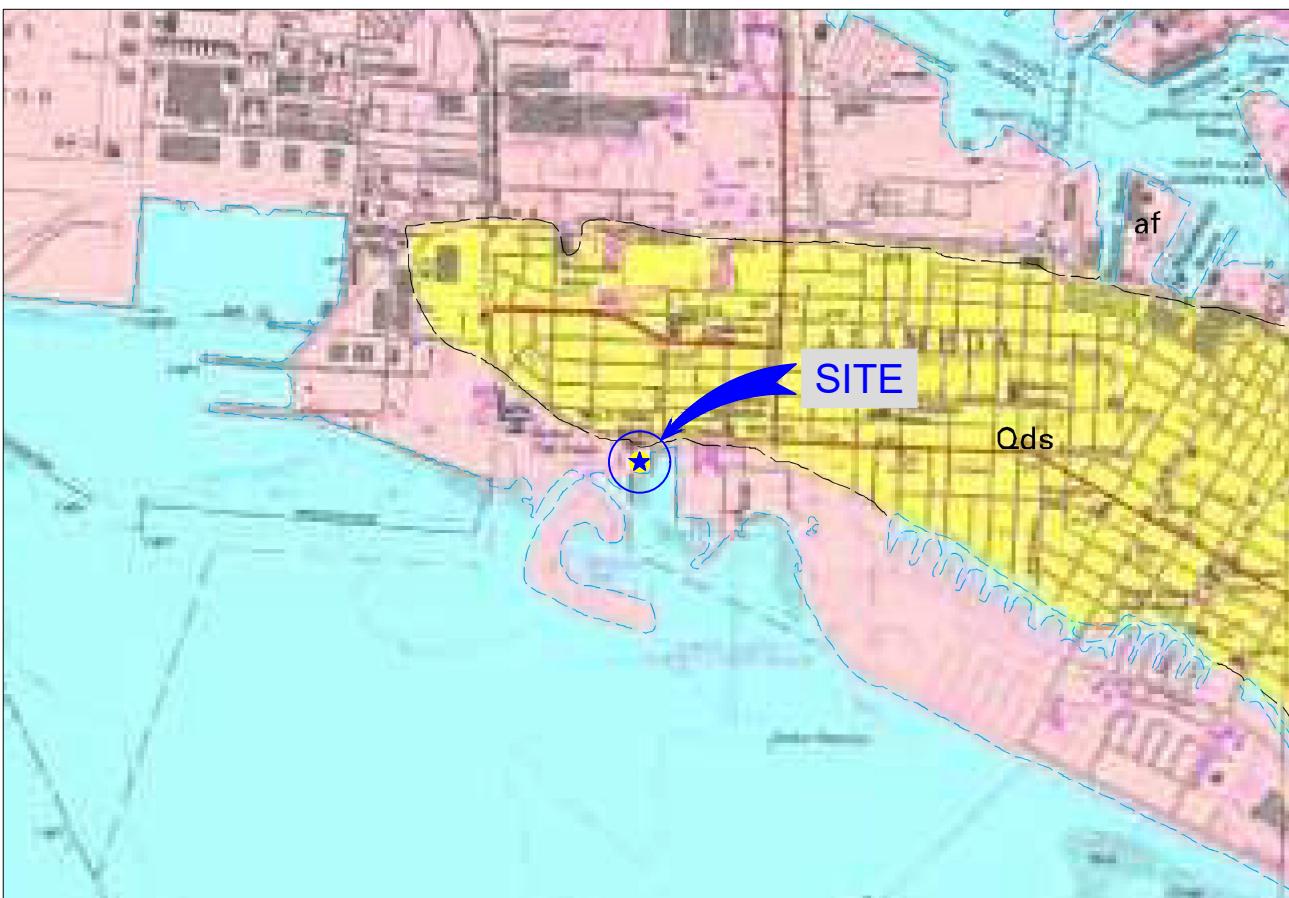
REGIONAL GEOLOGIC MAP

Geologic mapping¹ indicates the site is located in an area underlain by artificial fill sands, as shown on Figure 3. These artificial (manmade) fills were placed over older dune sands and soft clay (Bay Mud).

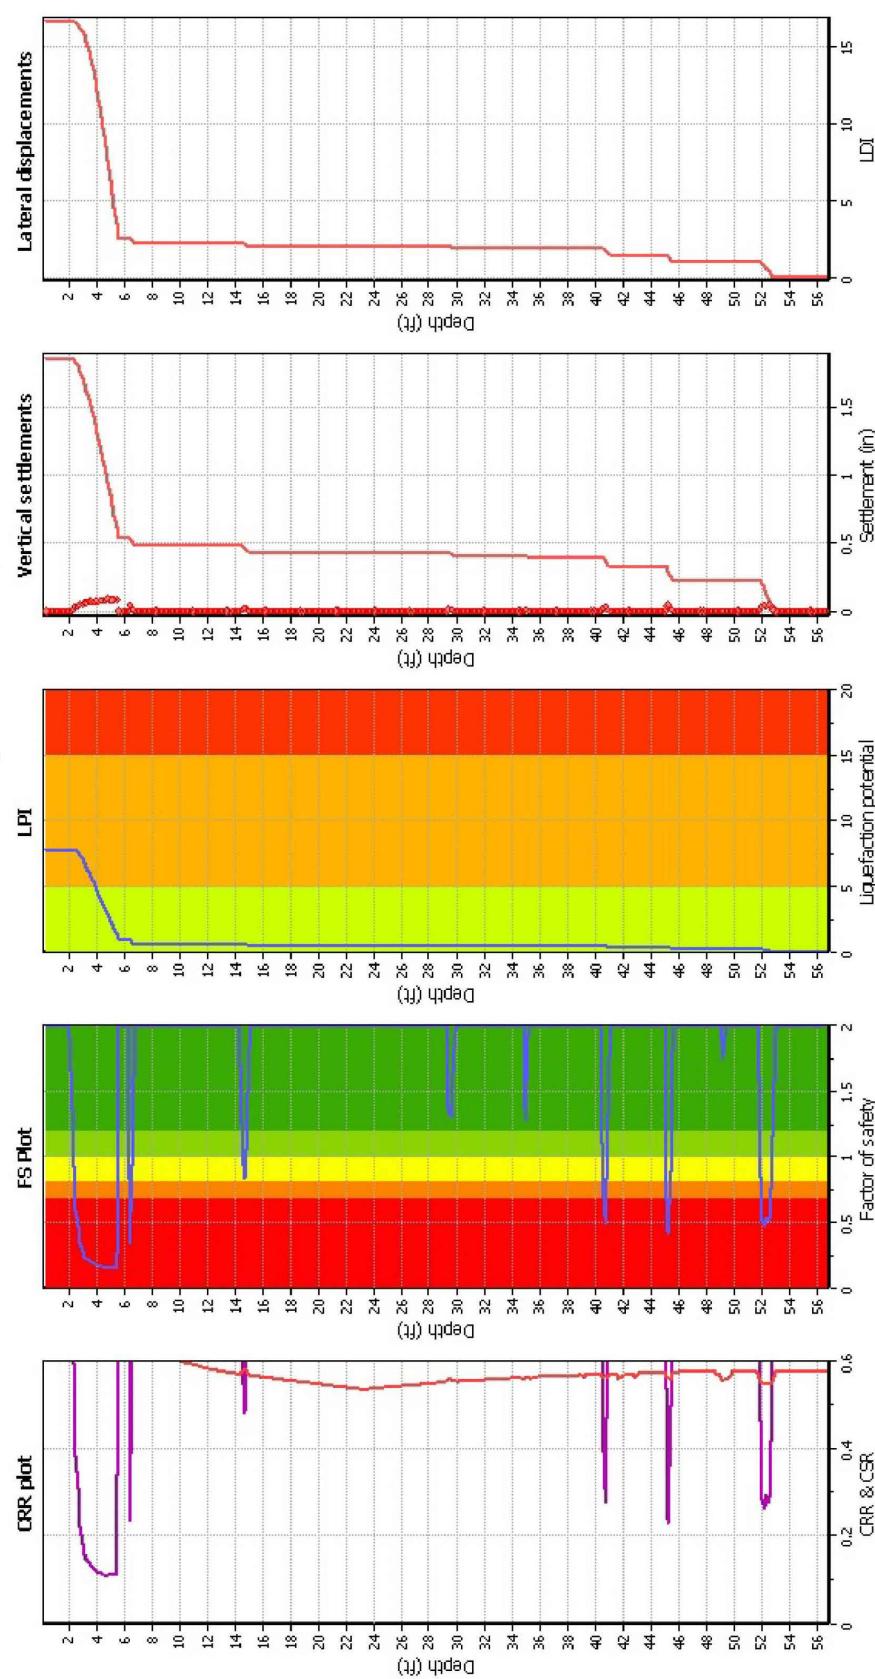
CPT-1 LIQUEFACTION ANALYSIS

We analyzed the potential for liquefaction utilizing the CPT Liquefaction Assessment software program CLiq (2007, ver. 2.1.6.9), and the procedures outlined by Idriss and Boulanger (2014). The design seismic conditions consisted of a magnitude 7.3 earthquake producing a PGA of 0.54g, which corresponds to the PGA_M per ASCE 7-10 Section 11.8.3, and assuming groundwater at the ground surface. The results of our liquefaction analyses are presented on Figures 5 through 8, and indicate granular soil layers observed between roughly one and nine feet, and discontinuous lenses between roughly 28 and 52 feet below the ground surface classify as liquefiable during the design seismic event. Therefore, we judge the risk of liquefaction at the site is high.

Potential liquefaction of sandy layers between one and nine feet below the ground surface may result in ground surface settlement of between roughly 0.5-inch to 1.5-inches, based on the liquefaction analyses discussed above, and as shown on Figures 5 through 8. Potential liquefaction induced differential ground surface settlement within a given building footprint area is estimated to be approximately one half of the total settlement (approximately 0.5 to 1.0-inches).
