MARCELLUS
CENTRAL SCHOOL DISTRICT

2015 BUILDING CONDITION SURVEY

VOLUME 01

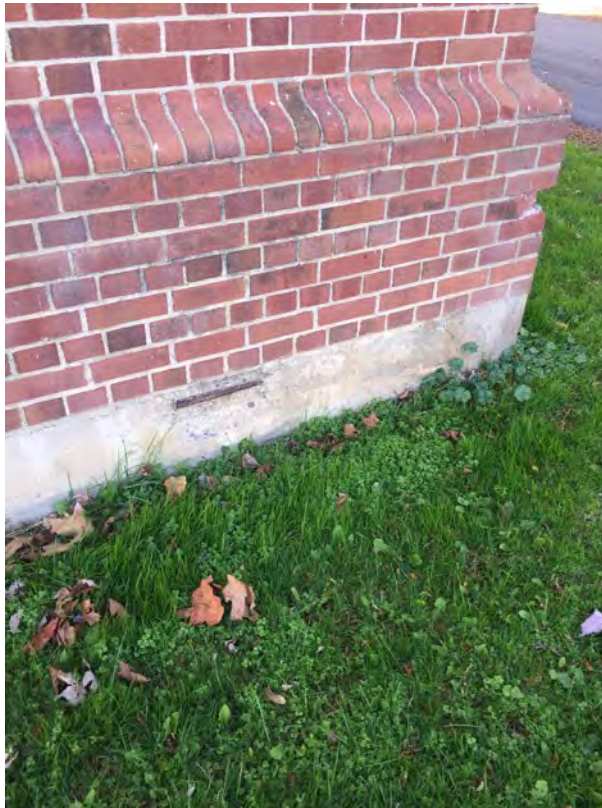
KCH – Masonry restoration, spalled foundation

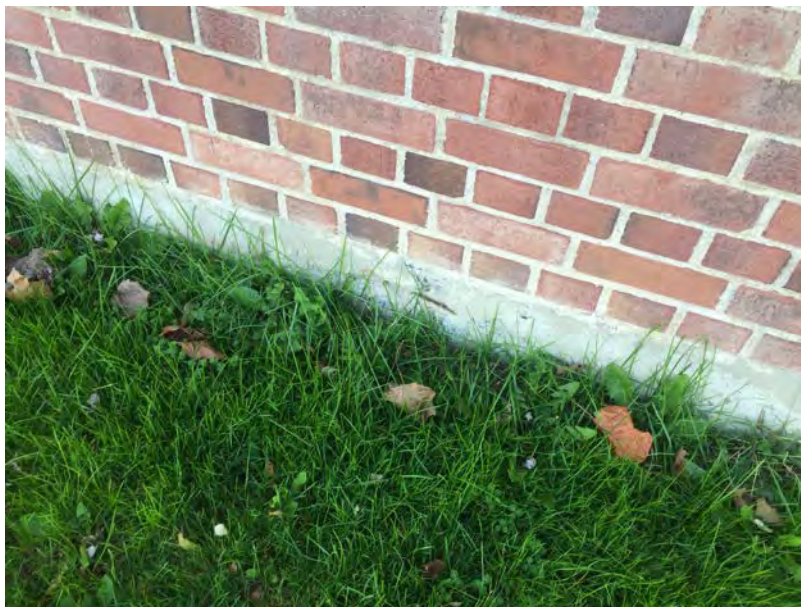
KCH – Masonry restoration, spalled foundation

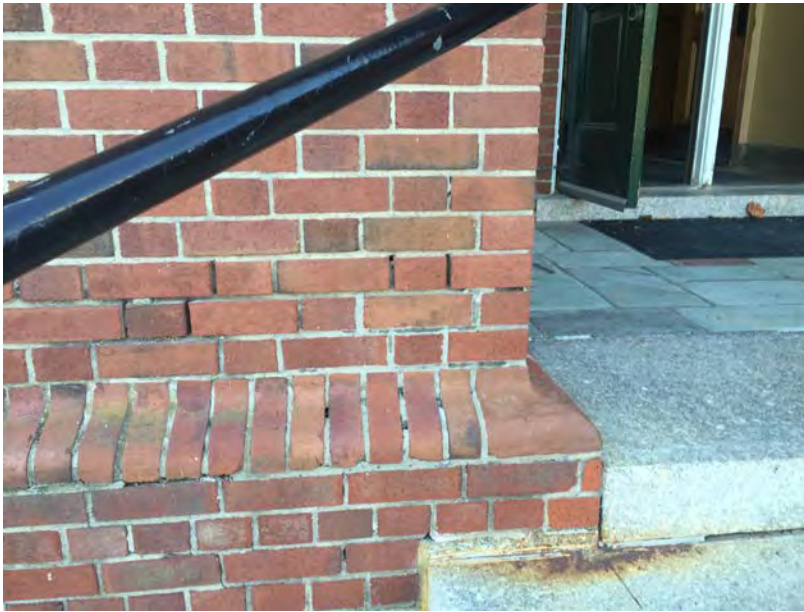
KCH – Mortar deterioration

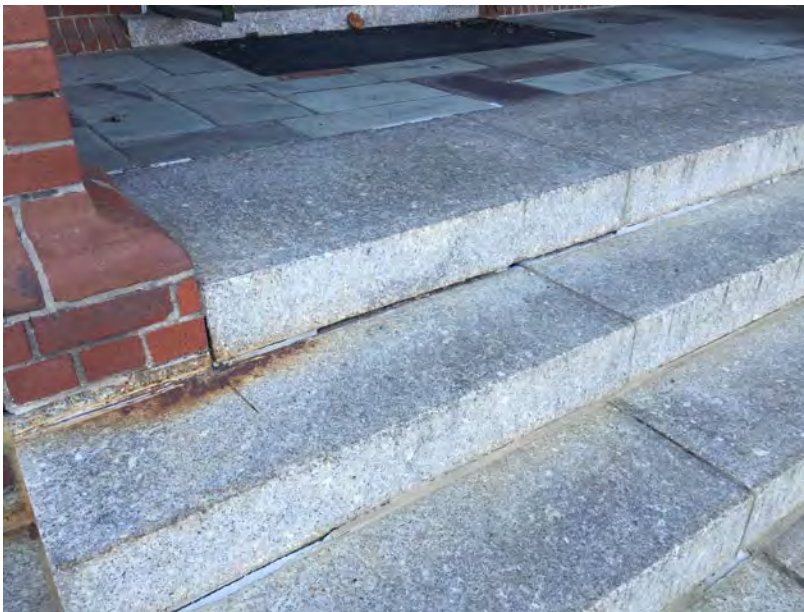
KCH – Granite step caulking

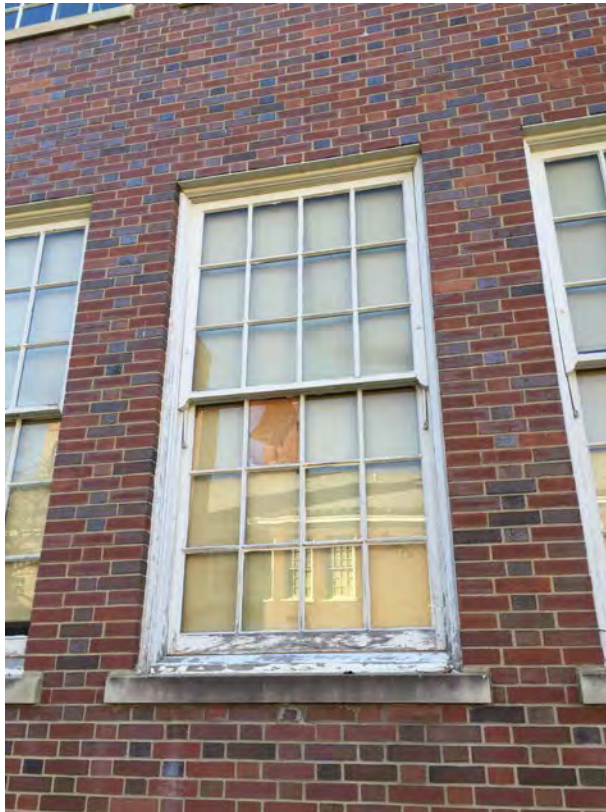
DMS – Original window replacement

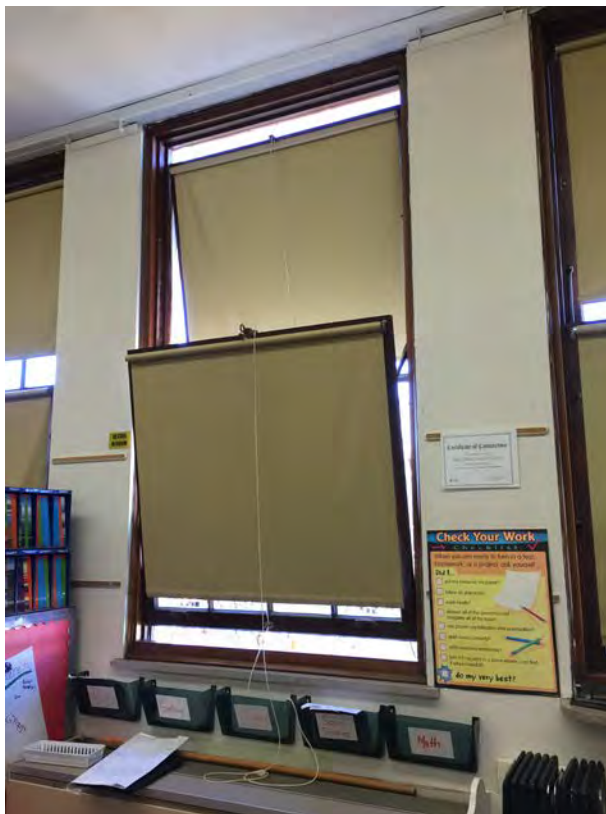
DMS – Original window replacement

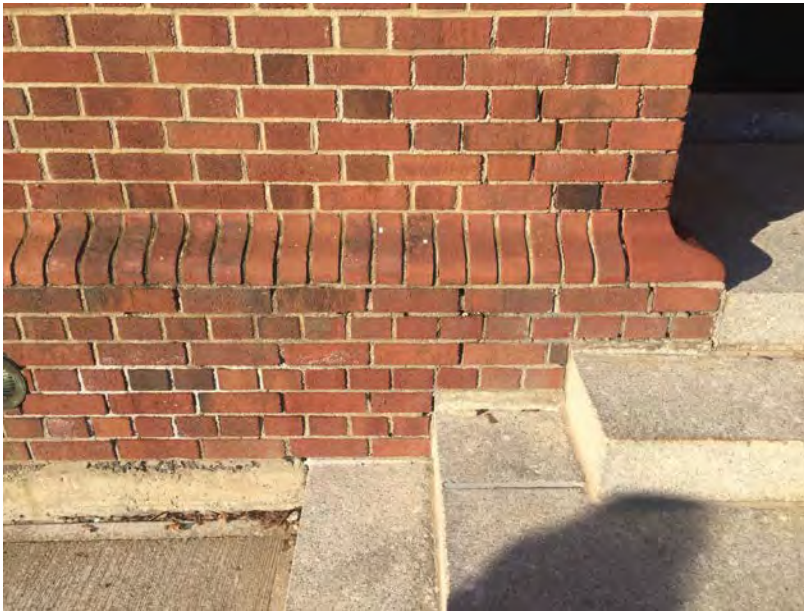
DMS – Masonry restoration, pointing

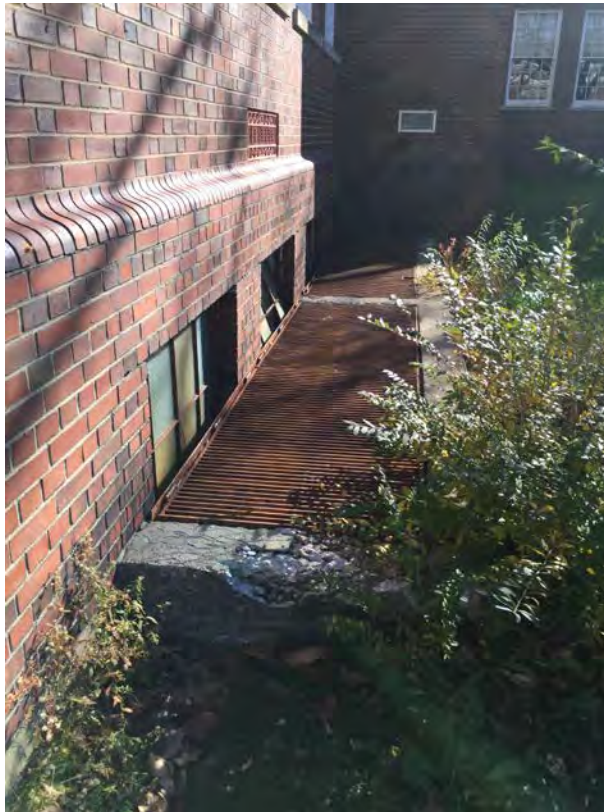
DMS – Courtyard areaway deterioration

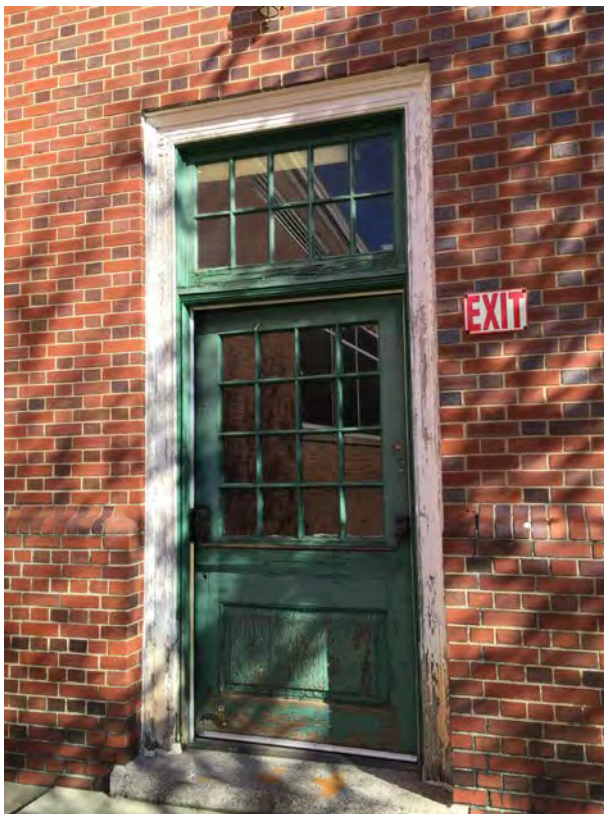
DMS – Replace older exterior doors

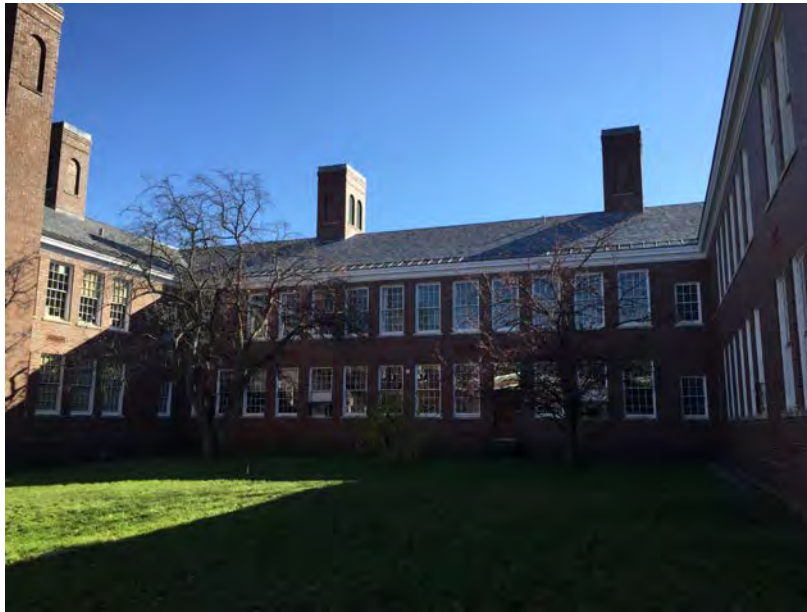
DMS – Provide accessible courtyard exit

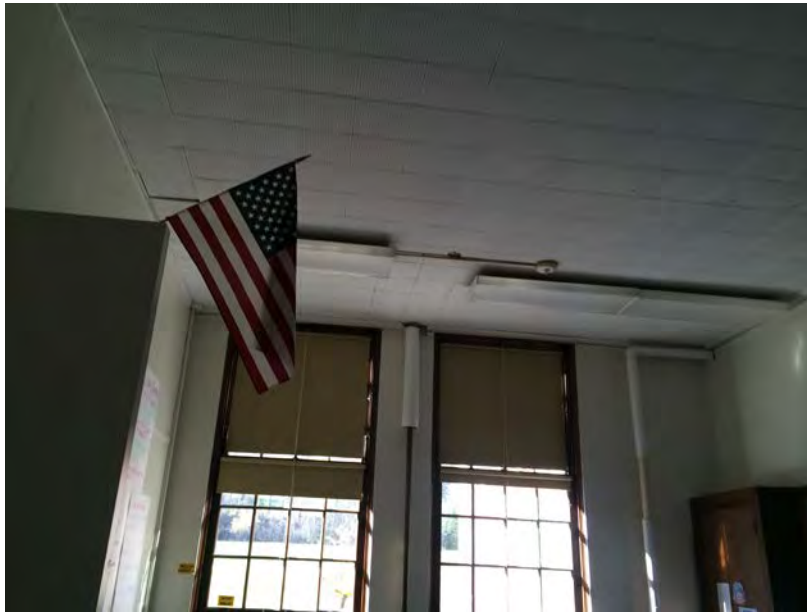
DMS – Replace concealed spline ceilings

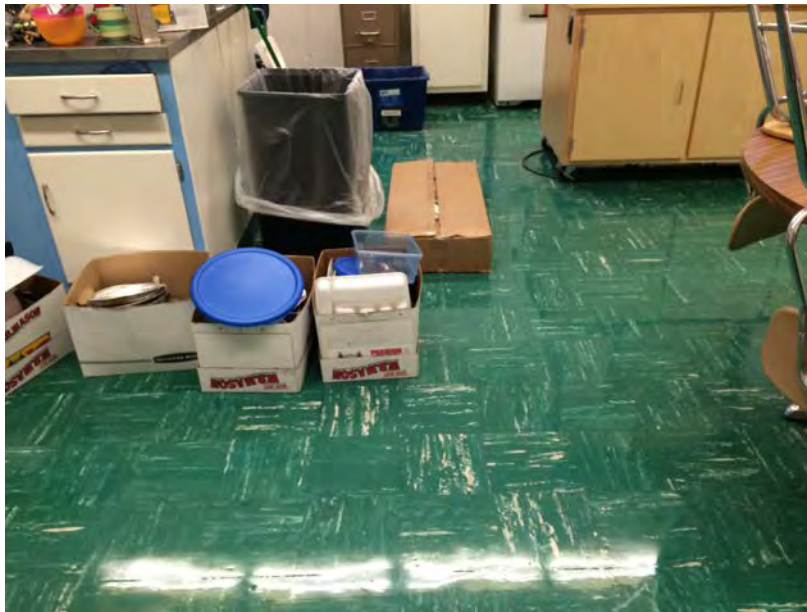
DMS – Replace flooring

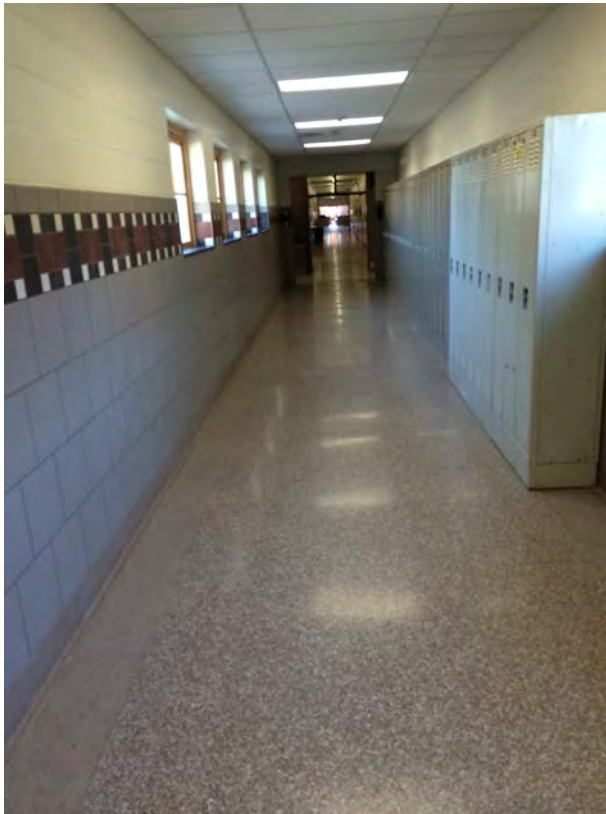
DMS – Resolve narrow corridors (remove lockers)

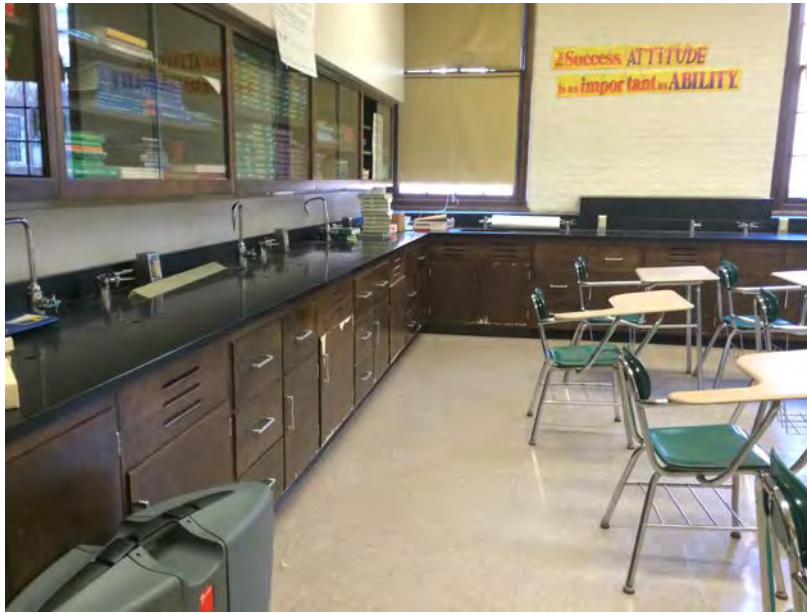
DMS – Replace older cabinetry

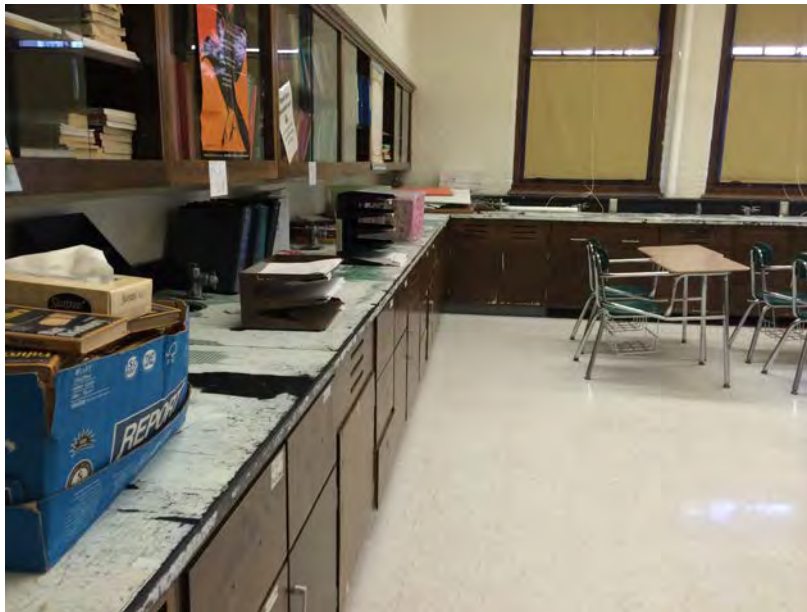
DMS – Remove/replace cabinetry

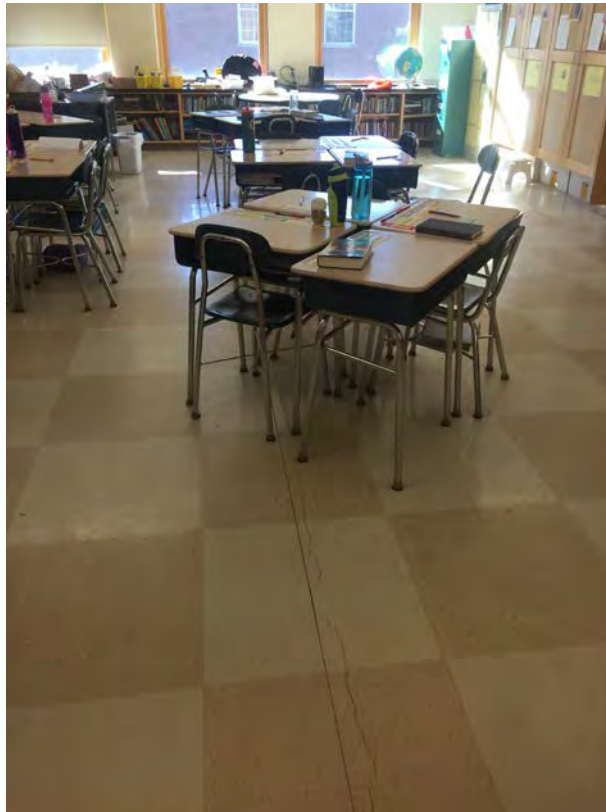
DMS – Resolve floor cracks in newer additions

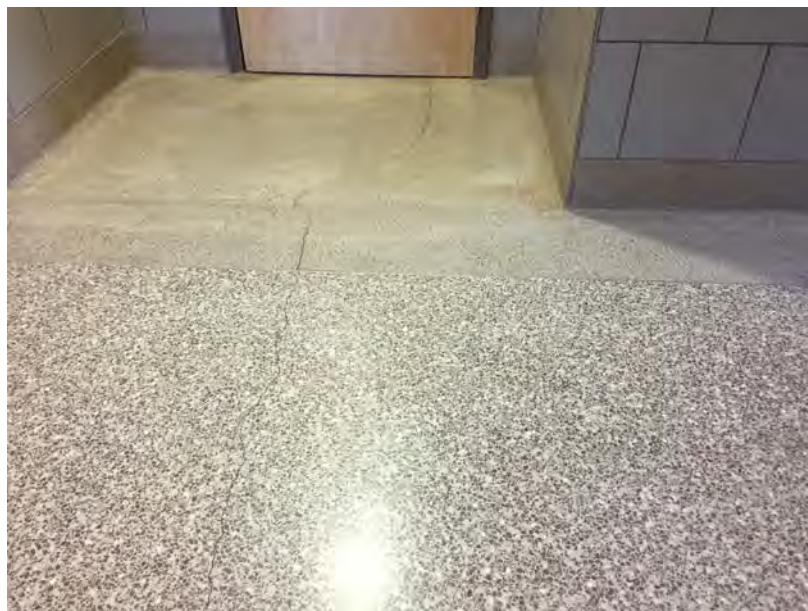
DMS – Resolve floor cracks in newer additions

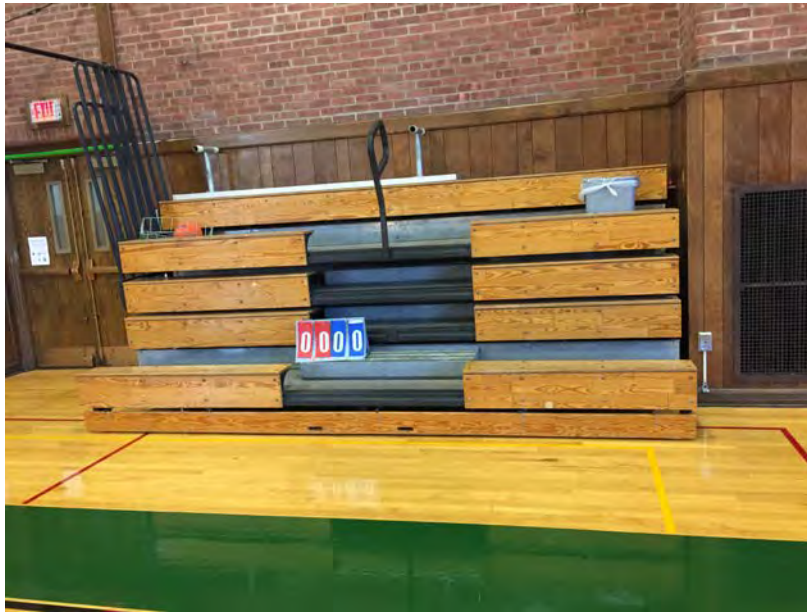
DMS – Renovate 4-6 Gym (replace bleachers)

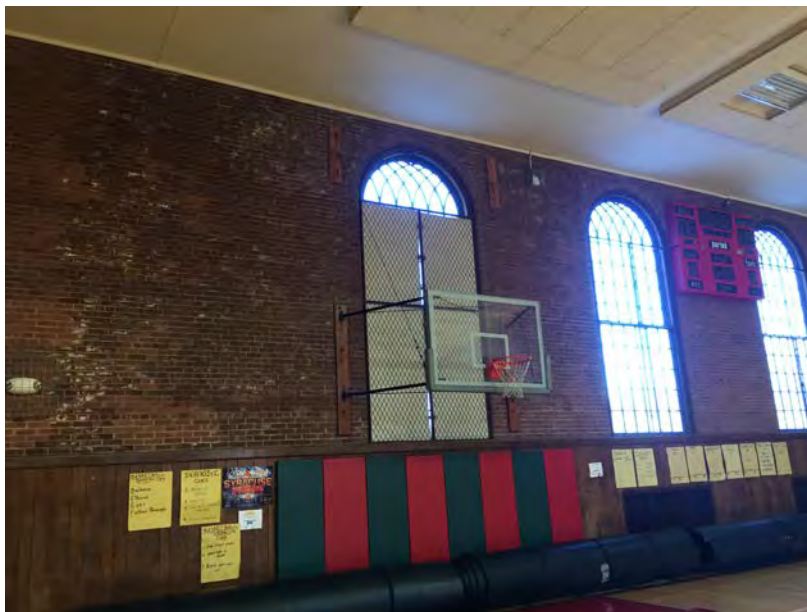
DMS – Renovate 4-6 Gym, resolve efflorescence

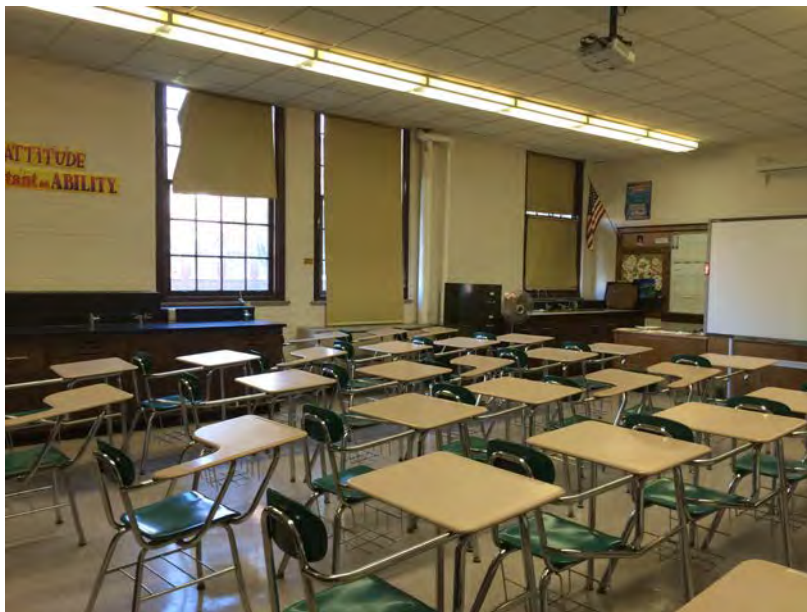
DMS – Replace older lighting

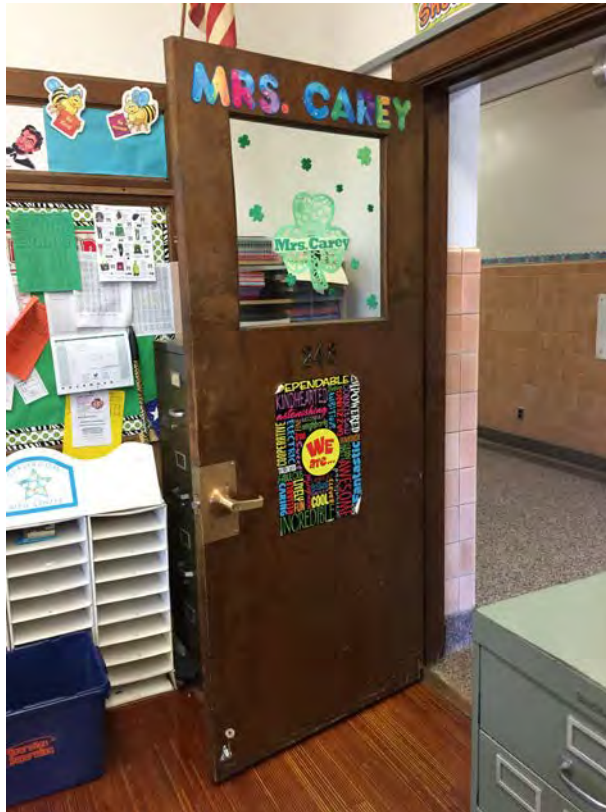
DMS – Replace older interior doors

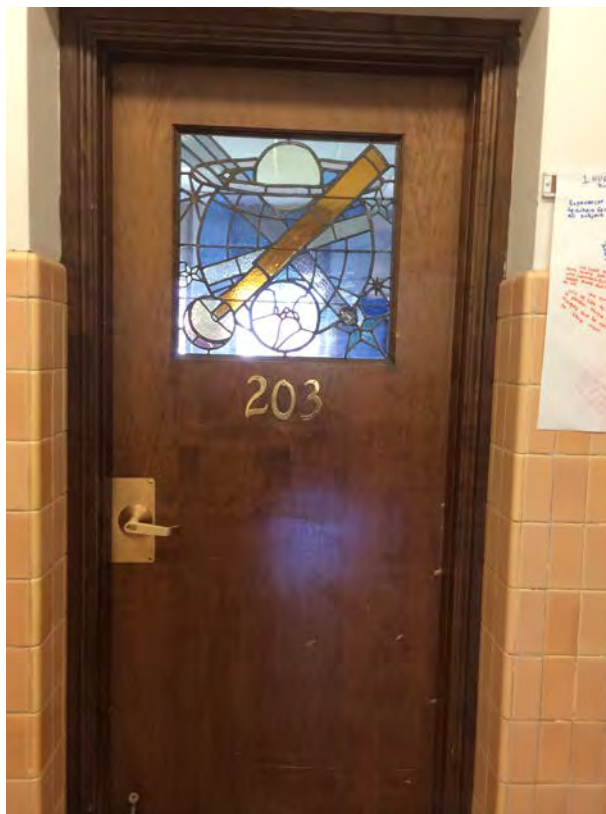
DMS – Reinforce leaded door glass

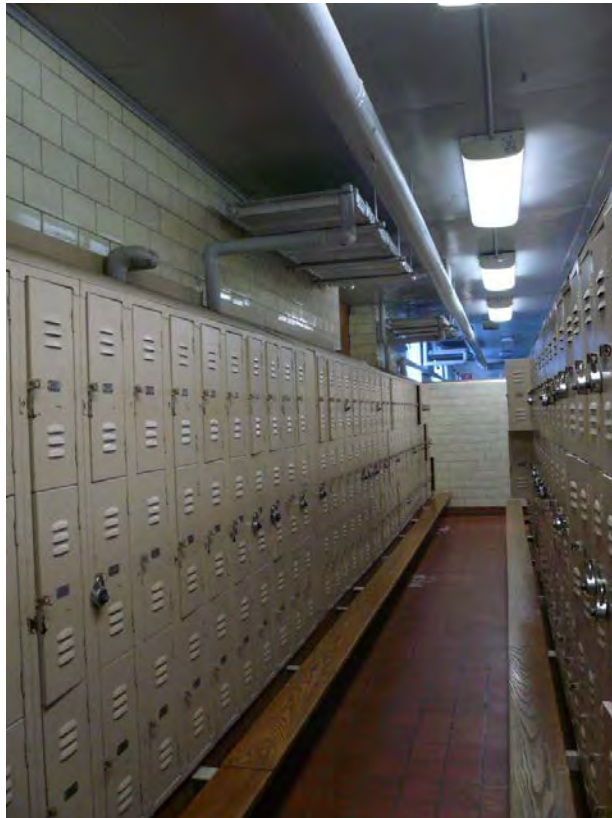
DMS – Renovate locker rooms, replace under slab sanitary

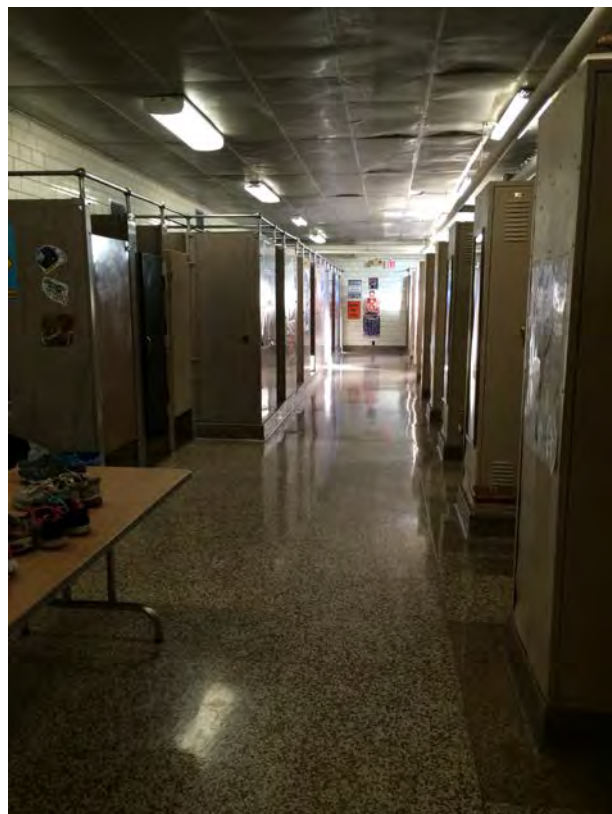
DMS – Renovate locker rooms, replace under slab sanitary

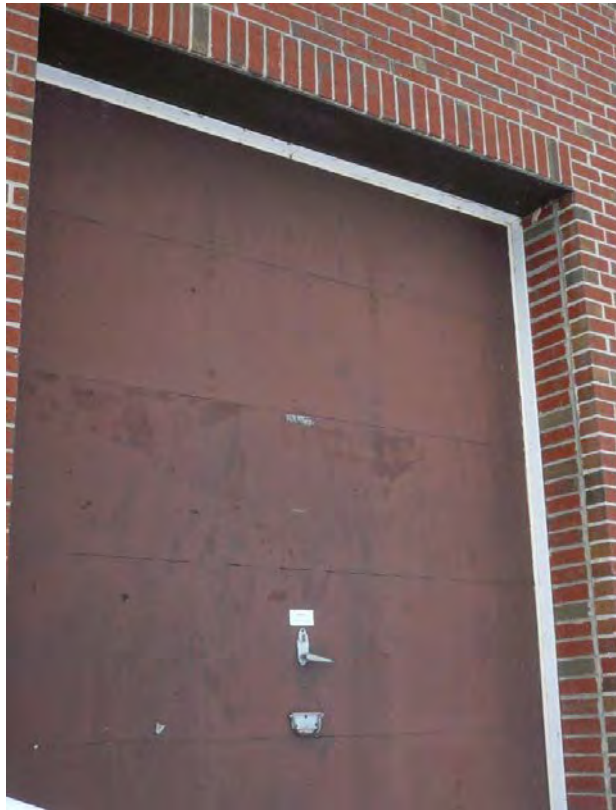
SHS – Replace Auditorium OH door

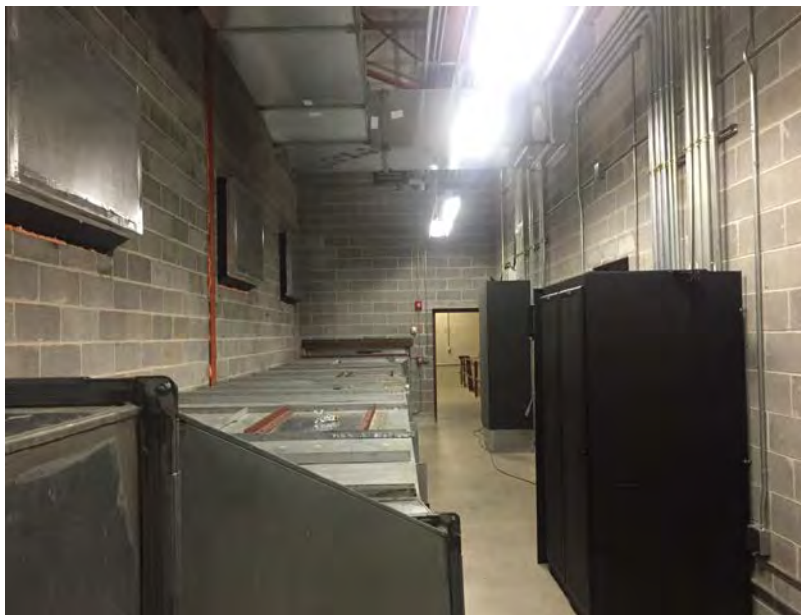
SHS – Secure Auditorium fan roof from student access

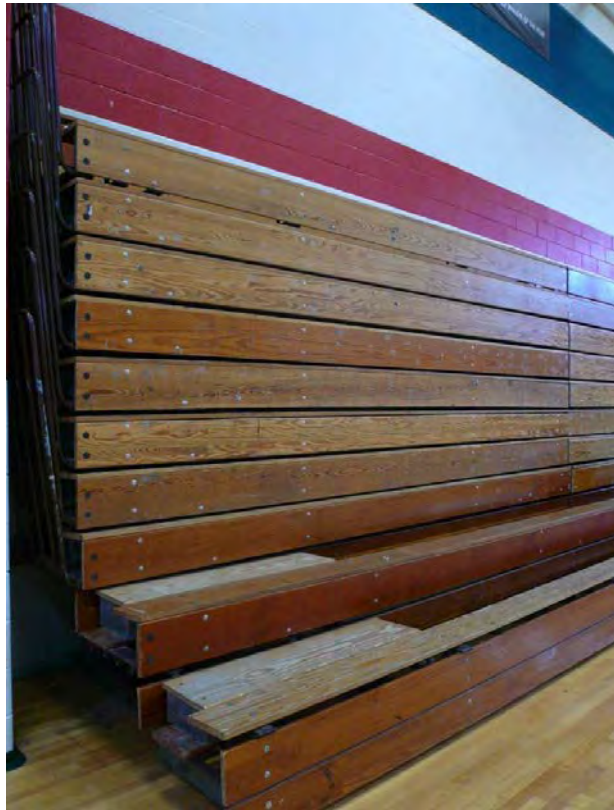
SHS – Gym bleachers, refurbish or replace with motorized

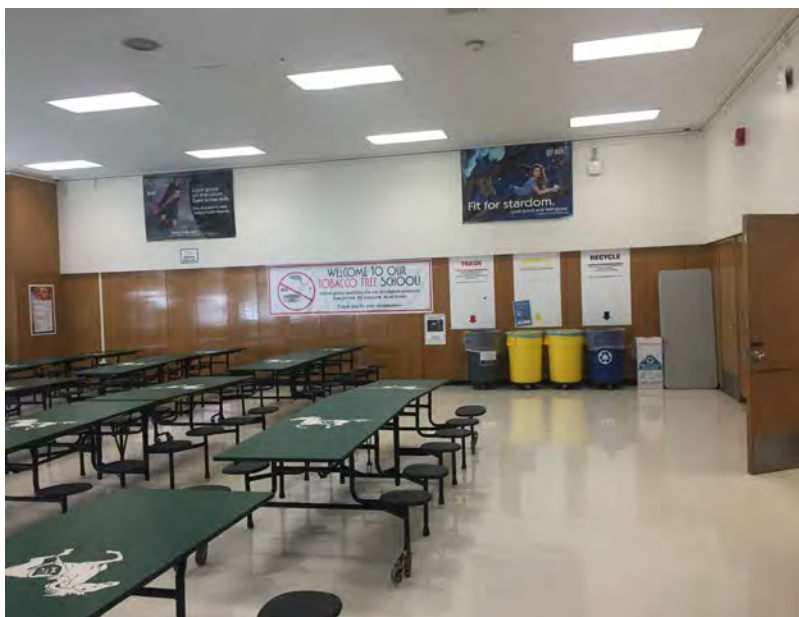
SHS – Renovate Cafeteria, add exit door to exterior

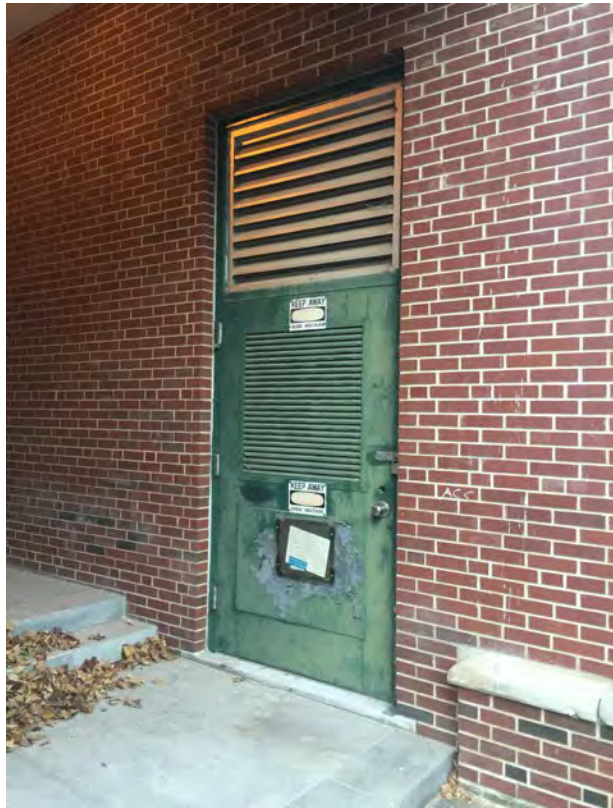
SHS – Replace older exterior doors

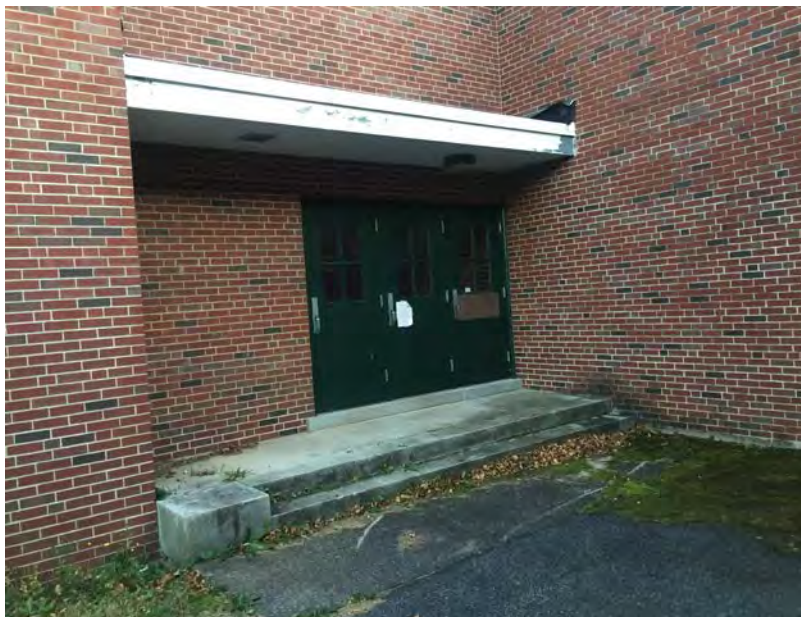
SHS – Replace older exterior doors

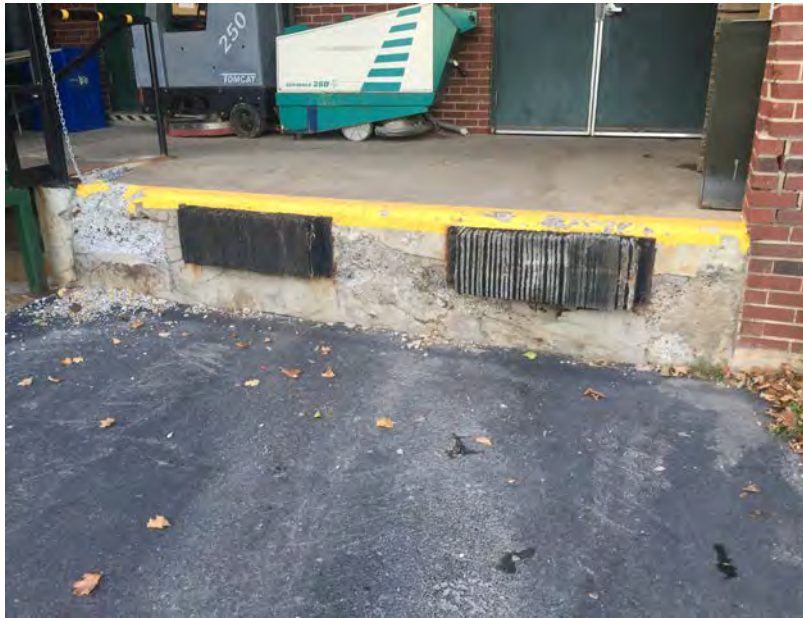
SHS – Masonry restoration

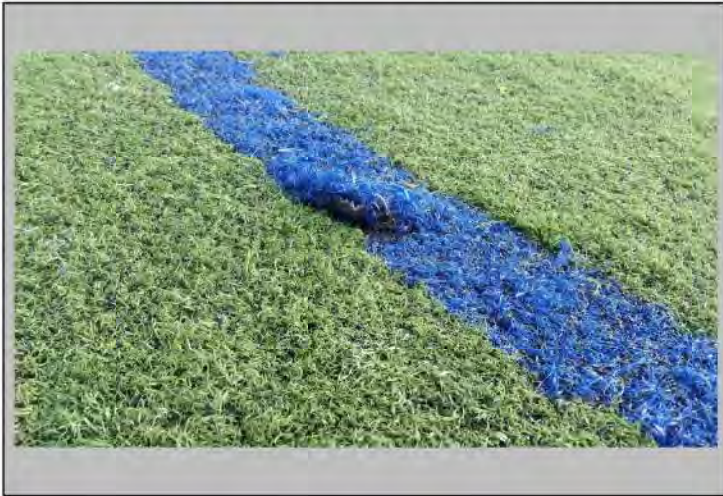
Photograph Number: 10
Budget Line Item Number: _____

Repair portions of turf lines that have come unglued (ATurf to provide cost for them to repair)

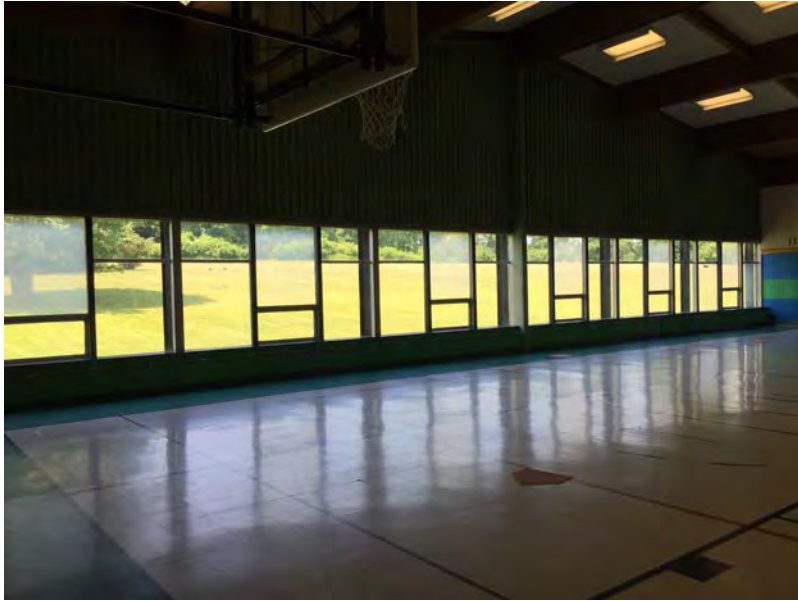
KES – Gym windows

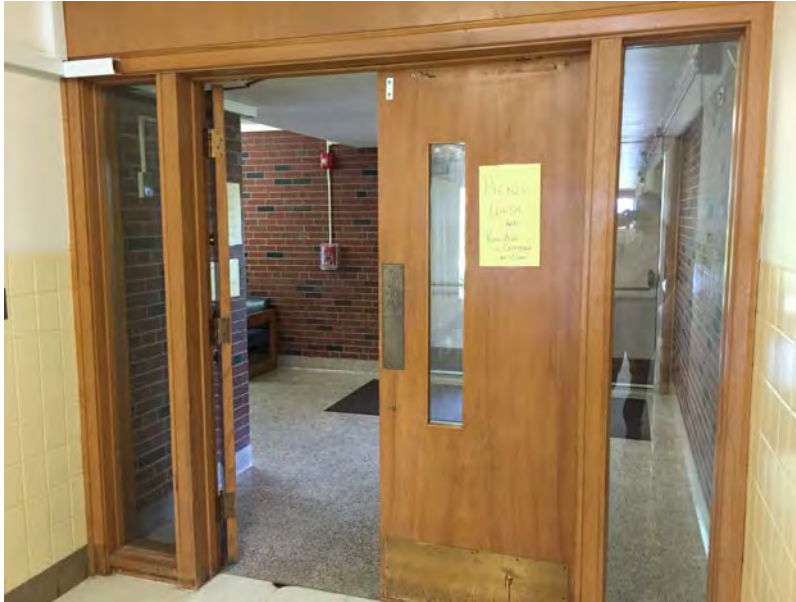
KES – Door and hardware replacement

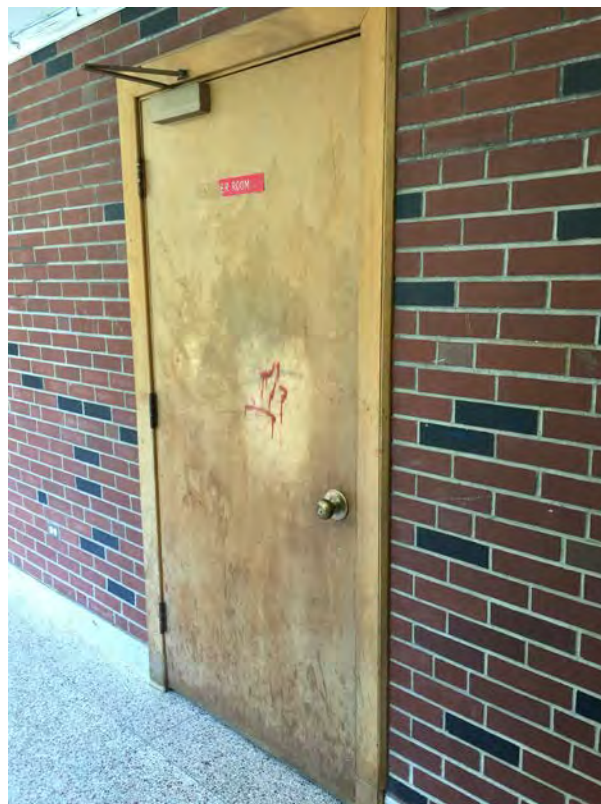
KES – Door and hardware replacement

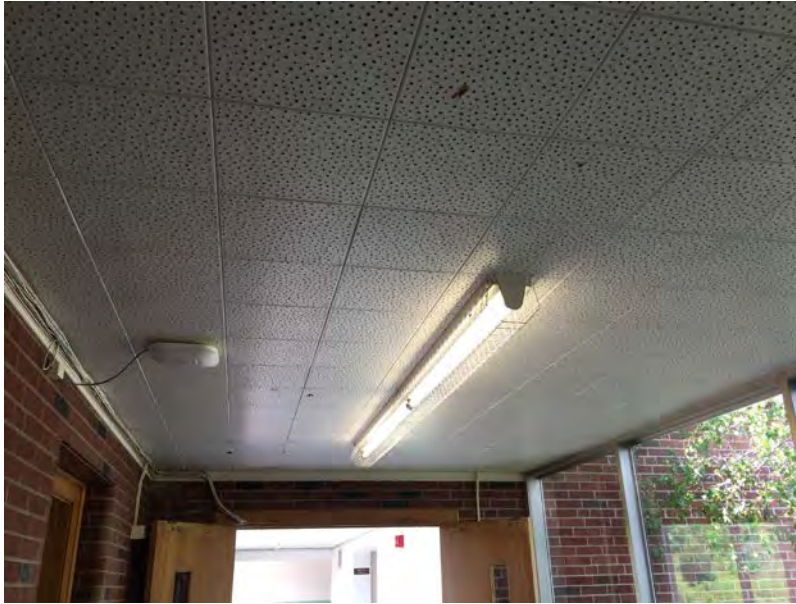
KES – Replace concealed spline ceilings and lighting

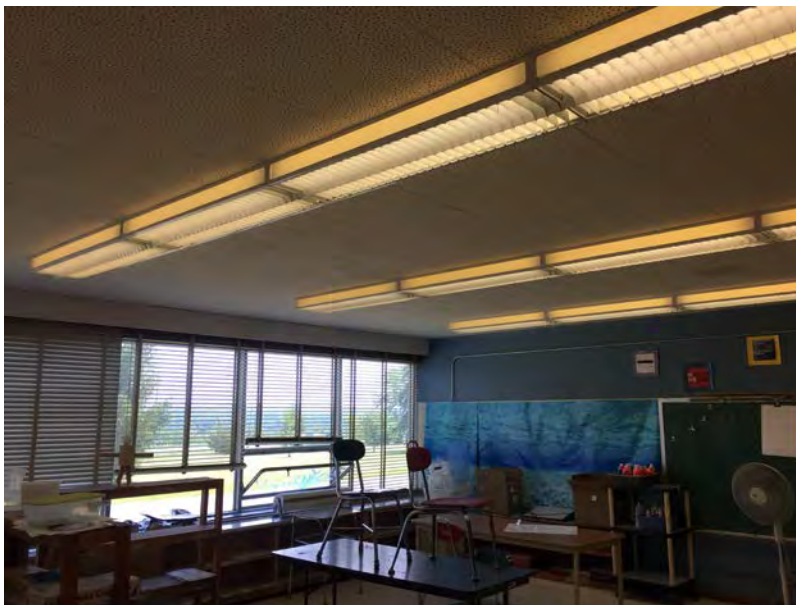
KES – Replace concealed spline ceilings and lighting

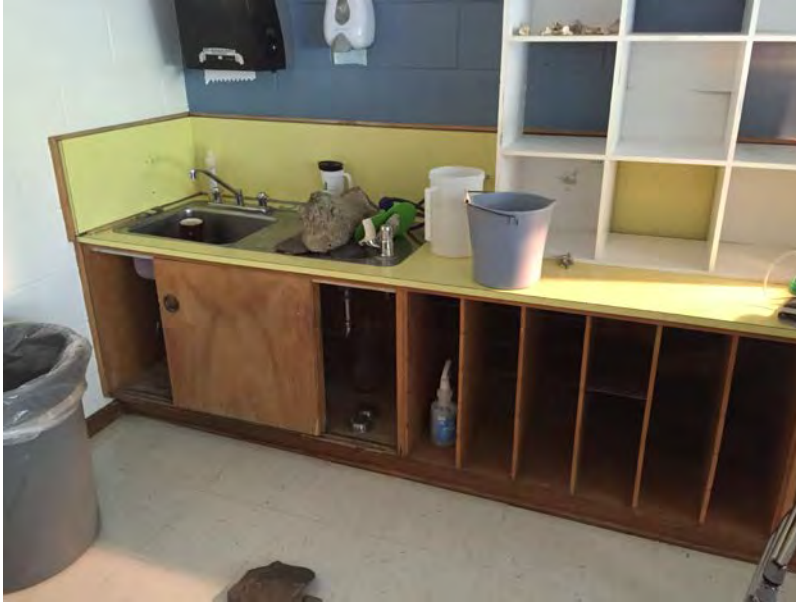
KES – Replace classroom cabinetry/plumbing fixtures

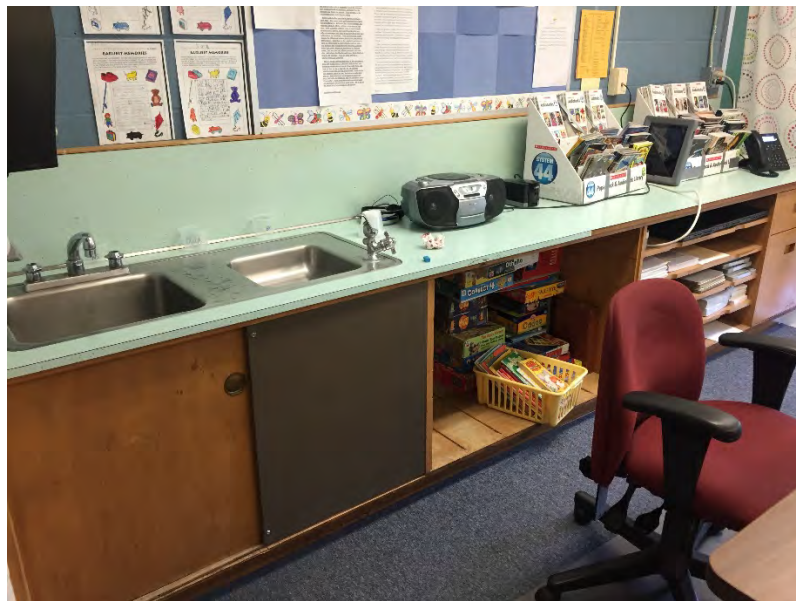
KES – Replace classroom cabinetry/plumbing fixtures

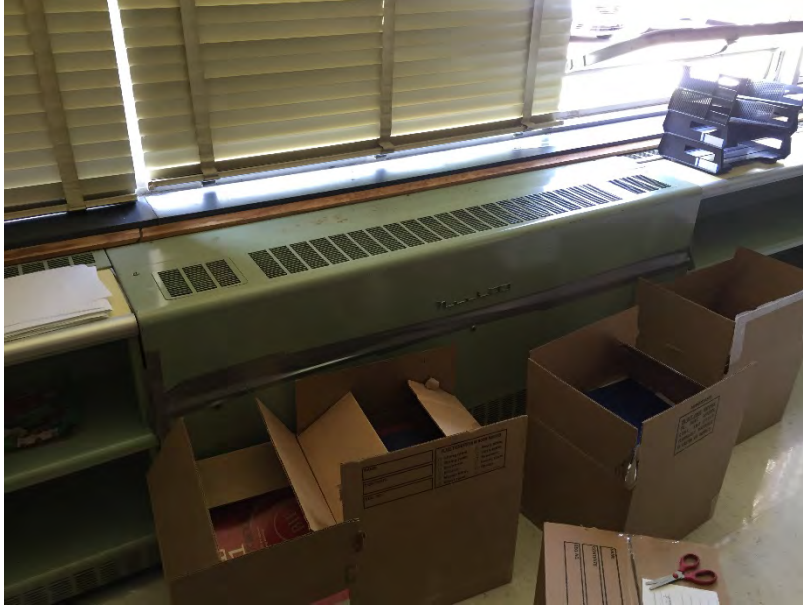
KES - Replace terminal units / heat piping

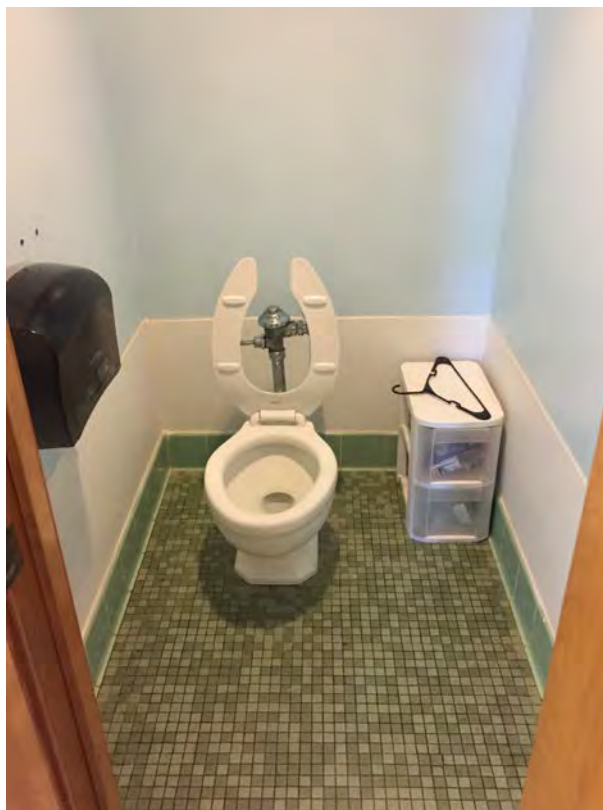
KES - Replace original plumbing fixtures

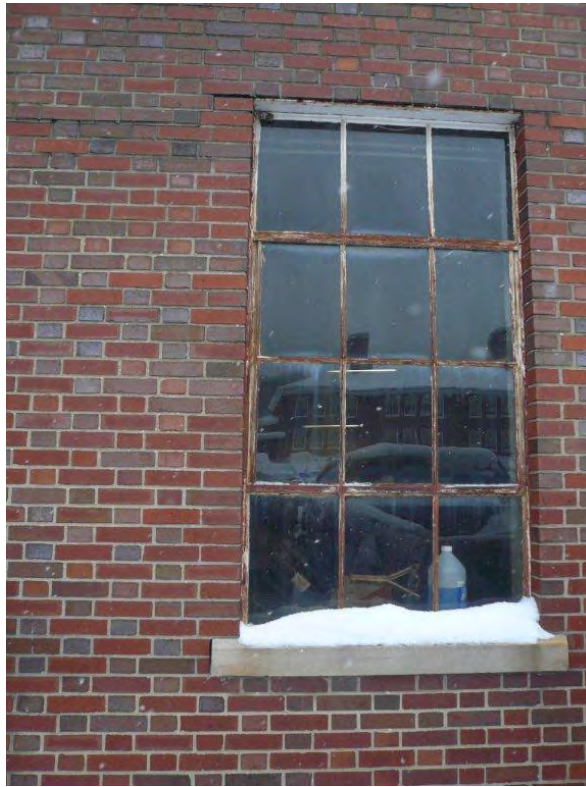
Maint. Facility – Replace steel windows

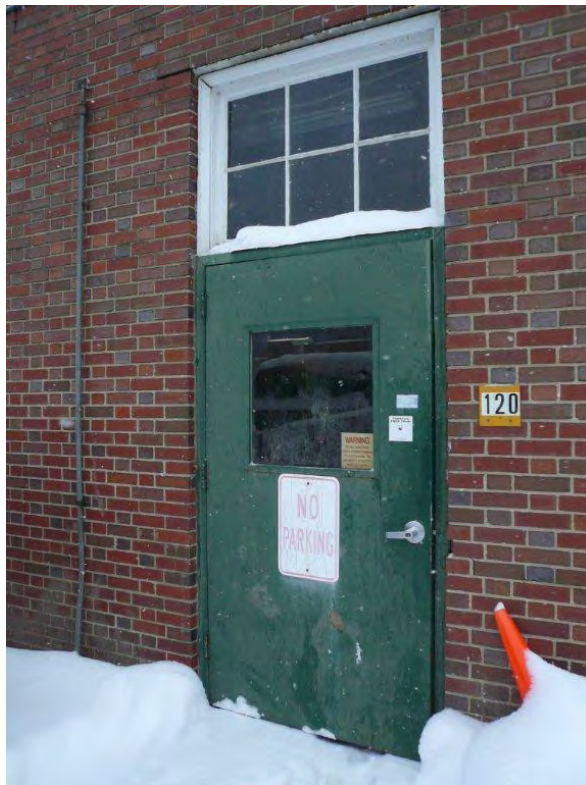
Maint. Facility – Replace exterior man doors

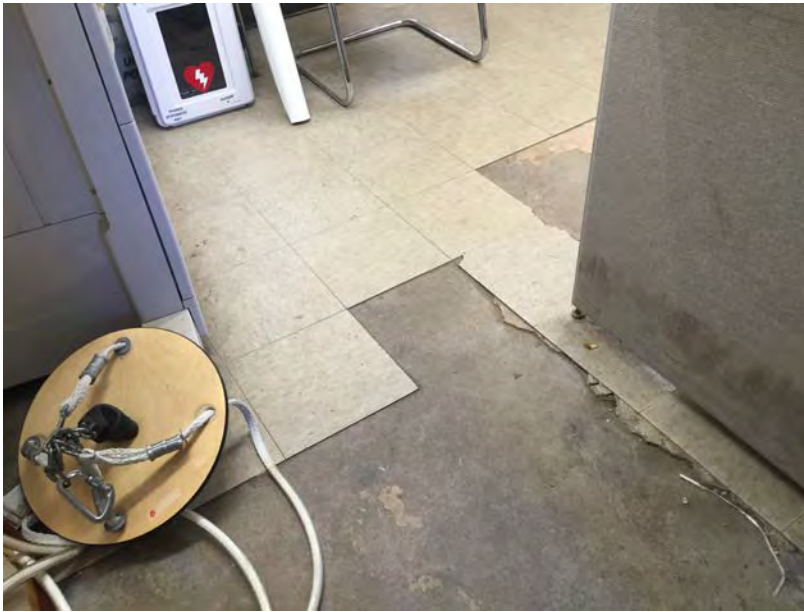
Maint. Facility – Replace flooring

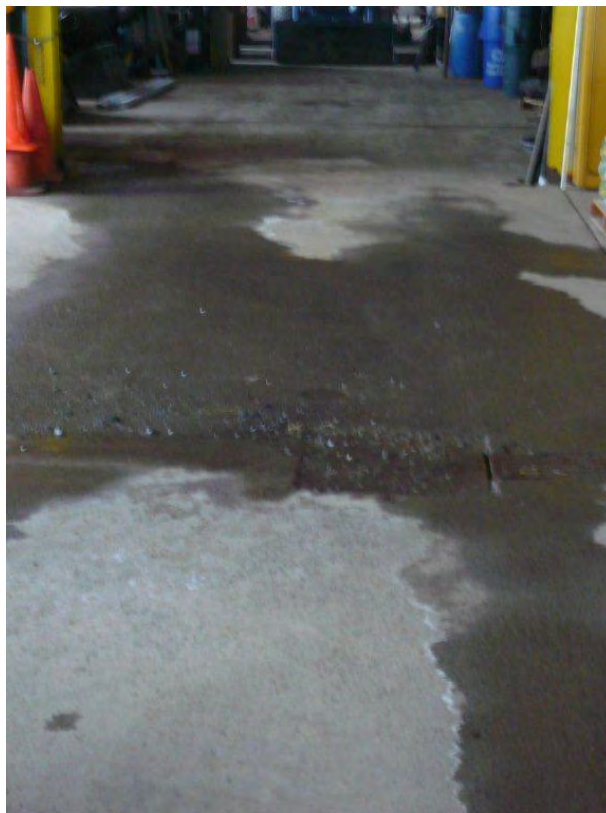
Maint. Facility – Coat bay floors

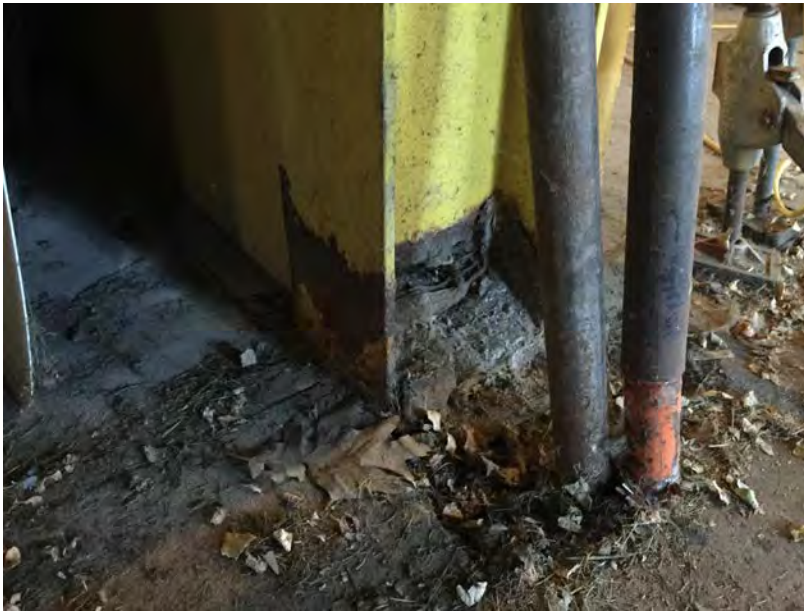
Maint. Facility – Repair column bases
