MARCELLUS
CENTRAL SCHOOL DISTRICT

2015 BUILDING CONDITION SURVEY

VOLUME 01

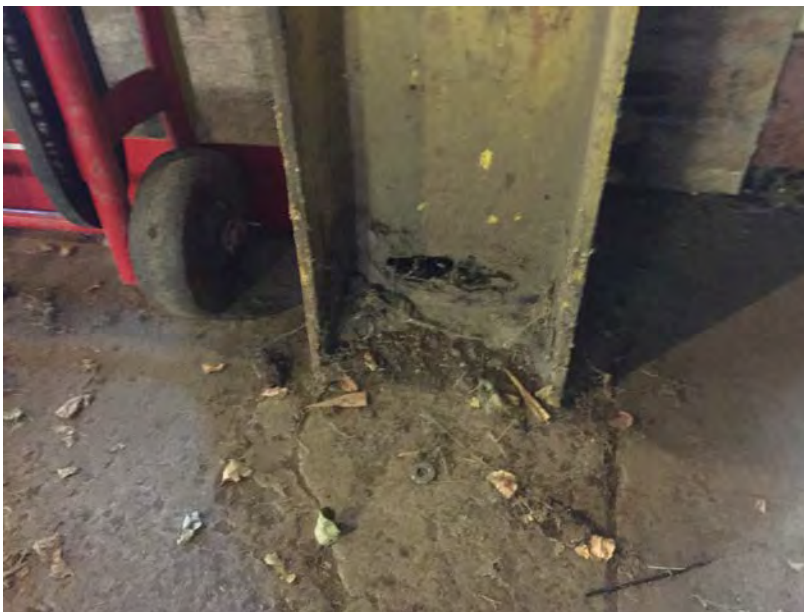
Maint. Facility – Repair column bases

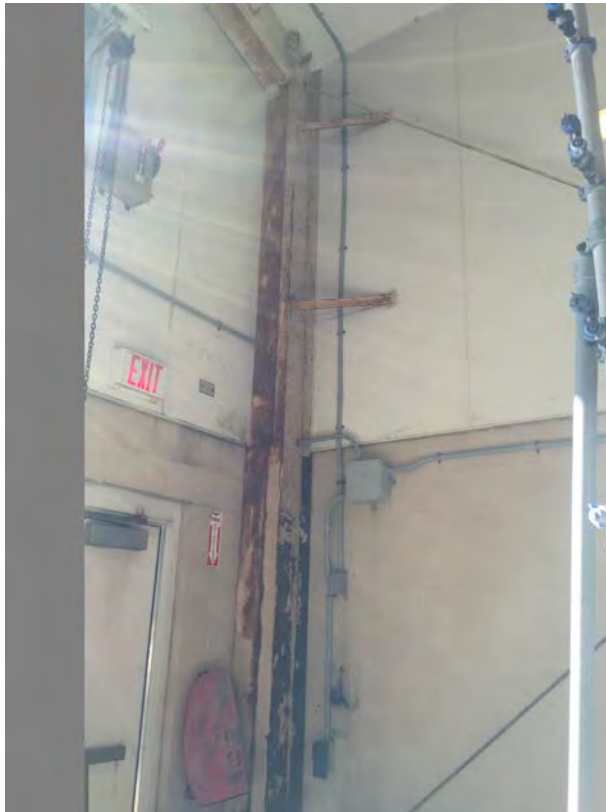
Trans. Facility – Resolve corrosion in wash bay

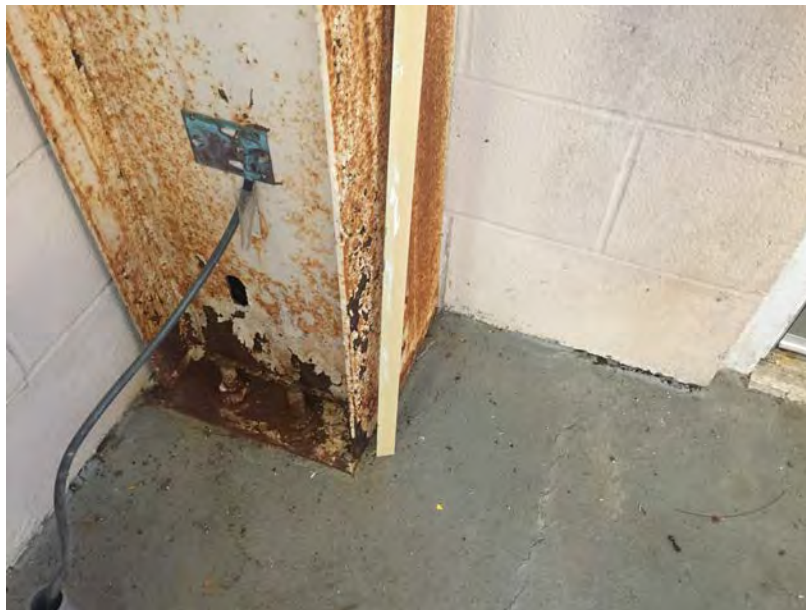
Trans. Facility – Resolve corrosion in wash bay
