Shields Valley Public Schools Master Planning

June 2, 2022

Elementary Schools Assessments

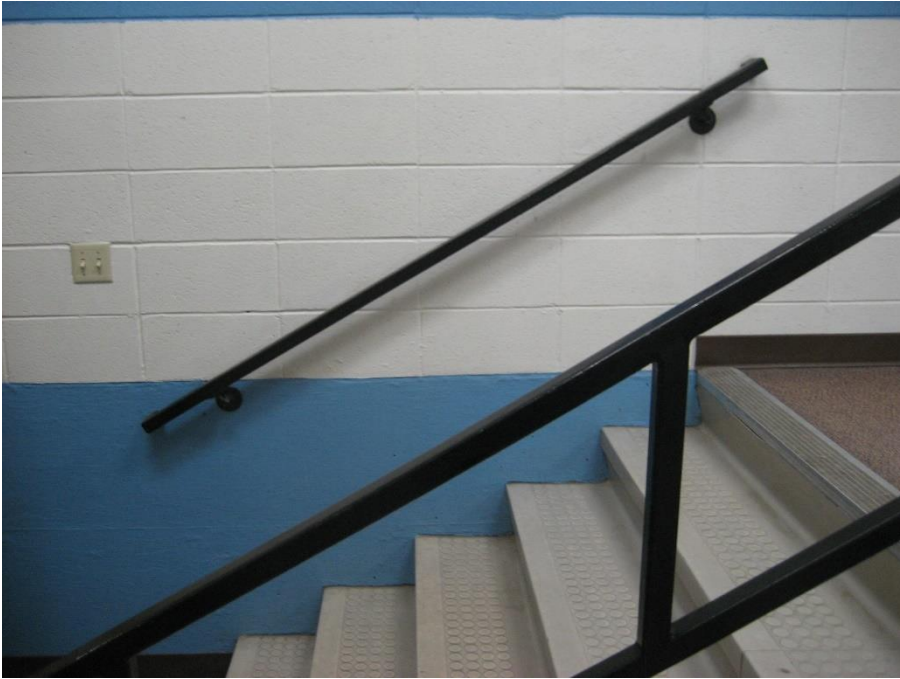
Figure 1- Handrail at Stair from Lobby down to Gym level.

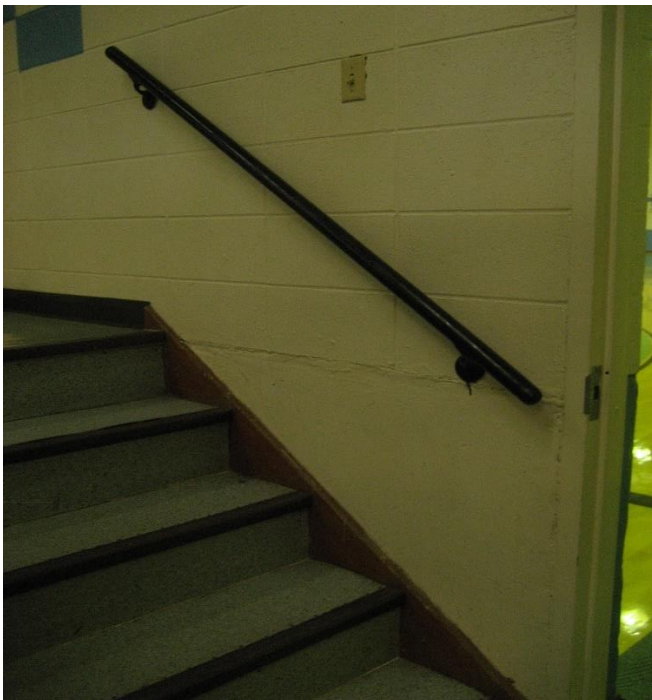
Figure 2 – Handrail at Stair from Stage down to Gym.

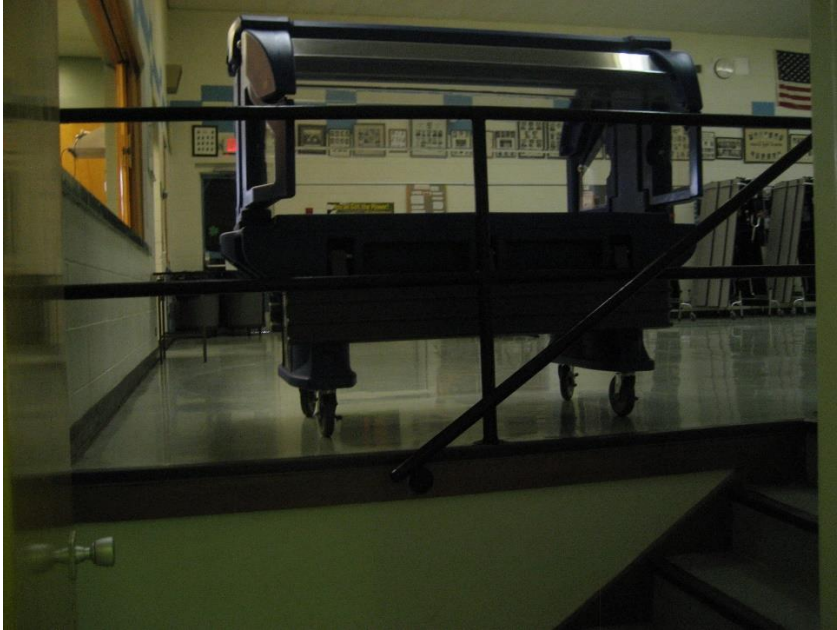
Figure 3 – Guardrail at Stair from Stage down to Gym level.

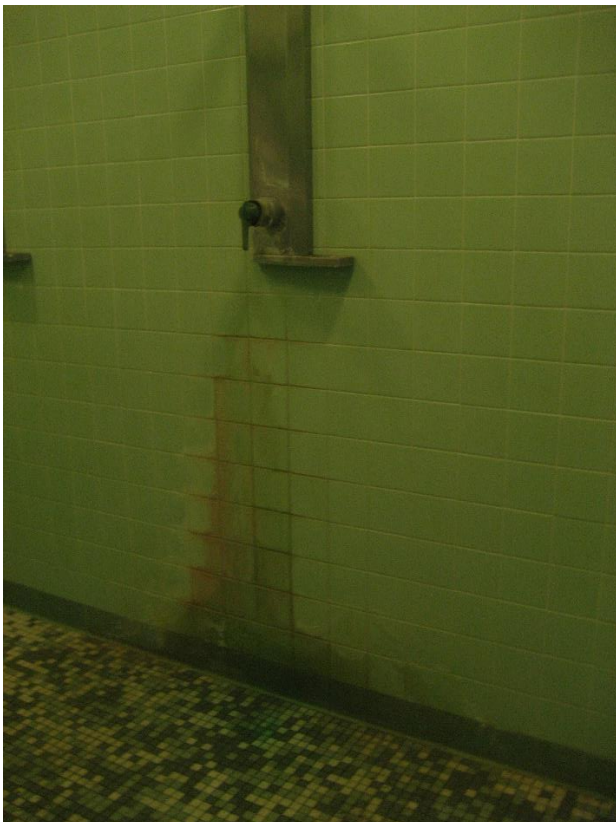
Men's Locker Room: Also located adjacent to the Gym, this locker room is very similar to the women's locker room. The room has painted concrete floors, painted CMU walls and some painted gypsum board partitions, and the ceiling is painted gypsum board with surface mounted light fixtures. The lockers, toilet partitions, toilet fixtures, and shower stalls are all original to the 1967 construction, as are the ceramic tile flooring, wall tile, and terrazzo shower bases. Some of the terrazzo bases are not in good condition and the shower fittings appear to be original. There is currently a leak at one of the shower faucets which has caused damage to the tile wall and tile flooring. None of the toilet stalls, showers, or lockers are ADA accessible. The doors are original wood doors set into hollow metal frames. The door hardware is an older closer and knob handle, which is not ADA compliant. The windows are single pane wired glass. The only elements in this area that are newer are the toilet accessories.

Figure 4 – Shower at Men's Locker Room.

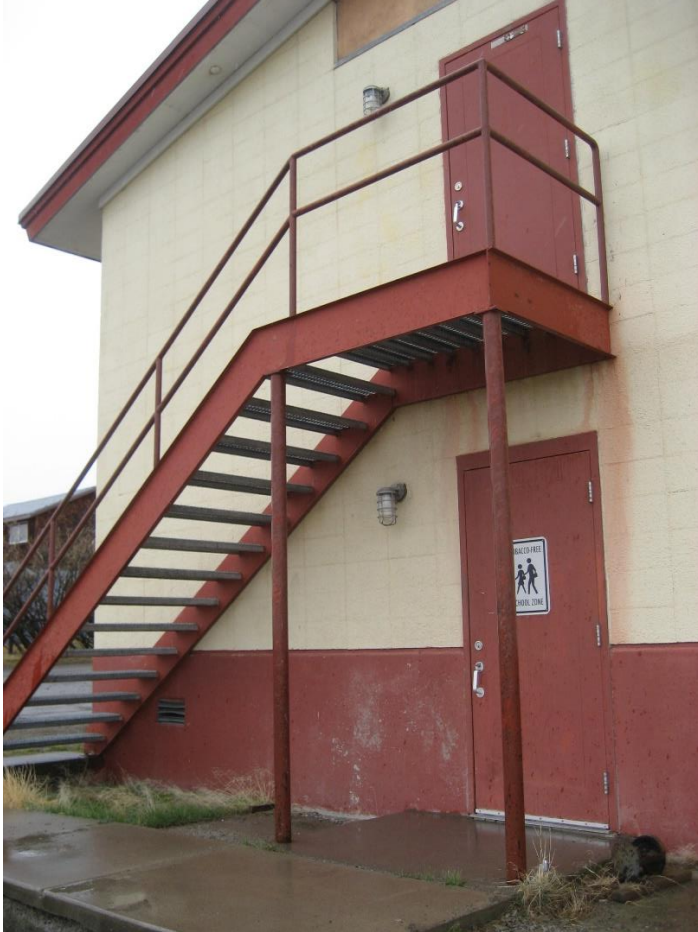
Music Room: Also located on the mezzanine in the Gym, this room has carpet flooring, painted CMU walls and painted gypsum board walls which are damaged in some areas. The ceiling is a 12"x12" glue-on acoustical tile with surface mounted fluorescent light fixtures. There is old wood shelving in this room. The original wood door and wood frame has a lever handle hardware. There is a suspended unit heater in this room with exposed insulated piping. There is an exterior emergency egress stair off this room leading down to grade. This stair has a metal guardrail that is not code compliant, as it does not have sufficient intermediate rail spacing within the guardrail and it also is missing handrails at both sides of the stair.

Figure 5 - Exit stair from Music Room at Mezzanine level.

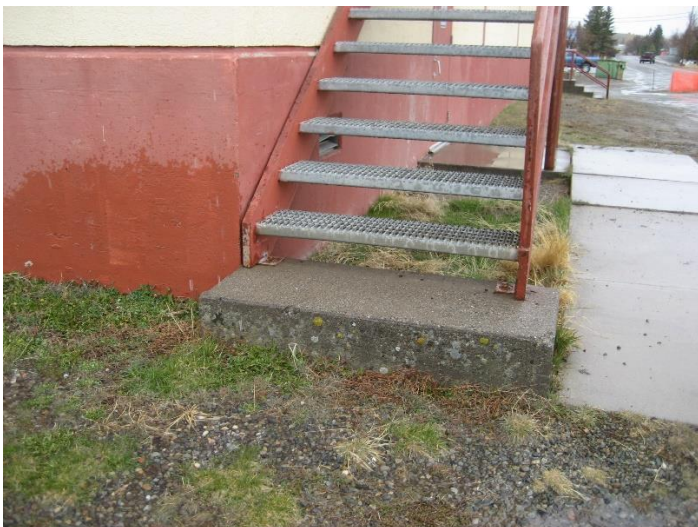
Figure 6 – Landing at bottom of Music Room exit stair.

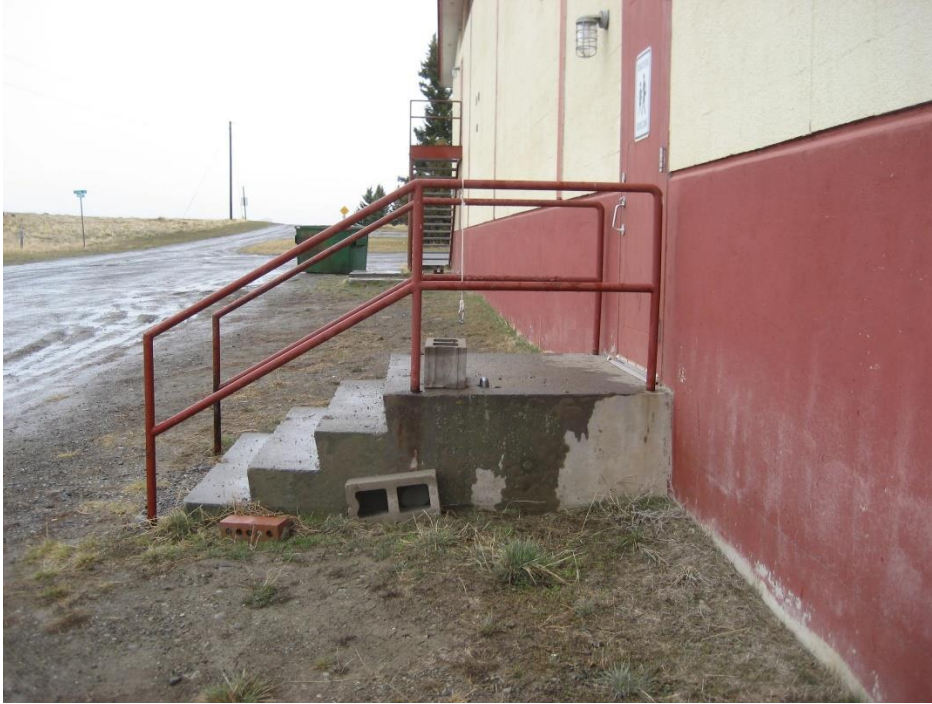
Figure 7 – Guardrail at northeast exit stair from Gym.

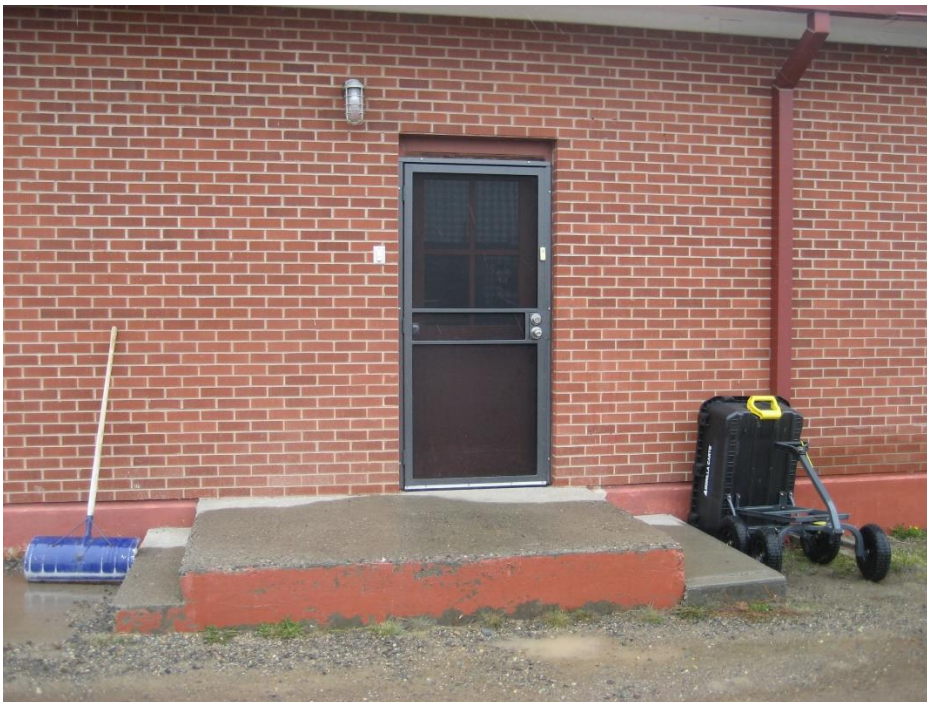
Figure 8 – Landing at exit door from Kitchen; missing guardrail.

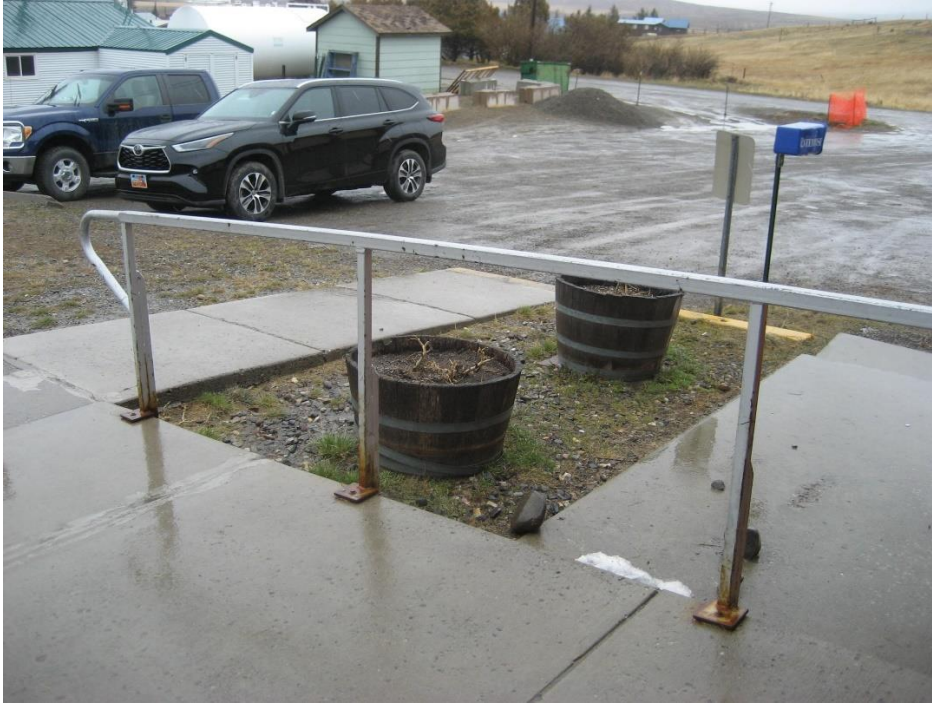
The entrance to the school is accessed via a long series of ramps from the gravel parking areas. There are no paved ADA accessible parking stalls available. The ramps themselves are of appropriate slope as to comply with ADA requirements however the upper landing at the entry doors is only 4'-6" in lieu of the required 5'-0" distance. And the guardrails along the ramps are not ADA compliant due to not having horizontal rails at 4" above the walking surface. There are some uneven surfaces in the concrete ramp in front of the entry doors along with some spalling concrete in that area. There is a painted stucco finish at the ceiling at the recessed entry area, some of which is in need of touchup repairs.

Figure 9 – Route to Main Entry from Parking Lot; No ADA parking is provided.

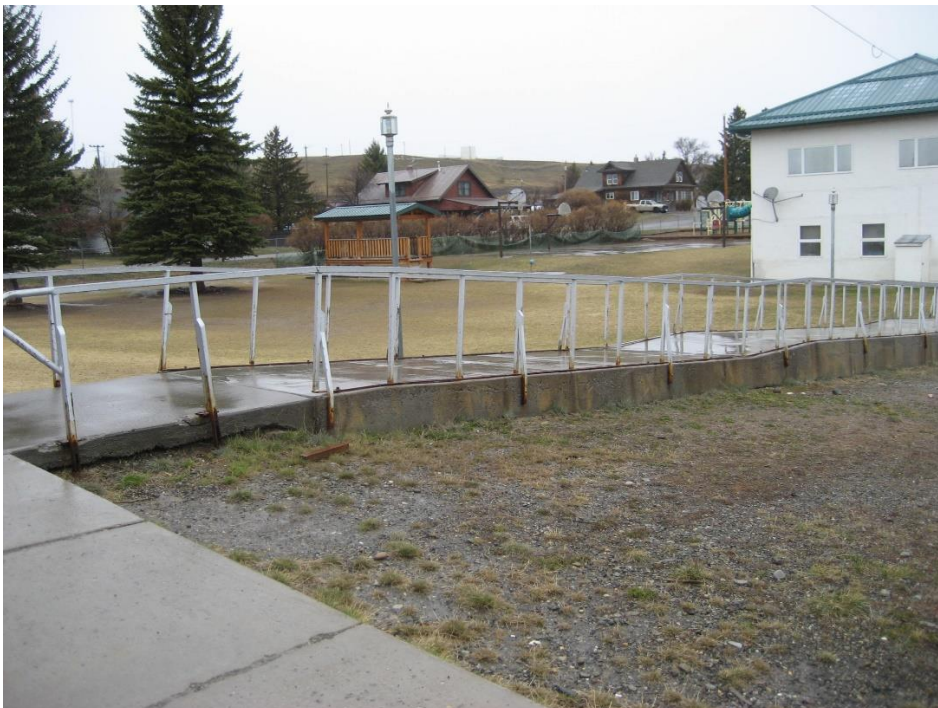
Figure 10 – Ramp from Red Building down to White Building.

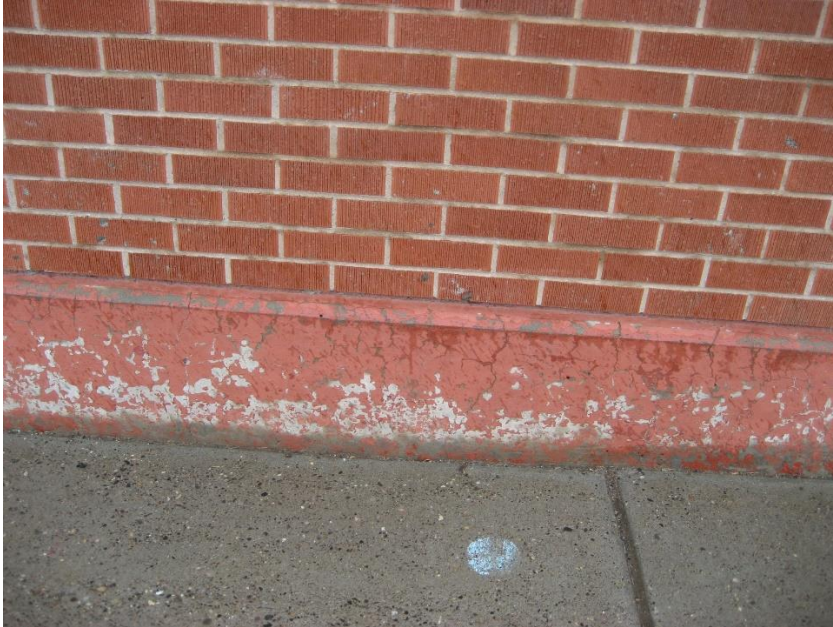
Figure 11 – Chipped and peeling paint at foundation wall.

At the perimeter of the school, the exposed portion of the foundation wall is painted but in many areas the paint is chipped and/or peeling. Repainting of the foundation wall is recommended.

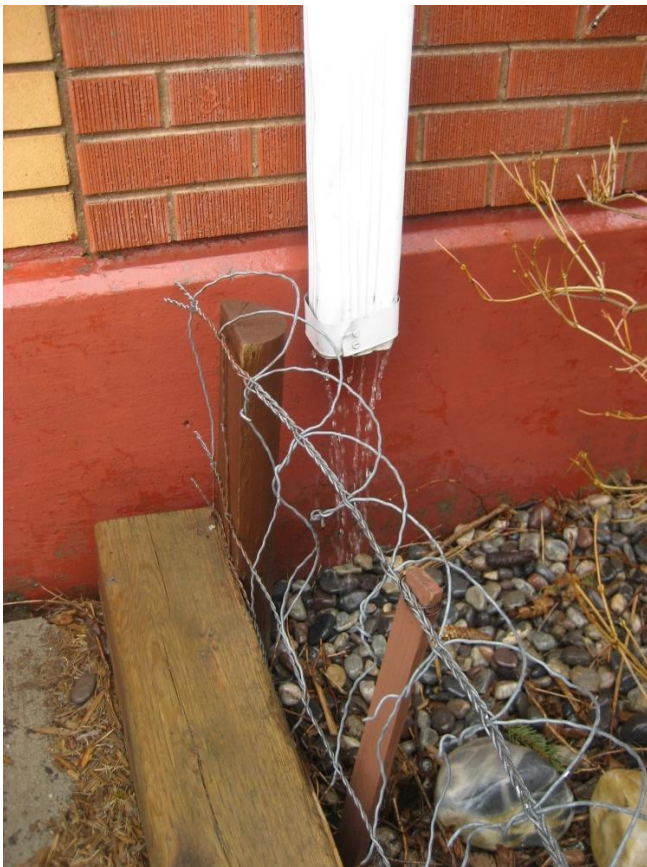
Figure 12 – Downspout missing rain leader at foundation wall.

Along the length of the roof line, there are painted wood soffits which are in need of repainting. There is also painted wood fascia at the roof, most of which has deteriorated beyond repair. It is recommended to cover the fascia with metal when the building is reroofed. Some eaves have gutters but not all do, this also should be rectified when the school is reroofed. At the northwest end of the school, it was noted that there was no rain leader at the bottom of the downspout to lead water away from the foundation.

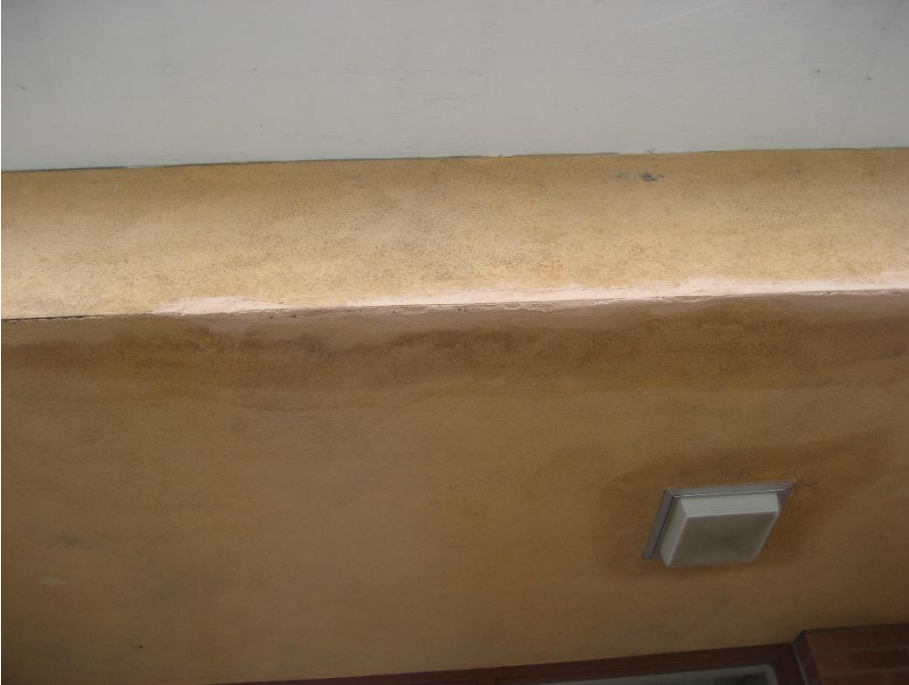
At the west end of the building, there is a painted stucco finish at the ceiling at the recessed entry area some of which is in need of touchup repairs, similar to the condition at the main entry ceiling.

Figure 13 – Patched stucco soffit at ceiling of Main Entry.

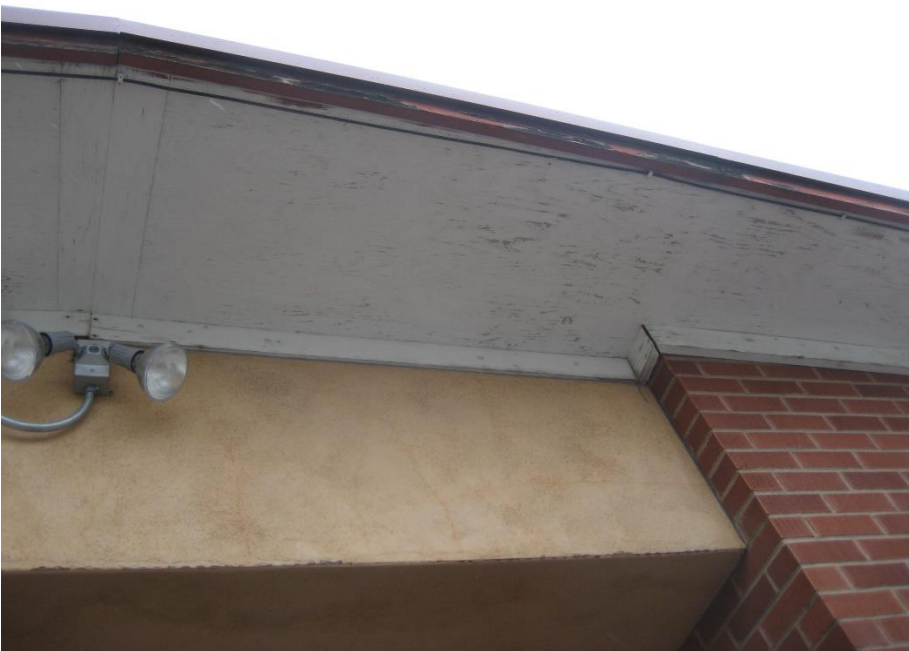
Figure 14 – Peeling paint typical at wood soffit and fascia at perimeter of building.

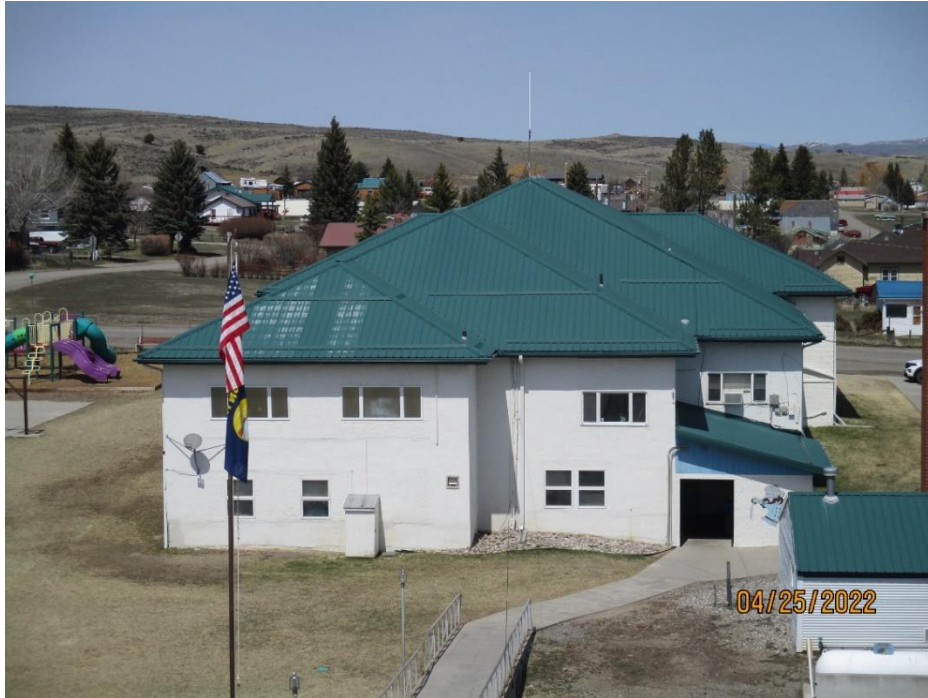
1913 Building: Metal panel paint is failing.

Recommend monitoring the metal roof finish and remove and replace the roof plumb pipe jacks in the next two (2) years. Seal all cracks in the stucco and limestone and repaint the building. Consideration for sealing and repainting and for window replacements depends upon expected future use of this building.

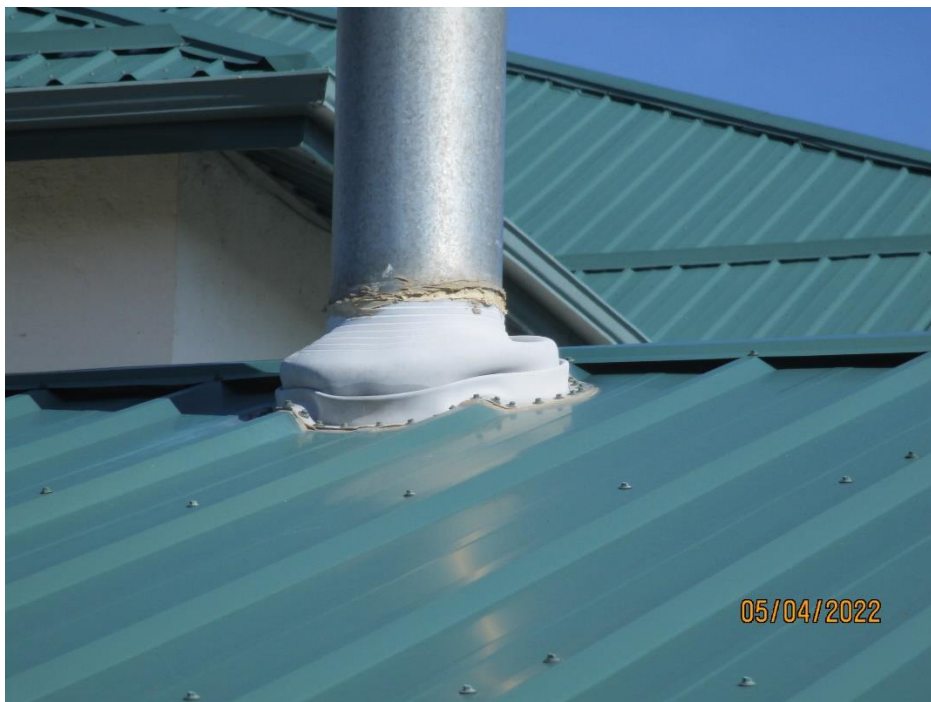
1913 Building: Pipe jack rubber gasket is failing.

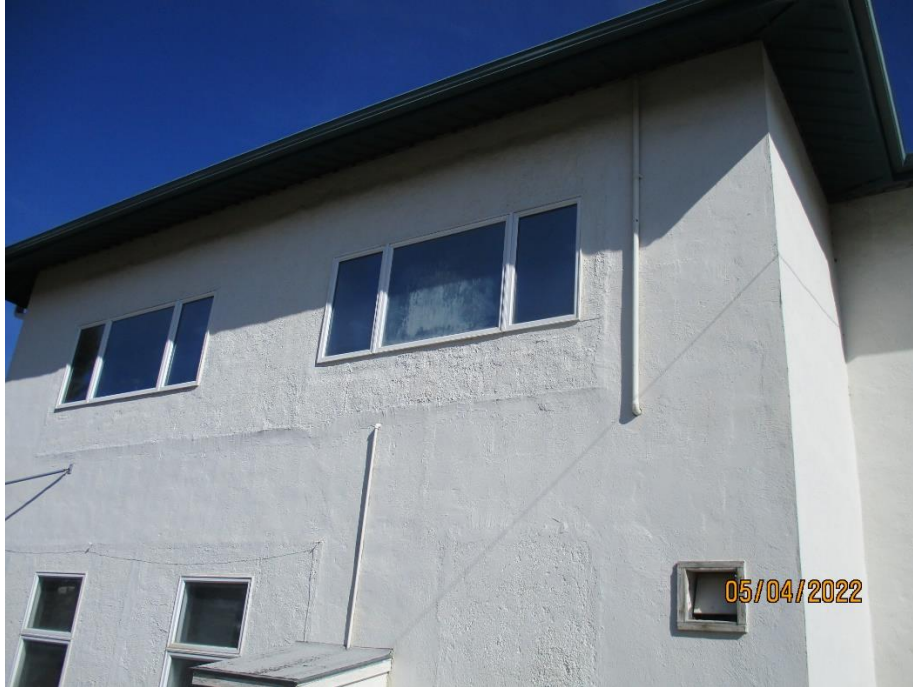
The building Envelope appears to be in fair condition. There are several small cracks throughout the entire stucco and limestone portion of the building. There are also several windows where the seals are broken, and moisture has fogged the window. There are also a few windows where the wood frames have deteriorated and failed.

1913 Building: Window seal has failed.

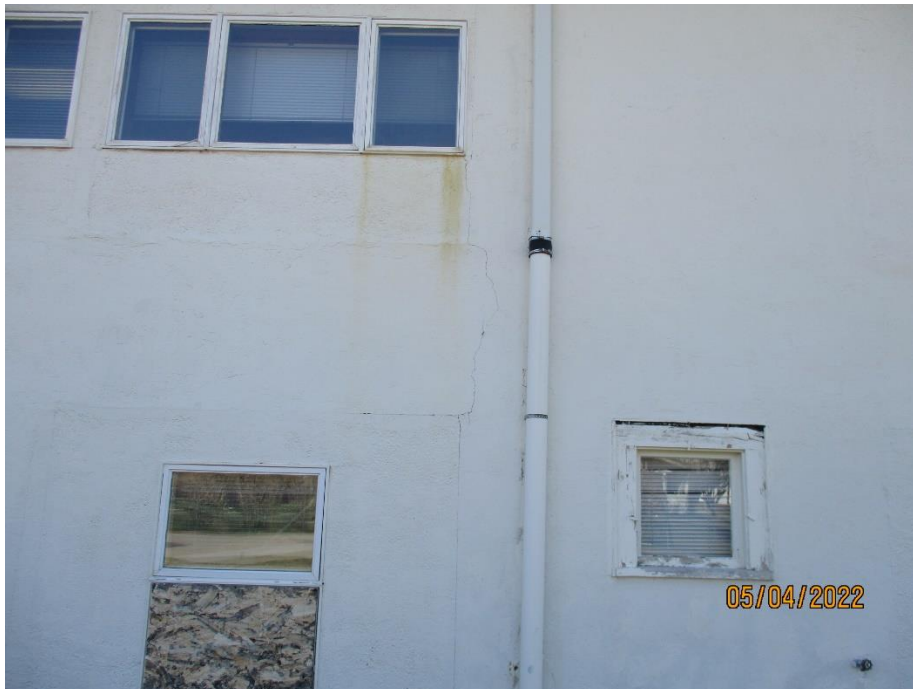
1913 Building: Cracks in stucco are evident as well as window frame has deteriorated.

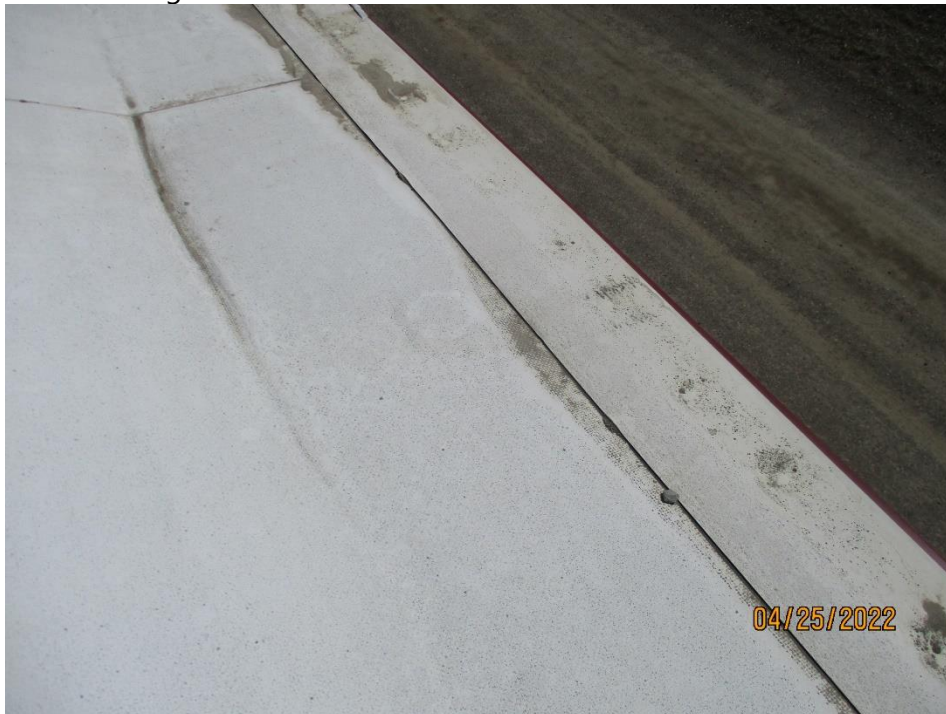
This roof does show signs of membrane wear & tear mainly due to age. The roof has new edge metal that has been stripped in. This stripping is in fair condition but is bucking water at the inside edge at the lap. The masonry wall has a large crack in the masonry joint that should be sealed.

1967 Building Roof Area A: Edge Stripping

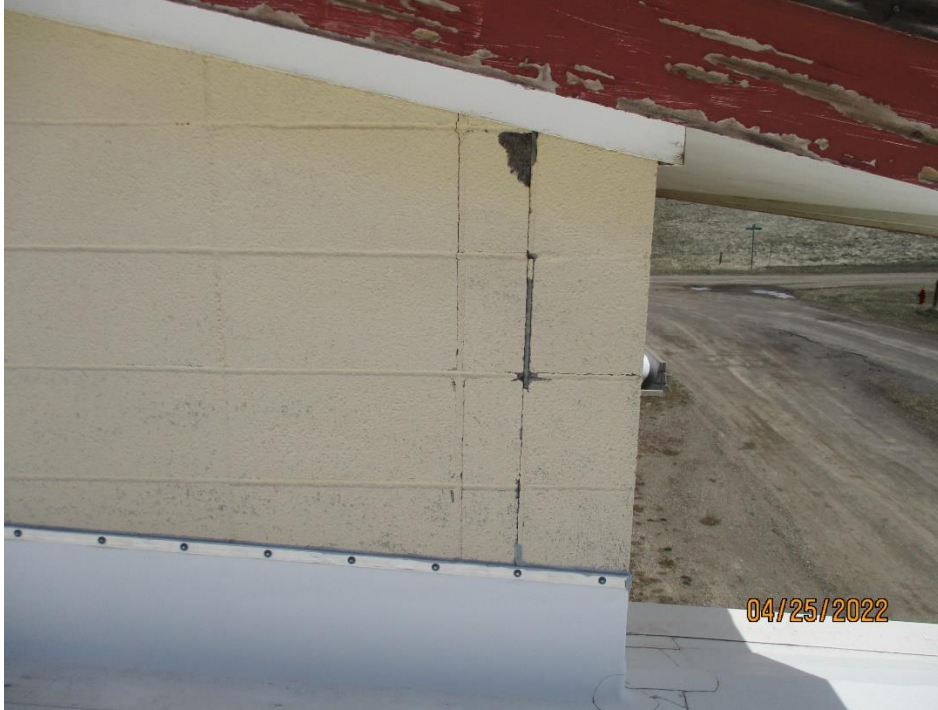
1967 Building Roof Area A: SW Corner of gym adjacent to roof section A is failing.

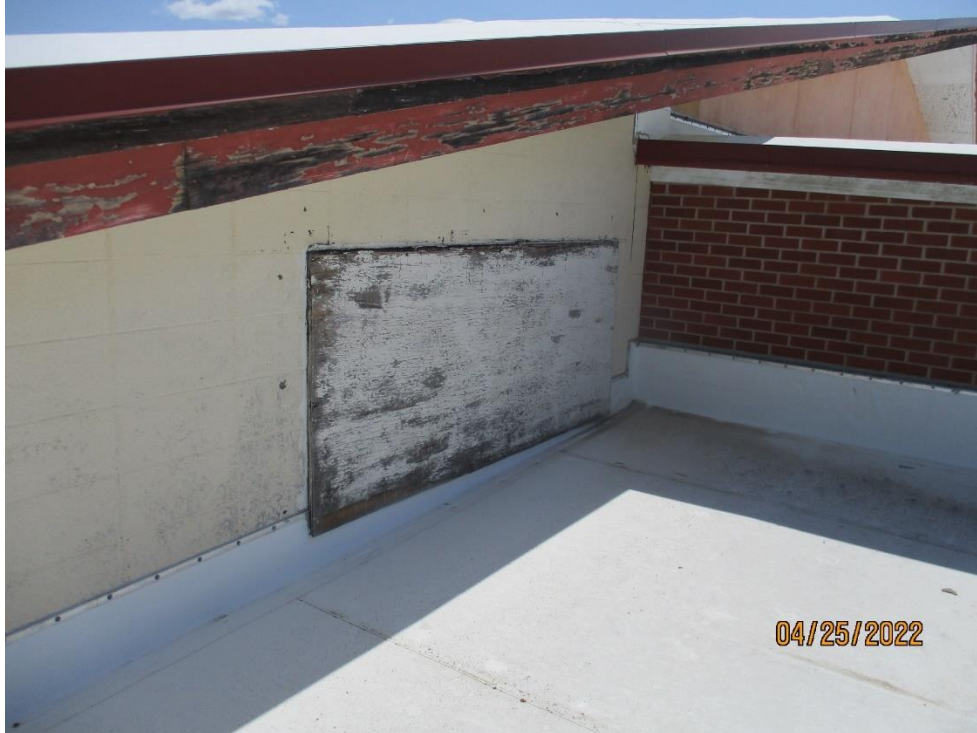
This roof also shows sign on normal wear & tear. The roof has new edge metal that has been stripped in. This stripping is in fair condition but is bucking water at the inside edge at the lap. On the east side of the building there is a piece of plywood attached to the wall. It appears to be at a location where a wall vent might have been in place at one time. The plywood has deteriorated and is not watertight at the perimeter of the plywood edge. This item needs to be removed and replaced with a properly insulated and covered and sealed prior to next winter.

1967 Building Roof Area B: Plywood attached to the gym wall. Deteriorated and not water tight.

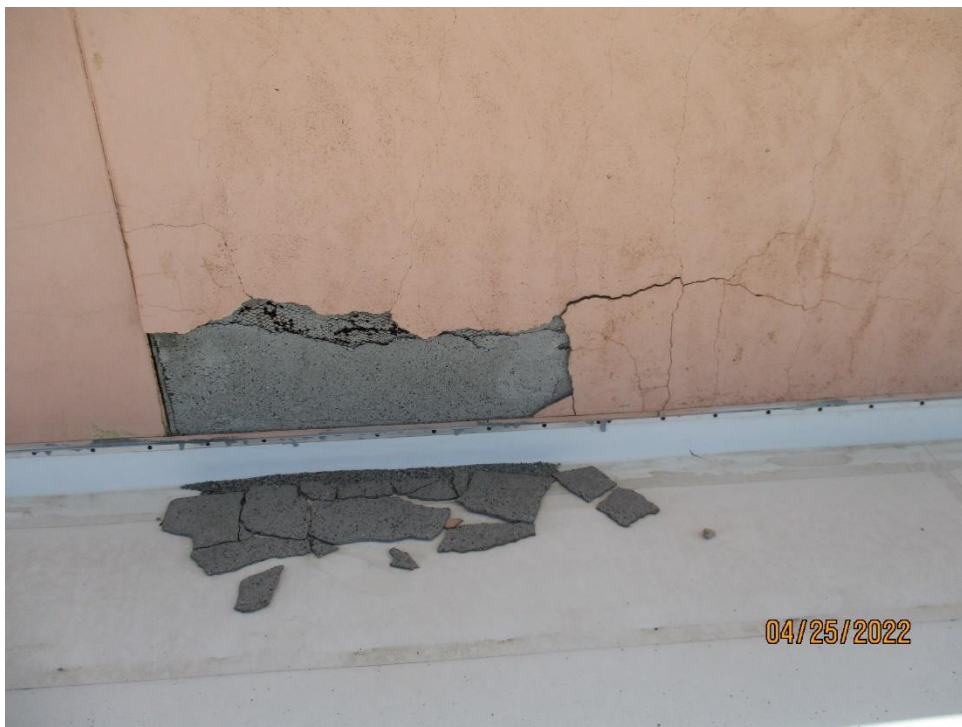
This roof also shows sign on normal wear and tear. The roof also has new edge metal that has been stripped in. This stripping is in fair condition but is bucking water at the inside edge at the lap. There is a stucco wall that is located at the east side of the roof section and is part of the gym wall. This is heavily cracked and deteriorated and is starting to fall off the wall in several locations. This needs to be sealed watertight as soon as possible for it to not leak into the building.

1967 Building Roof Area C: Entire stucco wall on the west side of the gym is failing.

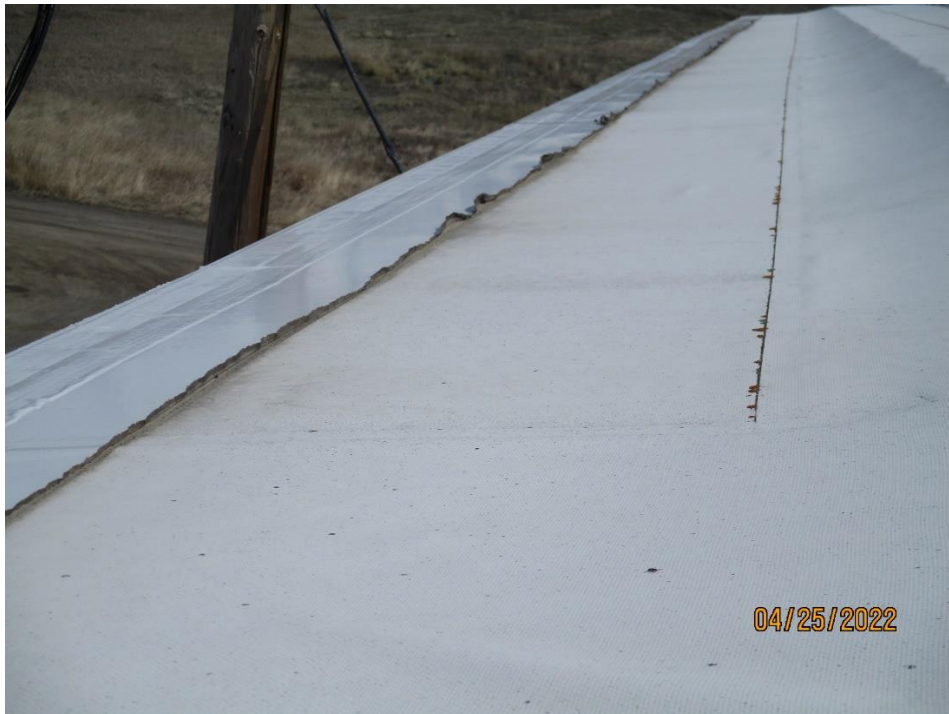
1967 Building Roof Area D: Strip in edge is failing on the gym.

I recommend that the district begin to budget for roof replacement of all the roof sections of the 1967 elementary school. I would also recommendation to cover the wood fascia with a 24-gauge Kynar coated metal on all the roof sections. This will eliminate further deterioration of the wood and it will eliminate a maintenance item for the school.

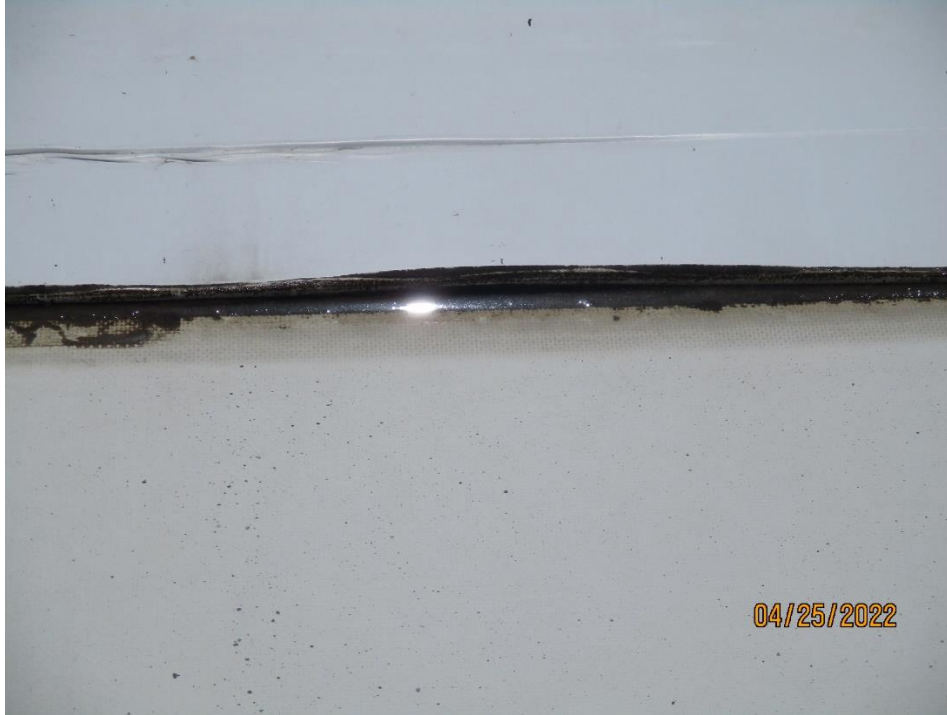
1967 Building Roof Area D: Water is bucking at the strip in edge.

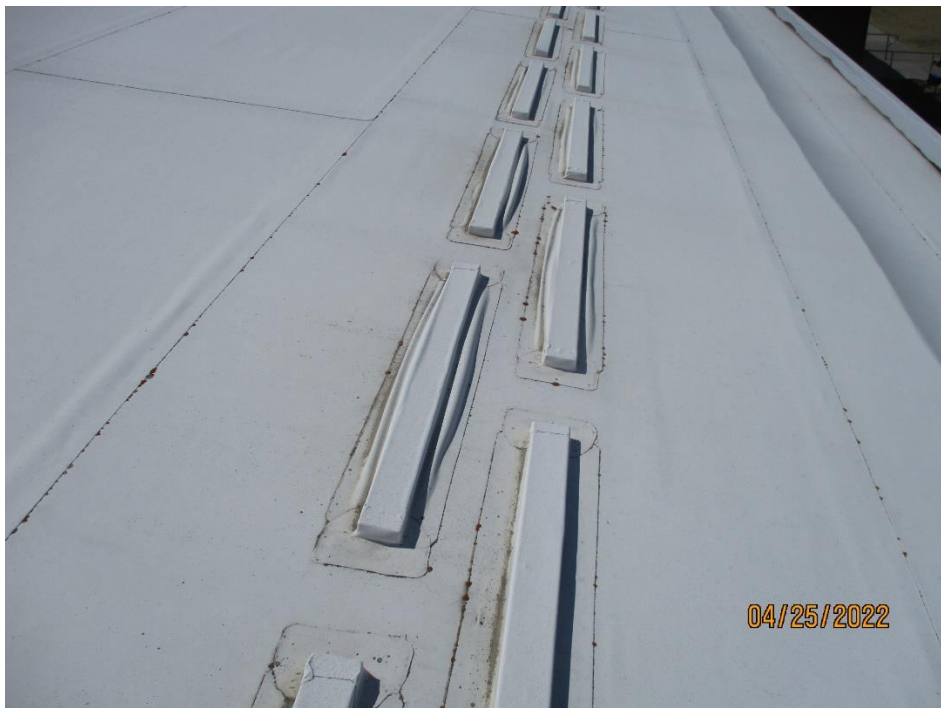
This roof area also shows signs of normal wear and tear. There is a snow retention system that was installed that consists of staggered 2x4 lumber that was secured and has been flashed with the membrane material. The northwest corner of the roof has experienced a wind uplift issue as the membrane has pulled away from several of the blocks in this location. The lower roof edge metal stripping is starting to fail in several locations but mainly at the lower edges of both sides of the gymnasium roof. These locations are also allowing moisture to pond at the edges of the stripping material. This edge metal stripping will eventually fail and allow moisture to enter at the edge metal fasteners. There were two roof vents that appear to have leaked at one time. These leaks appear to have been coming in from the vents on top of the curbs. This issue has been taken care of. There are two skylights on the roof. These skylights are aged and have seals that are no longer watertight. One skylight has moisture between the lenses. The other has fine cracks in the corners of the lens. Both skylights are aged and are in need of replacement.

1967 Building Roof Area D: Wind uplift at snow retention.

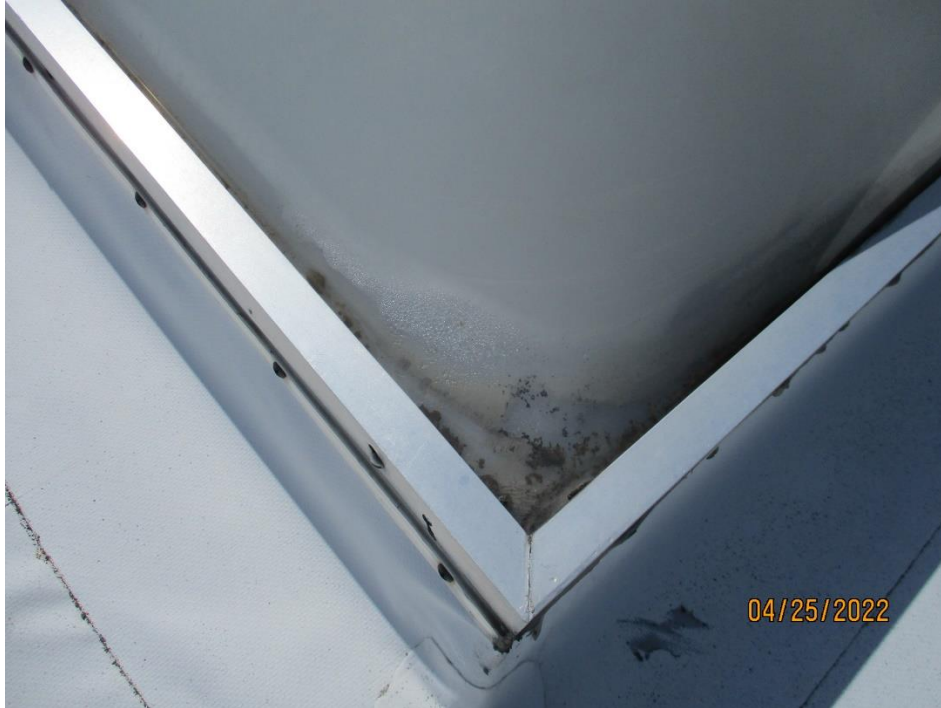
1967 Building Roof Area D: seals are broken. Moisture buildup in corner of skylight

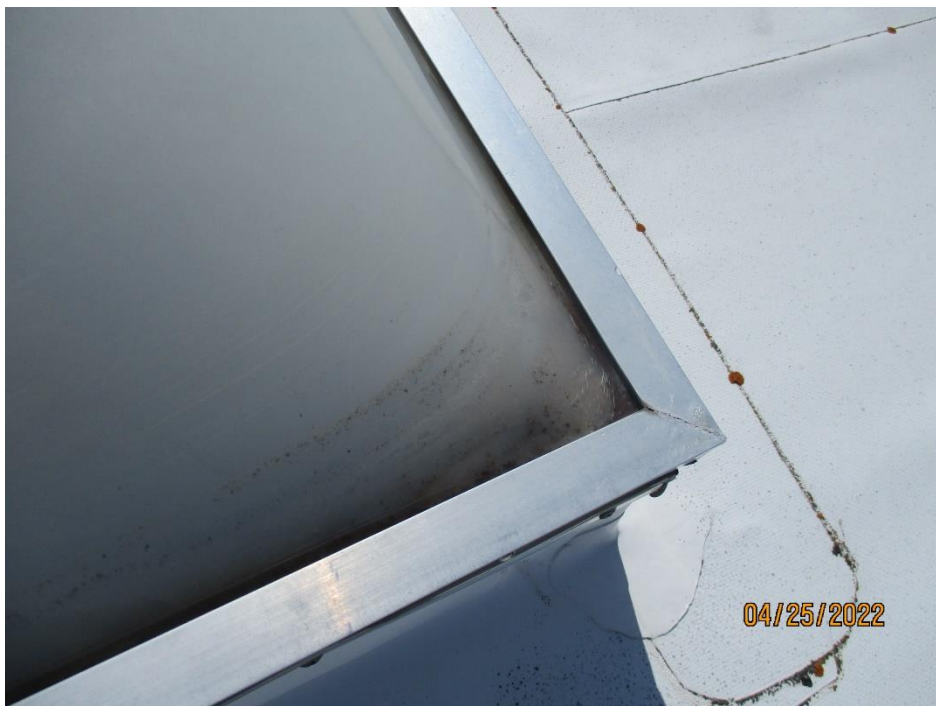
1967 Building Roof Area D: Skylight with moisture and cracking in corner.

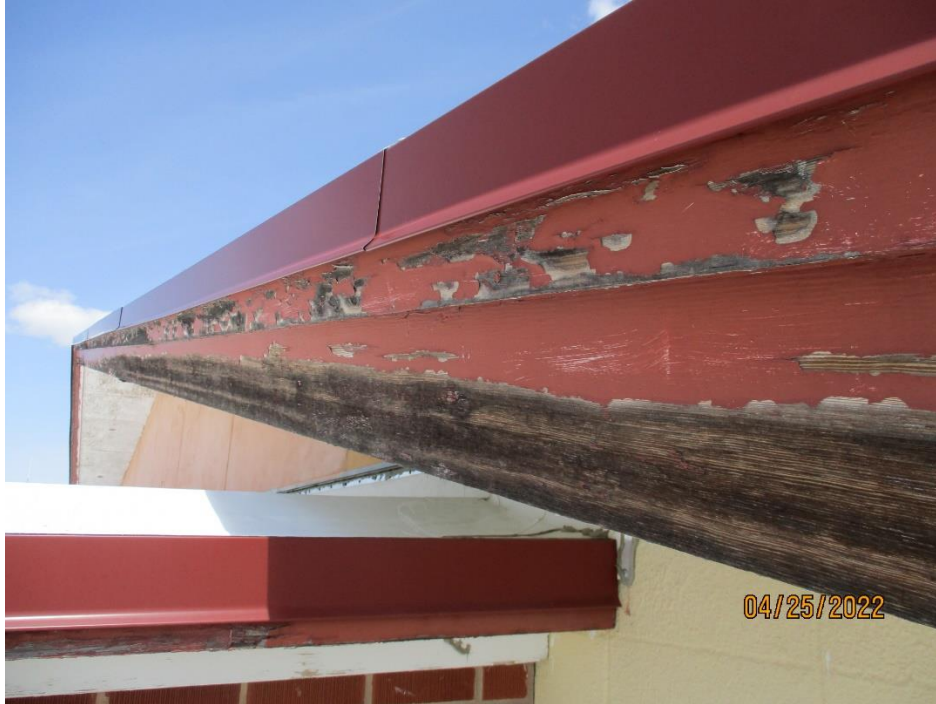
1967 Building Roof Area D: Fascia wood face should be clad with metal.

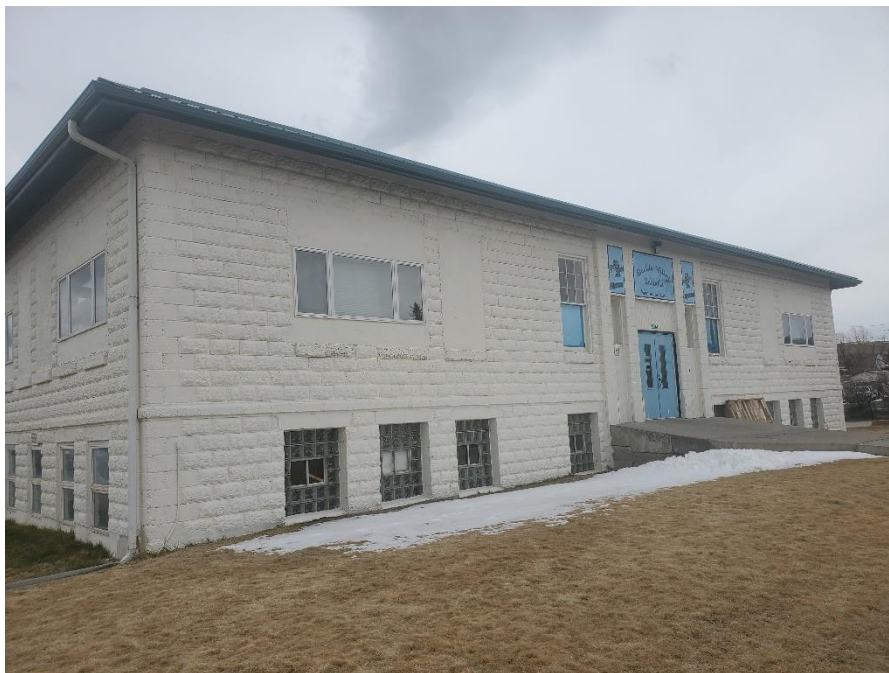
1913 Building: Adverse Grades at North Side of Building

It is apparent the majority of the deterioration to the masonry/finishes of the original building are a result of environmental conditions, and in particular moisture. In an effort to address this it is recommended that a qualified mason repoint all spalled and degraded masonry joints. In the most severe cases, cracks should be grout injected. It is also recommended that the exterior façade be detailed as to prevent moisture from infiltrating the structure, most notably at the corners of the window openings. At the ground level, it is recommended that at a minimum the exterior grades be reworked to provide positive drainage around the entire perimeter of the building. Excavation around the perimeter of the building to expose the foundations repointing deteriorated jointing and installing a waterproofing membrane to the below ground portions of the foundation would further aid in extending the remaining useful life of the structure.

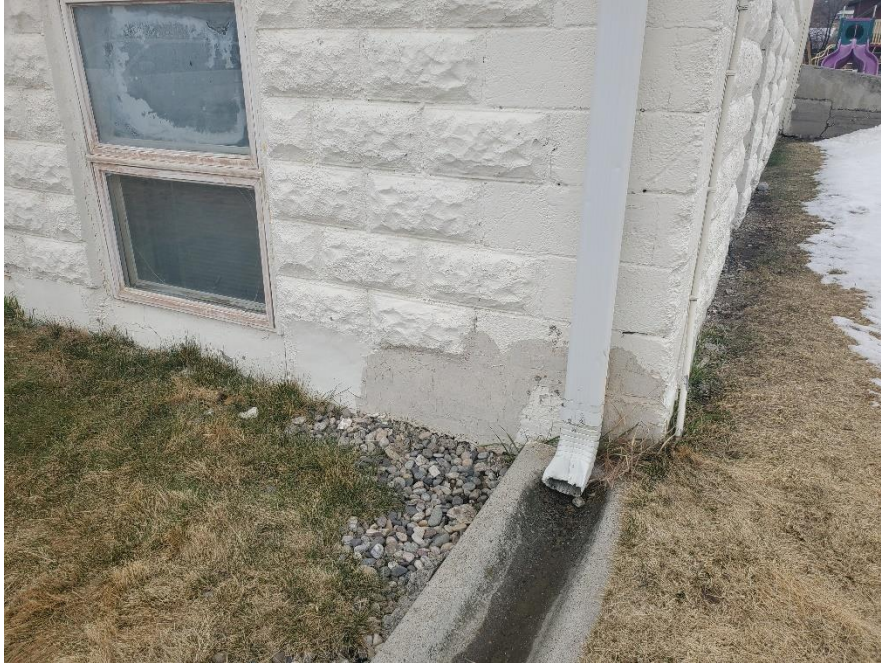
1913 Building: Adverse Grades and Foundation Deterioration at Northeast Corner of Building

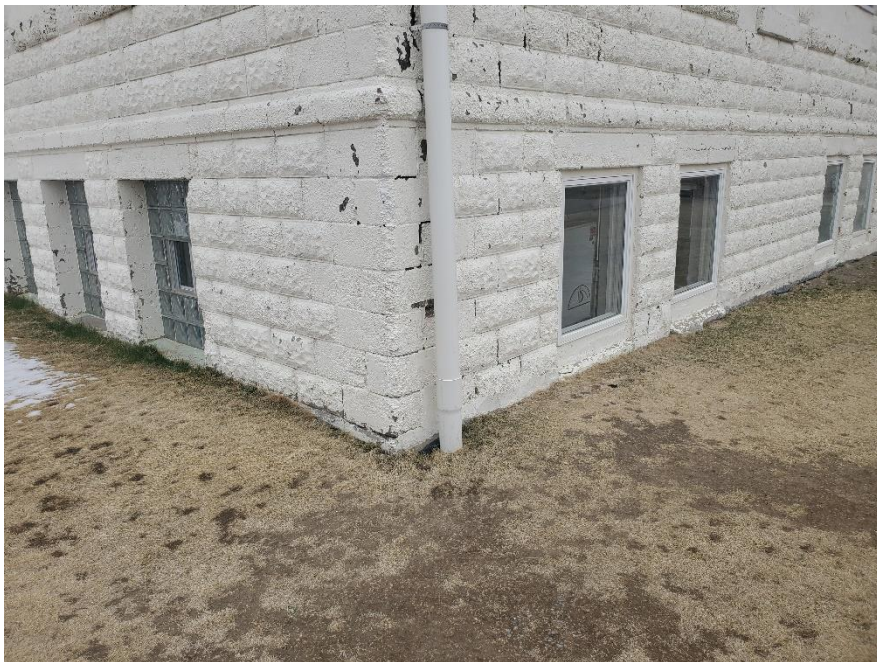
1913 Building: Adverse Grades and Foundation Deterioration at Northwest Corner of Building

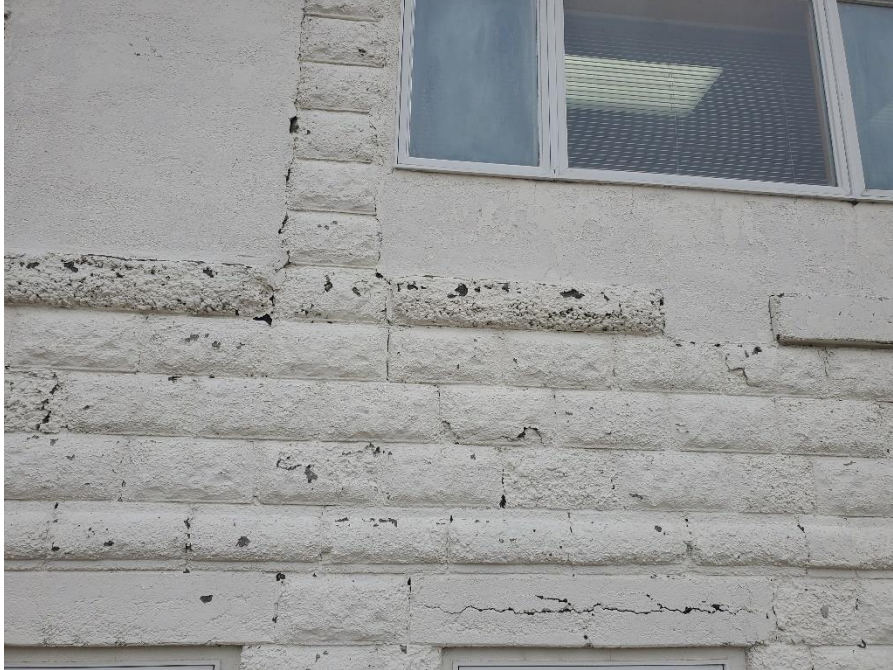
The exterior face of masonry covered with a layer of paint may be concealing some aspects, but the overall condition of the exterior is in fair condition. The most notable signs of deterioration occur in the mortar beds of the masonry joints. This deterioration of the mortar is caused by alkali silica reaction which occurs when the mortar experiences wetting and drying cycles. This deterioration was most significant near the bottom of the wall/foundation in areas where the existing site grades do not provide positive drainage away from the building and trap water against the foundation which based on observation of the interior of the building has also led to the intrusion of water into the building. Deterioration of the mortar has led to observed damages to the foundations however the current level of deterioration does not present a threat to life safety at this time. Observation of the exterior of the building did not indicate any signs of significant settlement or foundation related movement to the building.

1913 Building: Masonry Deterioration Due to Moisture
