Shields Valley Public Schools Master Planning

June 2, 2022

Elementary Schools Assessments

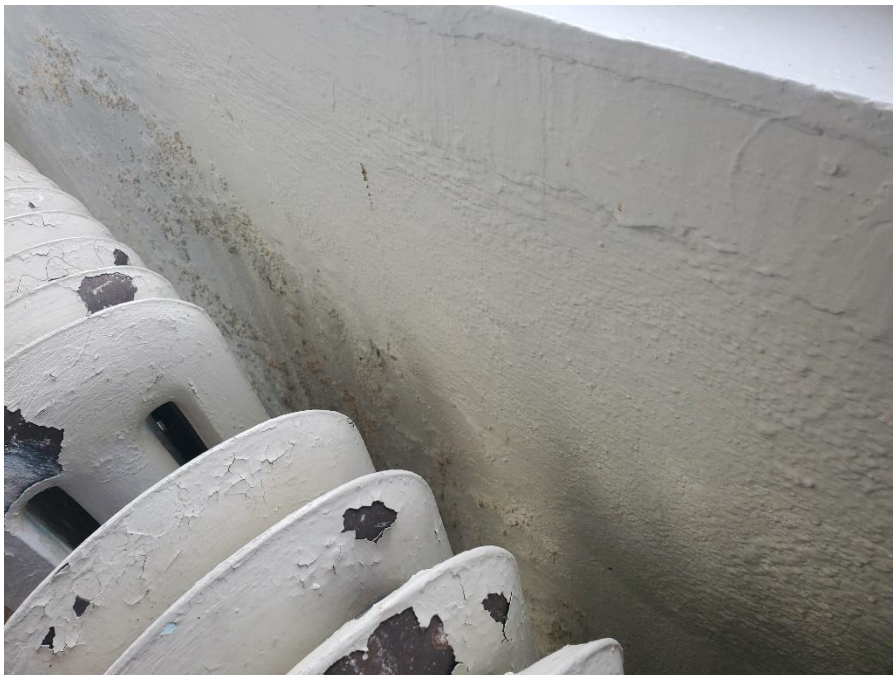
1913 Building: Foundation Deterioration at Interior Face of Foundation

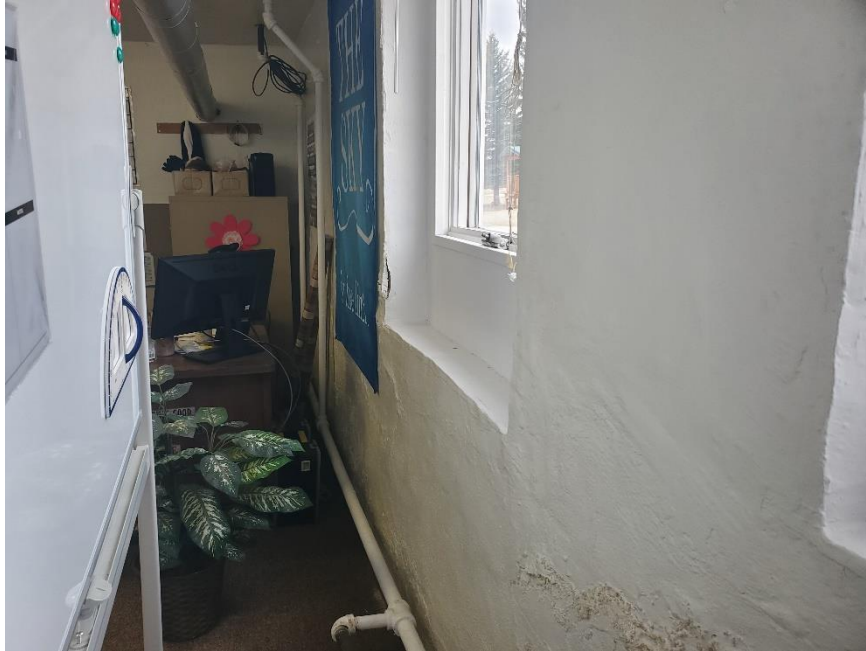
1913 Building: Foundation Deterioration at North Wall

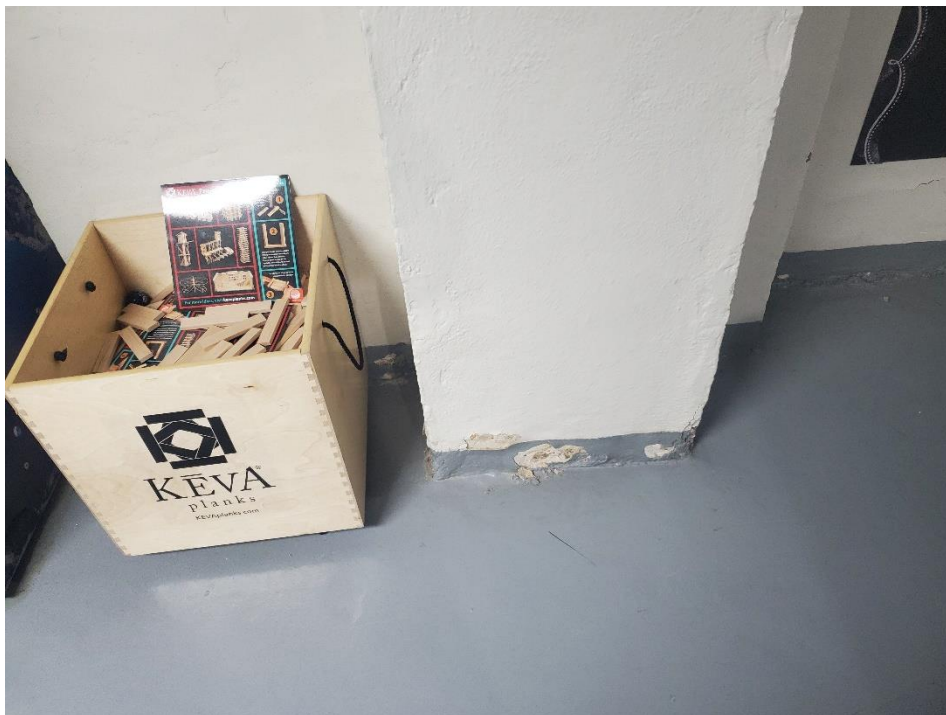
1913 Building: Alkali Silica Reaction At Interior Foundation

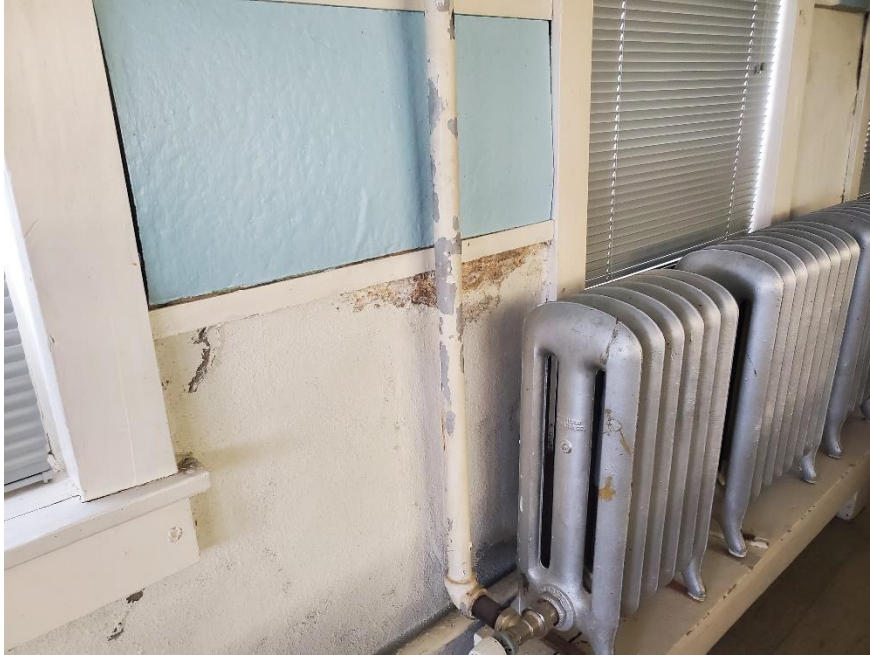
1913 Building: Foundation Deterioration At Interior Face of Wall

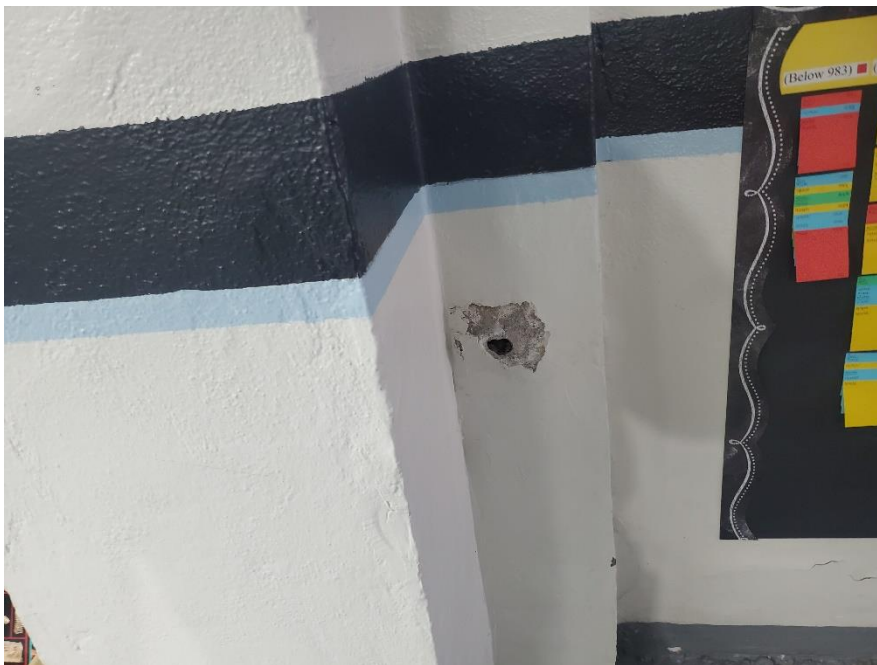
1913 Building: Alkali Silica Reaction on Interior Foundation Wall

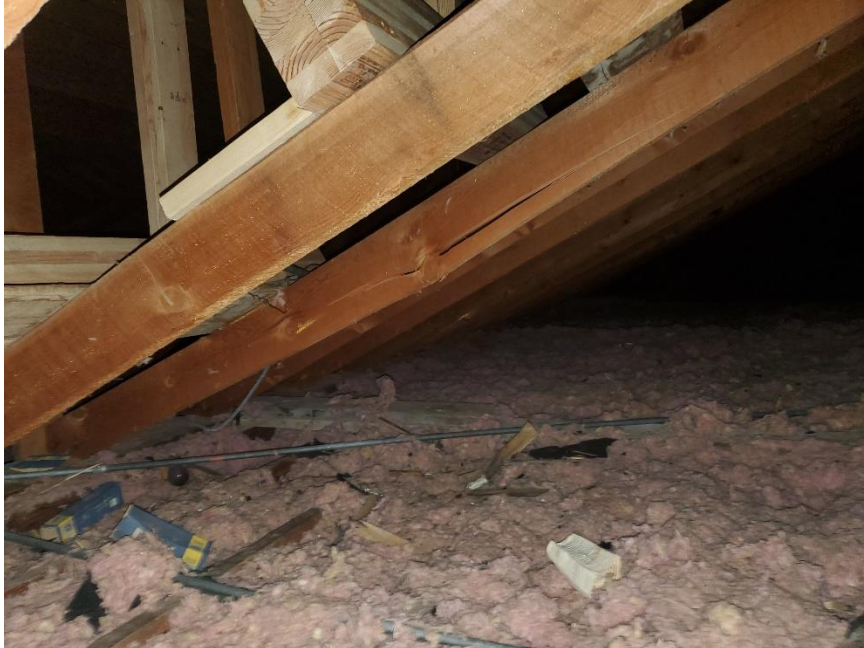
Overall, the roof structure appeared to be in good condition. There were no areas of dry rot, or mold observed that would indicate moisture issues. The only significant sign of distress observed was in the roof was the failure of one of the roof rafters where the ridge of the wood framed addition is overbuilt over the rafters of the original building. This failed joist was identified in previous assessments and has been modified since this previous assessment but rather than repair the damage a beam was simply installed to distribute this load to the two rafters adjacent to the failed roof rafter. This modification does not however adequately address the failure of the rafter and should be further repaired as recommended in the recommendations presented below.

1913 Building: Failed Roof Joist at Overbuild

With regards to the roof structure, we have provided for a temporary solution to help alleviate some of the stress placed on that single cracked joist. A more permanent solution should be devised that transfers the load from those joists entirely and supports it by the dividing wall between the two building sections and/or the central bearing line at the center of the addition.

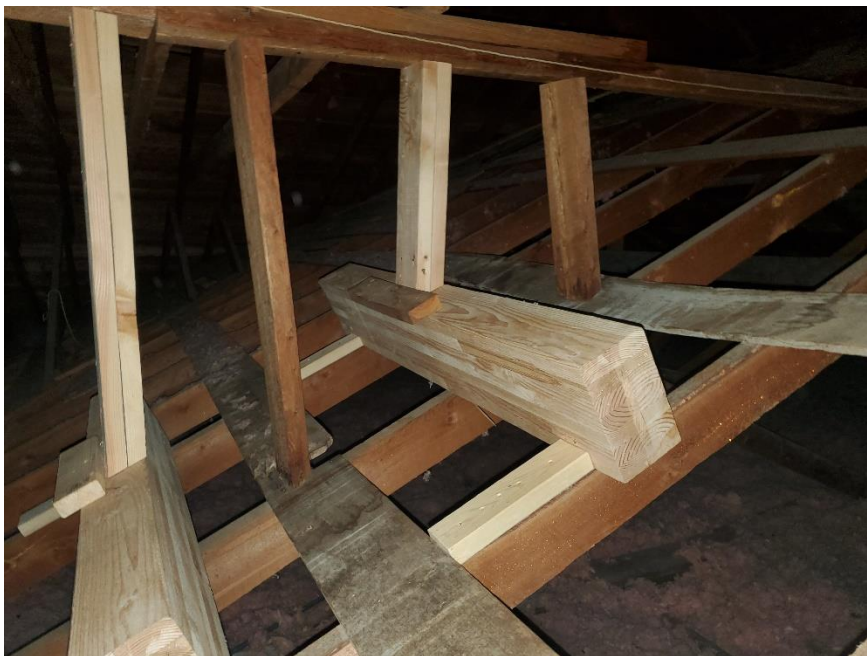
1913 Building: Prior Repair at Failed Roof Joist
