Facility Study and Master Plan

Vernon Public School Central Administration

30 Park Street, Vernon CT 06066

SUMMER 2023

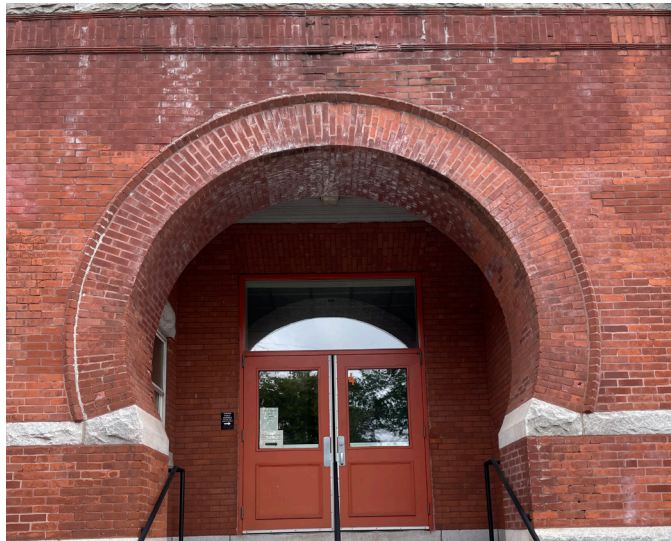
1. Location:

Sealant missing between door frame and brick facade

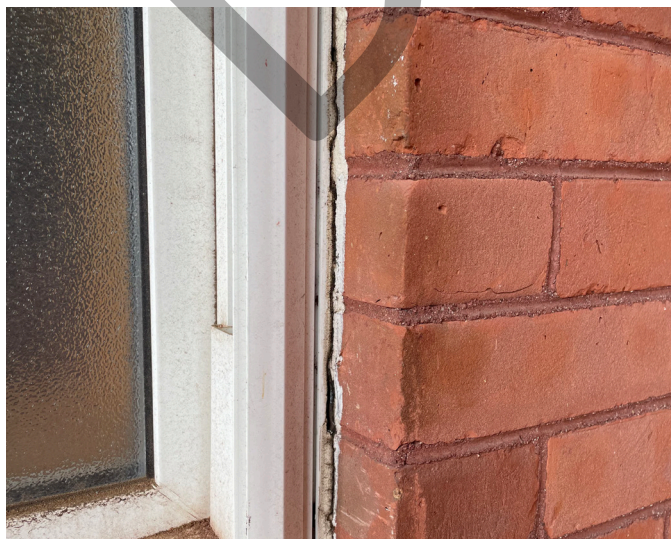
3. Location:

Sealant missing between window frame and brick facade

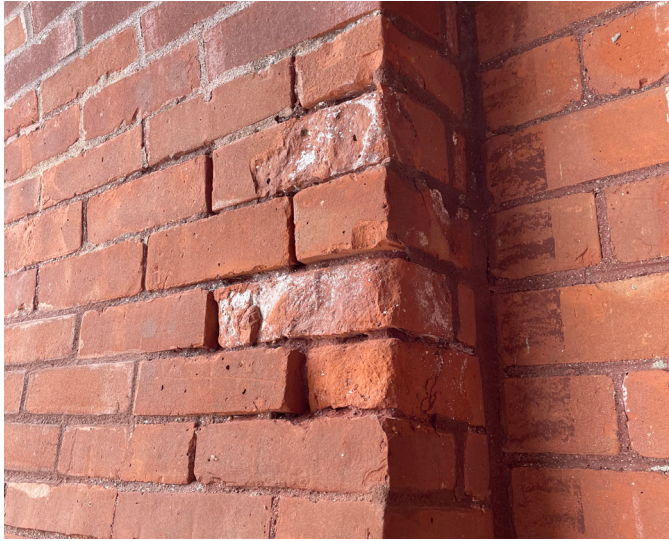
4. Location:

Damaged brick and areas where repointing is needed.

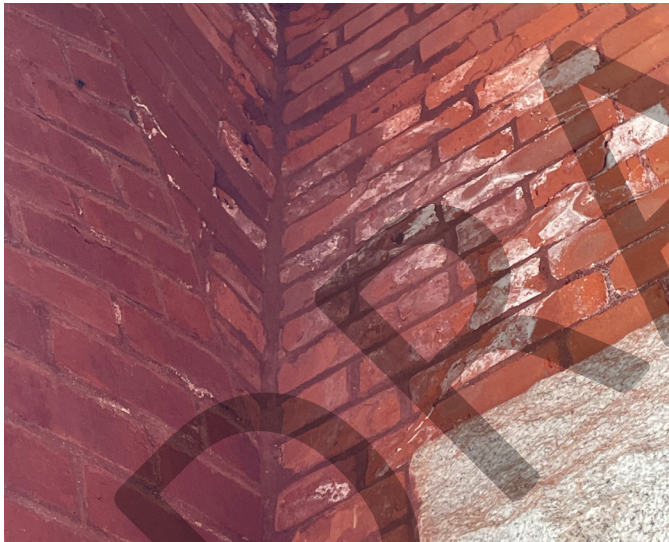
5. Location:

Areas of brick appear to have been replaced as various times and repointed in varying shades.

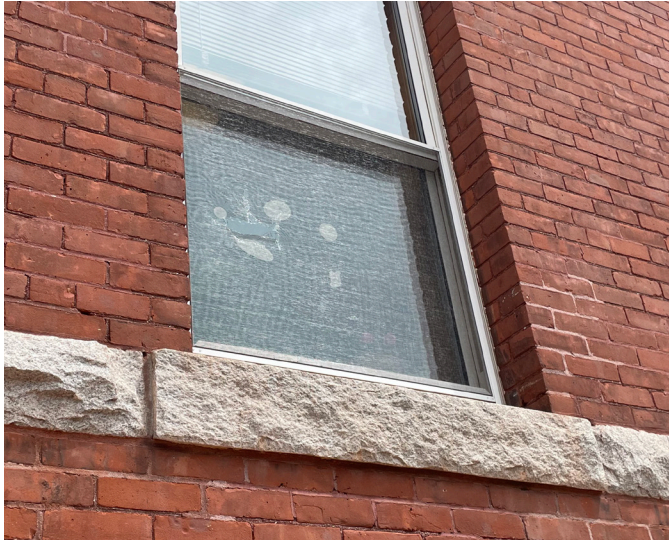
7. Location:

Damaged window screen

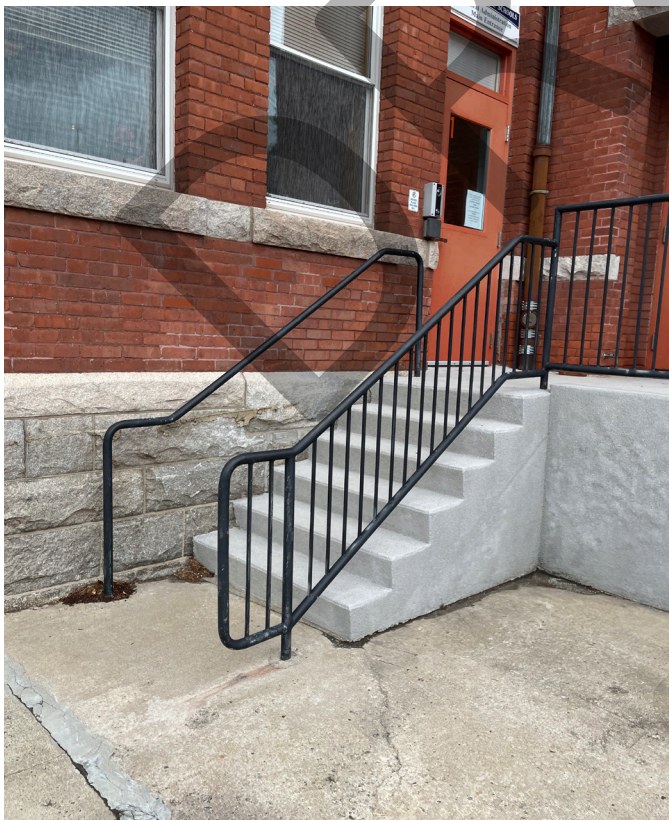
10. Location:

Exterior door sits high potentially allowing for water infiltration. No weatherstripping was visible.

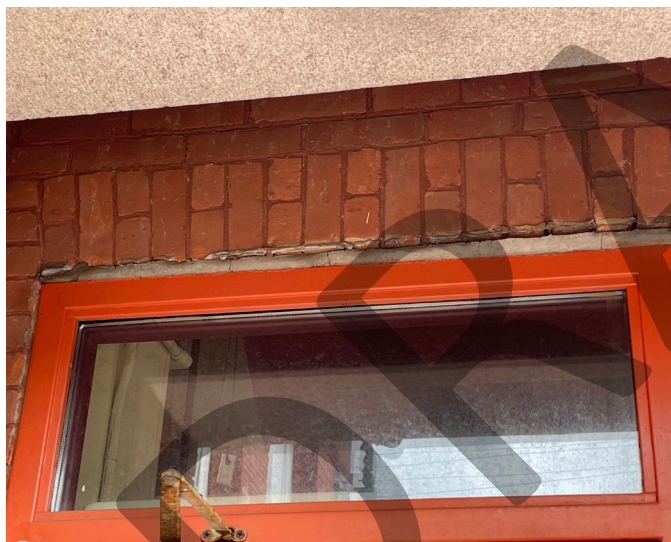
12. Location:

Sealant at door/window frame has deteriorated.

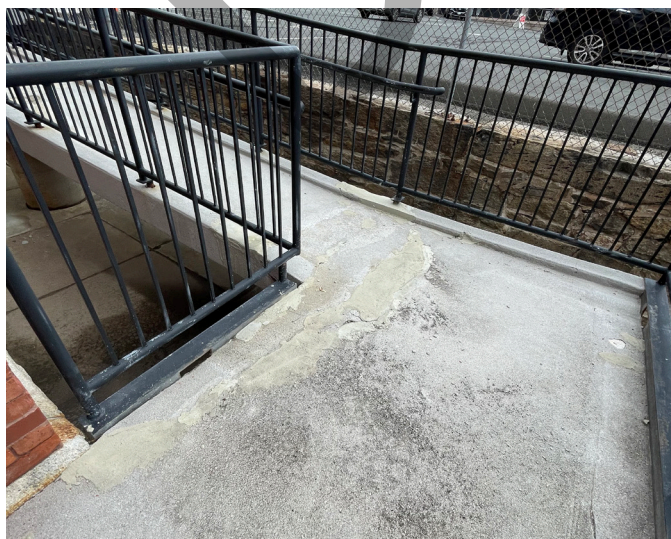
13. Location:

The exterior ramp at the east side of the building adjacent to School Street is in poor condition. There are many areas where the concrete is damaged and crumbling making usable for anyone in a wheelchair.

Ramp leading to east and south entrances is in poor condition.

- Replace exterior concrete ramp and landing leading from the parking area to the building.
- Repair cracks in walkways and replace missing drain covers.

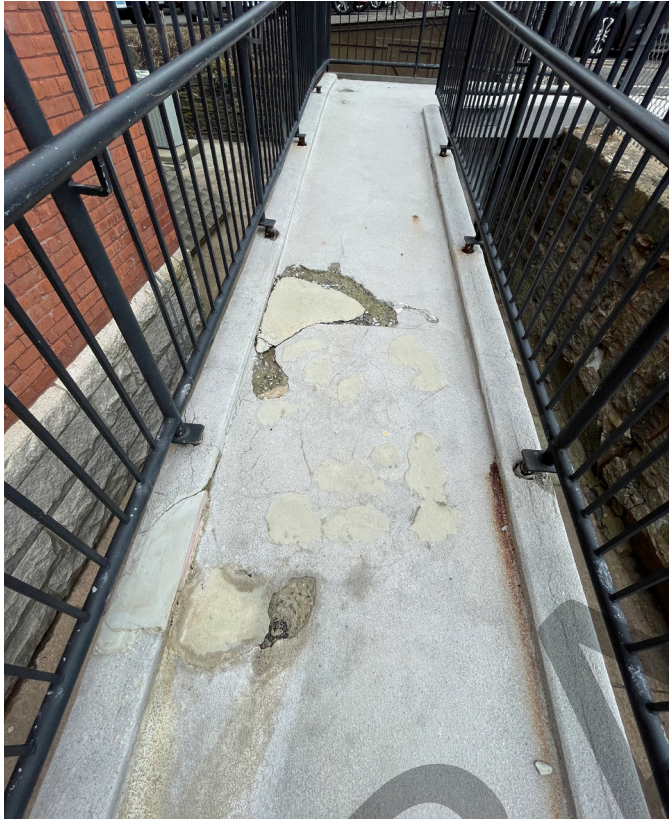
14. Location:

Concrete ramp in poor condition.

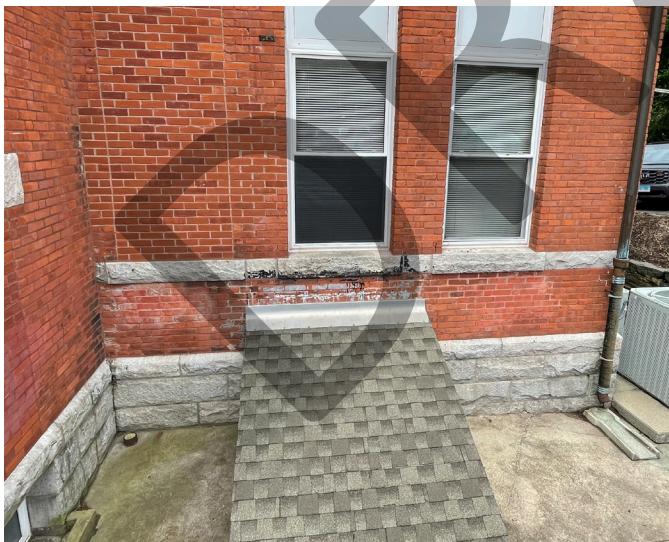
15. Location:

View of mold and mildew growth on low wall. Areas of brick crumbling and missing mortar.

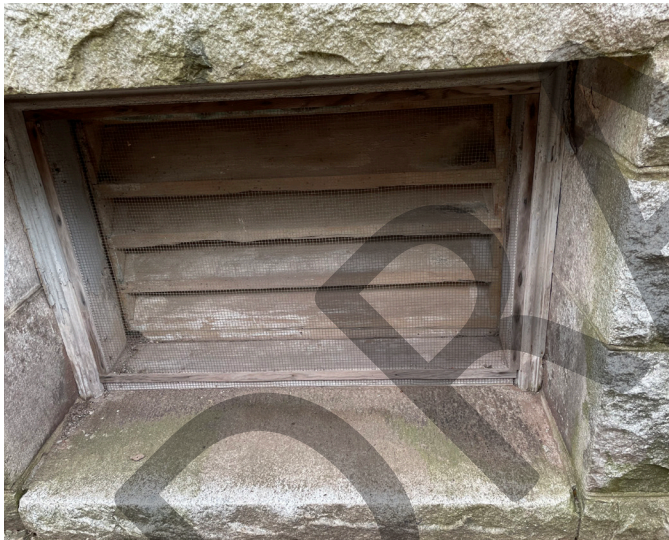
17. Location:

Mildew growth on stone foundation. Existing vent appears to have a wood frame and slats.

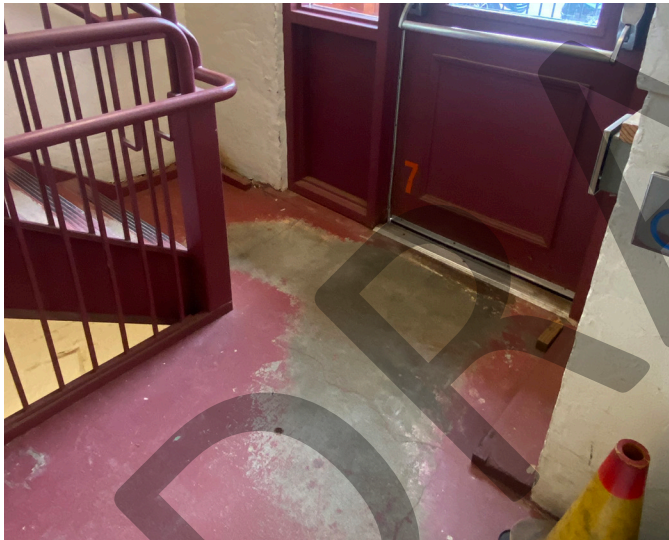
20. Location:

Painted stairs and handrails are worn and faded.

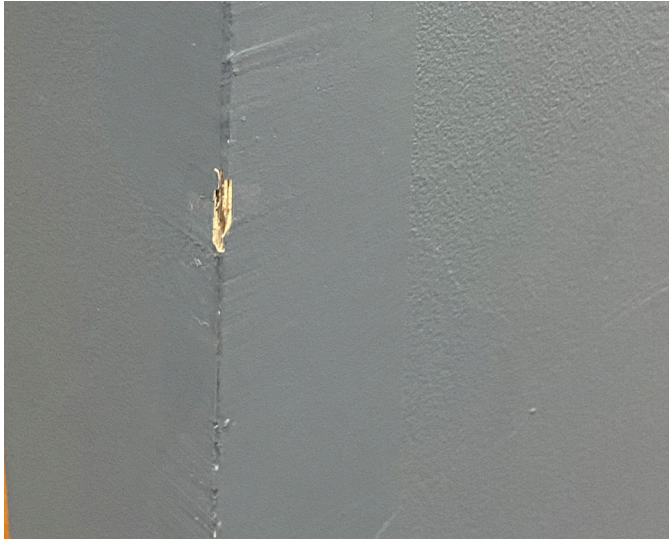
22. Location:

Outside corner of gypsum wall is damaged and needs to be repaired.

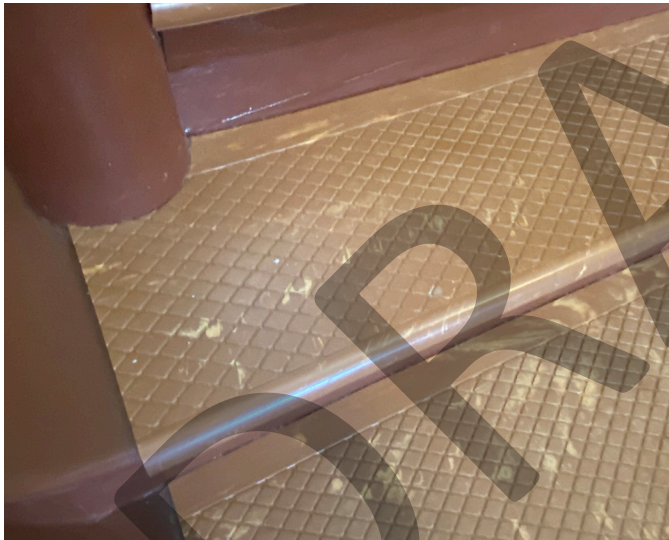
23. Location:

General wear and tear on rubber treads.

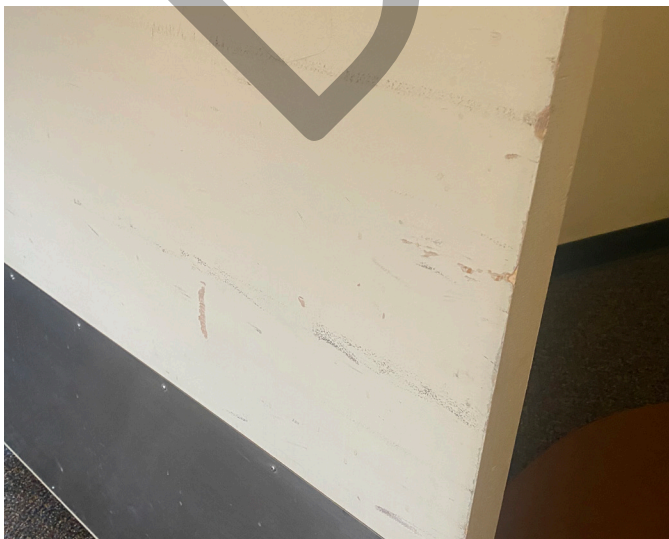
24. Location:

Door has scratches and chips that need repainting and repair.

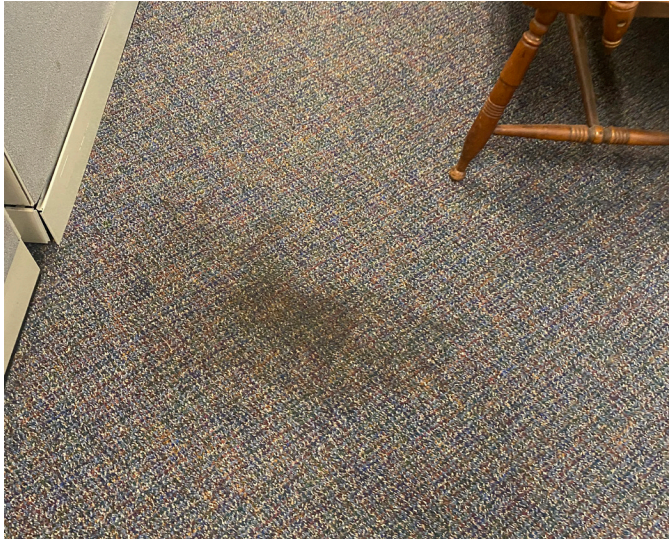
25. Location:

Stain on carpet needs to be cleaned or replaced.

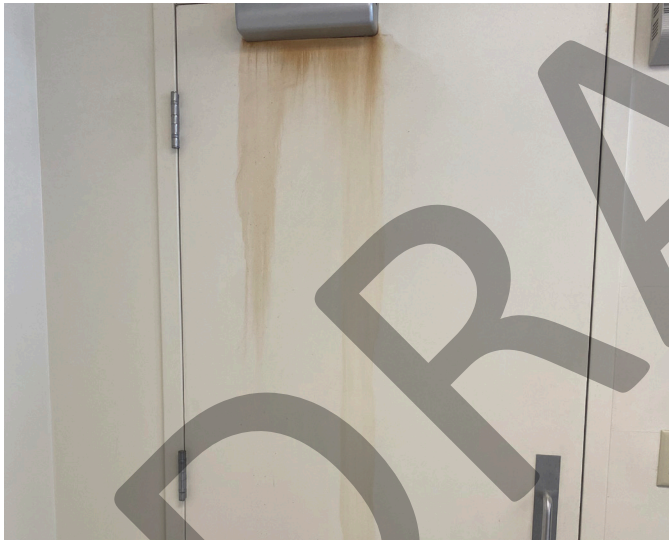
26. Location:

Rust from door closer is staining the door.

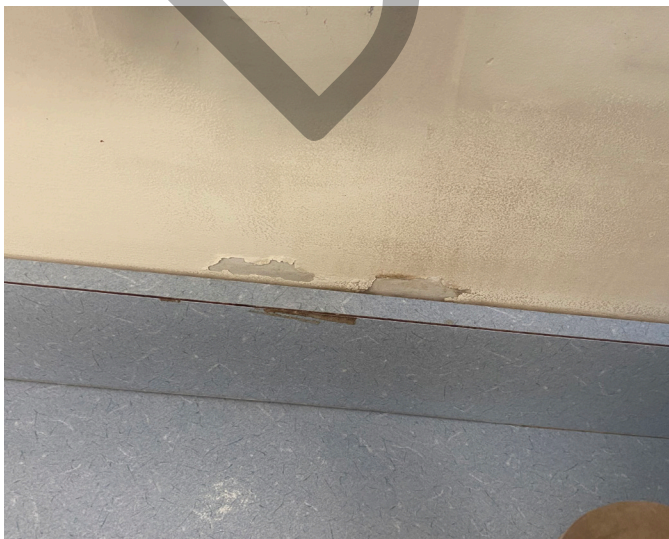
27. Location:

Plastic laminate back splash is chipped and light damage to the wall behind.

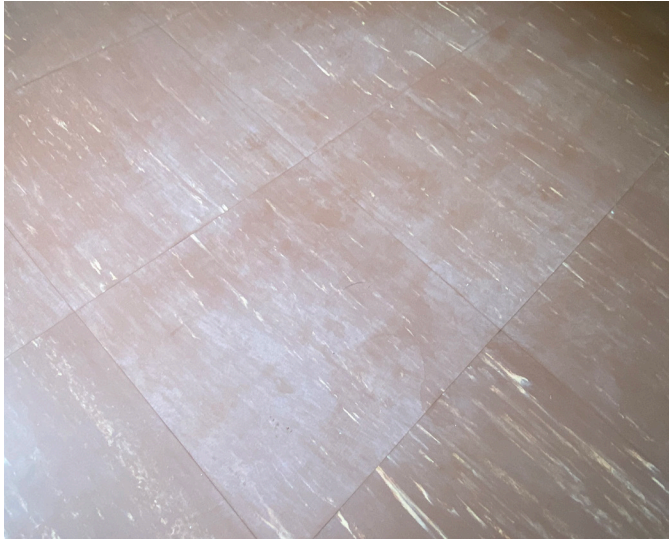
28. Location:

Rubber flooring is faded and should be refinished or replaced.

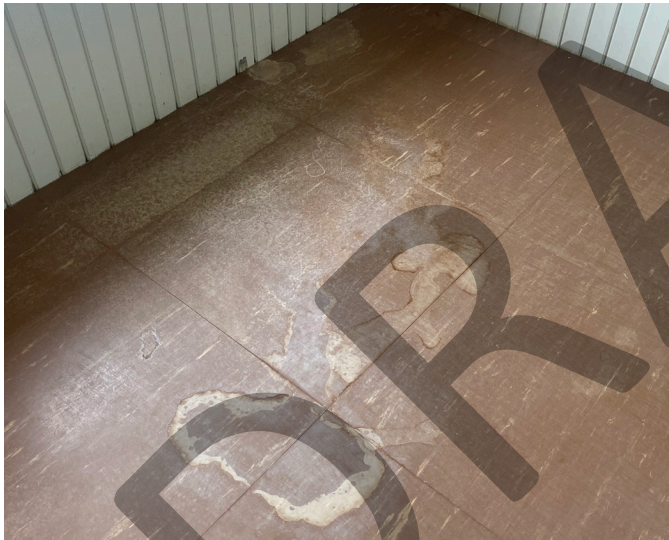
29. Location:

Rubber flooring shows water damage and staining.

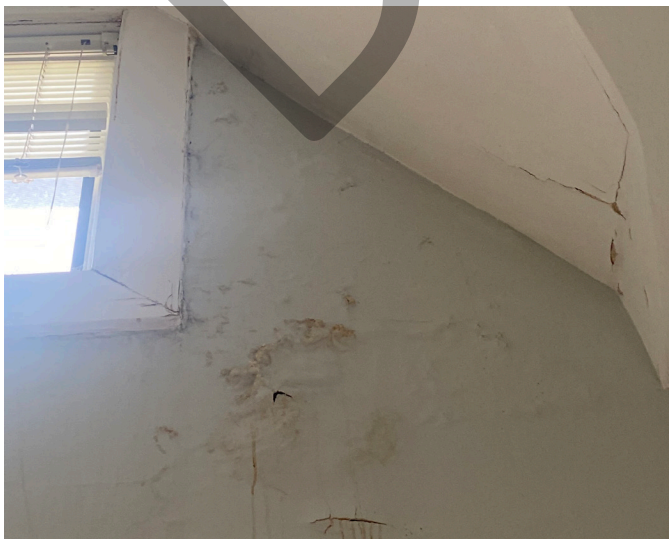
30. Location:

Wall shows several cracks and bubbling indicating signs of water damage.

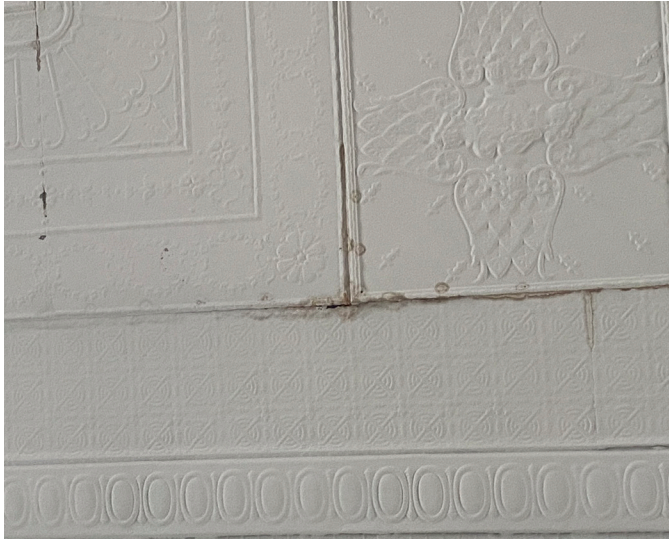
31. Location:

Damage to decorative ceiling.

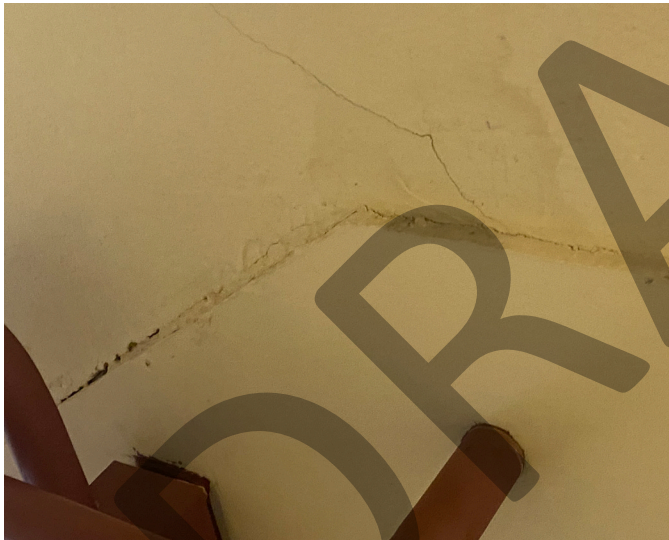
32. Location:

Cracking and chipping in wall should be repaired.

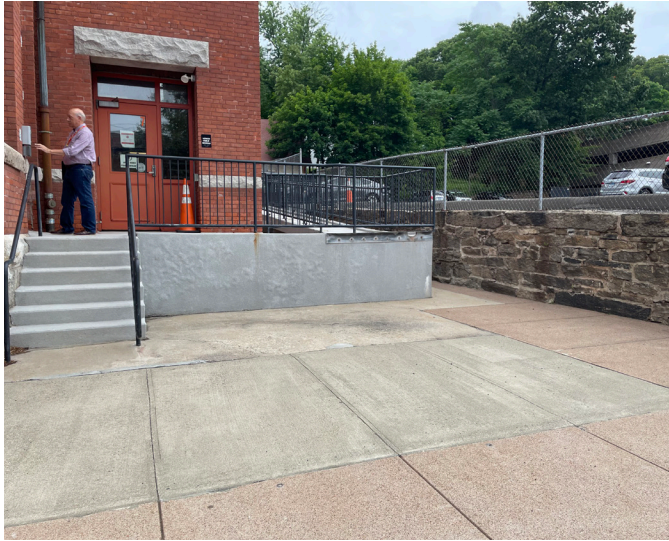
3. Location:

Concrete flooring cracking and stained in some locations.

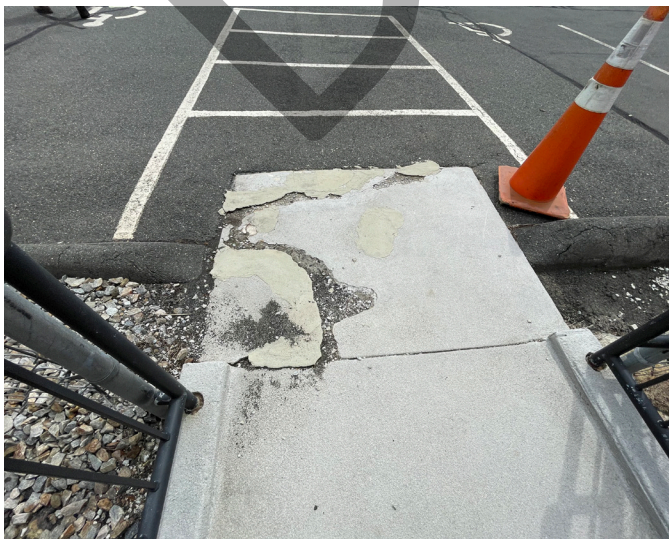
5. Location:

Deteriorating concrete ramp landing.

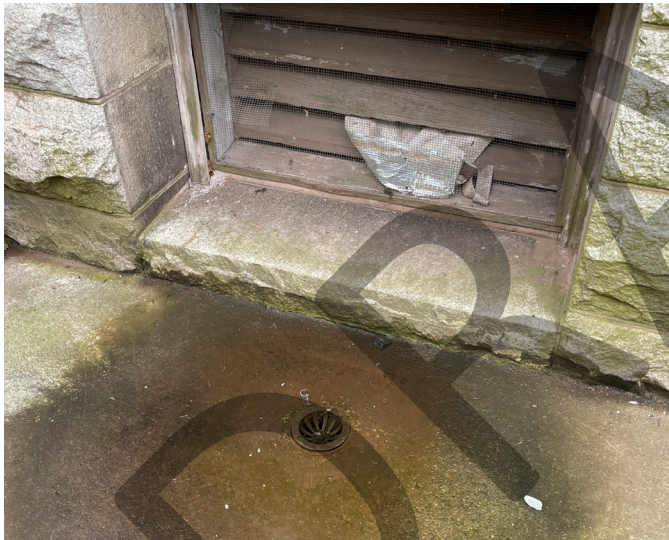
10. Location:

Missing drain cap in concrete walkway

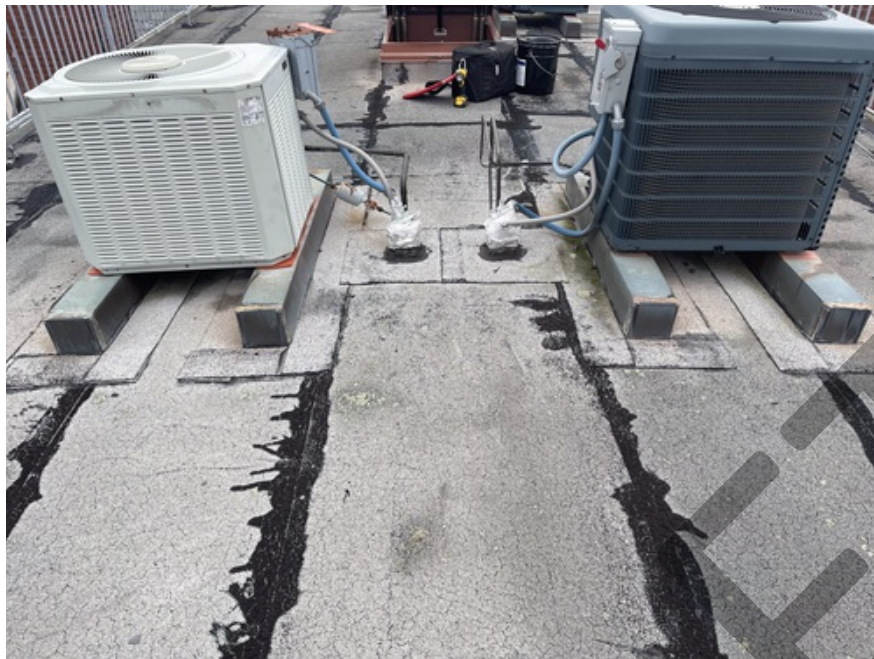
Photo 4

Mechanicals improperly flashed into system-saturated area

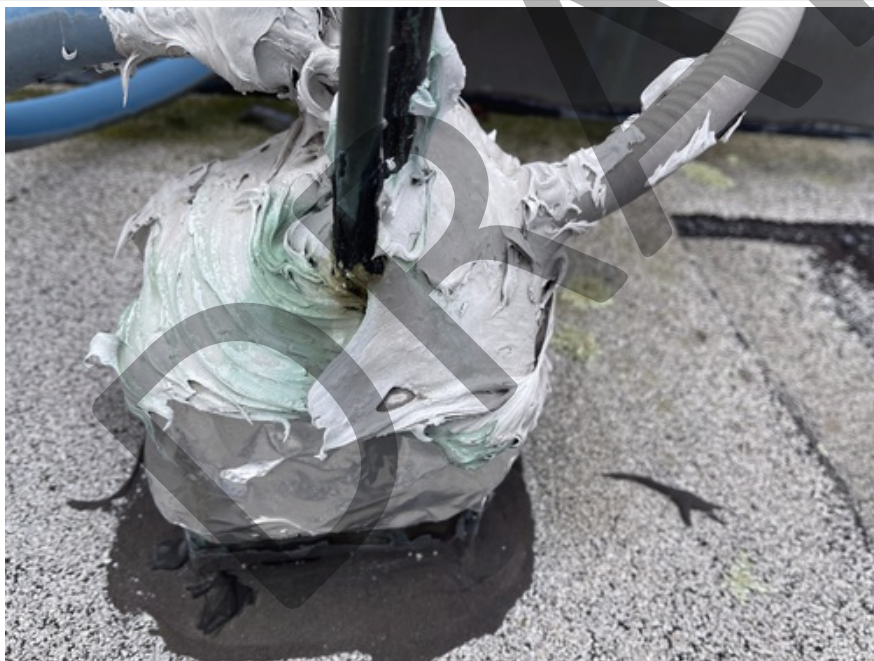
Photo 5

Failed pitchbox

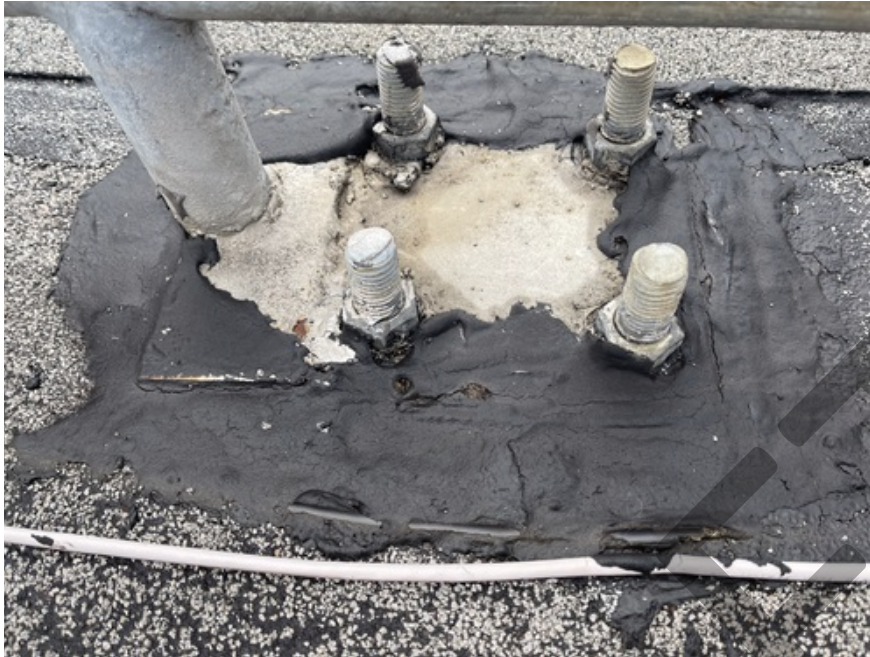
Photo 6

**Open condition- Failed
safety railings tie-in -
Consistent throughout**

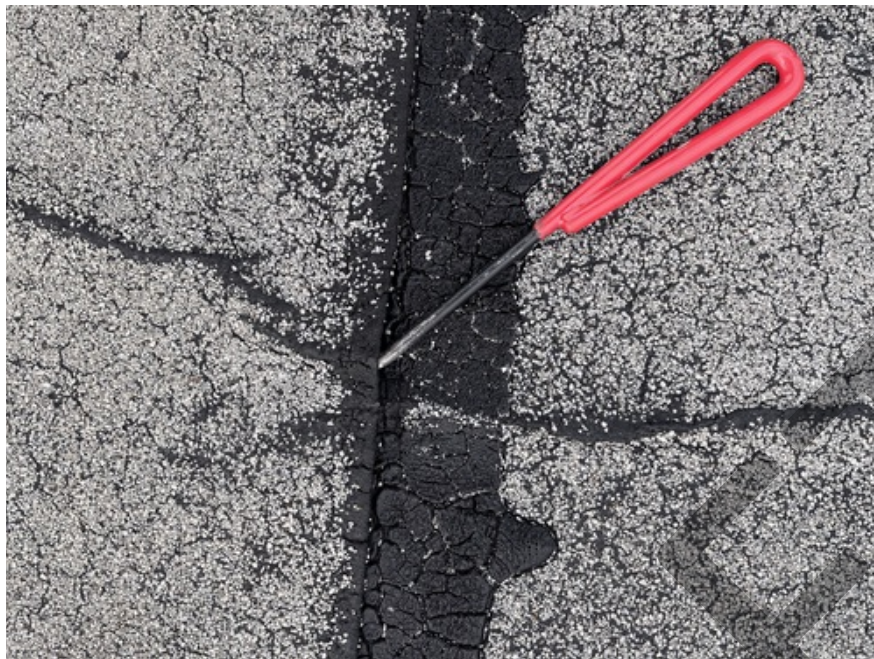
Photo 8

Open condition- Failed roofing system- Most seams were open

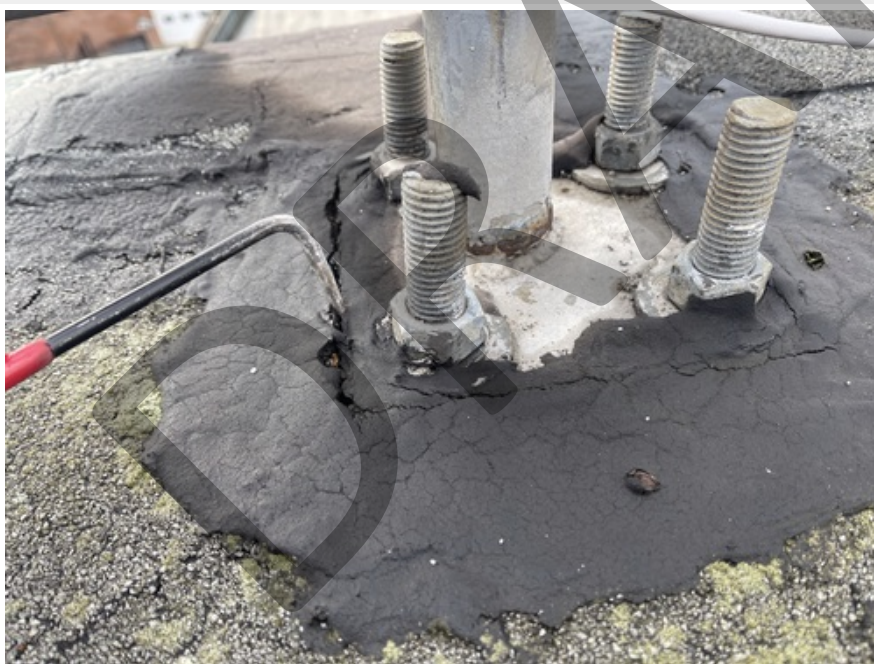
Photo 9

Open condition- Light post tie-in failure

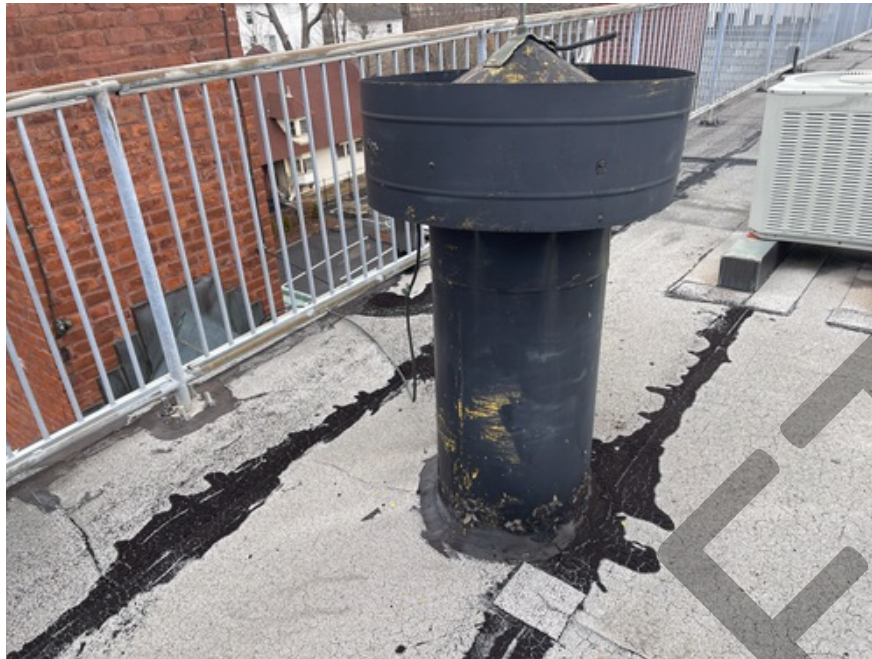
Photo 10

Improperly flashed in vent

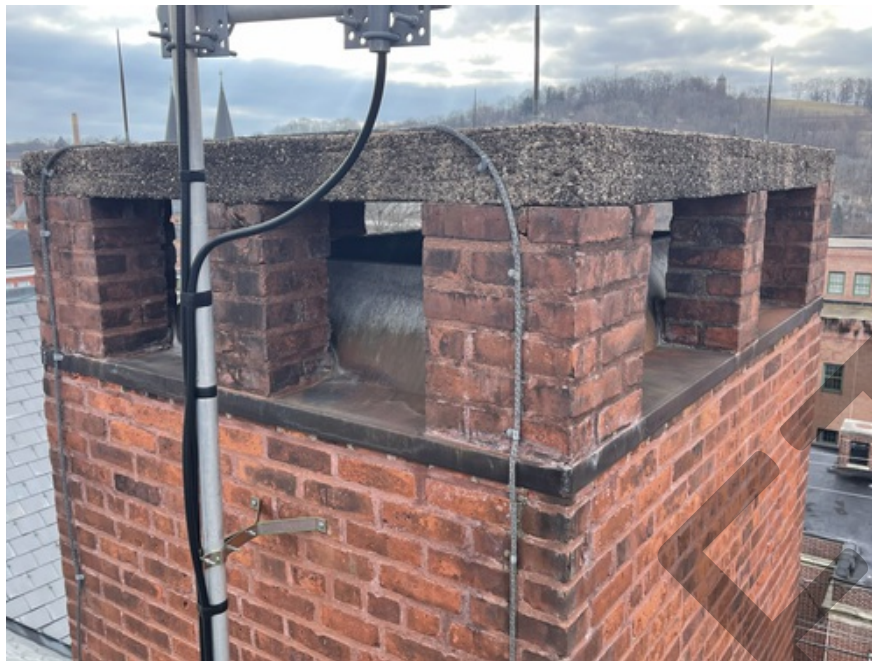
Photo 4

**Open condition- Porous masonry and exposed cap-
Repointing and sealing
needed**

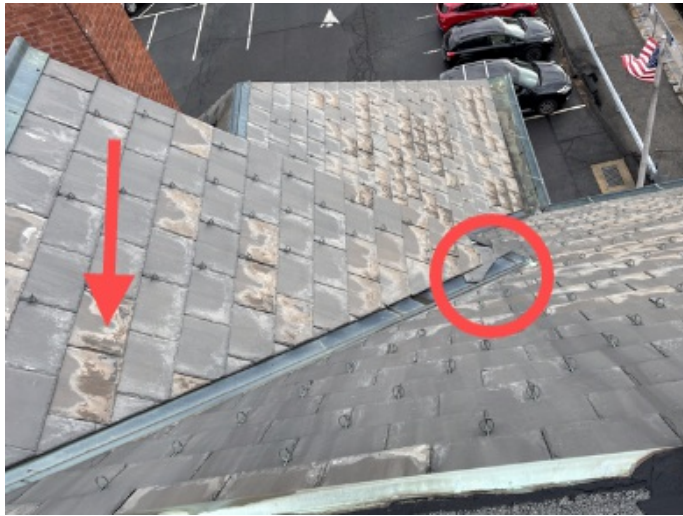
Photo 6

**Delaminating slate tiles- Loose and failed
slate- Consistent throughout**

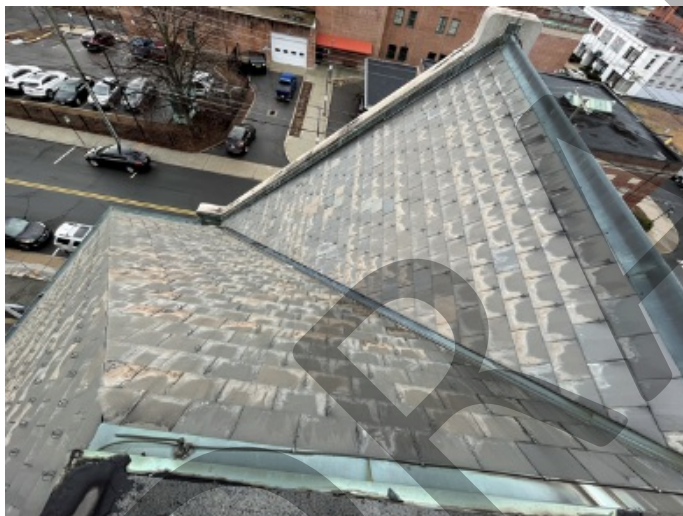
Photo 7

**Overview of slate- Further investigation
required**

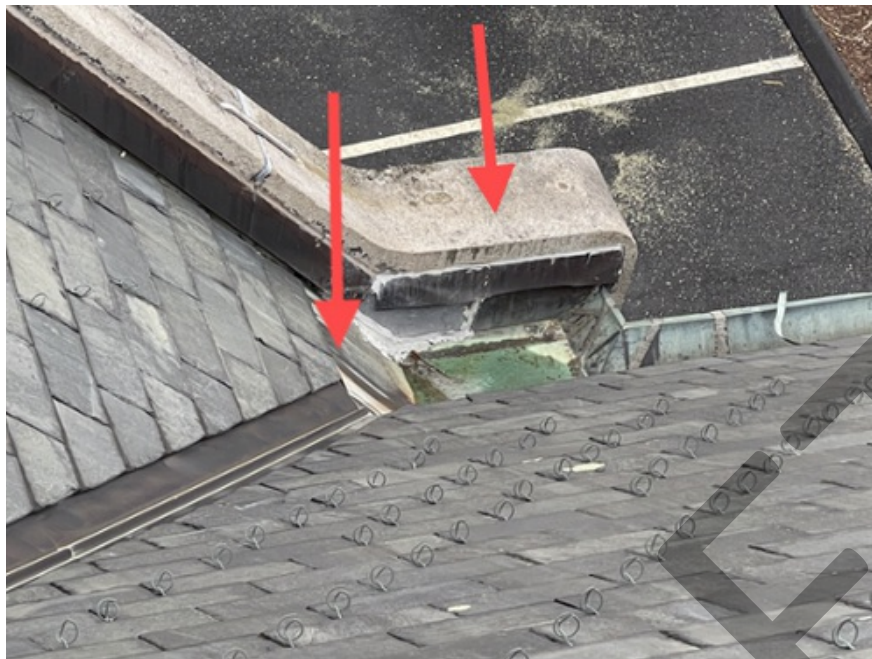
Photo 8

Porous masonry- Exposed copings- Loose slate tiles

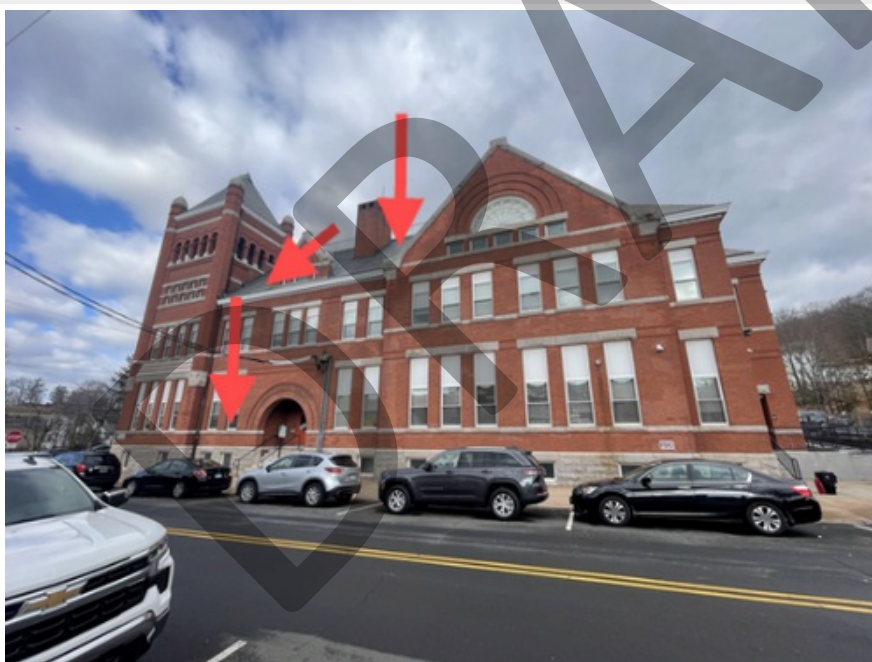
Photo 9

Loose slate can become a very costly and dangerous issue above a sidewalk

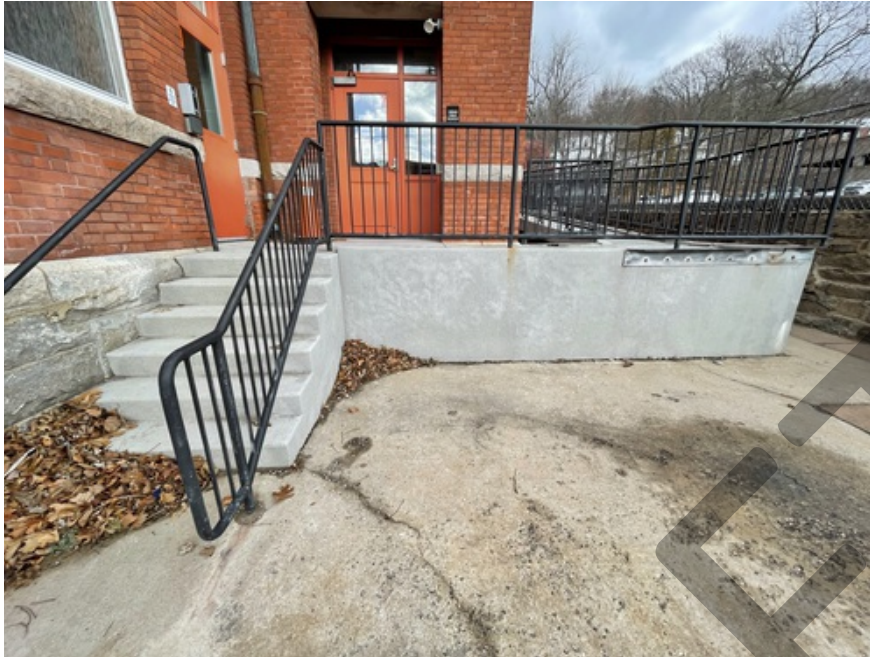
Photo 10

Failing ADA entrance

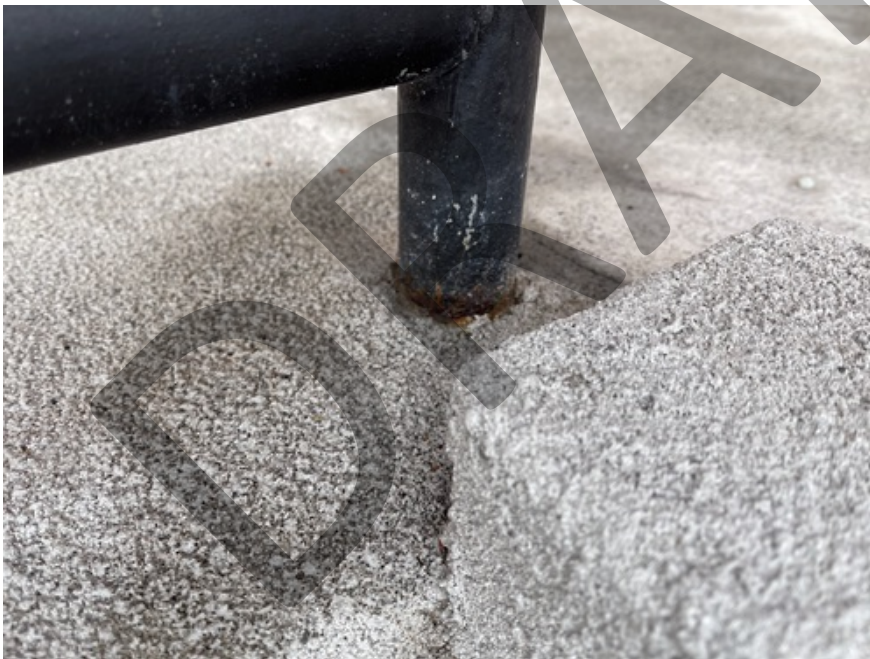
Photo 11

Non flashed penetrations

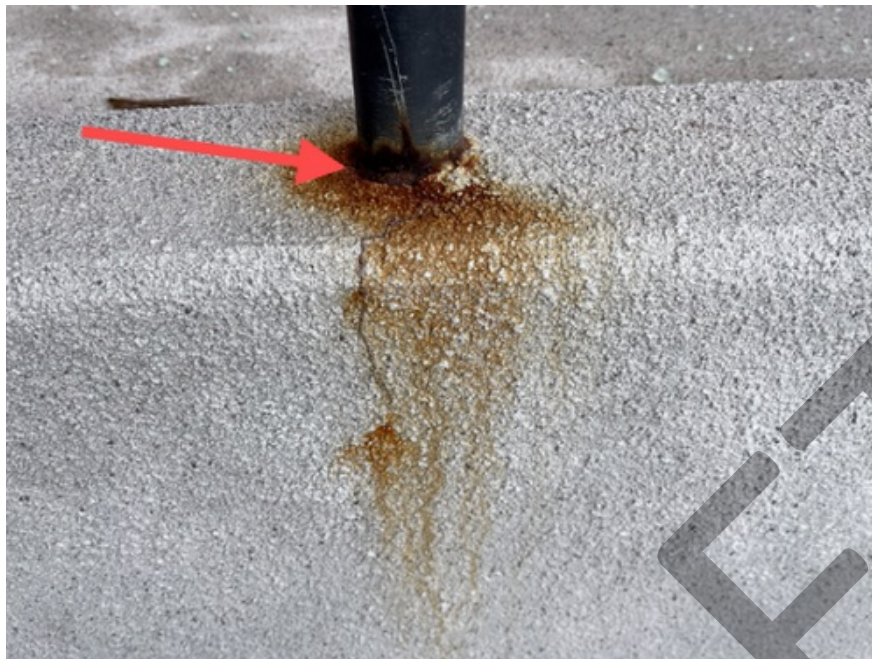
Photo 12

**Failed coating system-
Improper installation**

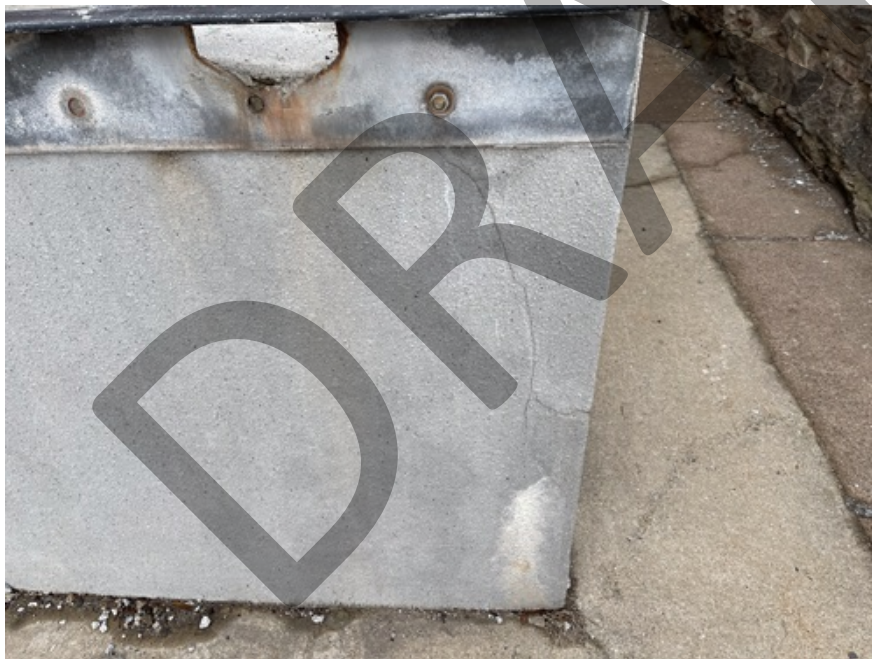
Photo 13

**Cracking and failed coating
system- Holding moisture
within the concrete**

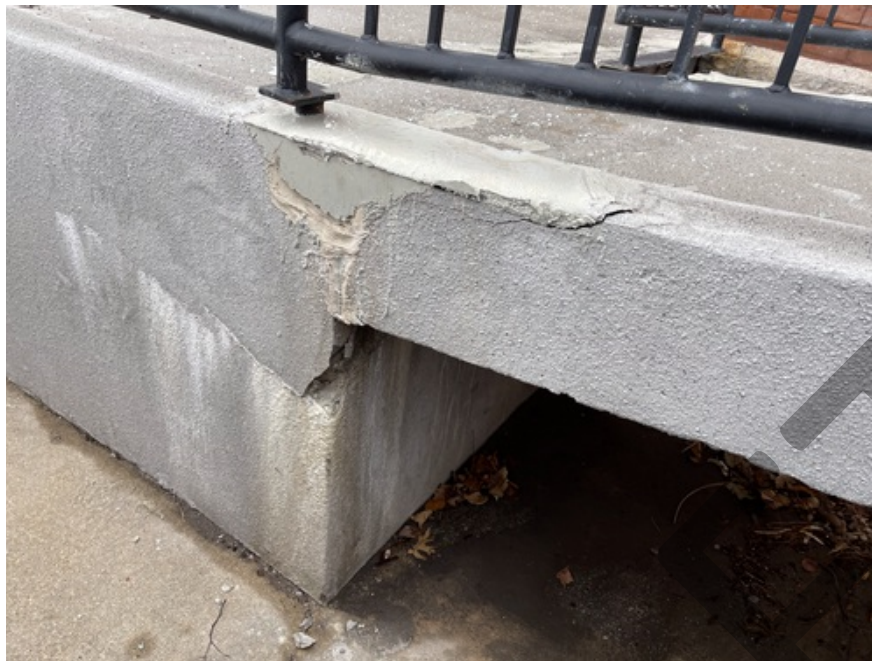
Photo 14

Failed transition and repair

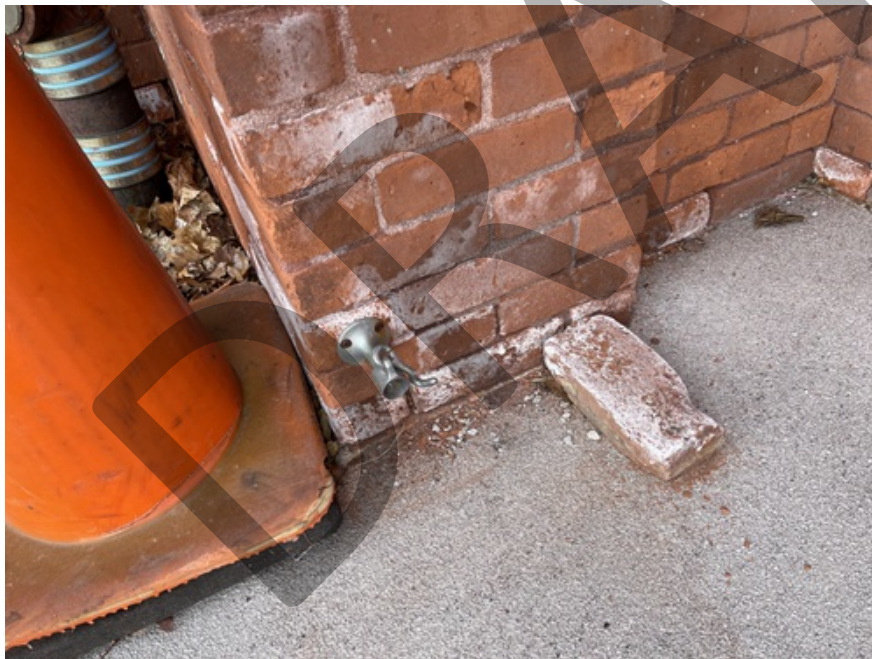
Photo 15

No membrane flashing and failing masonry due to salt and snow

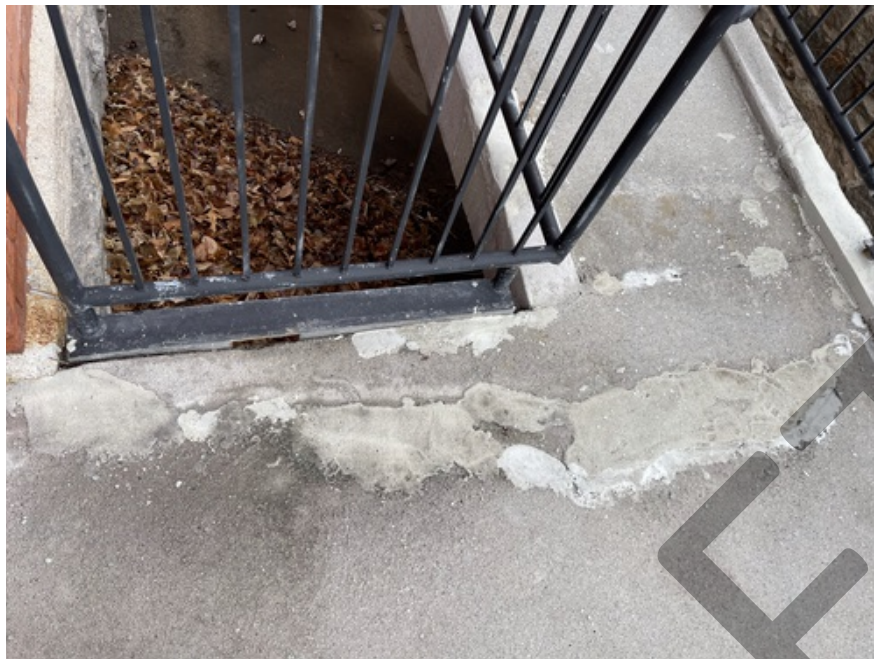
Photo 16

Improper and failed repairs- Tripping hazard

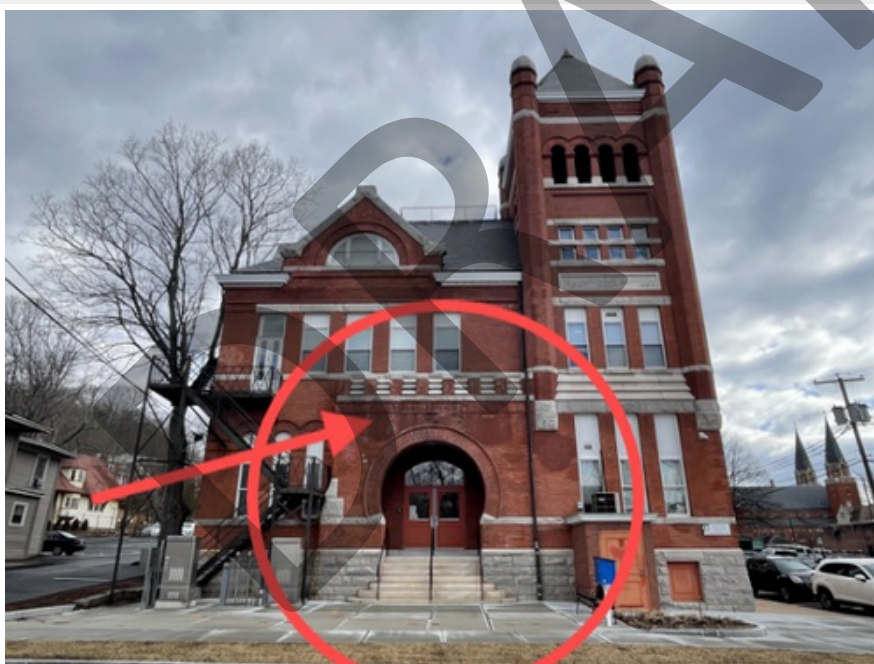
Photo 17

Masonry moisture retention- Specific to rear, west facing side

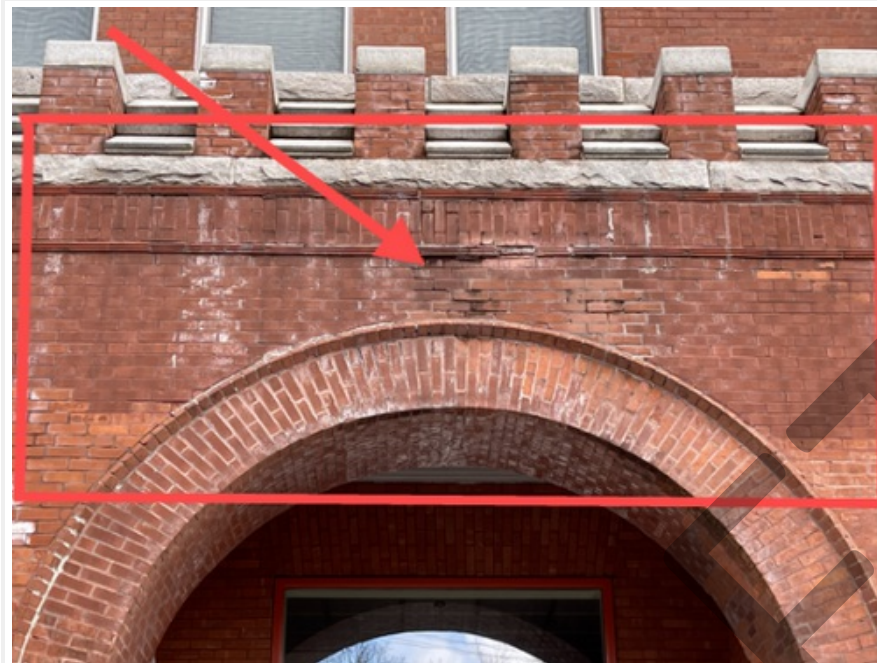
Photo 18

Potential for structural issue- Further investigation required
