Facility Study and Master Plan

Vernon Center Middle School

777 Hartford Turnpike, Vernon CT 06066

SUMMER 2023

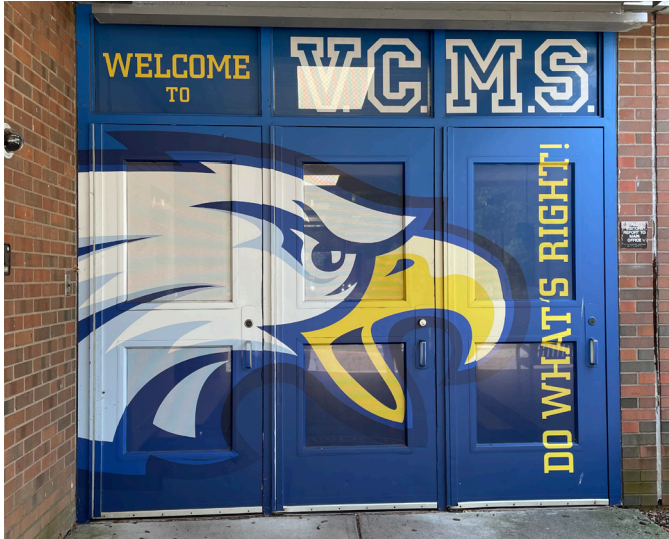
1. Location:

Expansion joint to the right of the main entry doors is degraded.

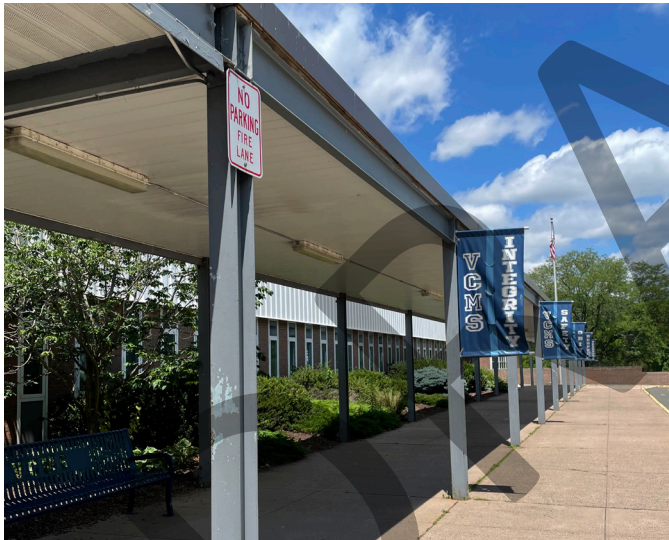
2. Location:

Finish peeling at columns and some rusting visible on the roof structure.

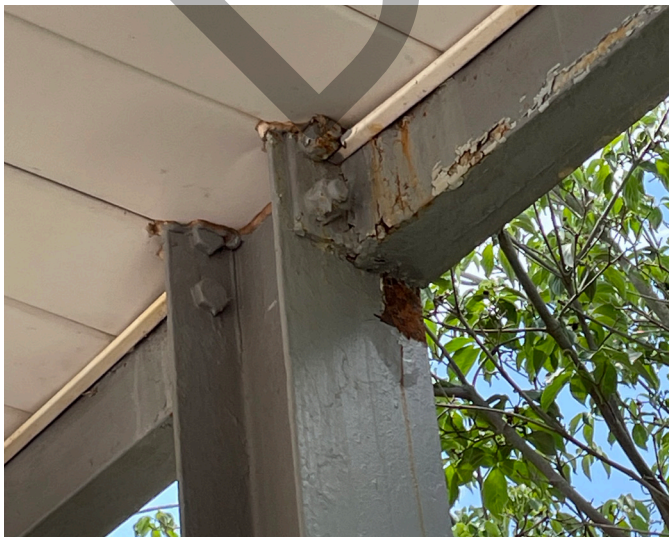
3. Location:

Rusting and peeling visible at beam and column - typical of several locations.

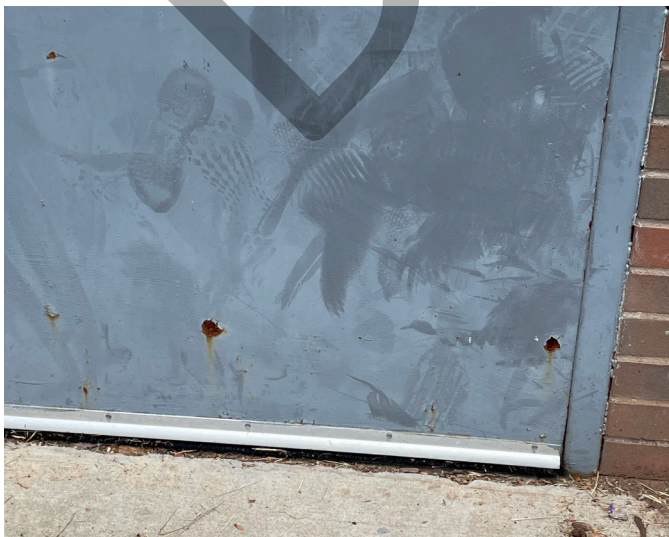
6. Location:

Residue from tape leftover on door. Door finish is faded and rusting is present near the bottom - this is a typical condition of hollow metal exterior doors with glazing.

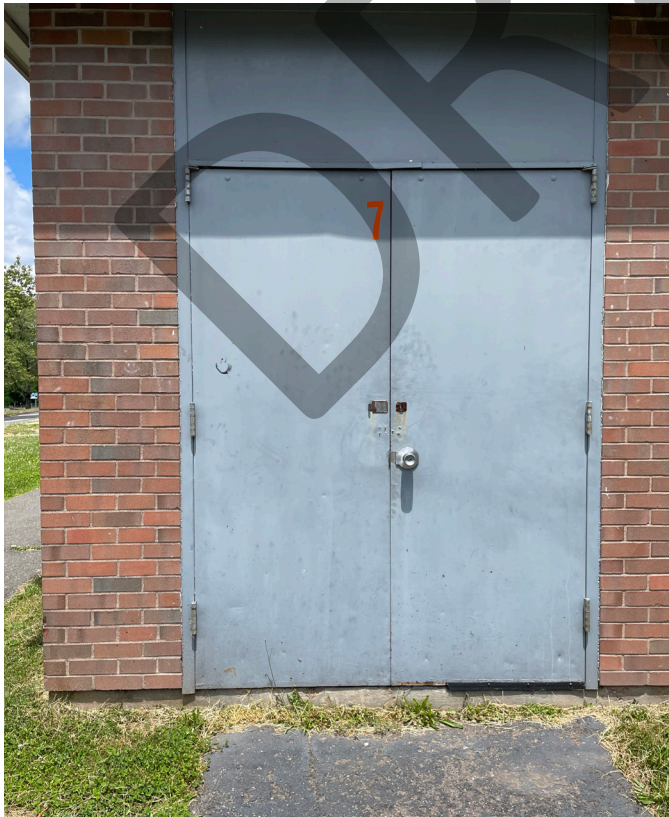
8. Location:

Example of missing weatherstripping. Hardware varies on exterior doors. Lock on this door is broken

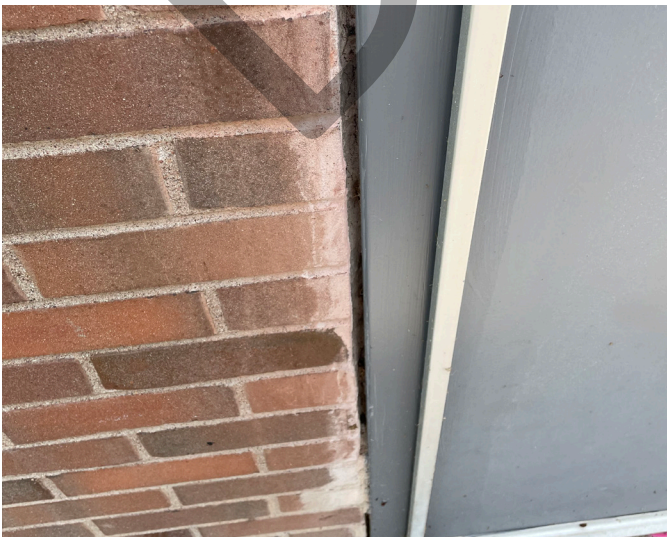
11. Location:

Missing sealant between door frame and brick.

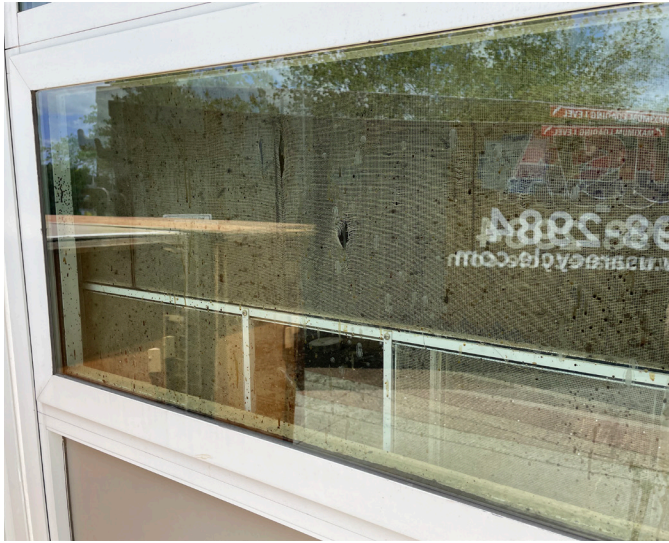
12. Location:

Window screens torn - typical condition in several locations

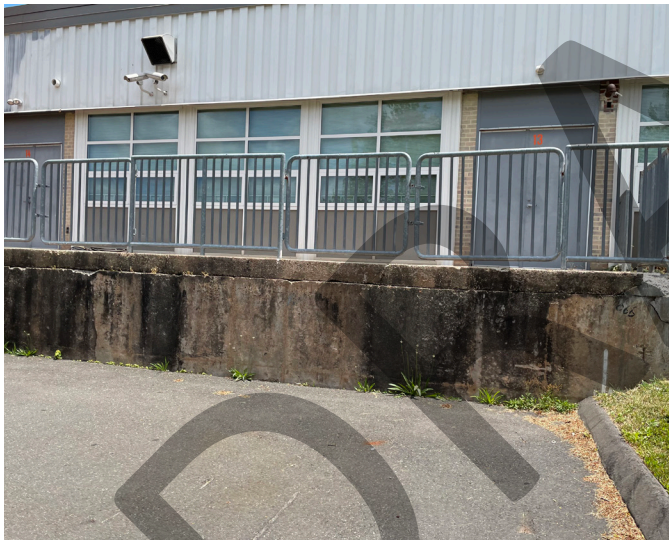
13. Location:

Deterioration, discoloration and cracking of retaining wall.

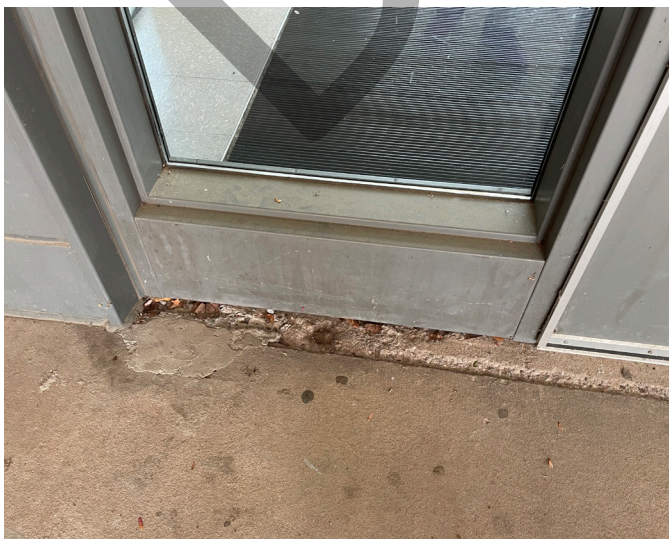
14. Location:

Concrete sill cracked

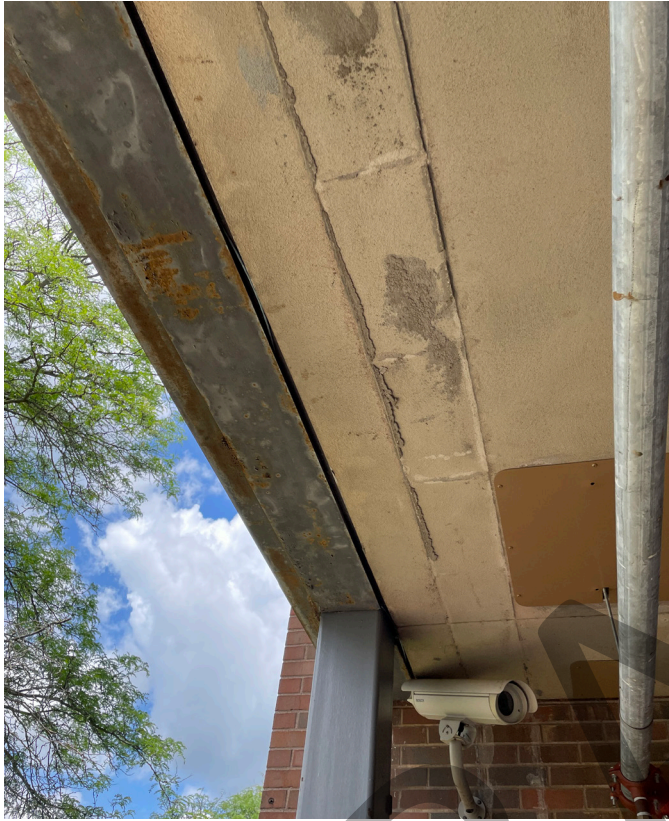
15. Location:

Metal finish is faded and stained.

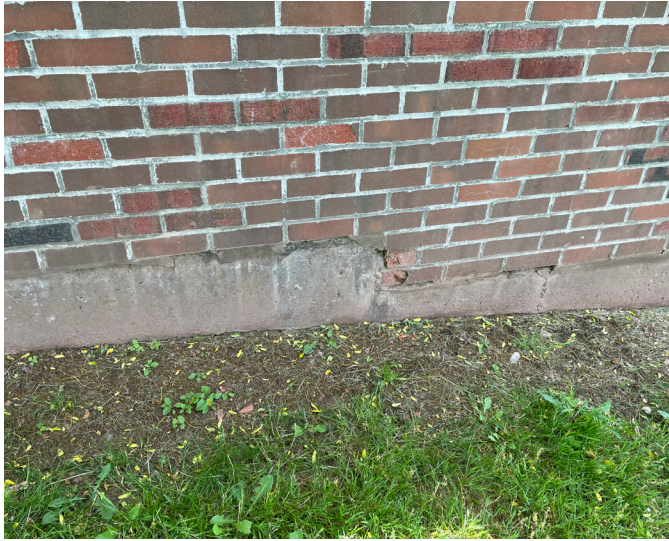
17. Location:

Crack in foundation wall concrete

- Repair cracks at foundation walls to avoid deterioration and water infiltration.

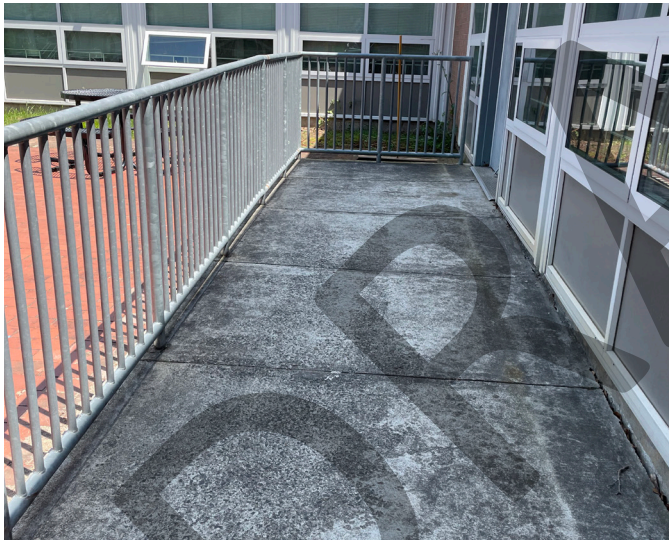
18. Location:

Bricks missing in walkway

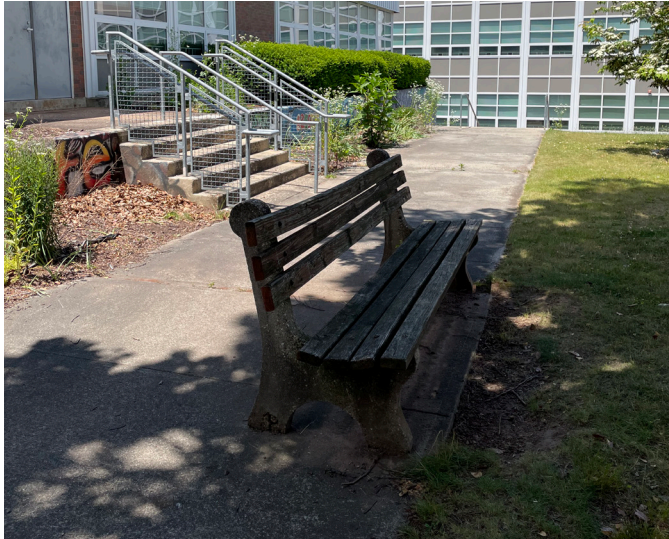
20. Location:

Damaged concrete steps.

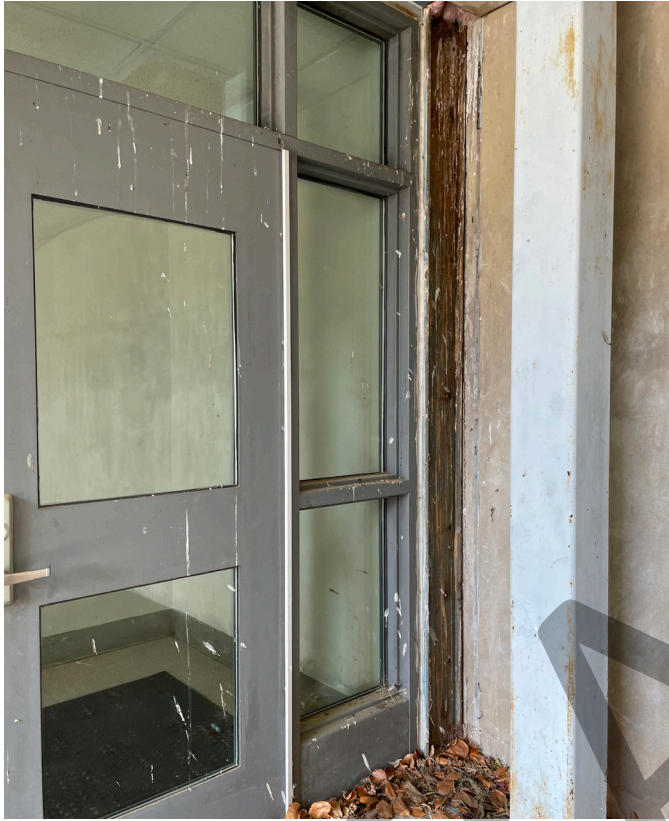
23. Location:

Lower entrance to classroom wing. Door is covered in debris and the adjacent surface is missing the finish, insulation is exposed to the elements and the door frame is rusting.

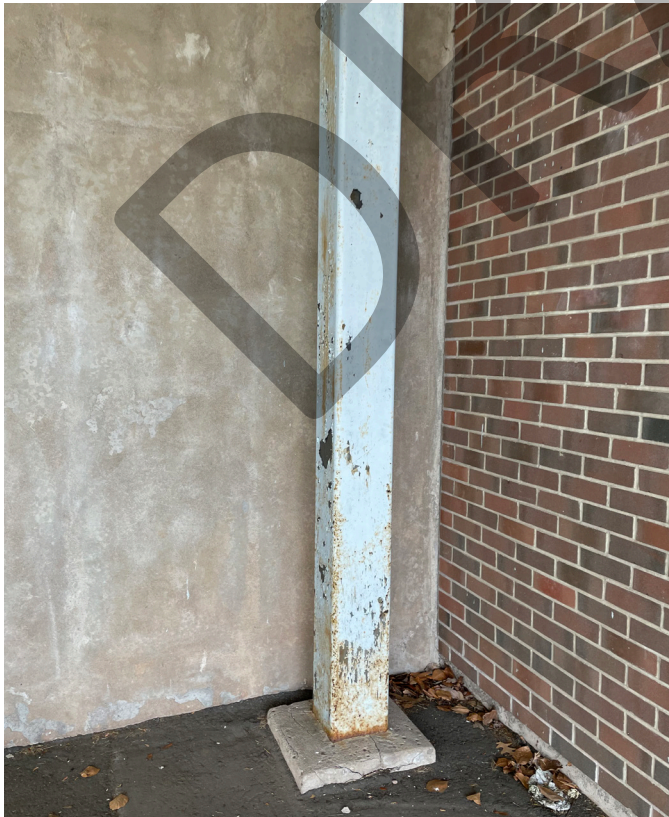
24. Location:

At lower entrance to classroom wing. Column finish is peeling away and columns are rusting.

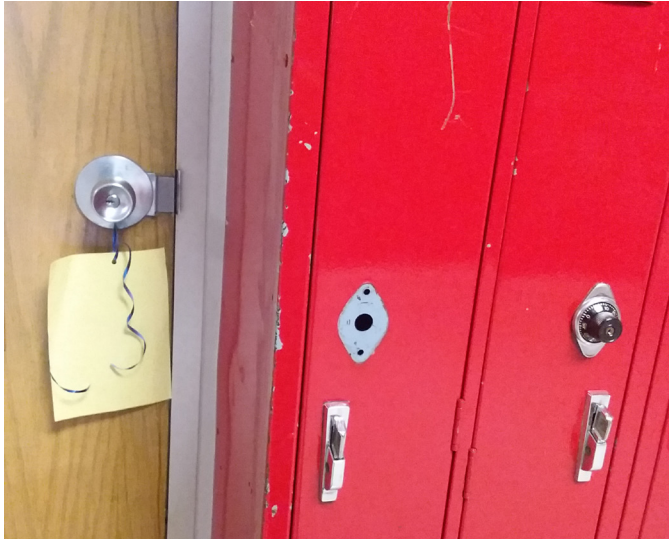
25. Location:

Lockers are chipped/scratched and locks are missing on several.

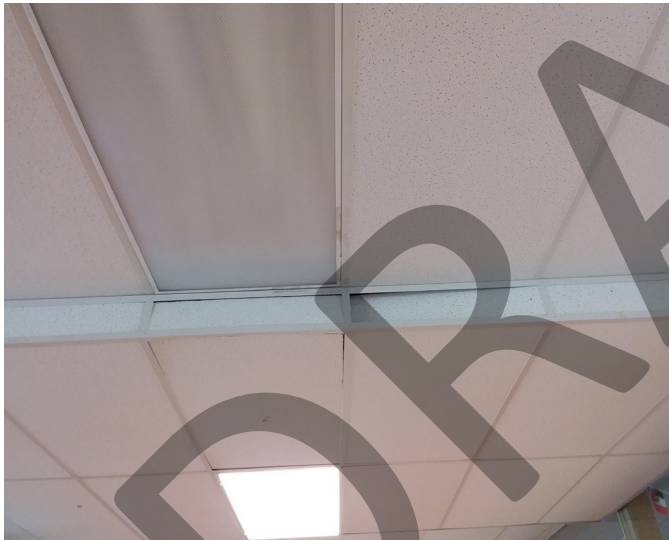
26. Location:

Ceiling Tile damaged.

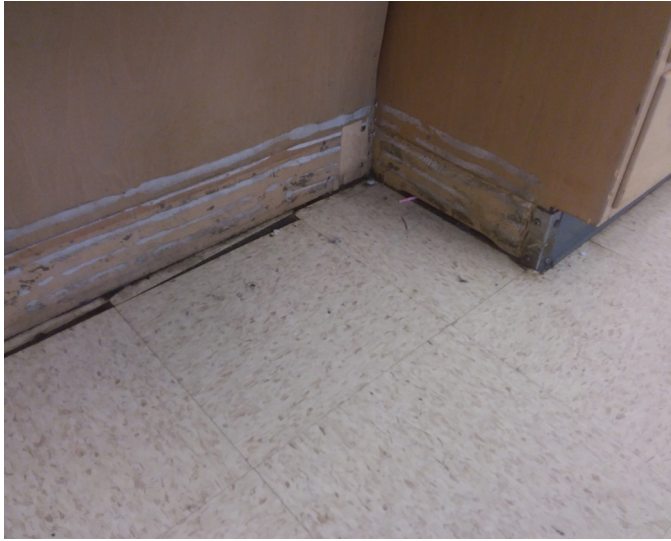
28. Location:

Missing and damaged wall base.

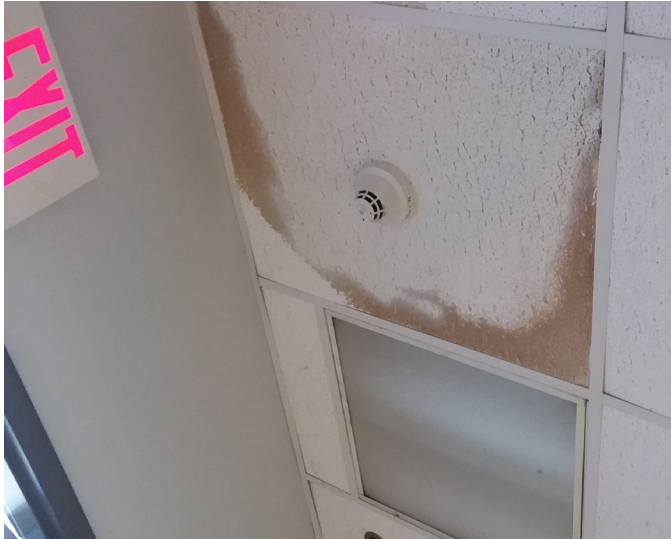
31. Location:

Stained ceiling tile appears to be from water damage.

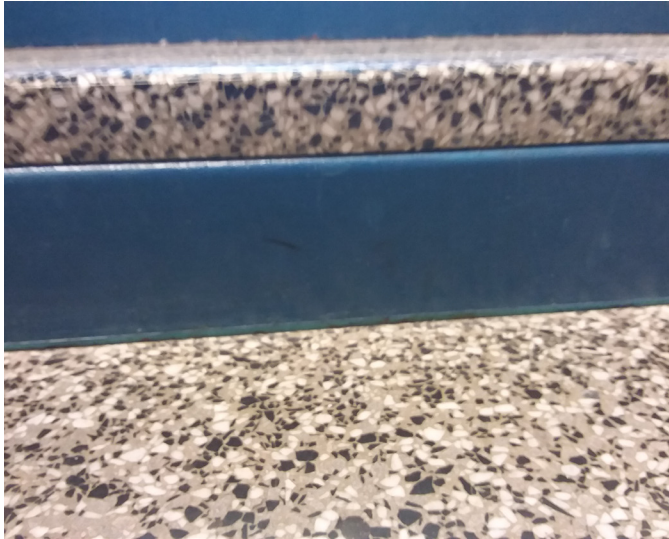
34. Location:

Floor tile is damaged and should be repaired.

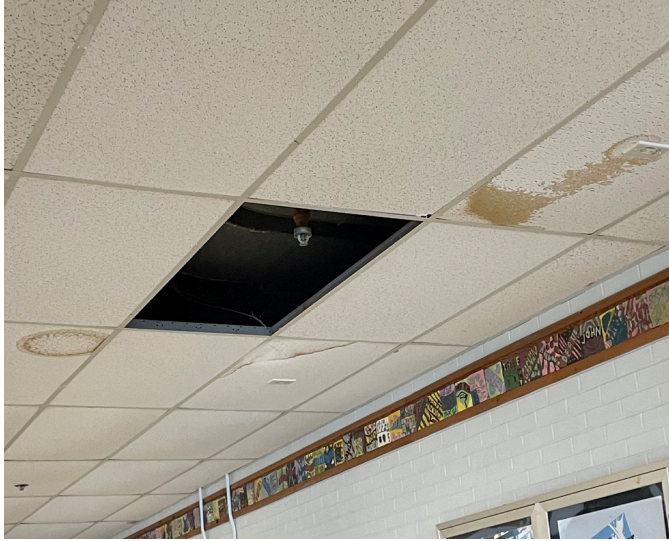
37. Location:

Appeared water damage on ceiling tile.

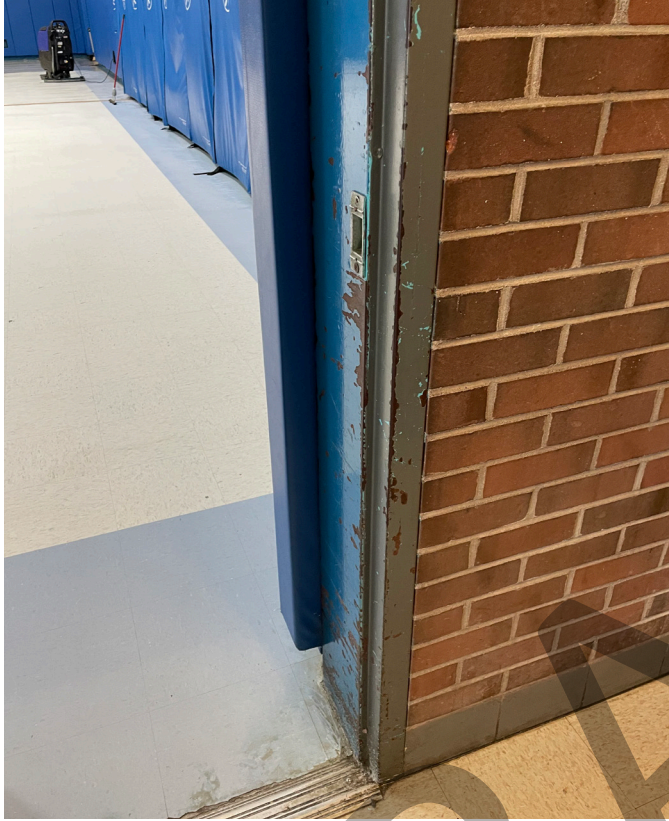
40. Location:

Chipped door frame and damaged VCT at transition.

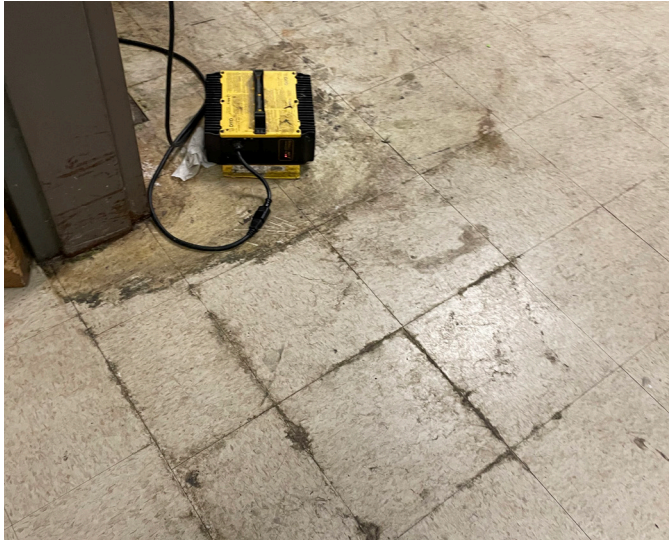
42. Location:

VCT is damaged and needs to be replaced.

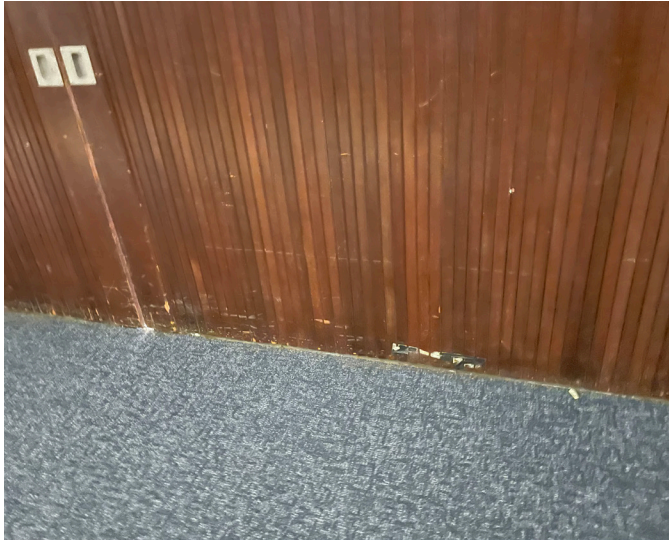
45. Location:

Wood paneling appears damaged and worn.

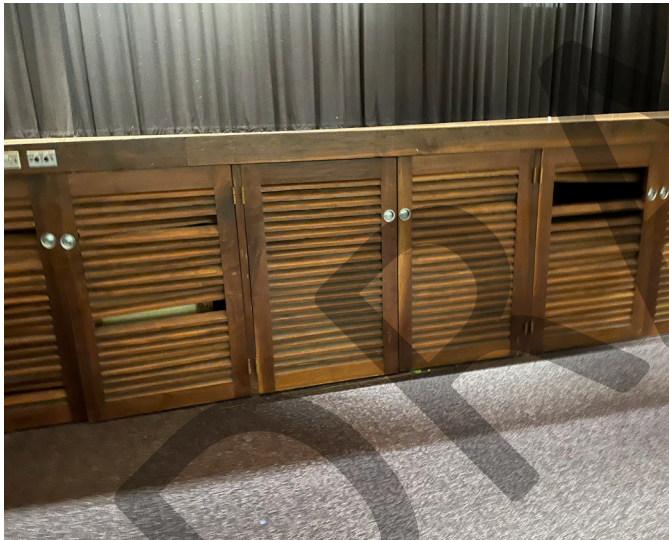
46. Location:

Broken storage doors under stage need repair.

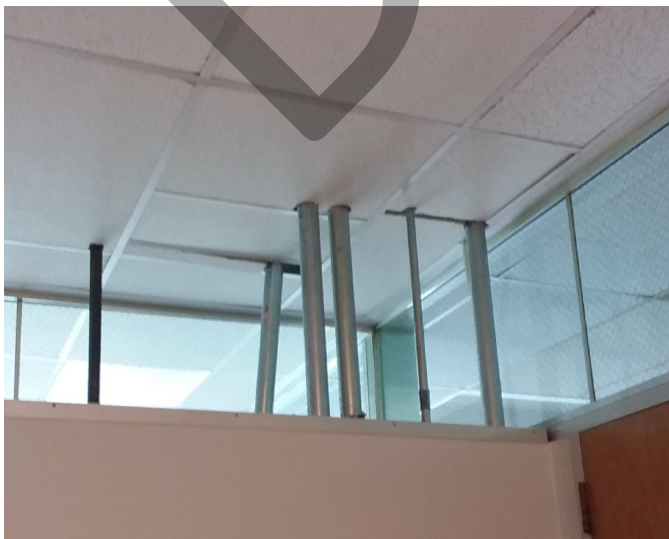
47. Location:

Damaged ceiling tiles.

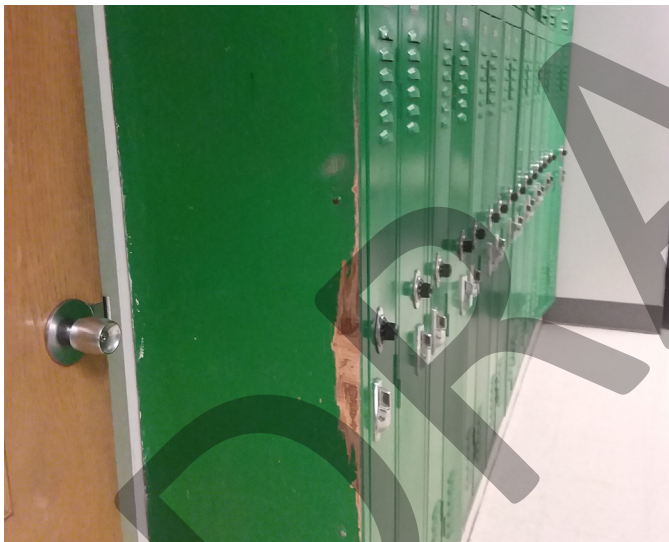
49. Location:

Damaged plywood end panel.

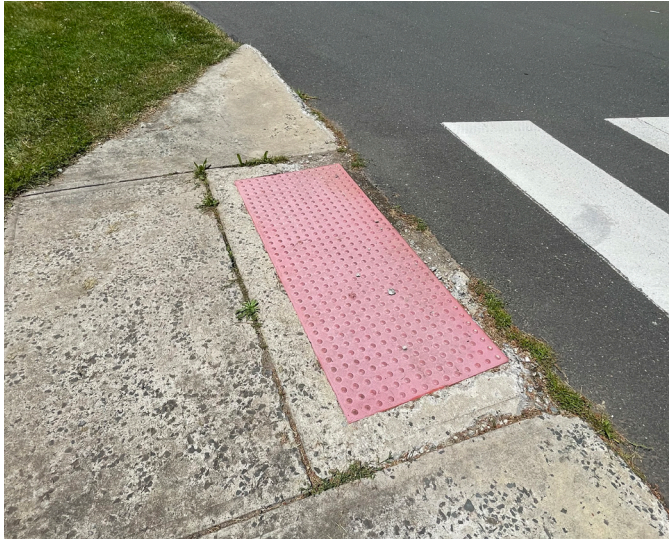
4. Location:

Concrete around walkway handicap access damaged.

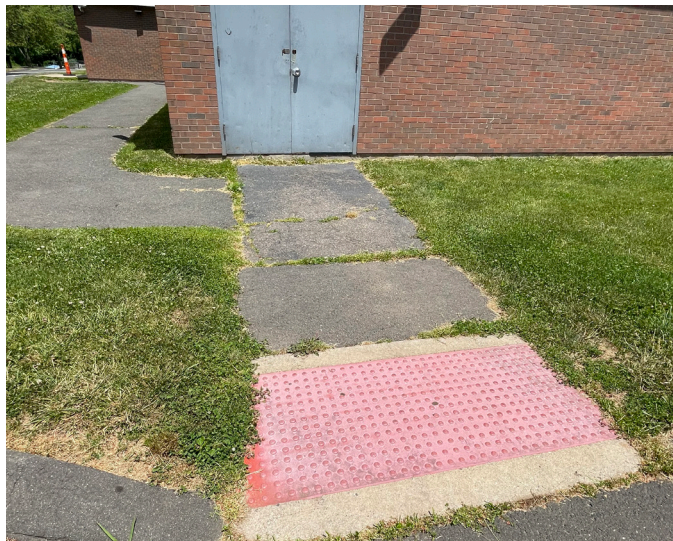
7. Location:

Bituminous pavement cracking in several locations. Vegetation overgrowth onto tactile warning pad.

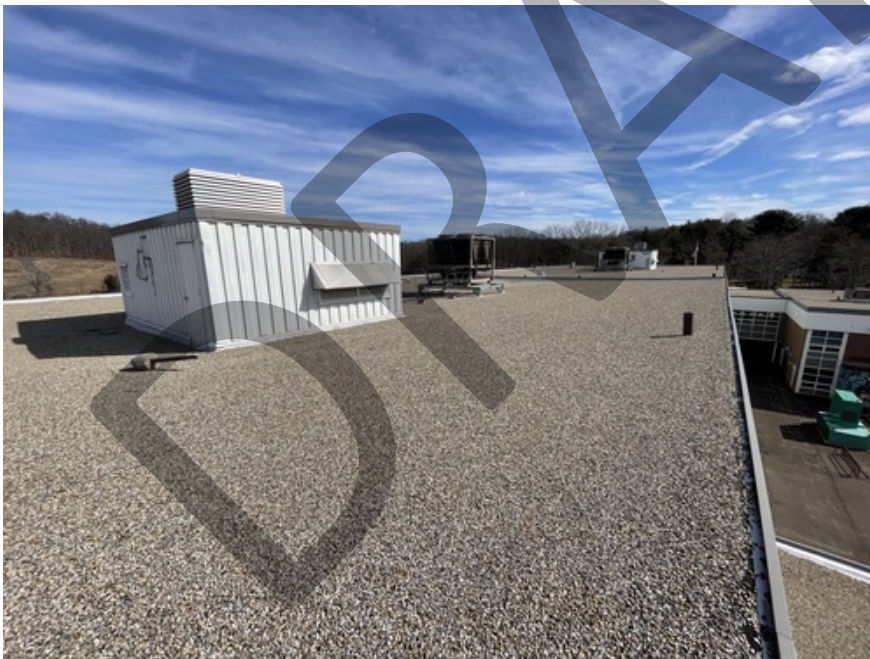
Photo 3

**Upper north section-
Penthouse walls are
leaking**

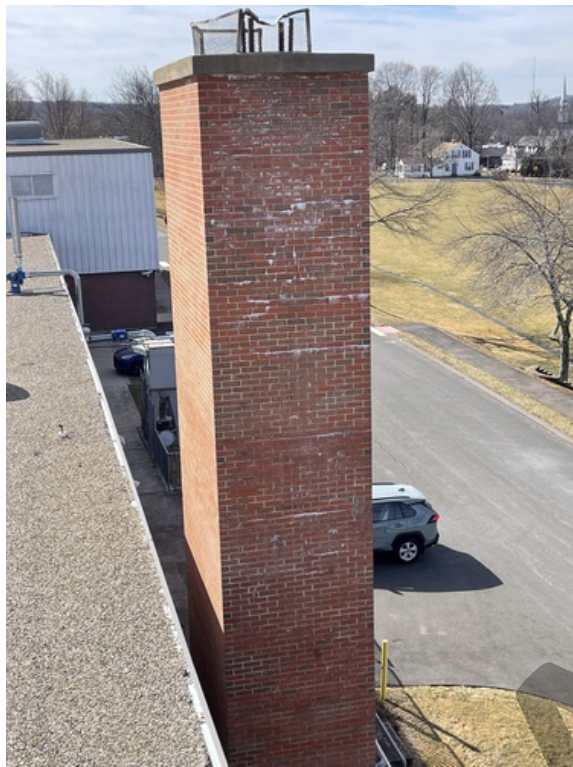
Photo 4

Chimney needs attention- Wall panels recommended

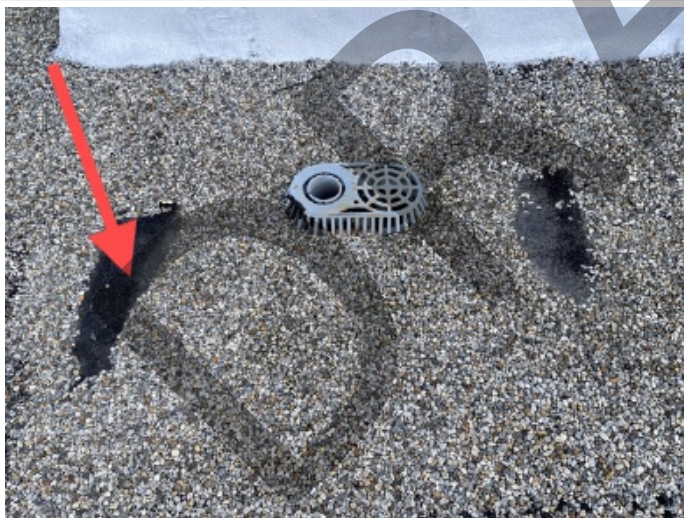
Photo 5

**Few areas of exposed membrane- UV
Protectant needed**
