Facility Study and Master Plan

Skinner Road School

90 Skinner Rd, Vernon, CT 06066

SUMMER 2023

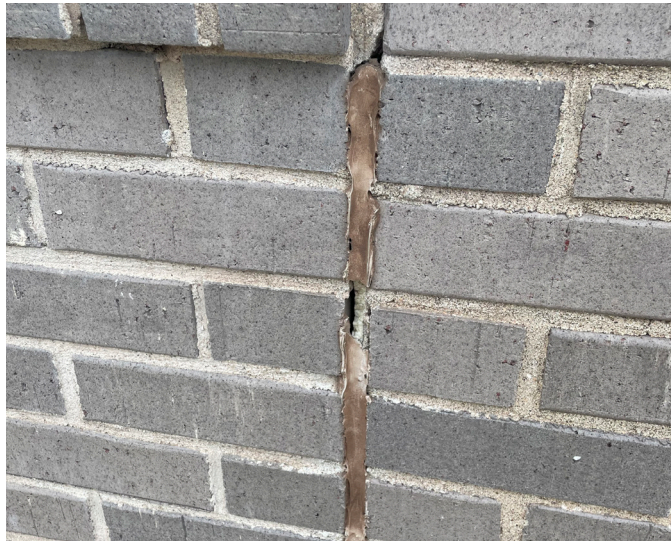
1. Location:

Joint deteriorating

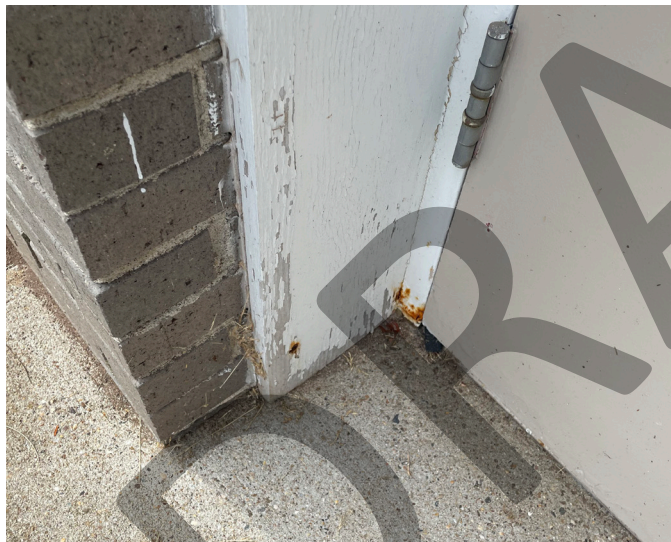
2. Location:

Wood door frame paint peeling and rust forming at nails - Typical condition throughout the building

- Refinish or replace doors where the paint is cracking and peeling
 - Provide new sealant at door frames
 - Replace or refinish wood frames
 - Replace wood at door headers

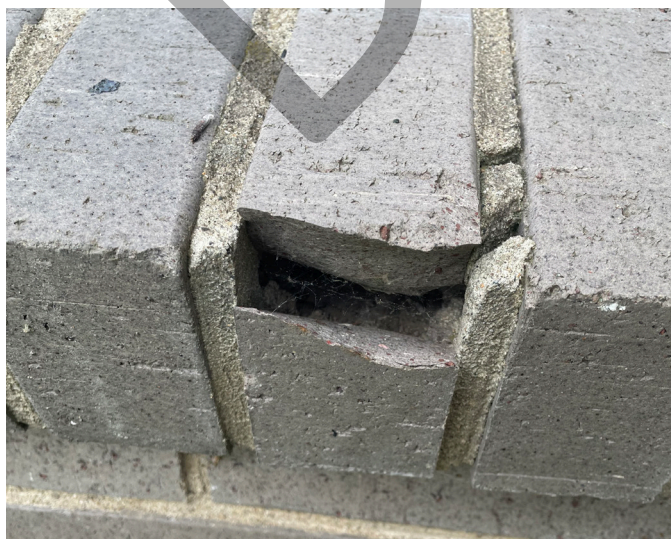
3. Location:

Damaged brick sill

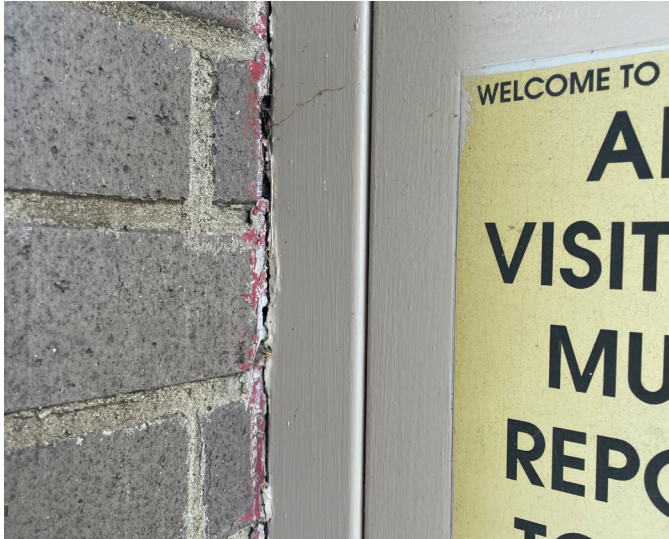
4. Location:

Sealant missing and cracking between masonry and door frame.

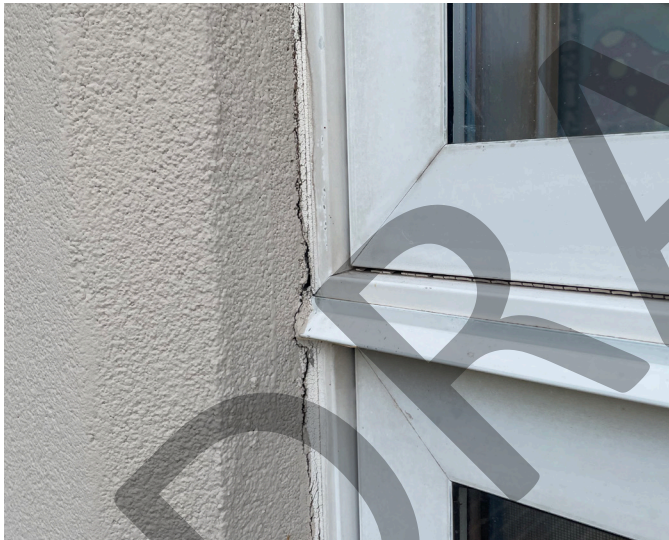
5. Location:

Cracking between cementitious facade and window frame.

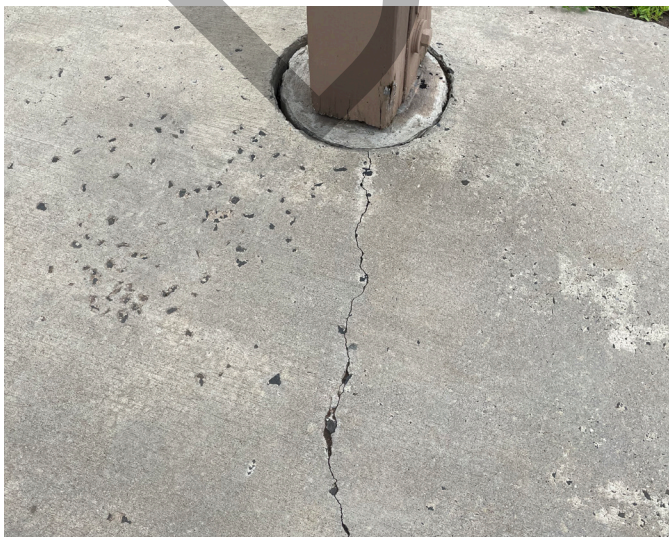
6. Location:

Crack in concrete near column - occurs in several locations.

- Repair concrete cracks at bus canopy
- Repoint brick in areas of deterioration

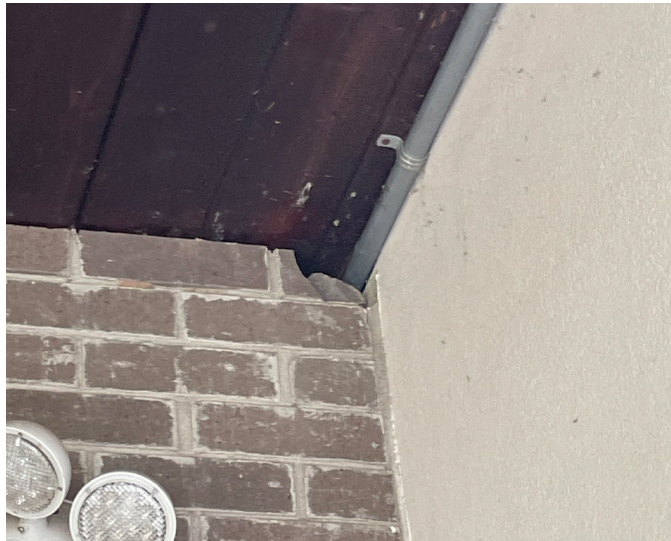
7. Location:

Missing brick in upper corner.

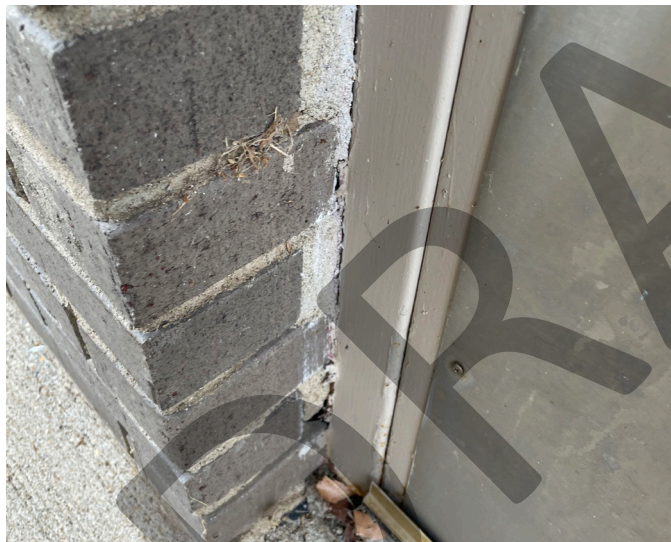
8. Location:

Deterioration of brick and caulking.

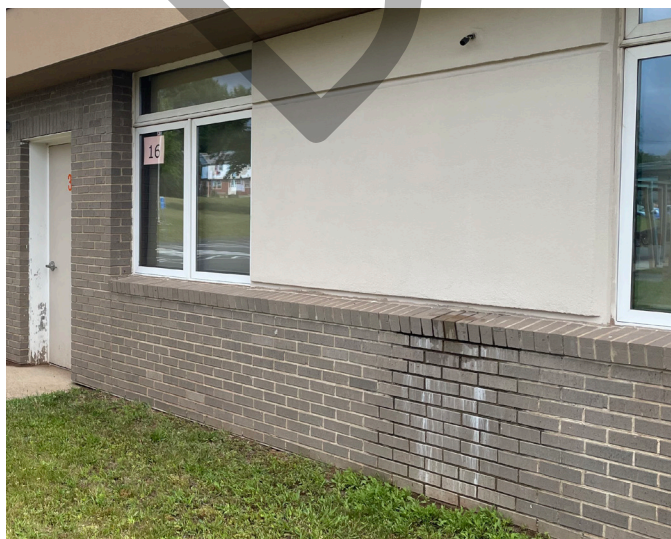
9. Location:

Water is dripping from pipe above causing discoloration of brick and slowly deteriorating mortar.

- Redirect pipes that are leaking water directly onto the masonry facades
- Replace damaged or broken interior signage
- Replace stained, damaged or peeling VCT flooring. Further investigation into the moisture content of the slab should be performed prior to replacing the flooring.

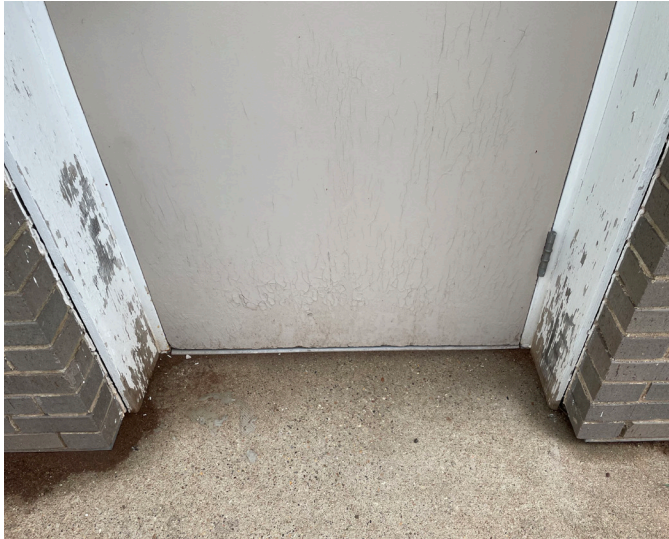
10. Location:

Wood door frame paint peeling and rust forming at nails - Typical condition throughout the building. Paint on door is cracking and beginning to peel away.

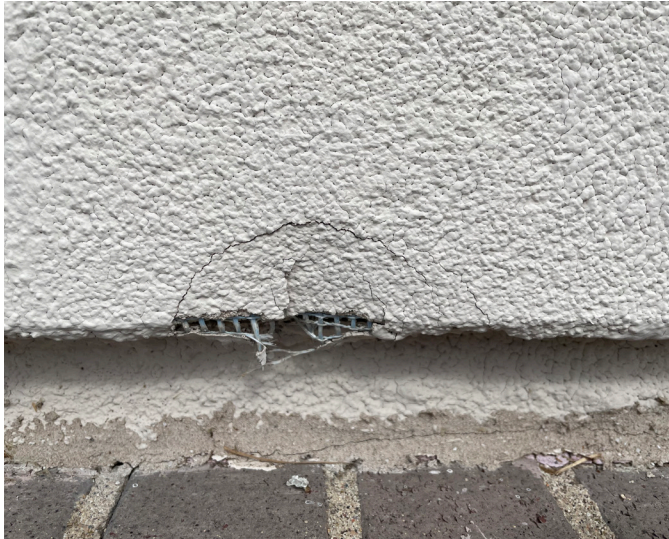
13. Location:

Damaged cementitious facade.

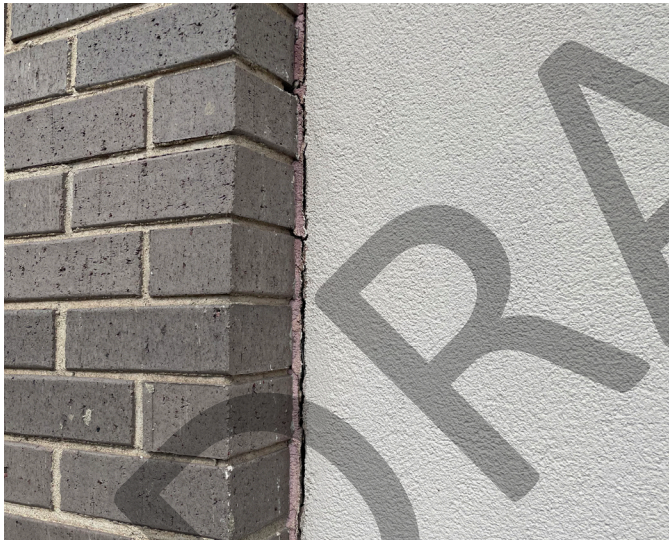
14. Location:

Sealant between cementitious facade and brick facade is cracking and pulling away.

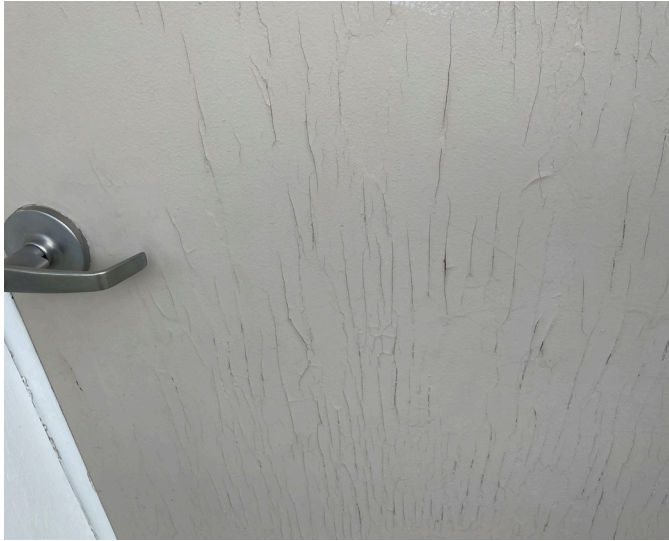
16. Location:

Paint on door is cracking and beginning to peel away - Typical condition throughout building.

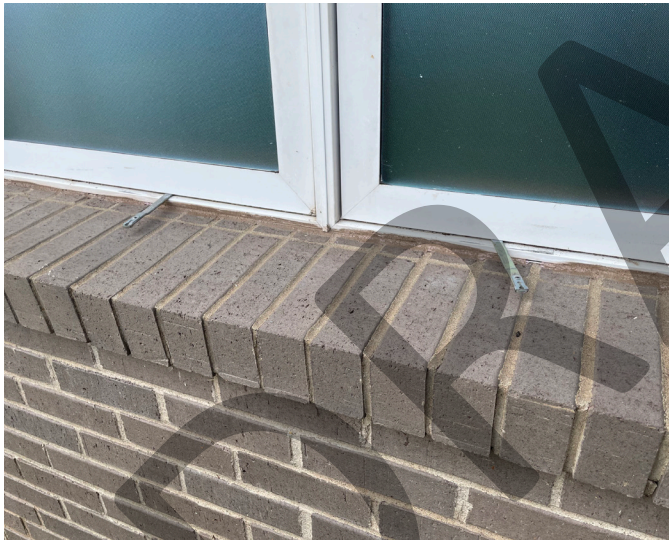
17. Location:

Window closer/opener is broken

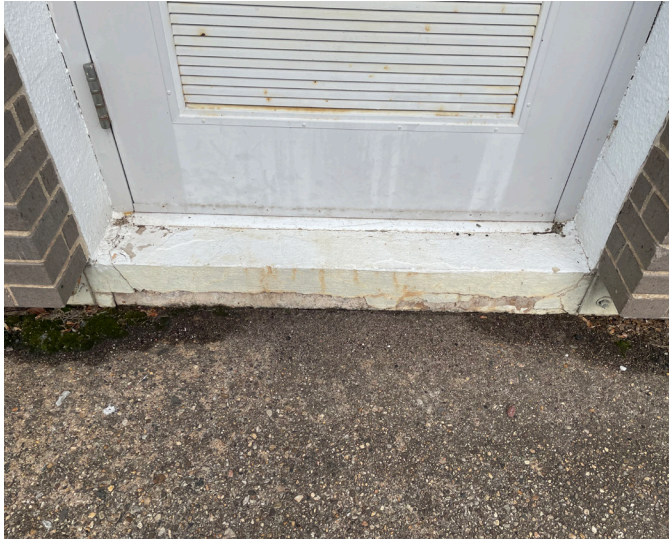
19. Location:

Concrete sill finish is falling off. The door and frame are rusted.

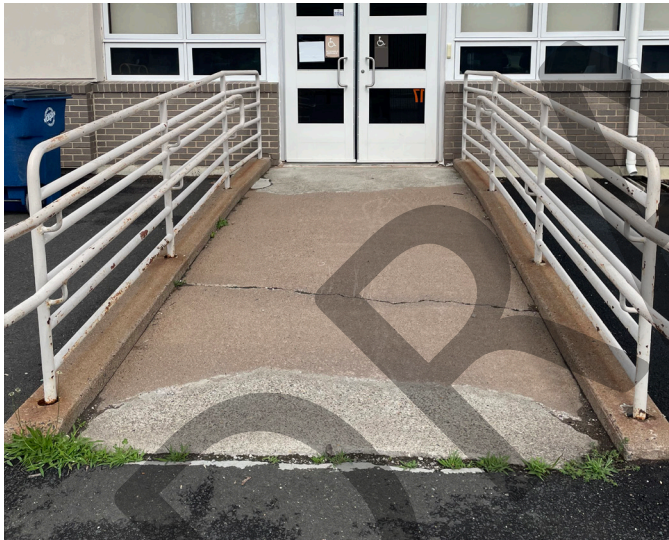
23. Location:

Concrete ramp is needs to be redone - cracking, uneven surface and vegetation are potential hazards.

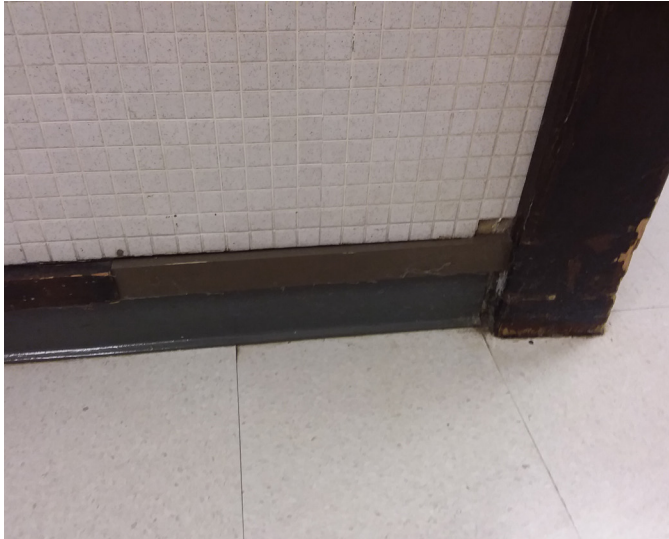
39. Location:

Wall tiles missing and stained. Wood trim and corner is damaged and needs to be repaired.

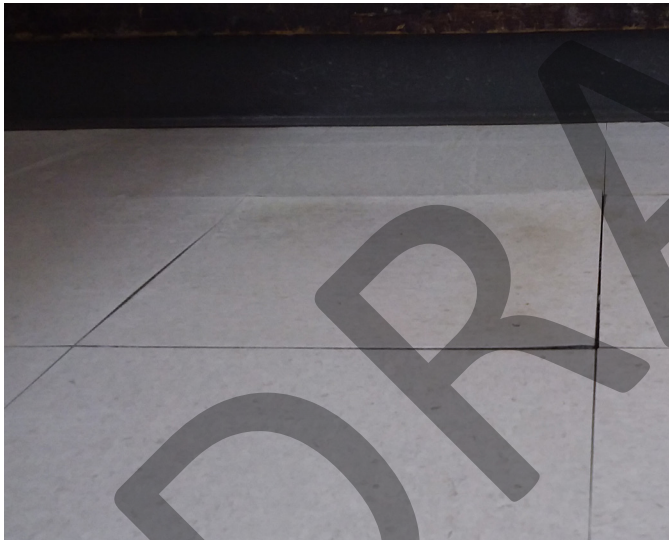
49. Location:

Flooring is popping up which is an indication there may be high levels of moisture in the existing slab.

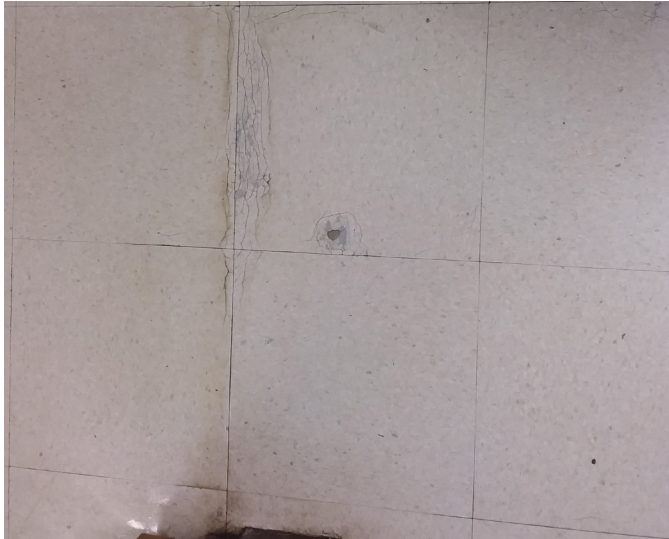
51. Location:

VCT is stained and cracking

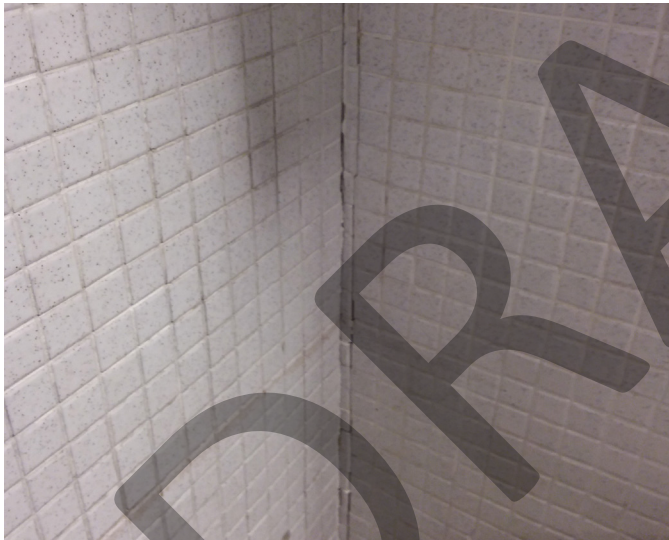
52. Location:

Tile finish is faded and cracked.

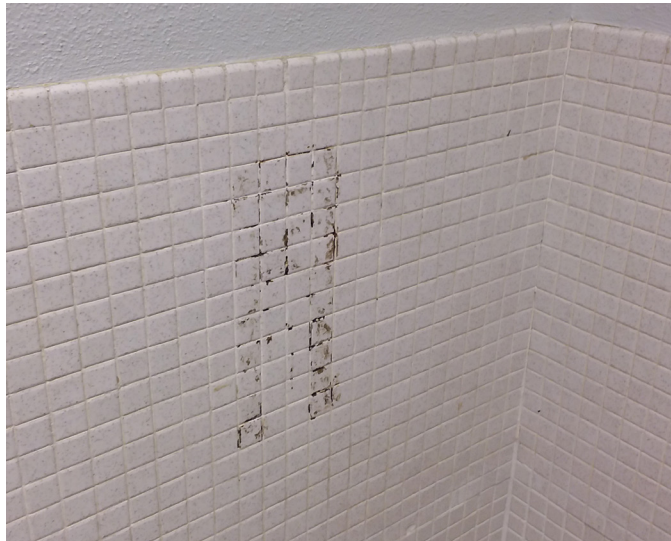
54. Location:

Damaged wall tile.

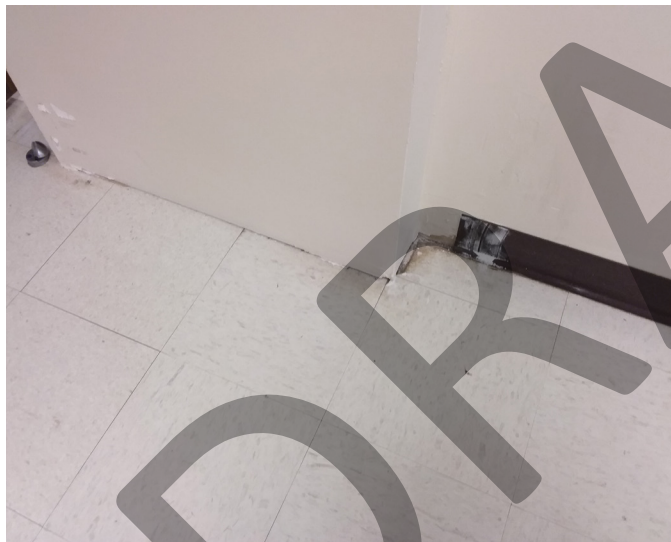
55. Location:

Missing wall base and base of gypsum wall damaged.

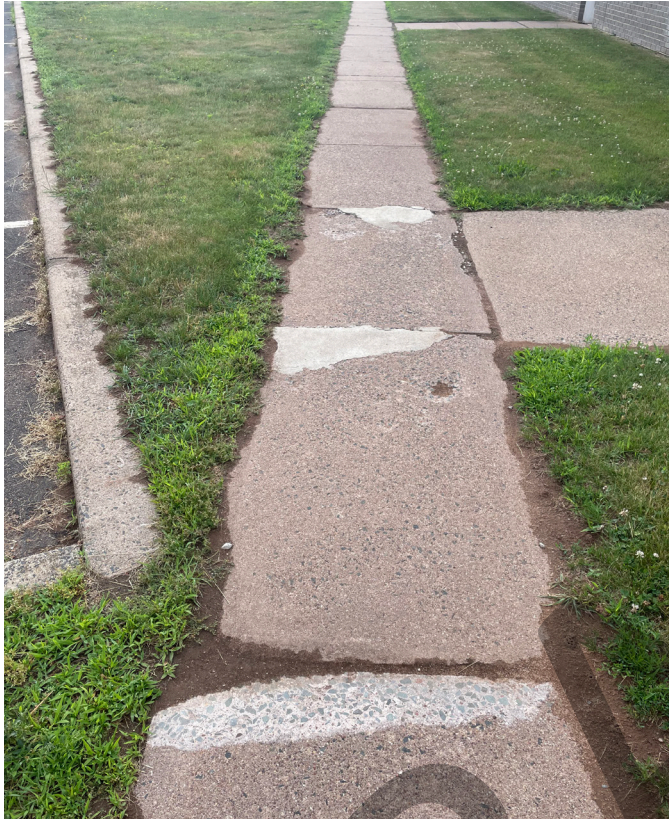
4. Location:

Concrete walkway has been patched in a few locations. Gaps between walkway sections and areas of uneven surface pose a hazard.

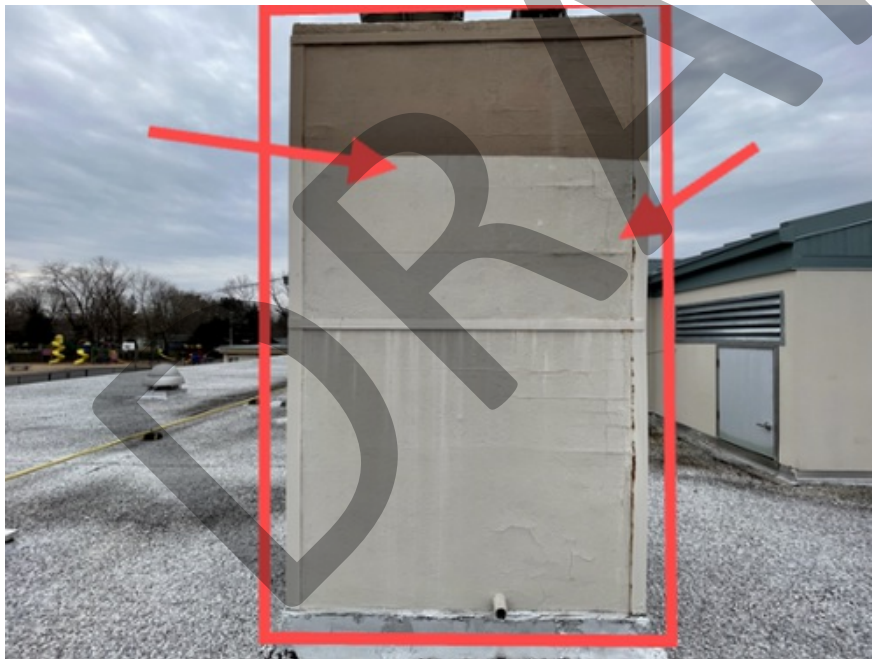
Photo 6

Failing CMU chimney- Wall panel system suggested to keep moisture out

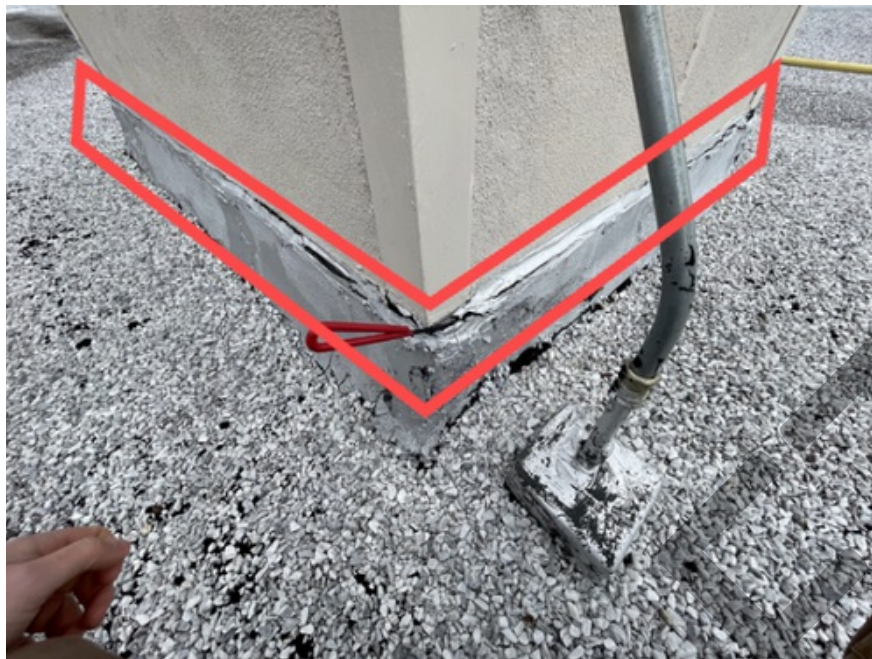
Photo 7

**Improper flashing-
Installation of wall panel
system and counter
flashing suggested**

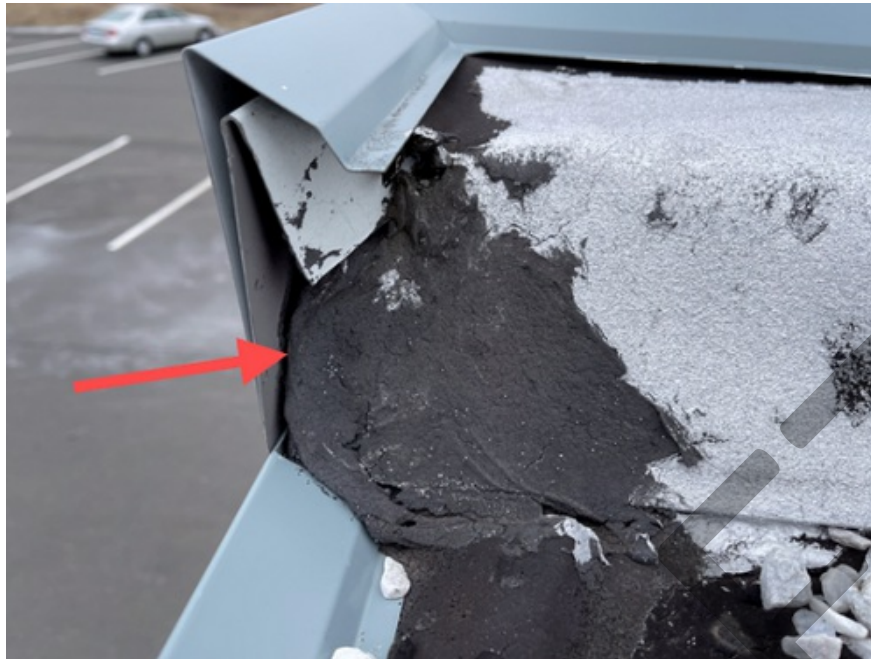
Photo 9

Open condition- Aging and exposed mastic

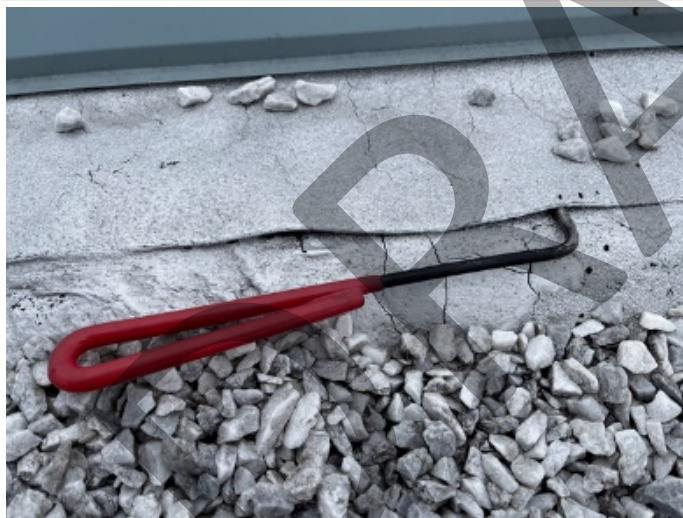
Photo 10

Open condition- Small fish mouths on perimeter edge

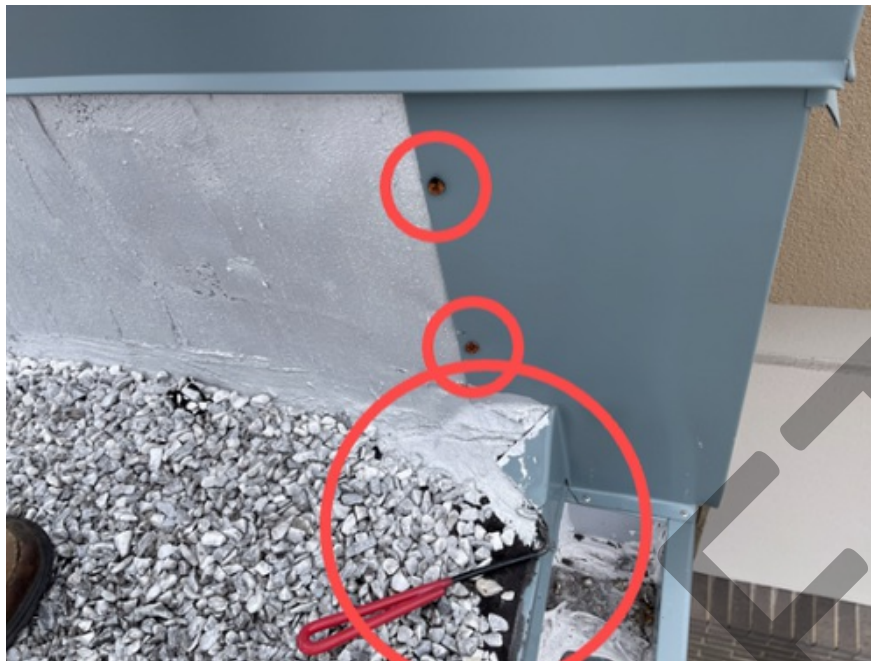
Photo 13

**Open condition- Perimeter
edge- Wind scor-
Reinforcement
recommended**
