Facility Study and Master Plan

Northeast School

69 East St, Vernon, CT 06066

SUMMER 2023

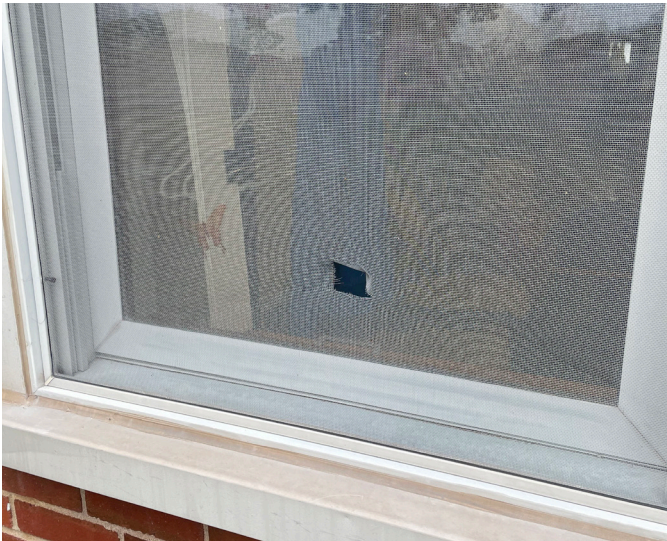
1. Location:

Screen torn and/or damaged - several locations throughout building

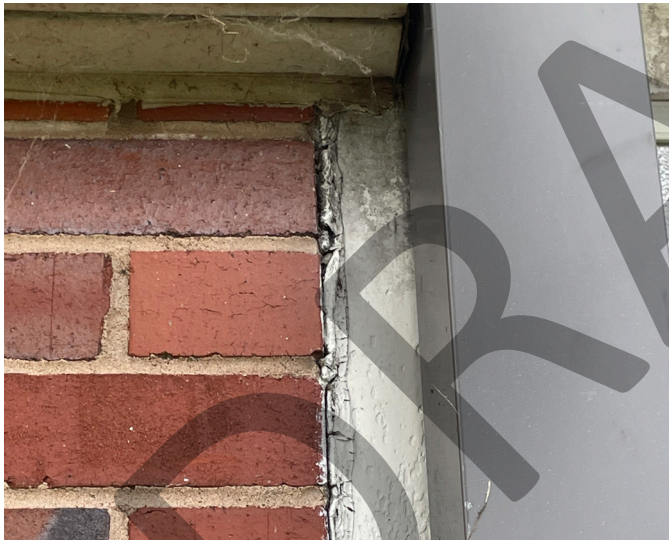
11. Location:

Cracking in brick - no obvious sign of cause

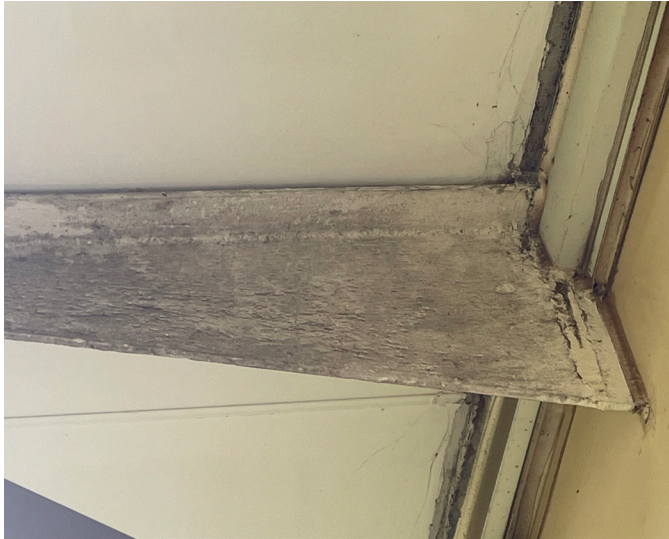
13. Location:

Missing and damaged flashing below metal panels

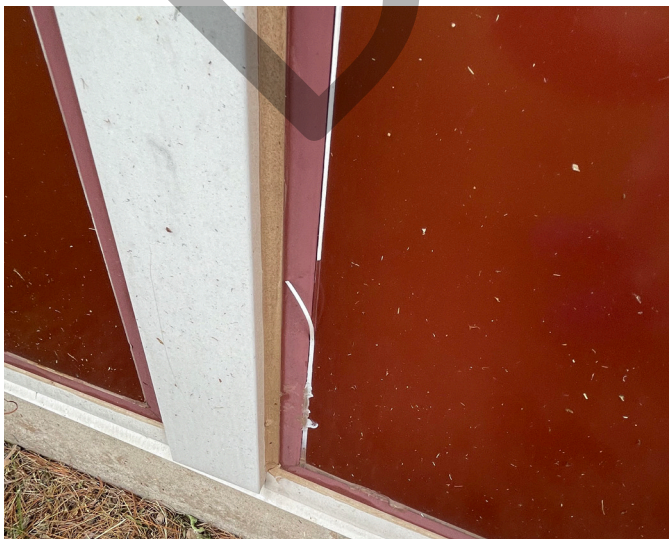
15. Location:

Typical at many metal panels - sealant is missing or breaking away

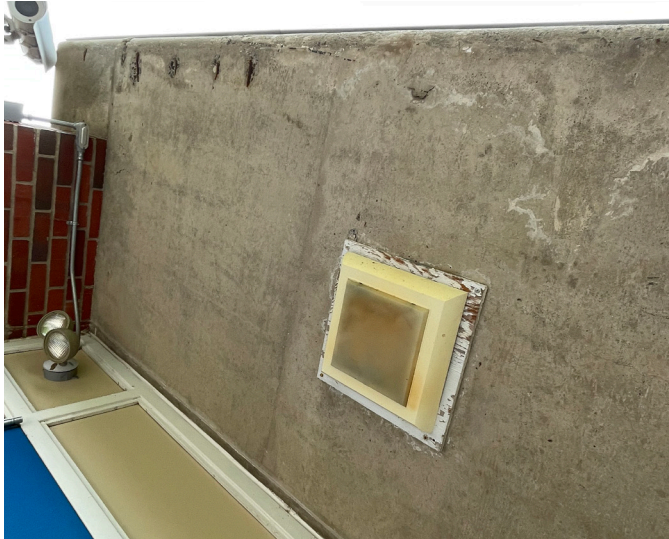
16. Location:

Underside of soffit needs patching and refinishing. Light fixture is old and needs to be replaced along with frame.

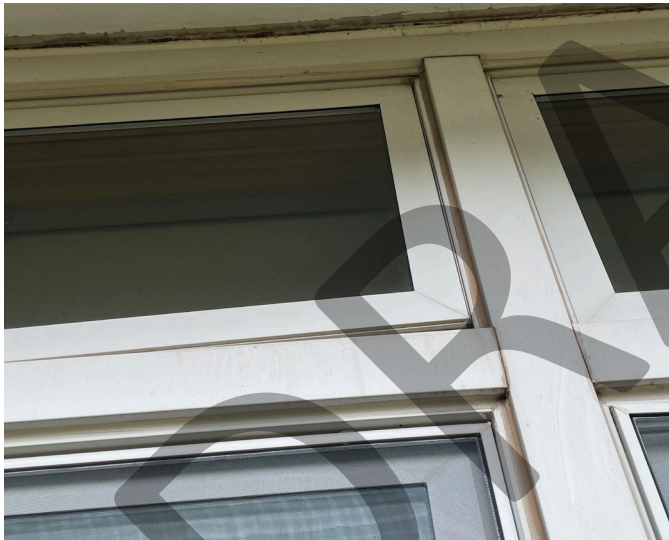
17. Location:

Many panels are rusted and need to be replaced to prevent further deterioration.

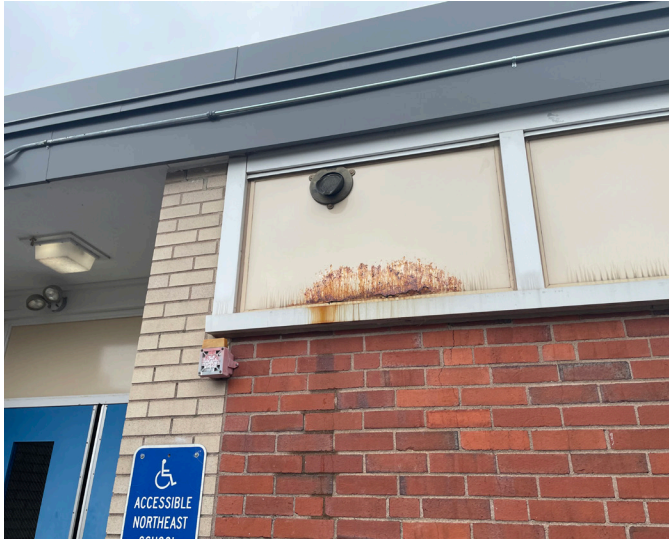
22. Location:

Water damage to the metal panel, frame and brick.

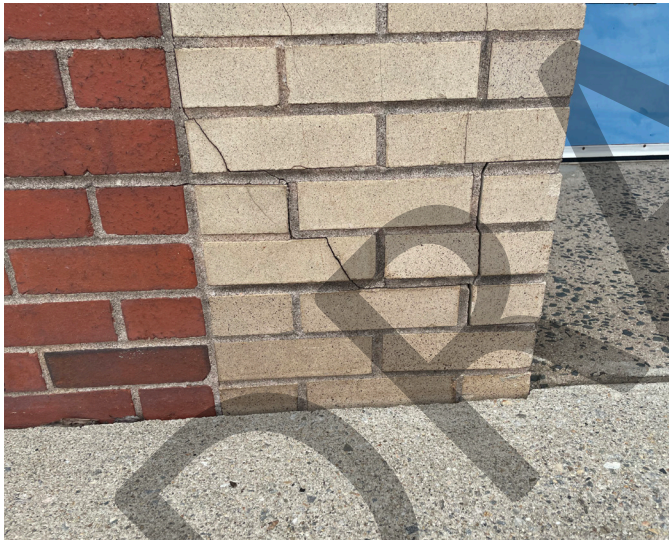
23. Location:

Cracking visible at brick

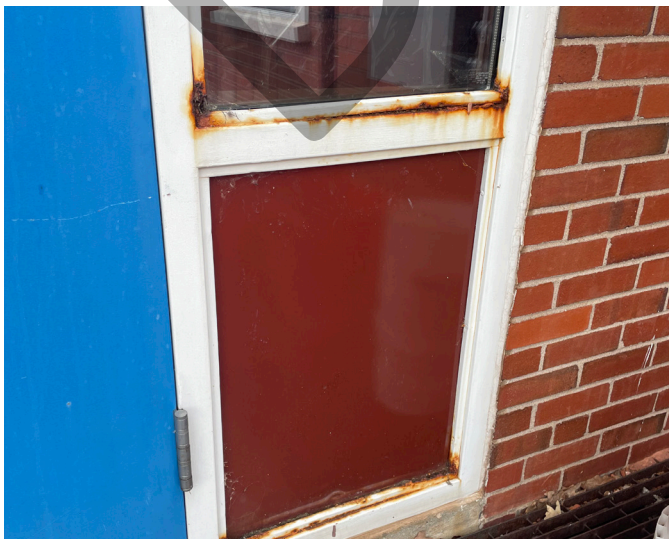
24. Location:

Significant rusting at exterior doors with sidelights - this is a typical condition throughout the building

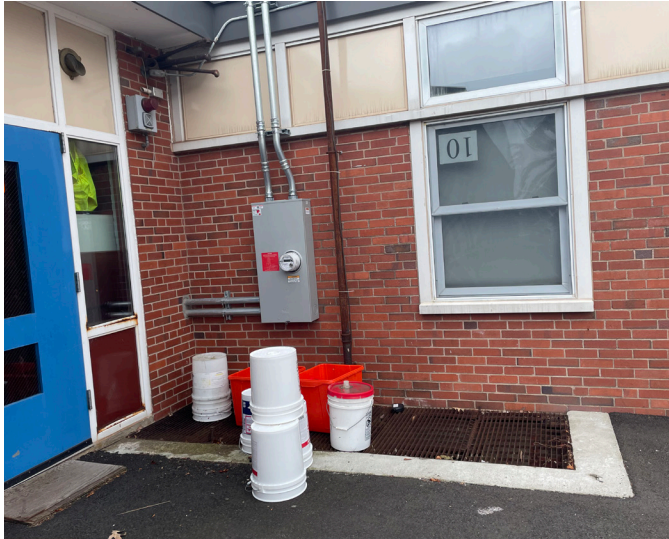
25. Location:

Grates are a potential hazard for young children. Most are loose and fairly rusted.

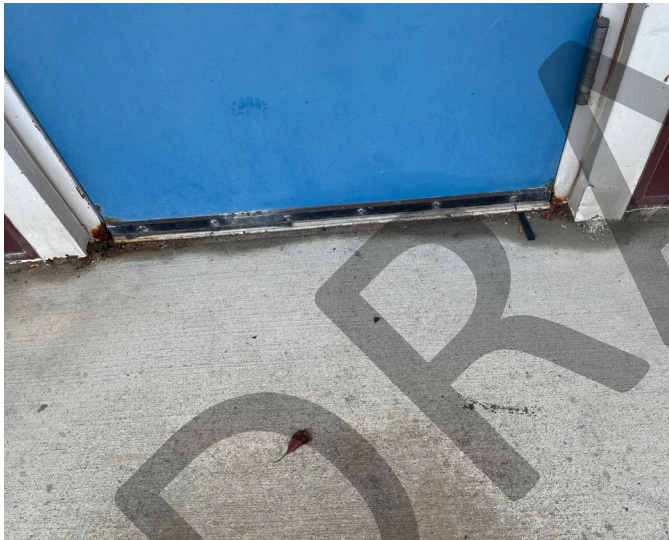
26. Location:

Typical condition at hollow metal doors - finish fading and weatherstripping deteriorating

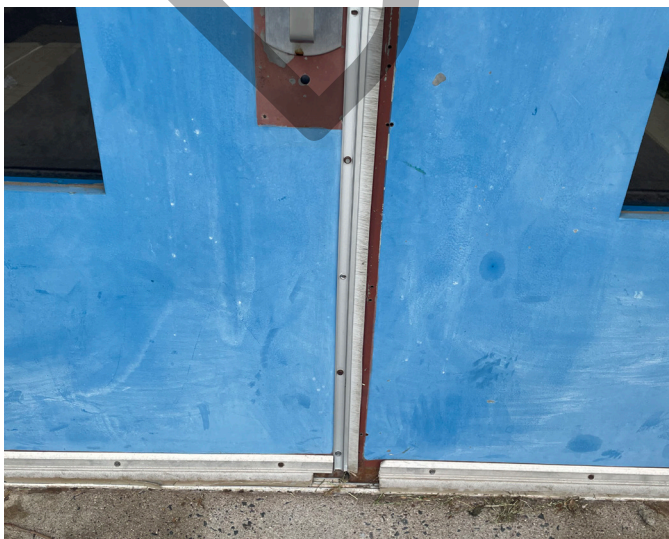
27. Location:

Hollow metal door - holes remain from hardware replacement, finish significantly faded, weatherstripping deteriorating.

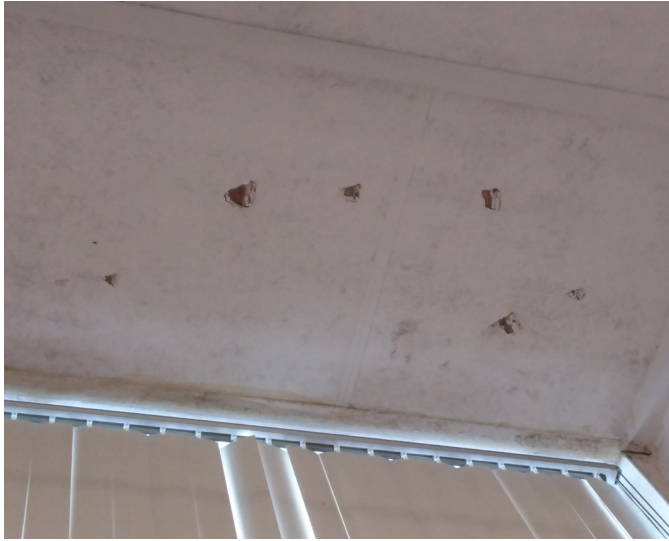
34. Location:

Painted insulated ceiling has gouges and holes. Repair is needed.

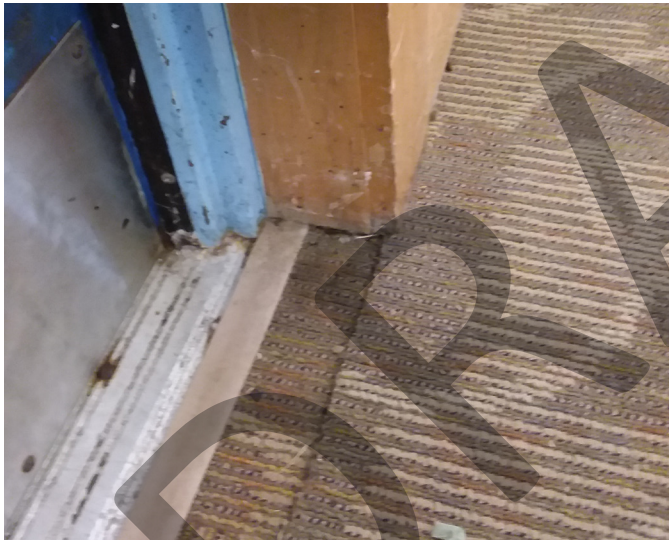
35. Location:

Carpet tile is popping up at door transition and needs repair.

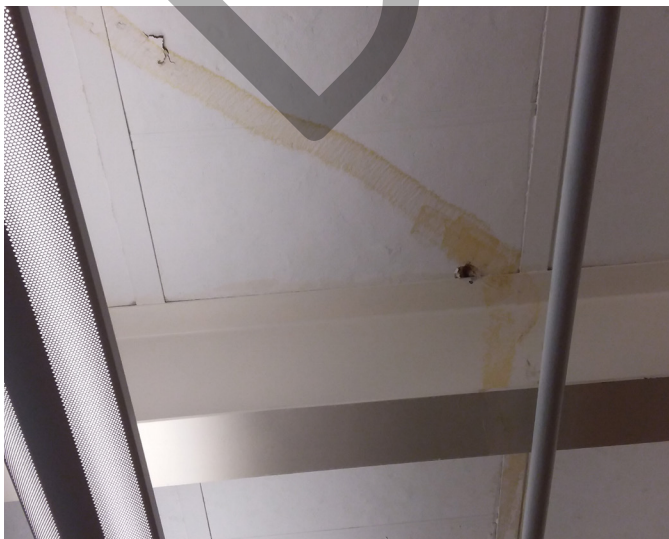
36. Location:

Water damage is seen on the insulation and stained across multiple tiles.

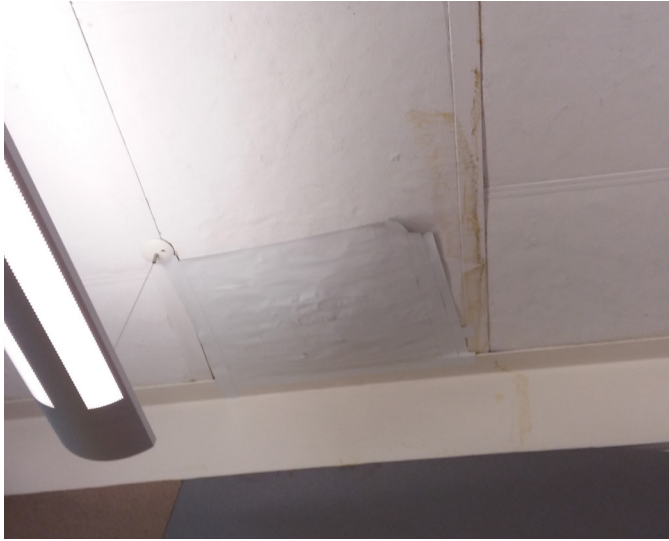
37. Location:

A square area is seen patched where water damage is seen.

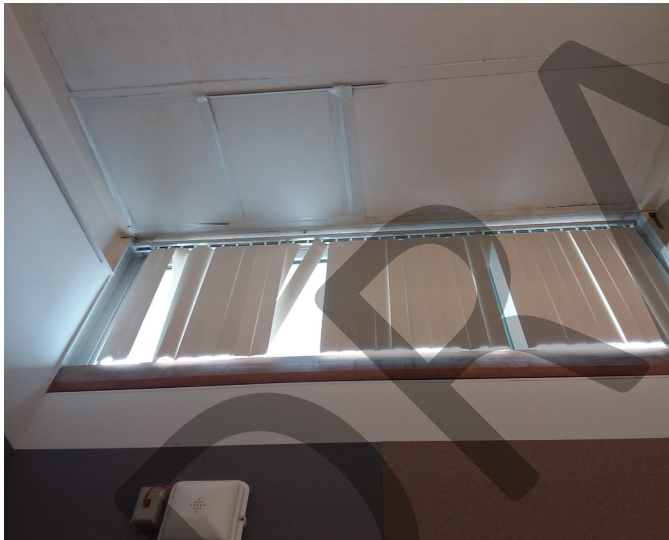
38. Location:

Vertical blinds are damaged and needs replacing.

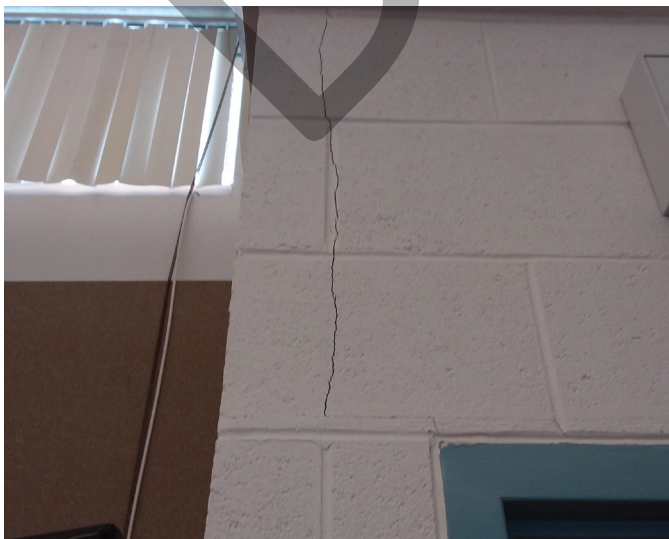
39. Location:

Crack running through 3 coursings of CMU.

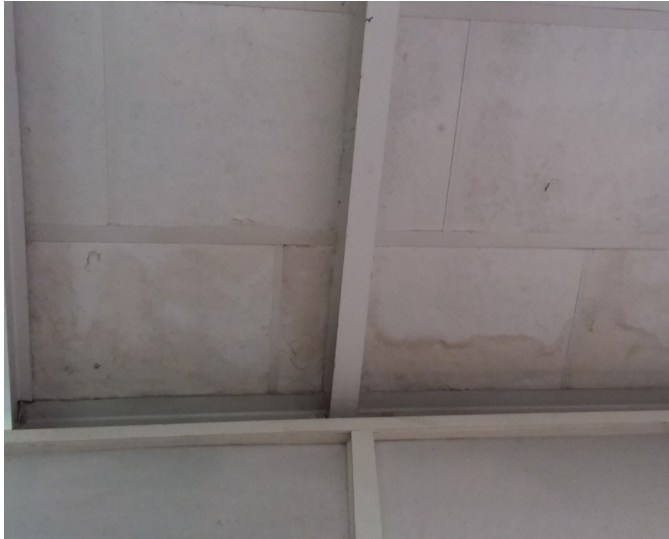
43. Location:

Installation is stained and peeling in some areas.

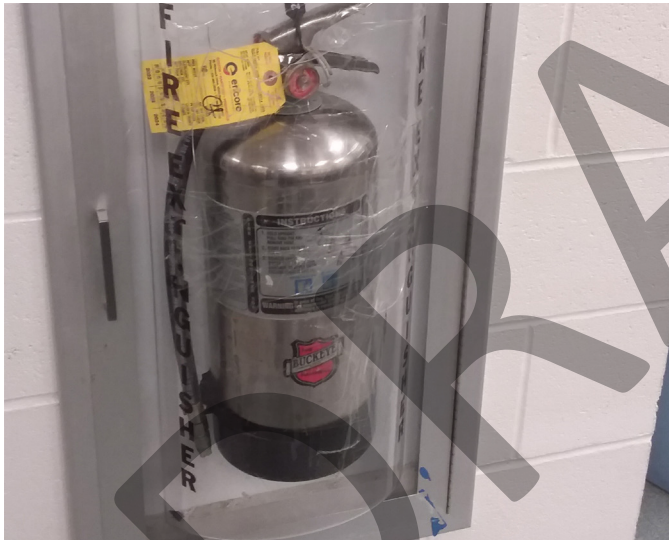
47. Location:

Fire extinguisher door is broken and needs repair.

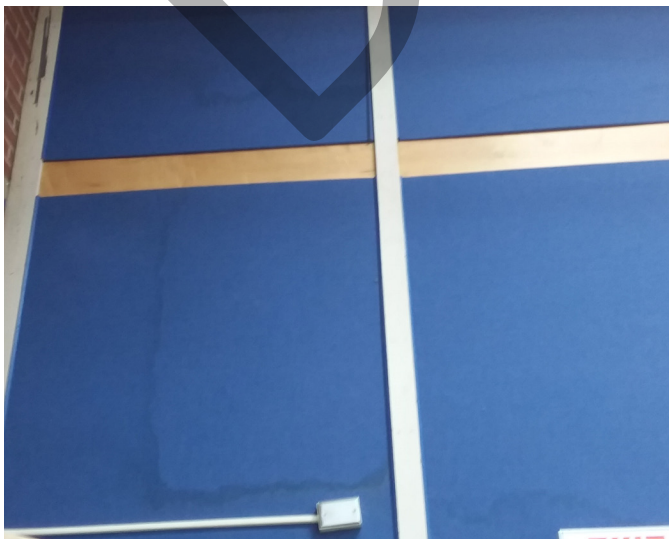
48. Location:

Water stain on acoustical wall panels.

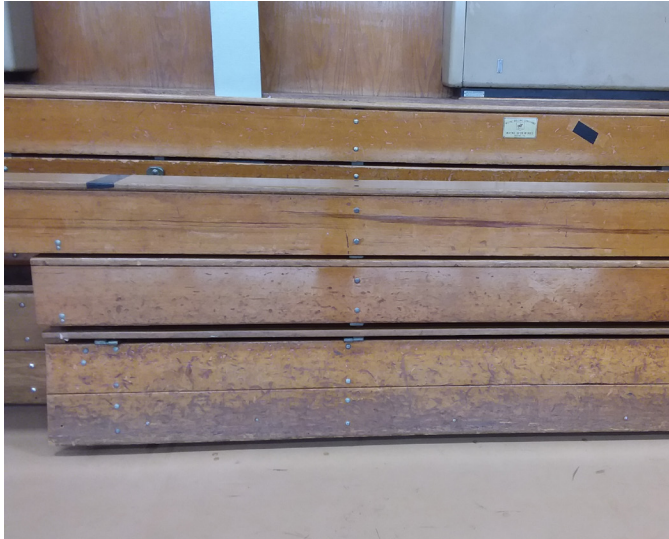
49. Location:

Wood bleachers are faded and scratched. Bleachers need to be refinished and repaired.

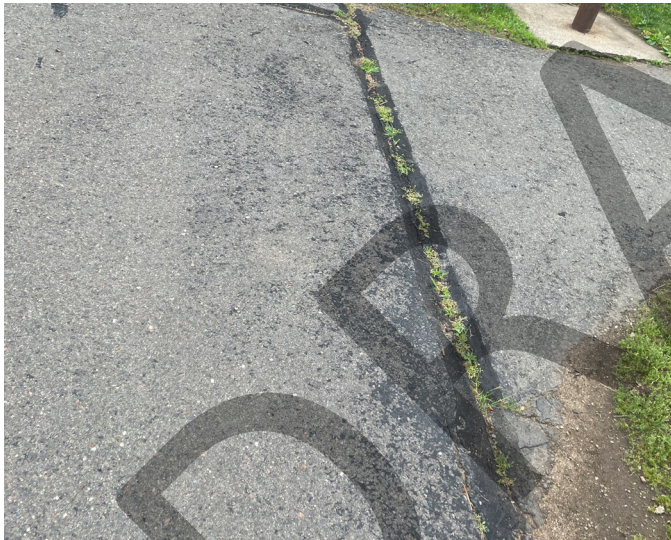
5. Location:

Walkway has been patched in several areas - grass is beginning to grow in the cracks

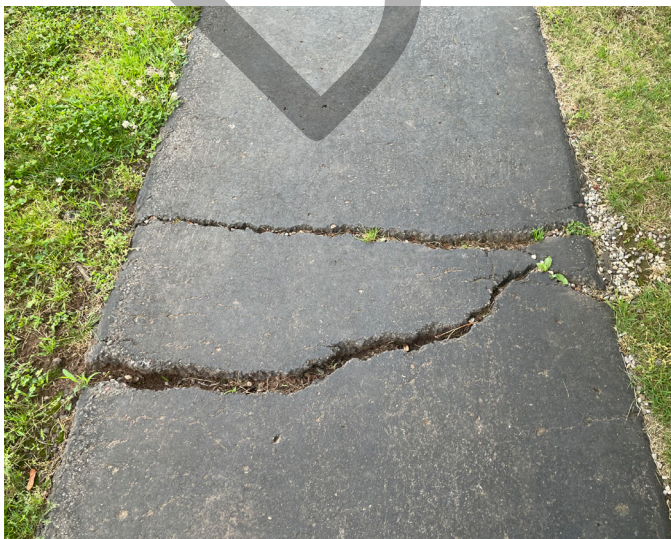
6. Location:

Cracked bituminous walkway - several locations

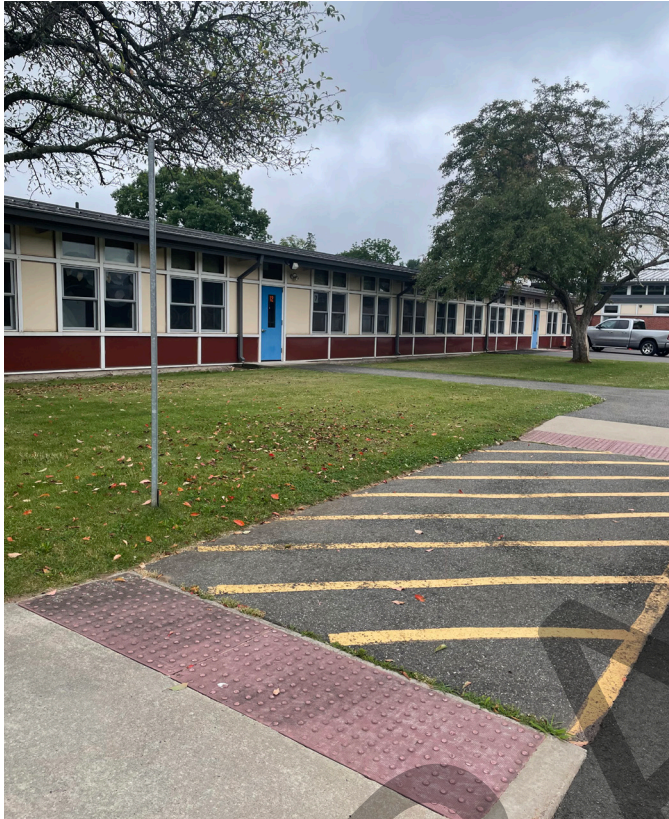
10. Location:

Missing signage

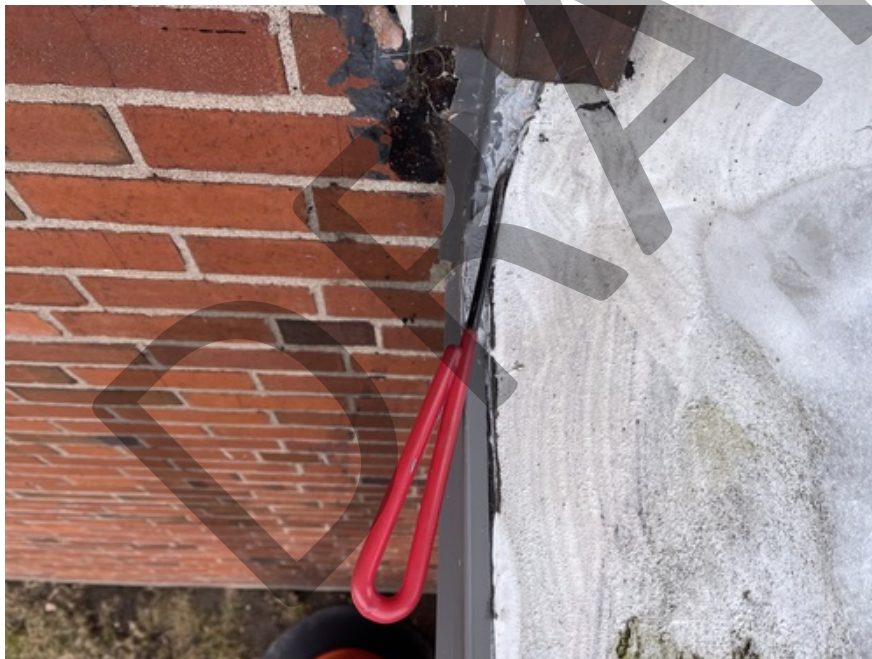
Photo 3

Open condition- Flashing

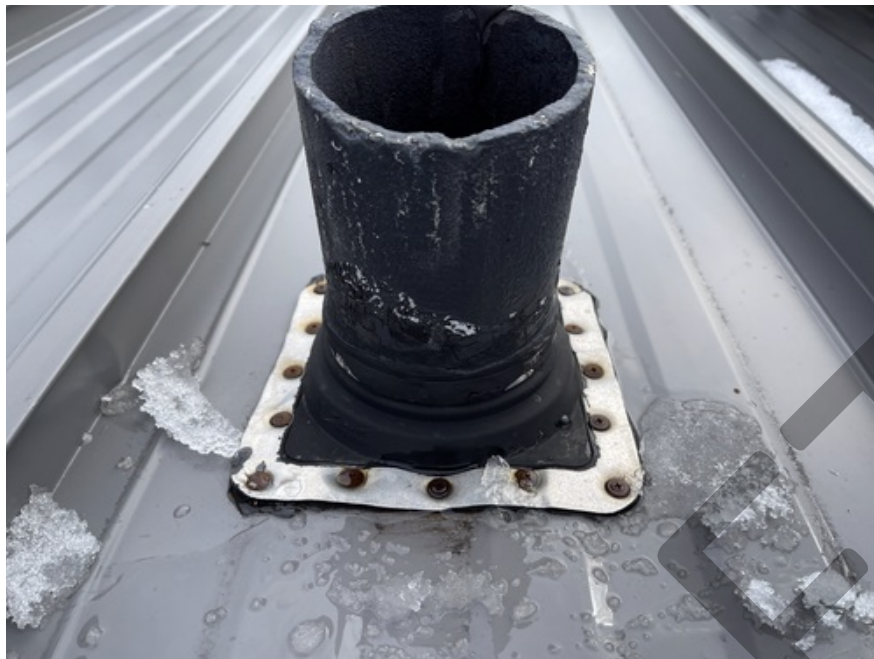
Photo 4

**Through Fastened bott-
Sealing recommended**

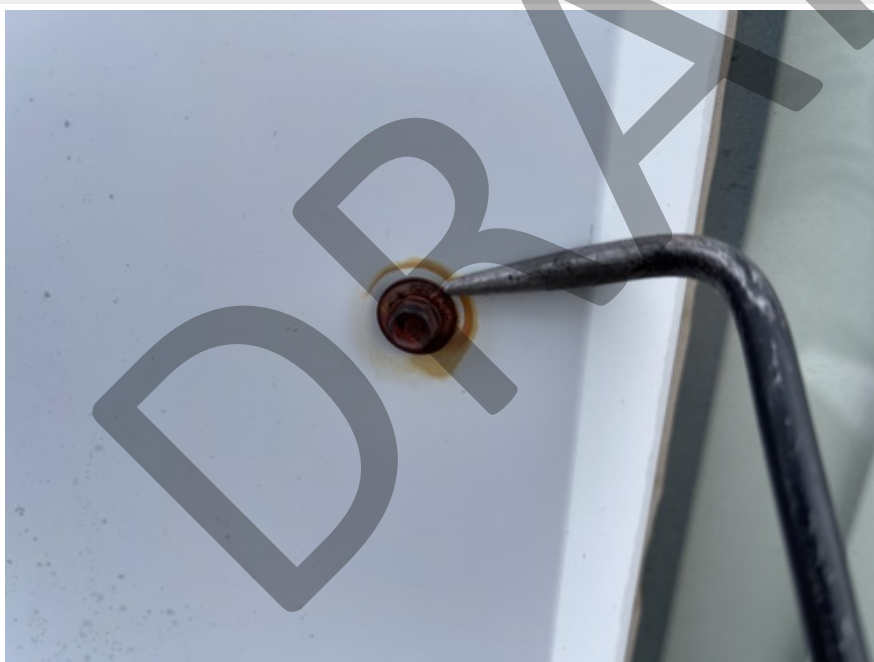
Photo 5

**Open condition- Exposed
fasteners**

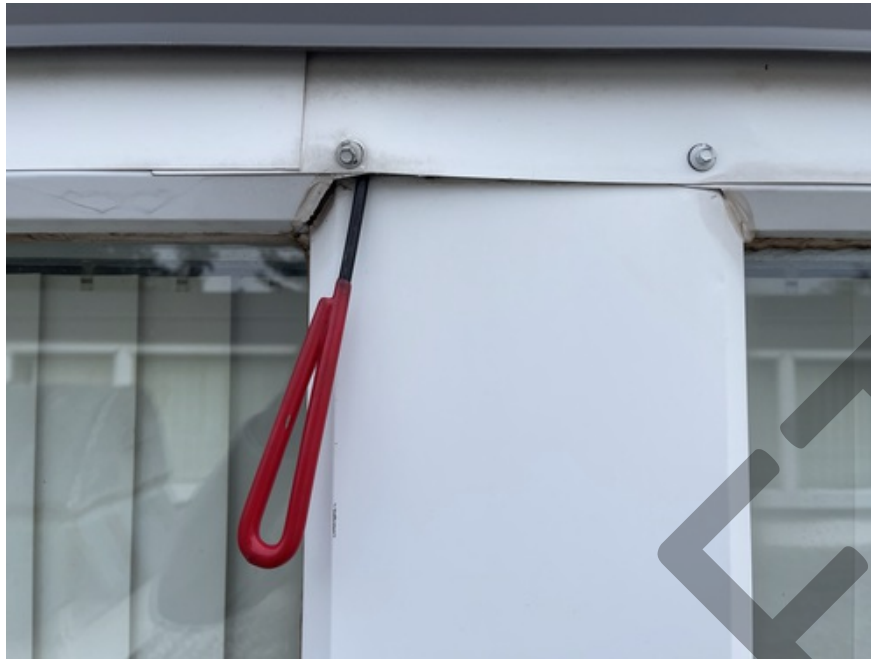
Photo 6

Open condition- Window metal trim- Consistent throughout

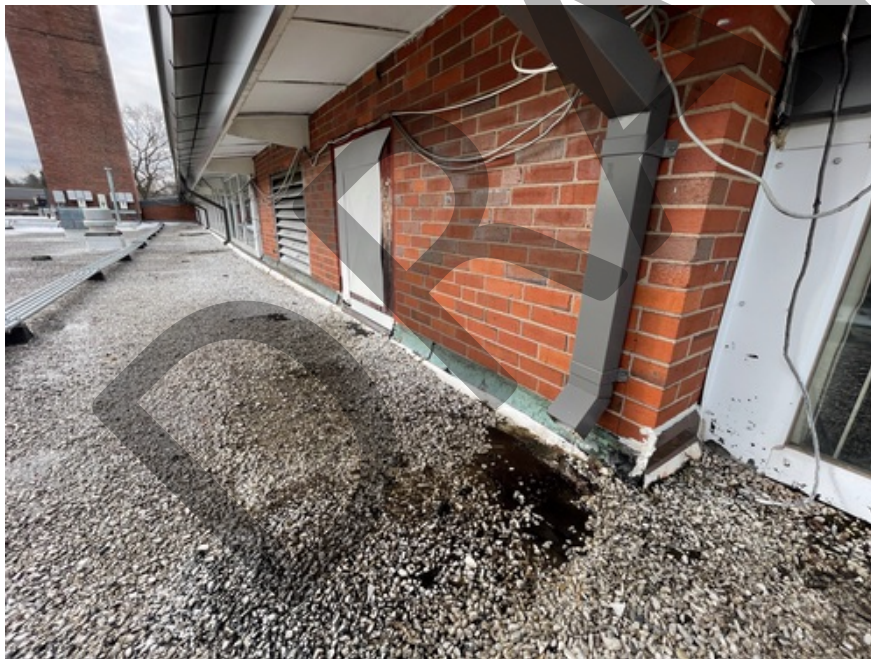
Photo 7

Recommend a splash block and Sealing masonry

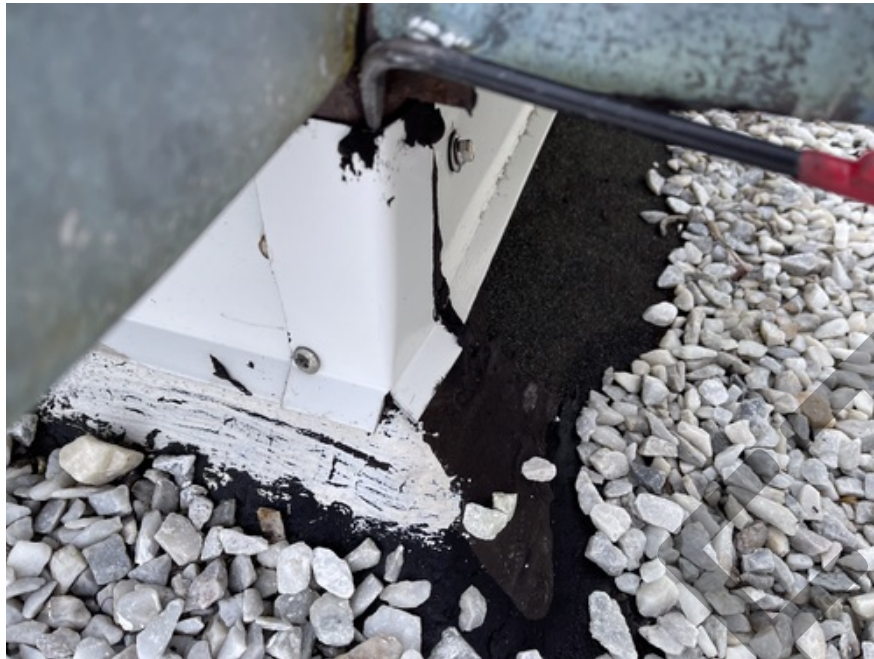
Photo 8

Open condition- Curb flashing on unit

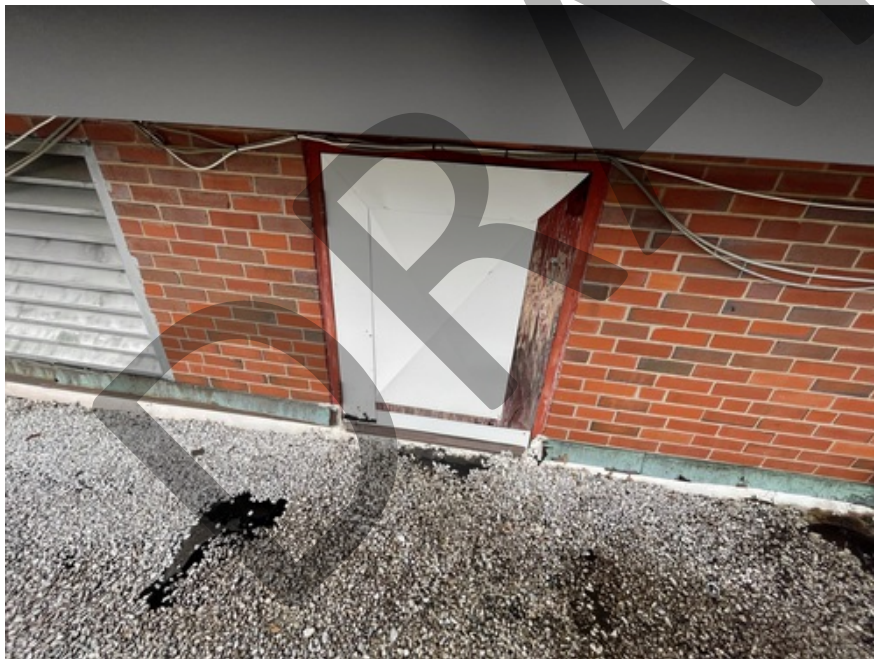
Photo 9

Open condition- Exposed wooden door

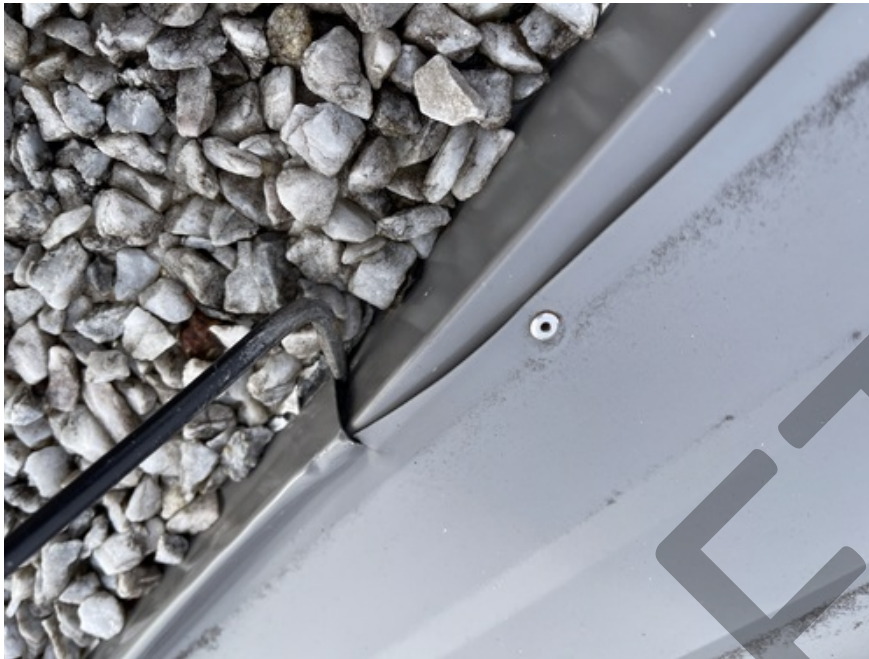
Photo 10

Open condition- Metal trim transition- Resealing recommended

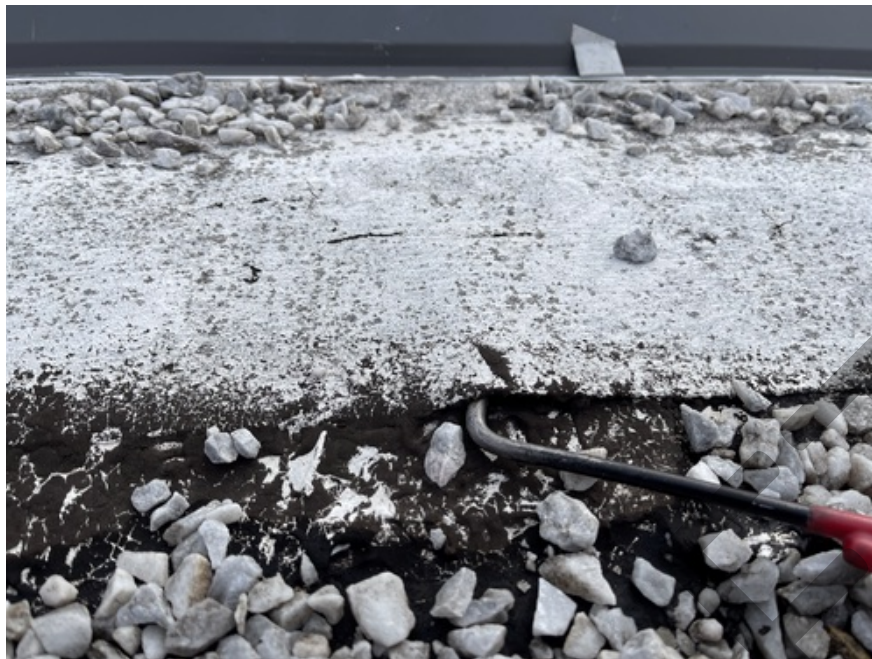
Photo 12

Open condition- Perimeter flashing need some attention

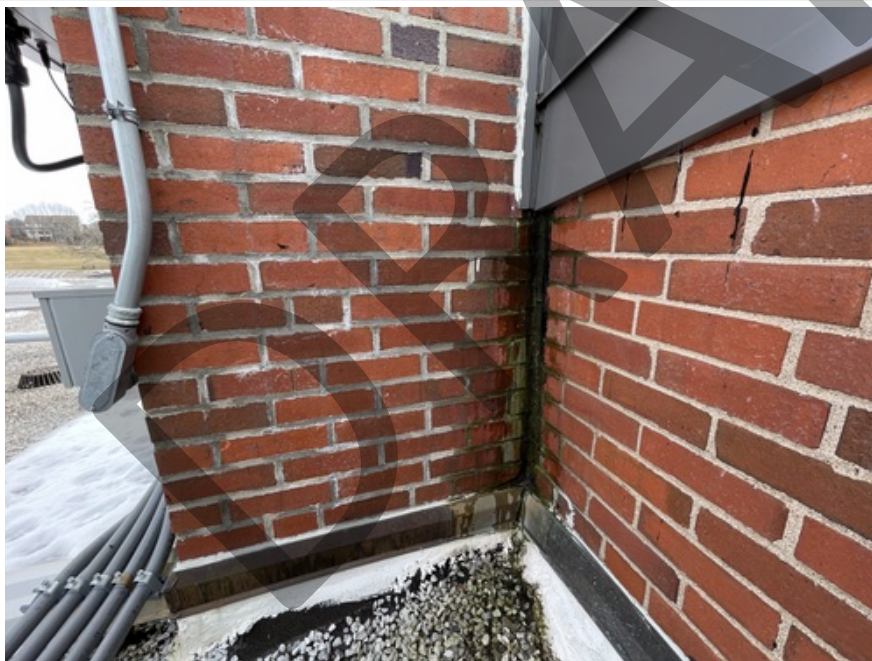
Photo 13

Open condition- Exposed masonry- Chimney is recommended to be sealed and or wall paneled

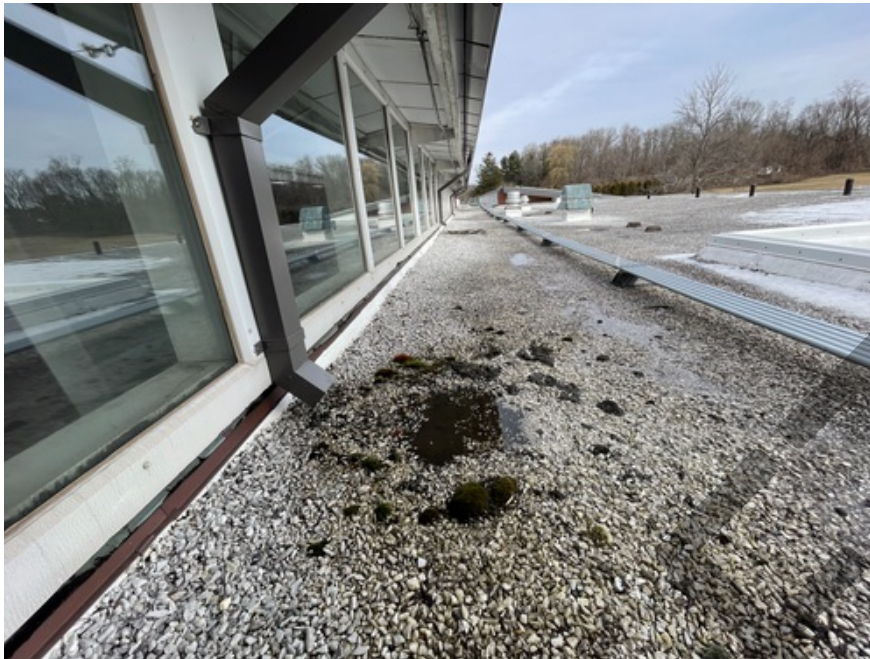
Photo 14

Splash Block needed to prevent membrane wear

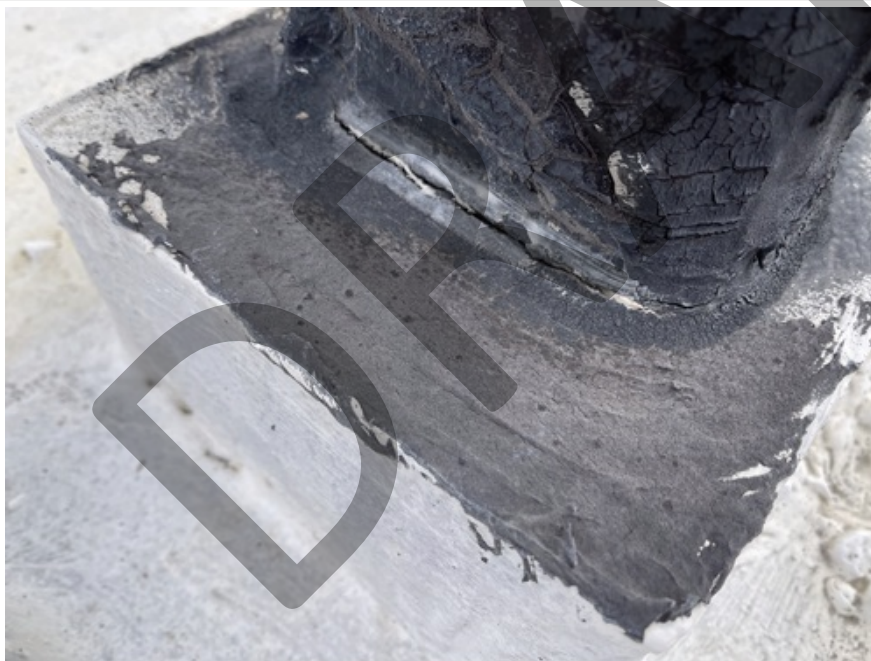
Photo 17

**Open condition- Curb
flashings starting to show
signs of weathering**
