Facility Study and Master Plan

# Next Step Building

38 Park Street, Vernon CT 06066

SUMMER 2023

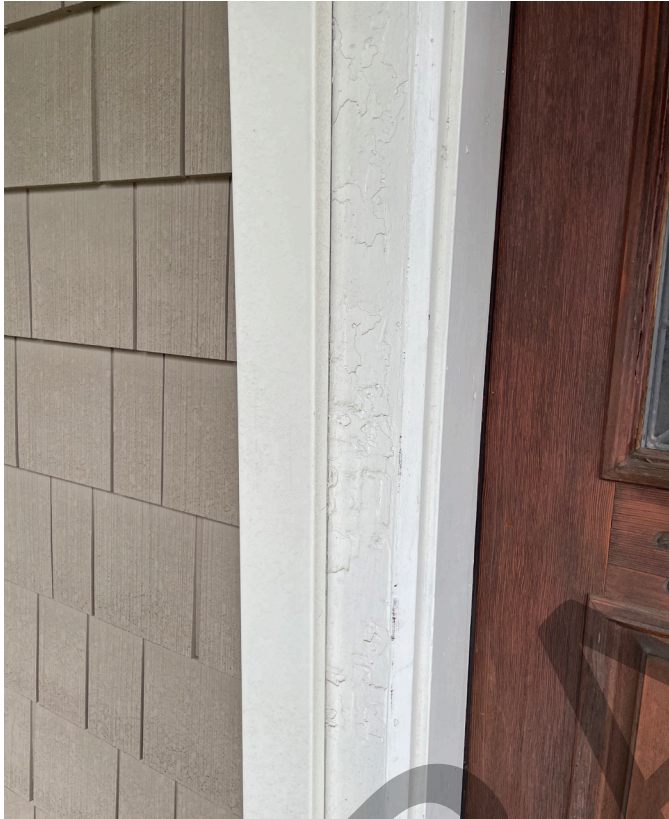
West Elevation - Front Door

Door frame finish peeling

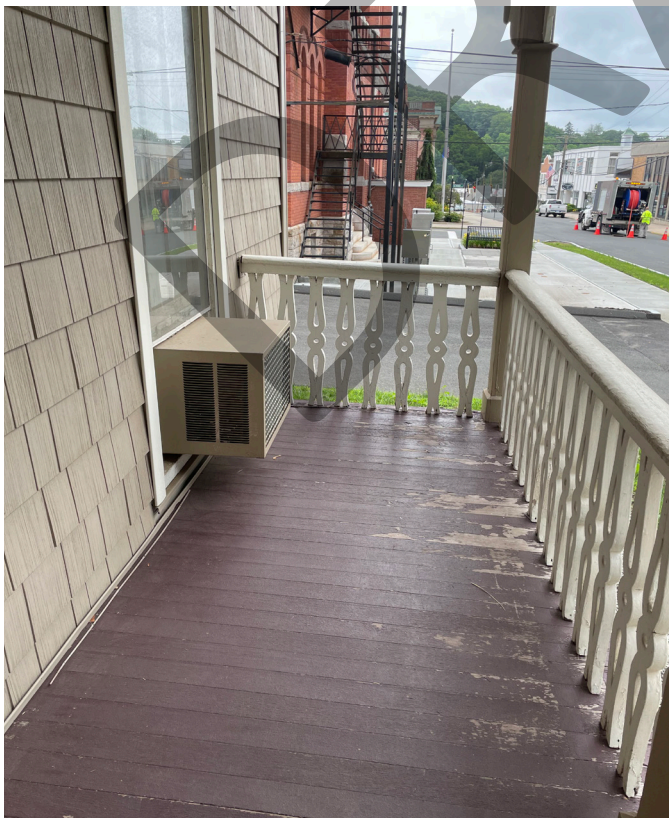
West Elevation - Porch

Wood flooring needs to be refinished.

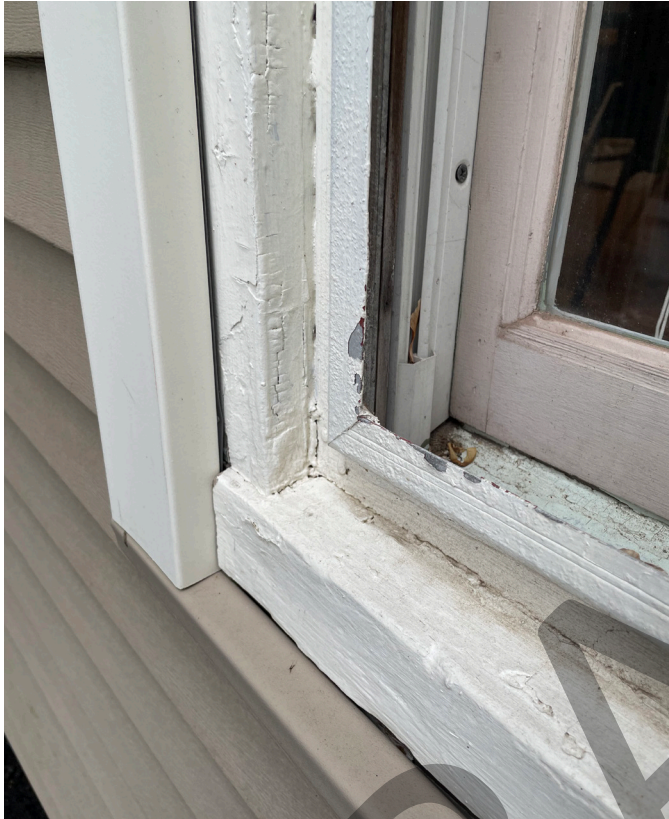
West Elevation

Various parts of the window frame appears to be made of wood and metal. The frame needs to be refinished.

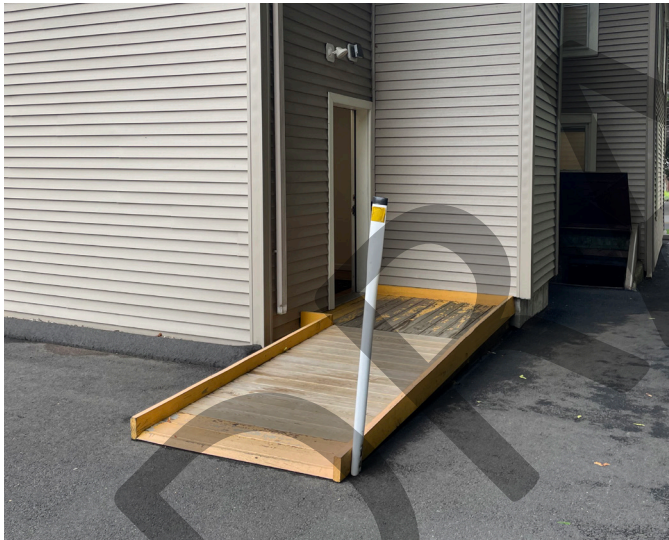
East Elevation

Wooden ramp does not have any handrails and the finish has worn away.

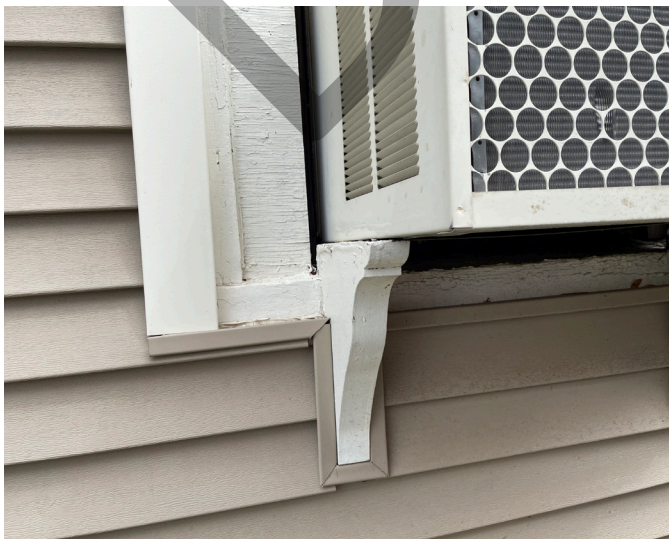
South Elevation

Frame below AC unit is cracked and wearing away.

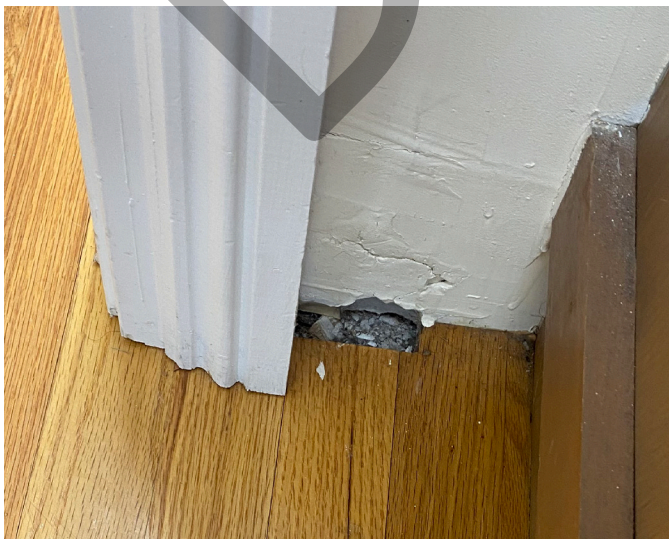
First Floor

Chunk of wood floor missing.

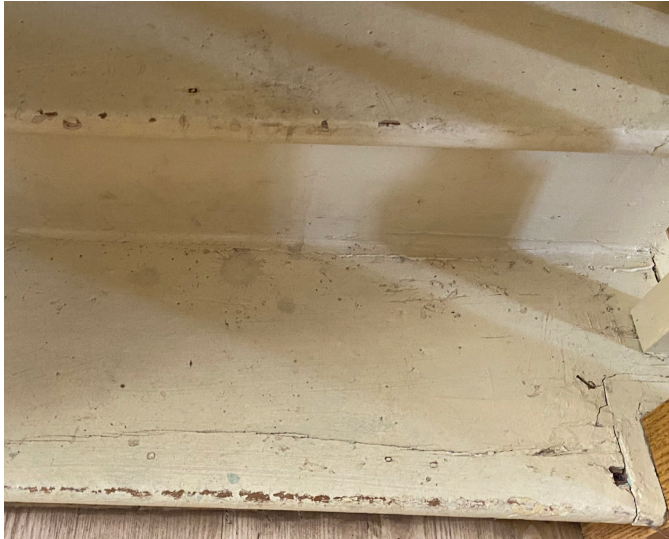
First Floor Stairs

Paint is chipped and the wood is deteriorating on some parts of the steps.

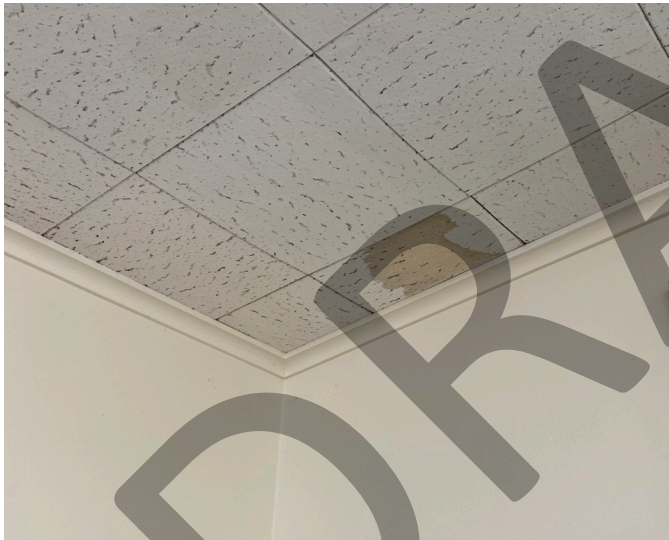
Second Floor

Stained ceiling tile due to possible water leak.

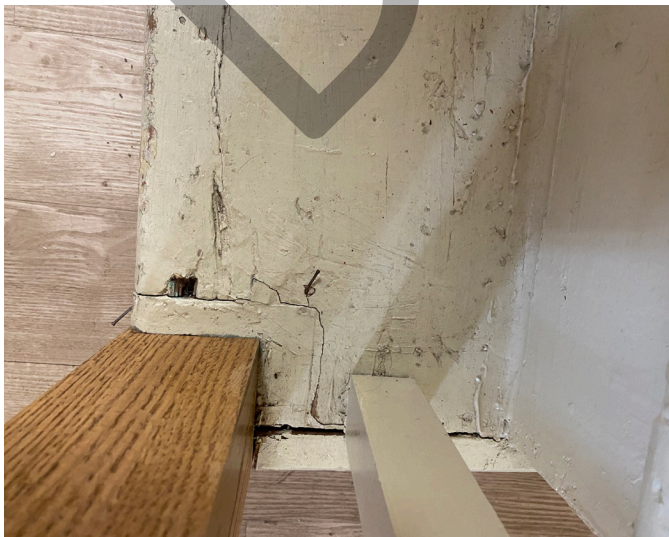
Second Floor Stairs

Damaged stair tread.

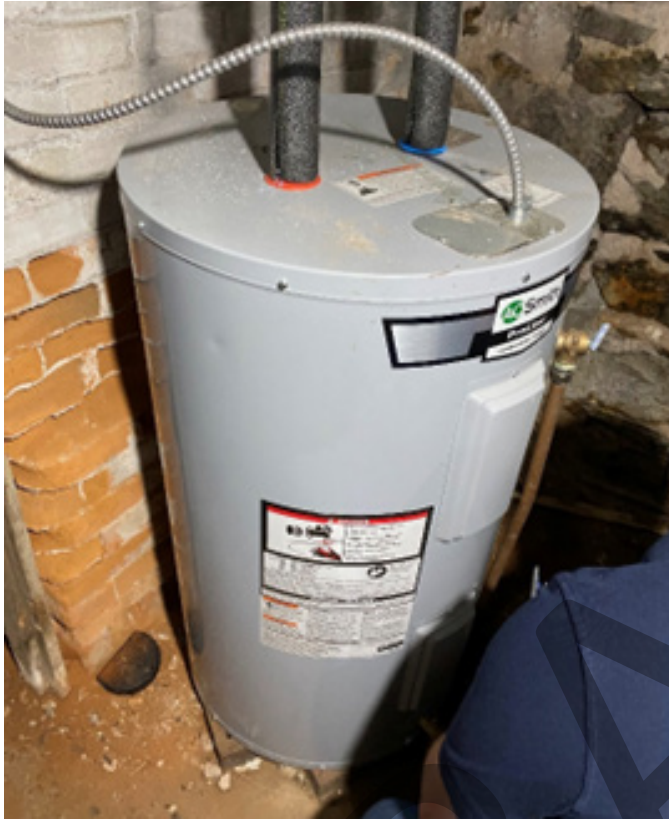
Basement

Water Heater

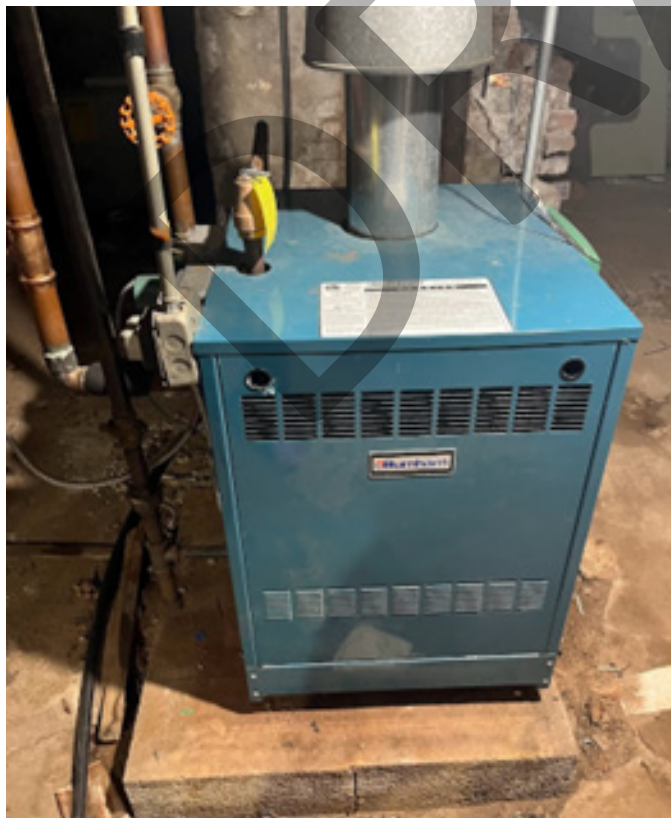
Basement

Burnham Atmospheric Boiler

- Heating Plant: The existing atmospheric boiler is located in the basement. The existing boiler is nearing the end of its useful life and we recommend it be replaced with a high efficiency condensing boiler.
- Ventilation/Exhaust: The existing building is naturally ventilated through windows. We recommend providing mechanical ventilation and exhaust in line with ASHRAE 62.1/IMC.
- Cooling: The existing building first floor is cooled by an air conditioner in the basement, the second floor by window ac units. The basement air conditioner is beyond its useful life and we recommend it be replaced in kind. Further we would recommend replacing window AC units with centralized split system to serve second floor area.
- Controls: The existing building does not have a centralized control system. Space thermostats to be installed to serve second floor heating and cooling.

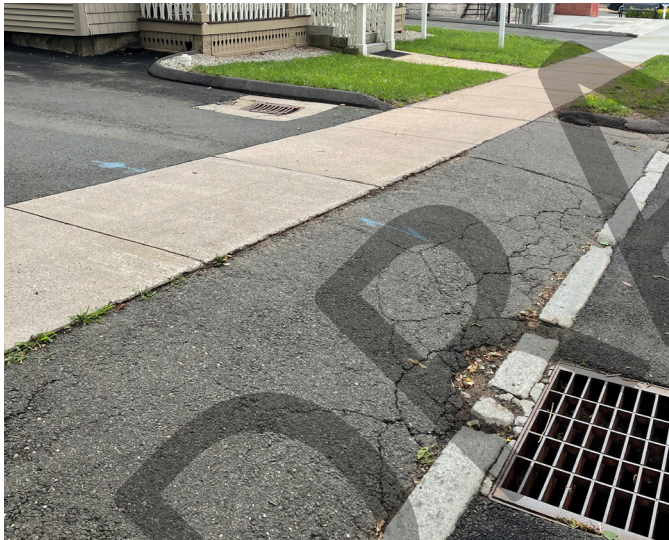
North Driveway

Cracking in bituminous entry drive and concrete edging.

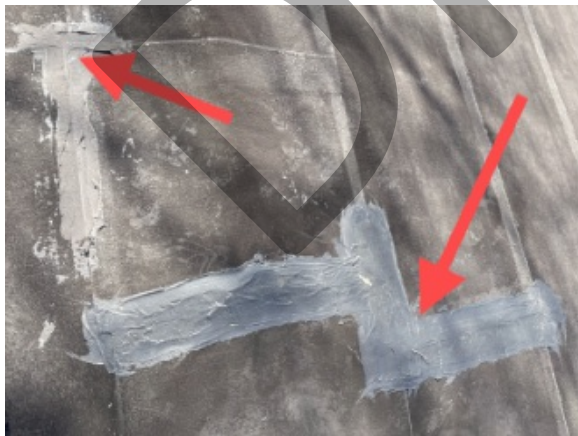
*Photo 2*

**Failing previous repairs**

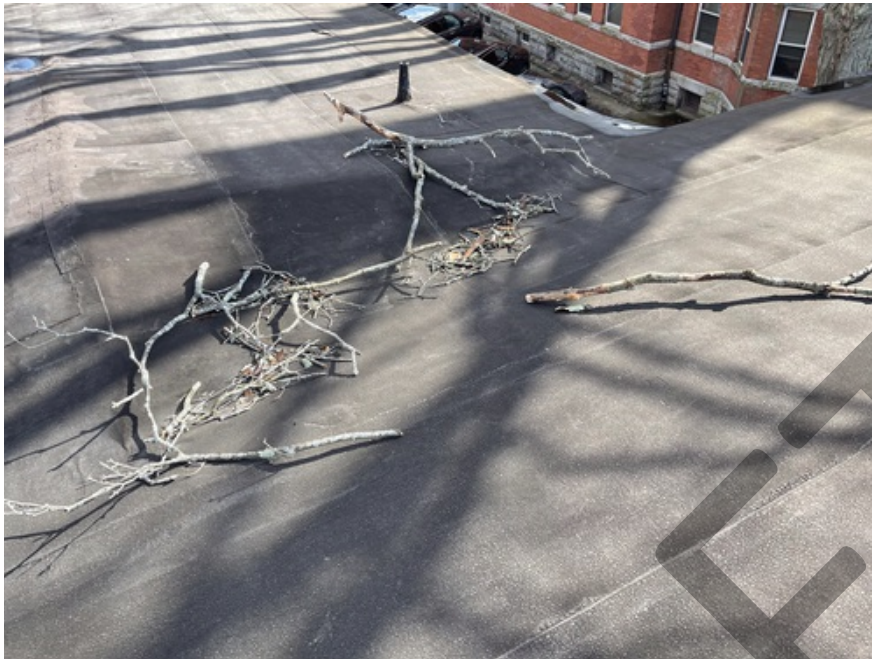
*Photo 3*

**Debris- Cutting back or removal of the nearest tree recommended**

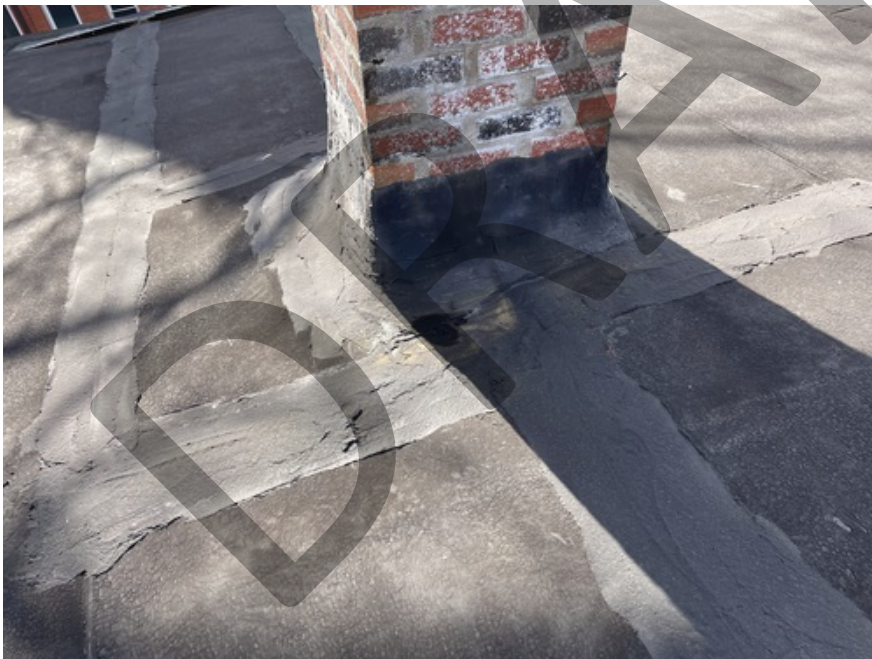
*Photo 4*

**Improper chimney flashing- Exposed porous masonry**

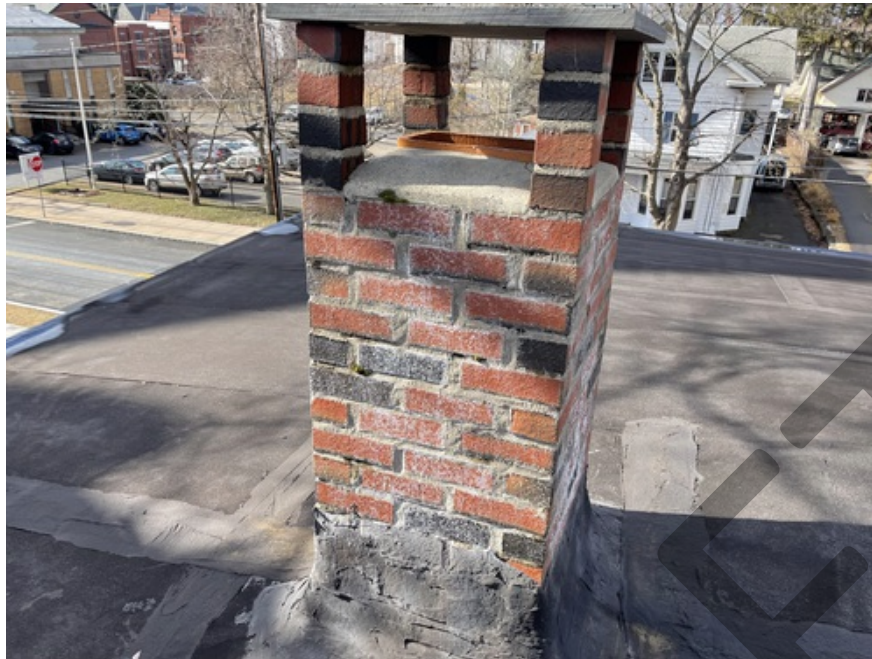
*Photo 5*

**Open condition- Porous masonry- Potentially obsolete**

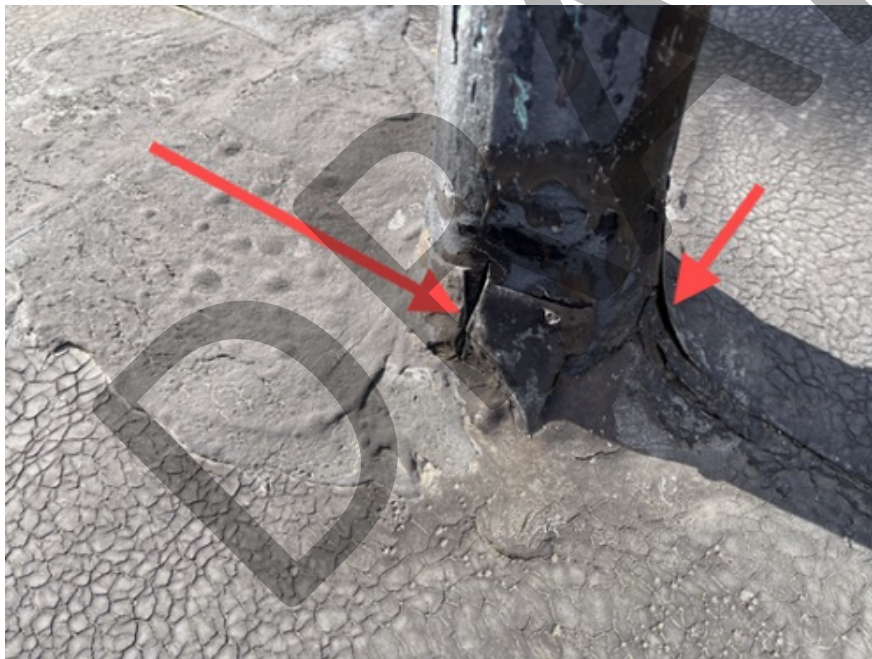
*Photo 6*

**Open condition- Failed and improper soil stack flashing**

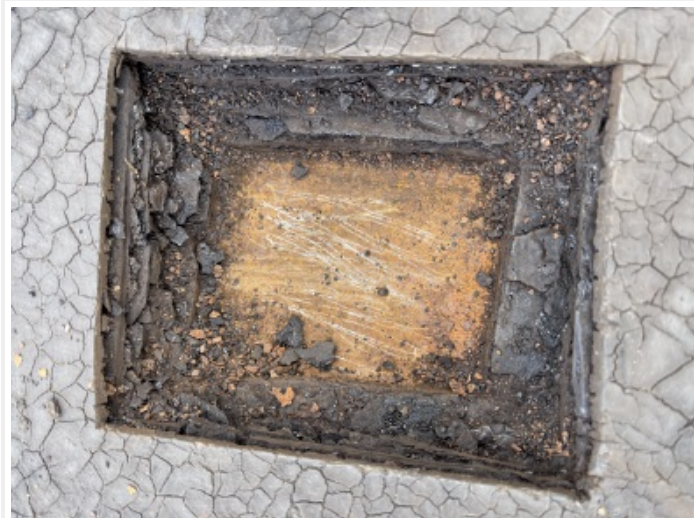
*Photo 7*

**Core Cut: Three roofing systems found**

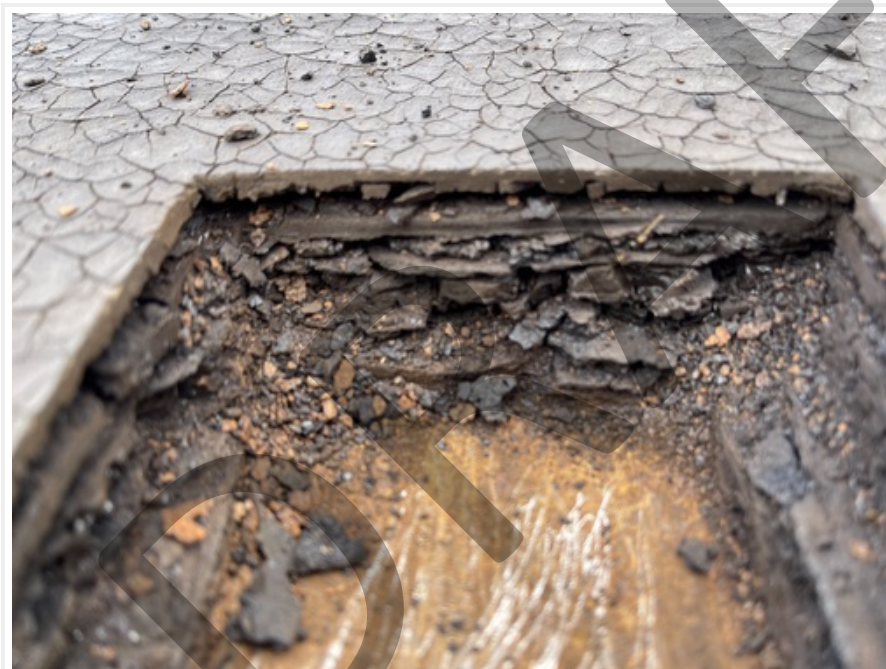
*Photo 8*

**Metal roof- Four ply BUR -  
App Modified torched  
down**

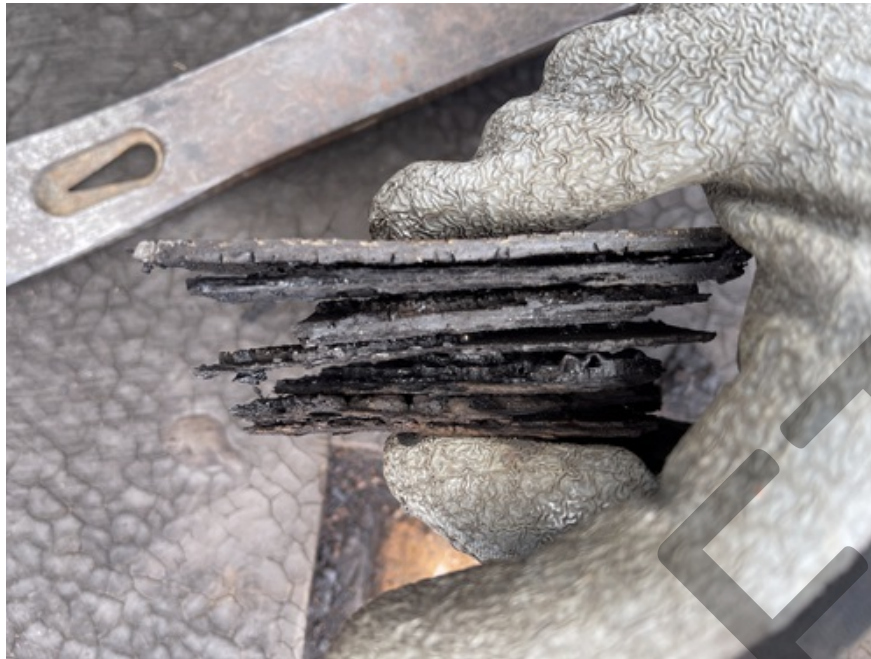
*Photo 9*

**Significant weight and potential for ASB-  
Environmental testing needed**

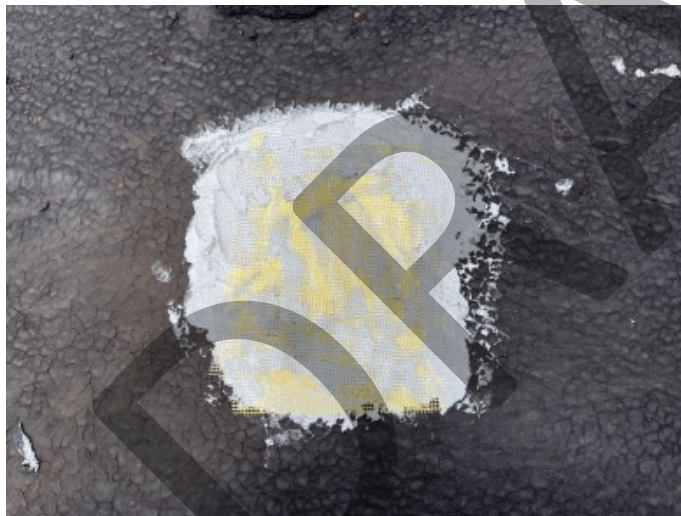
*Photo 10*

**Properly repaired core cut with  
reinforcement**

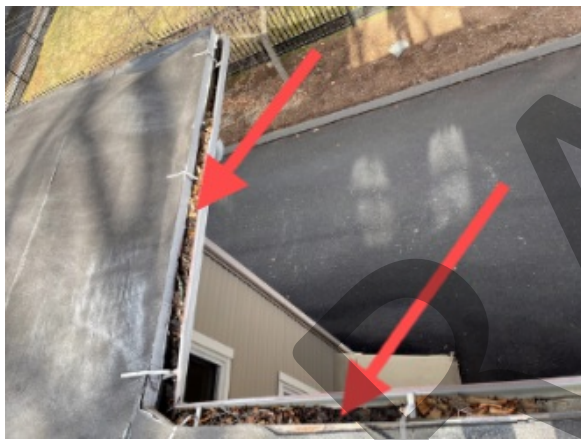
Photo 12

**Improperly installed gutters- Clogged with leaves and debris**

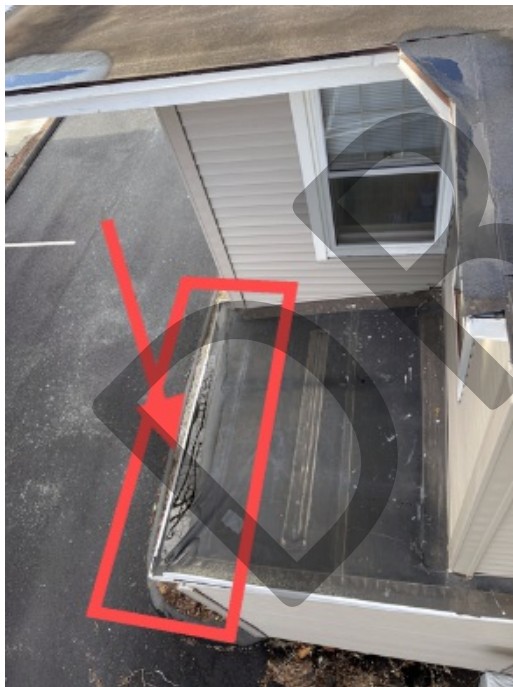
*Photo 14*

**Open condition- Failed EPDM lower roof**

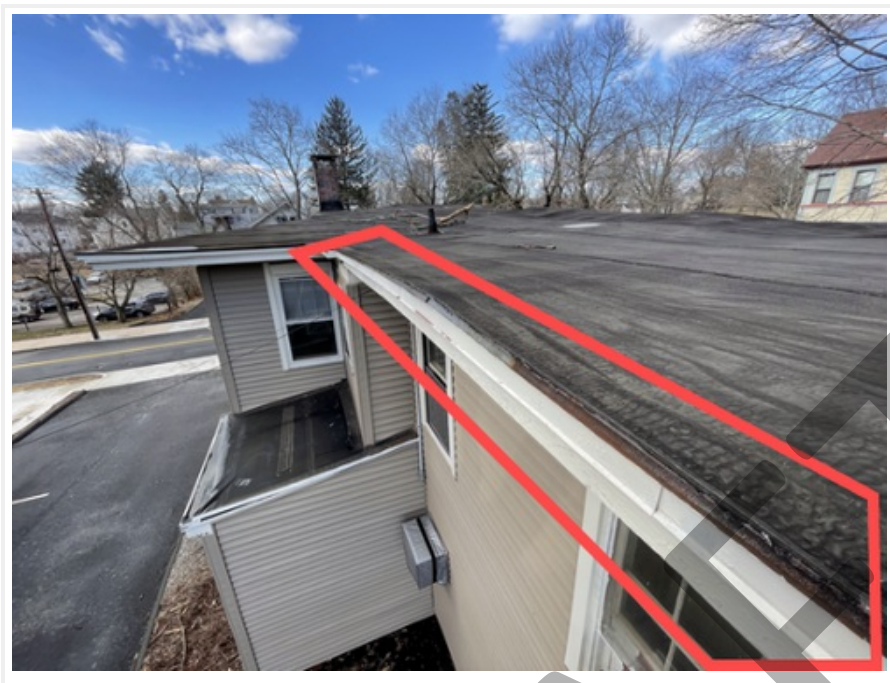
*Photo 15*  
**Open condition- Perimeter  
edge lifting**
