Facility Study and Master Plan

# Maple Street School

20 Maple St, Vernon, CT 06066

SUMMER 2023

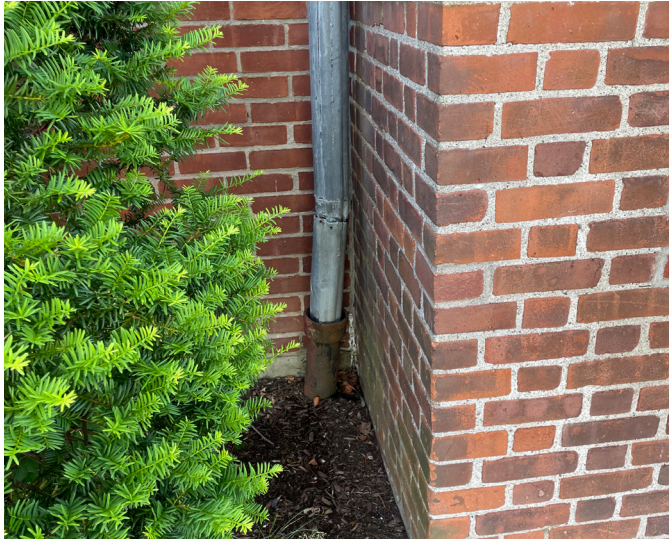
### 1. Location:

Damaged downspout and rusted boot

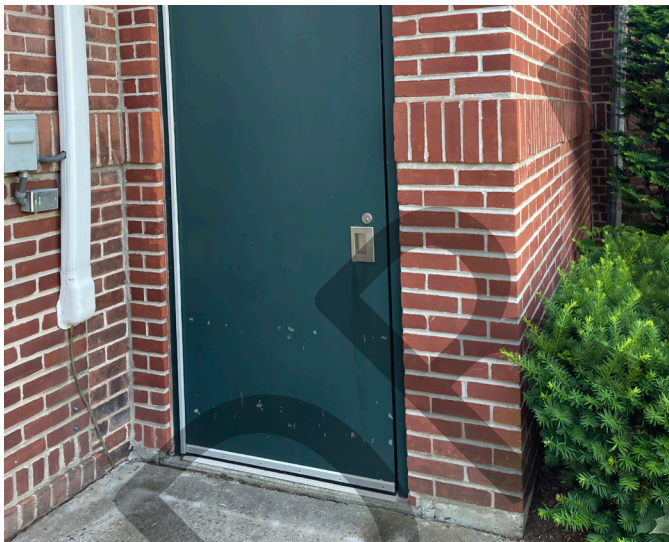
### 2. Location:

Damage at lower portion of door -  
typical in this area

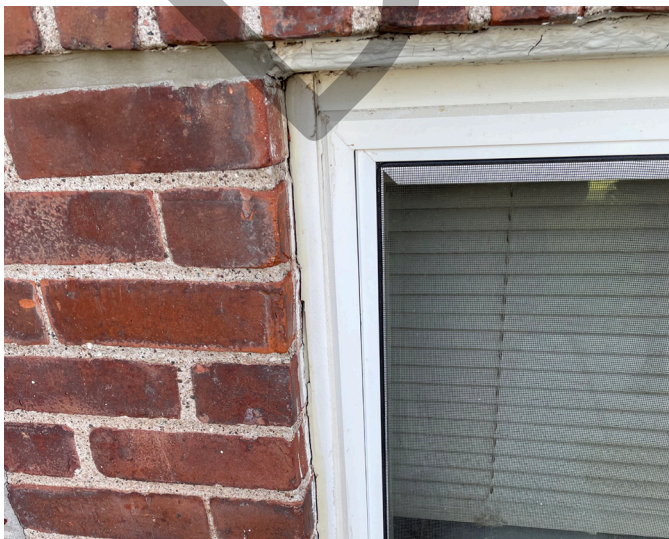
### 3. Location:

Window sealant cracked and  
deteriorating

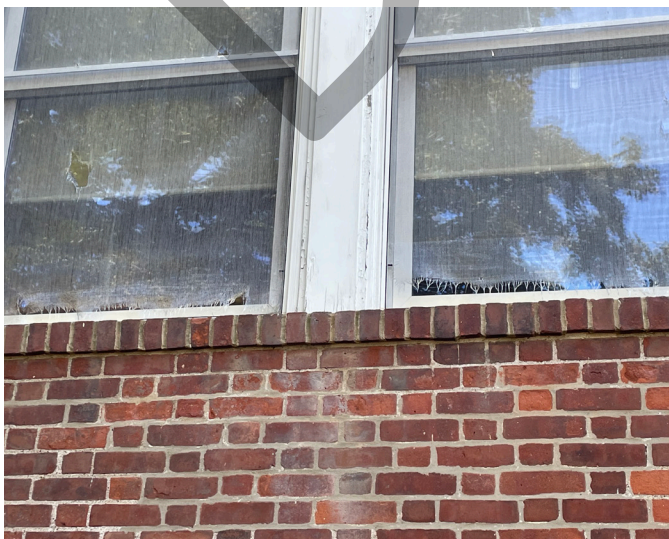
### 6. Location:

Window screens torn and damaged.  
Wood frame at windows is peeling

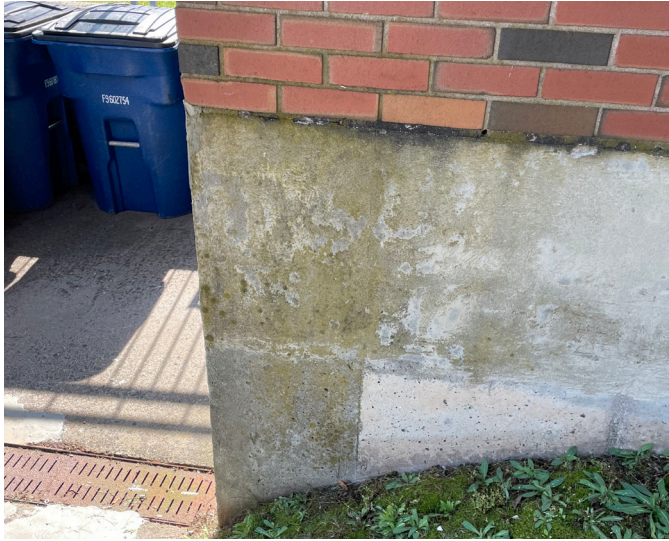
### 13. Location:

Moss and mildew build up on foundation

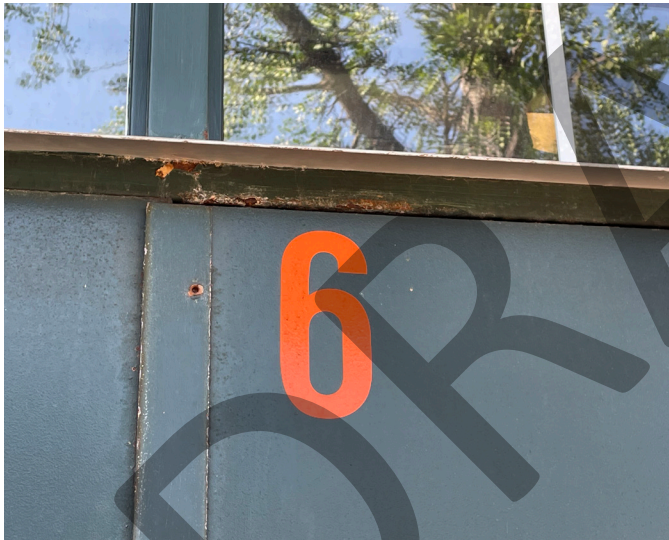
### 14. Location:

Deterioration of door frame visible in several locations

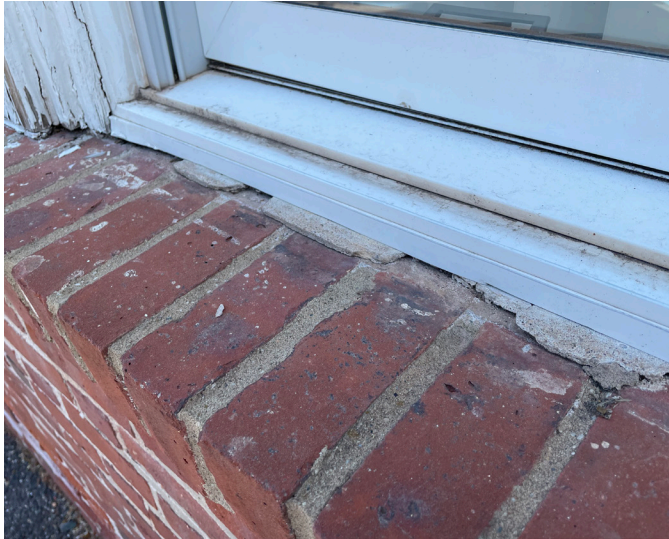
### 28. Location:

Sealant missing and falling off window sill. Deteriorated wood frame

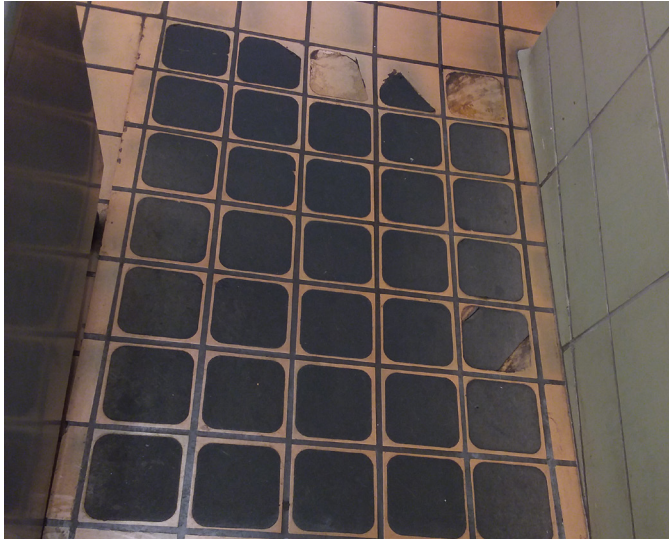
### 31. Location:

Quarry tile has what appears to be rusting and some cracking.

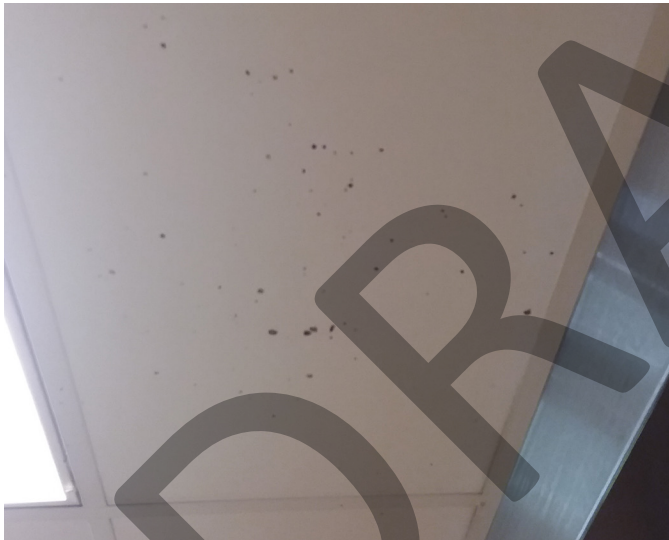
### 32. Location:

Stain and marks on ceiling tile.

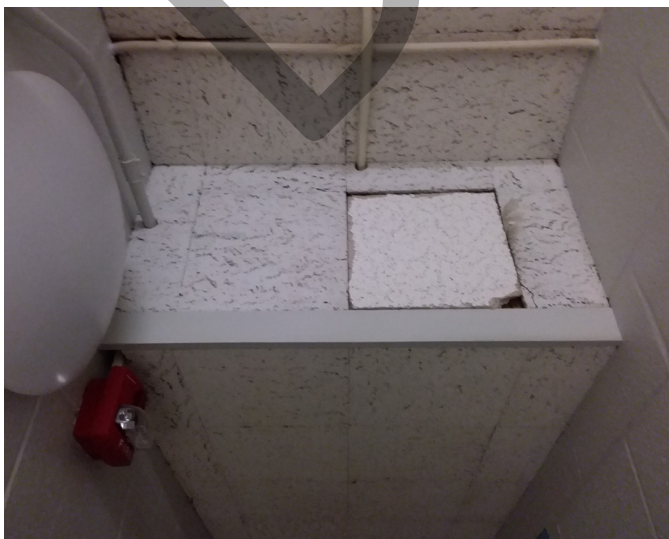
### 33. Location:

Acoustic tiles are damaged and not secured properly.

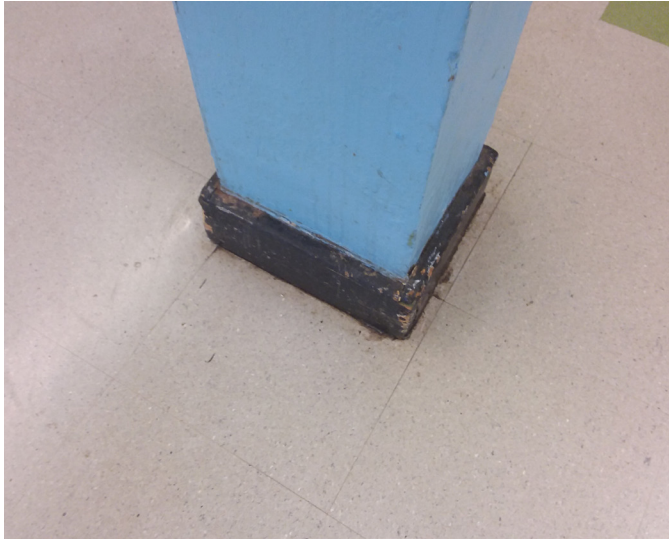
### 34. Location:

Wood wall base is chipped and deteriorating.

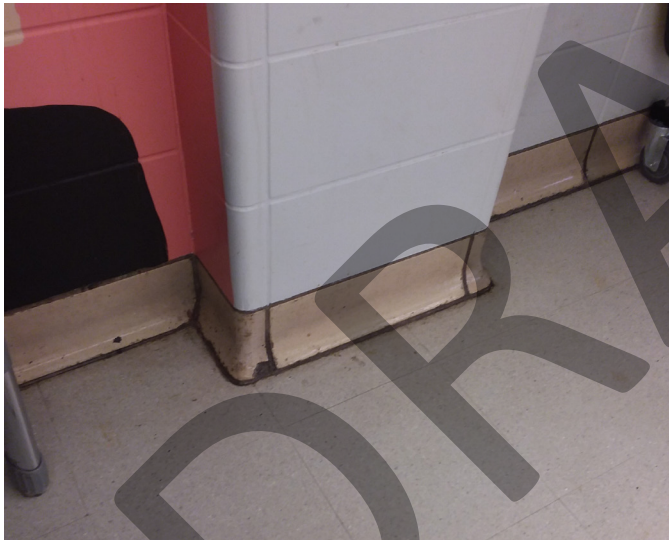
### 35. Location:

CMU wall base is chipping and needs repair.

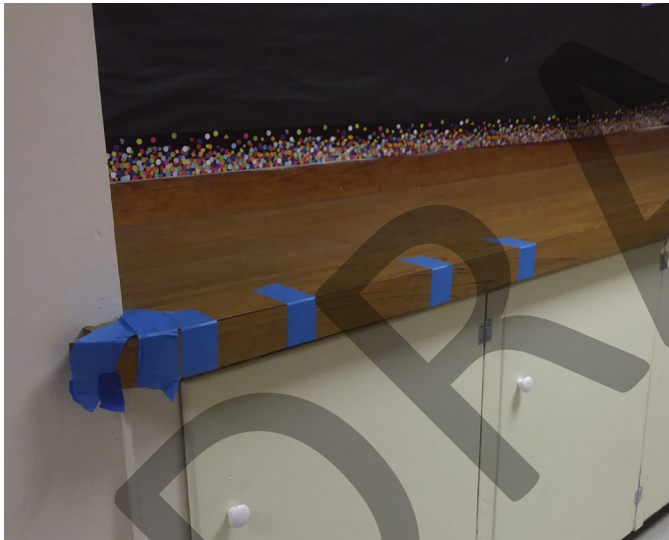
### 38. Location:

Plastic laminate counter edge-band is popping off and needs repair.

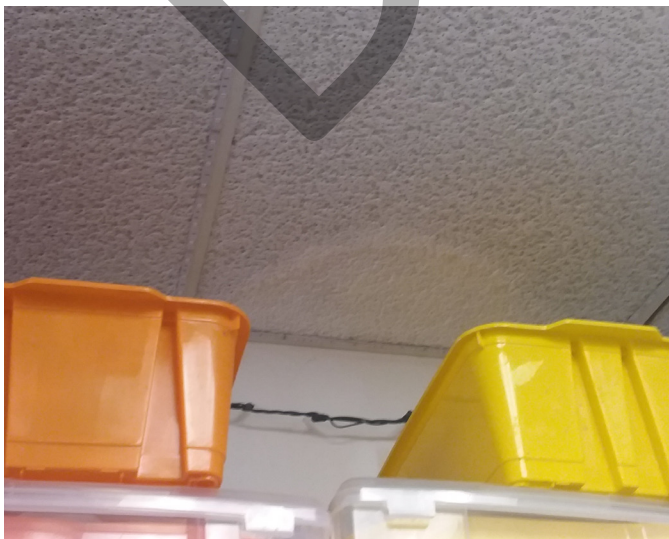
### 39. Location:

Stained ceiling tile.

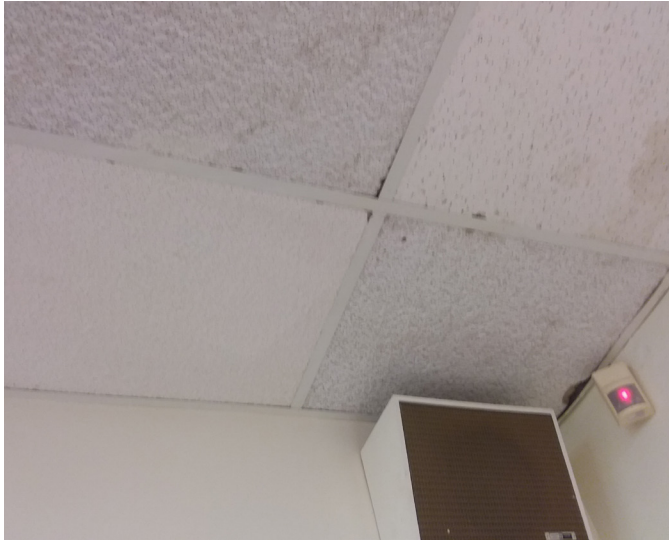
### 43. Location:

Ceiling Tile stained.

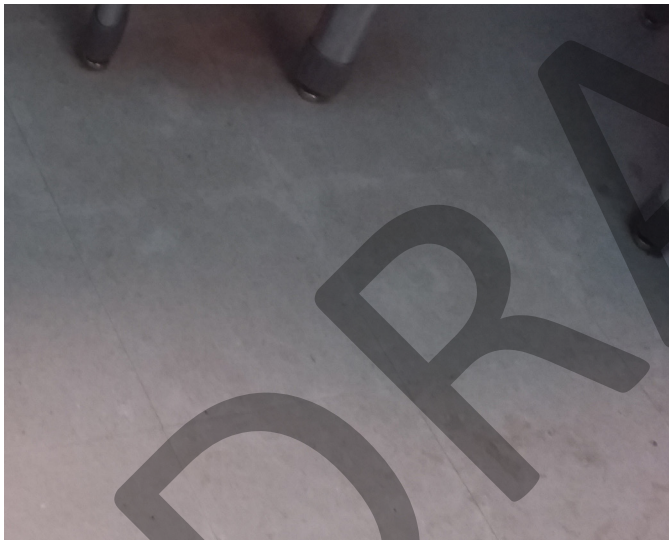
### 50. Location:

VCT is discolored and finish is wearing away.

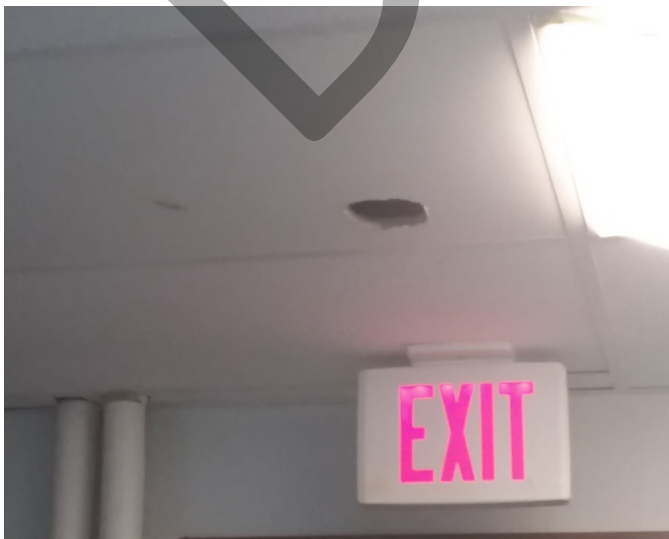
### 51. Location:

Hole in ceiling needs repair.

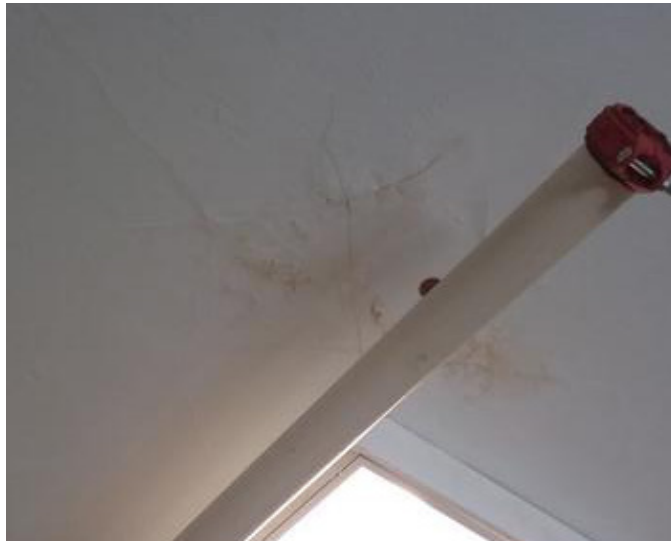
### 55. Location:

Apparent water damage to ceiling.

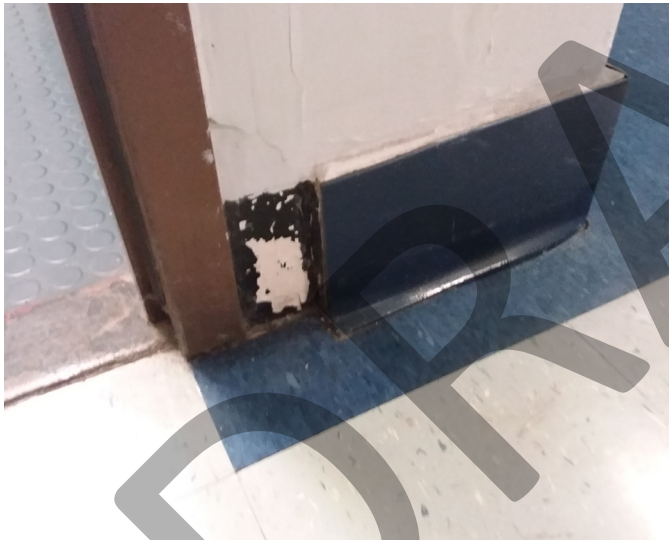
### 59. Location:

Wall base broken and needs repair.

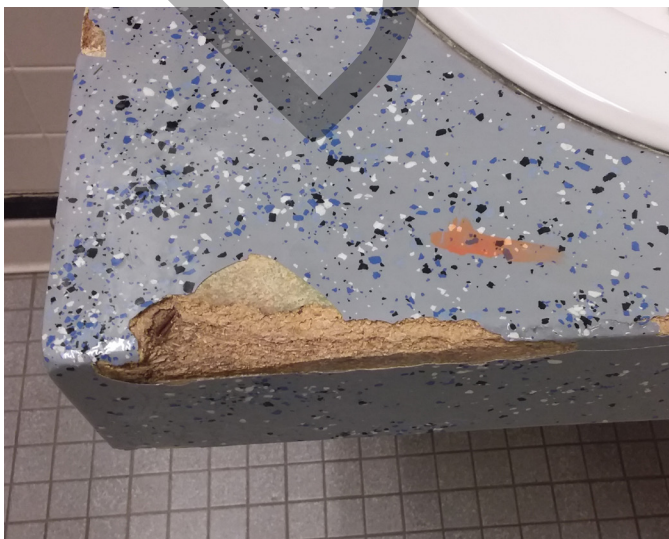
### 60. Location:

Countertop severely damaged and chipped and bubbling in other areas.

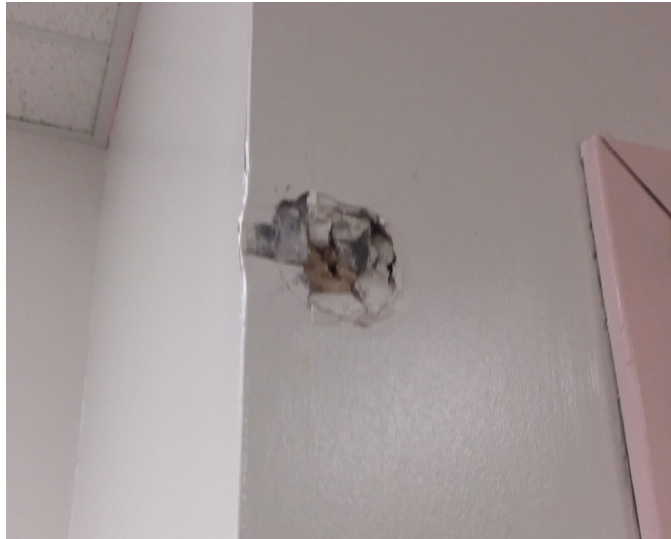
### 61. Location:

Hole in wall that needs repair.

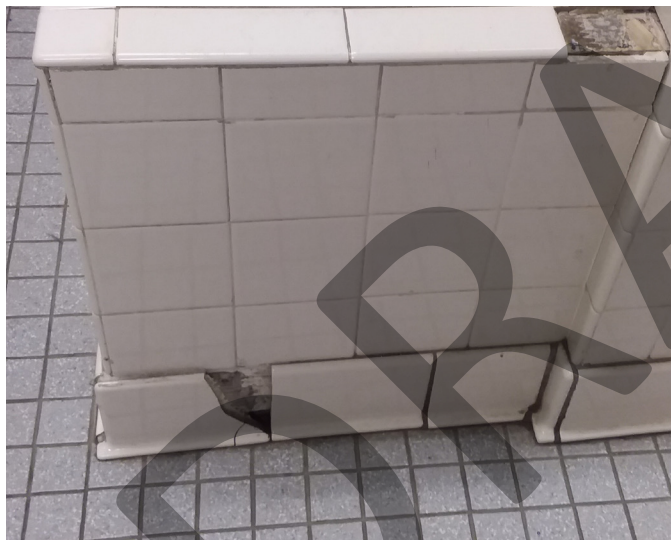
### 62. Location:

Broken and cracked tiles need to be replaced.

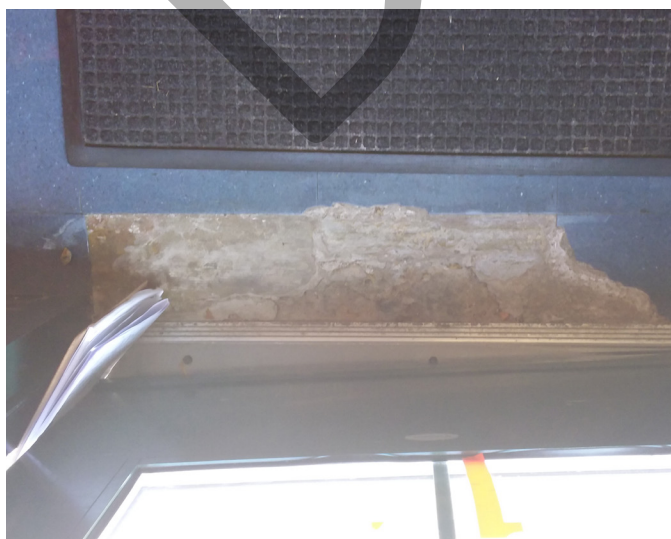
### 63. Location:

VCT by exit door is completely ripped up and needs to be replaced.

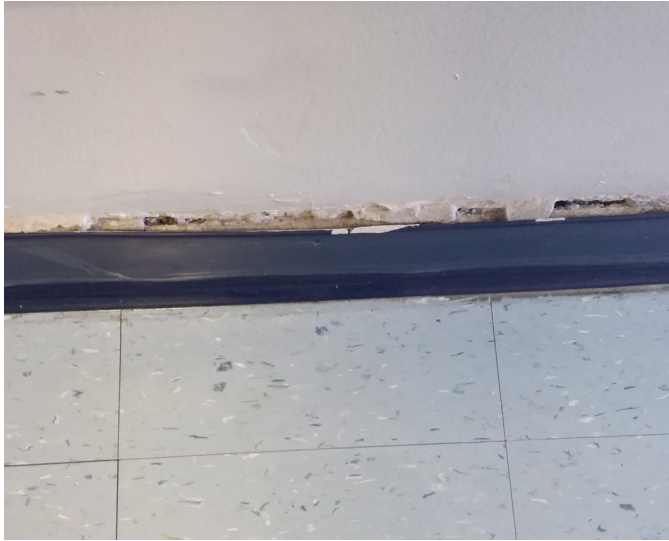
### 64. Location:

Wall/ wall base crumbling and cracking.

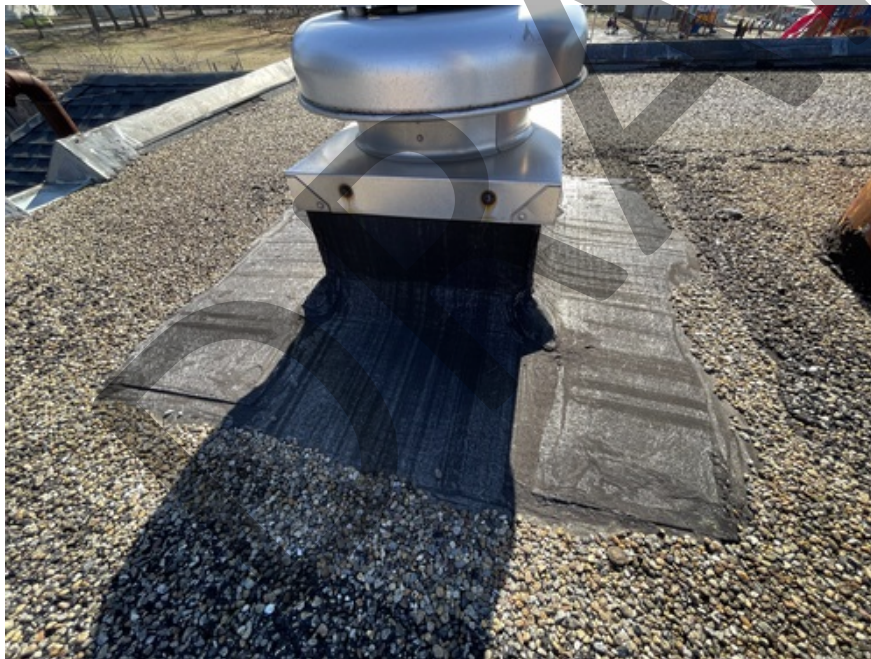
*Photo 5*

**View of the mineral modified section- mid-level- Clogged drain and minor ponding**

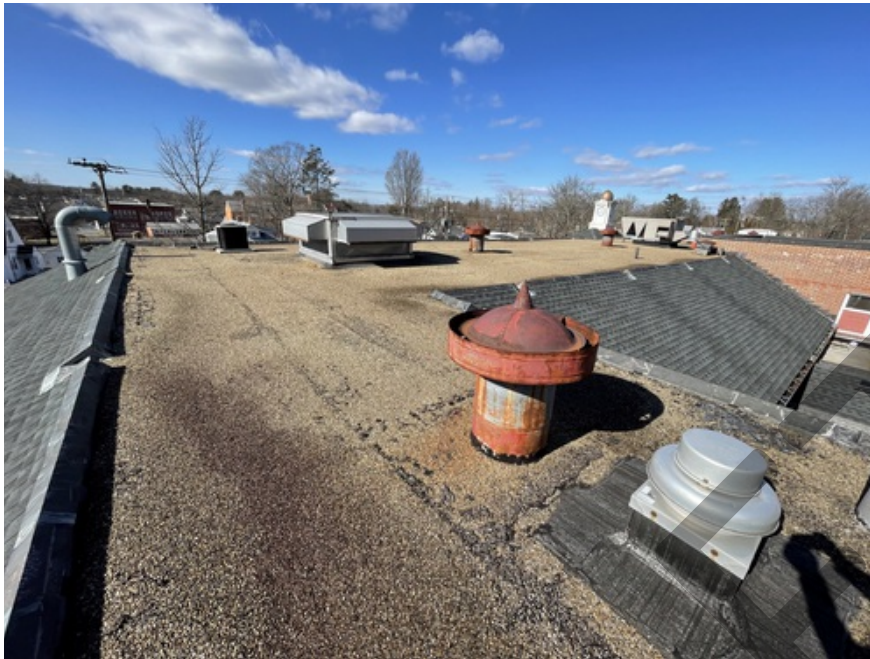
*Photo 6*

**Exposed felts and scrim- Consistent throughout- UV Degradation**

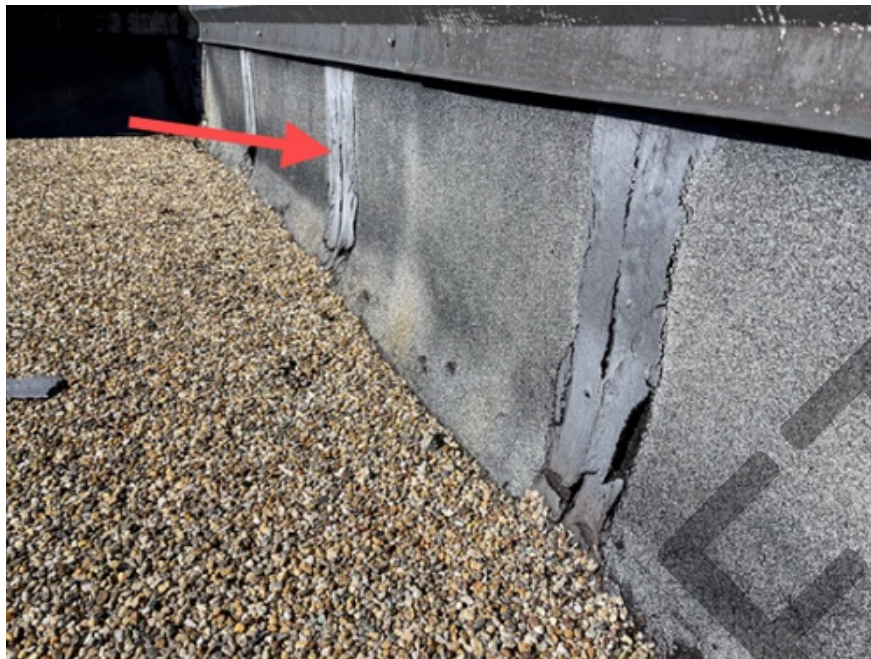
*Photo 8*

**Drain grate openings larger than the pea gravel- Will cause a clogged drain- Screen recommended**

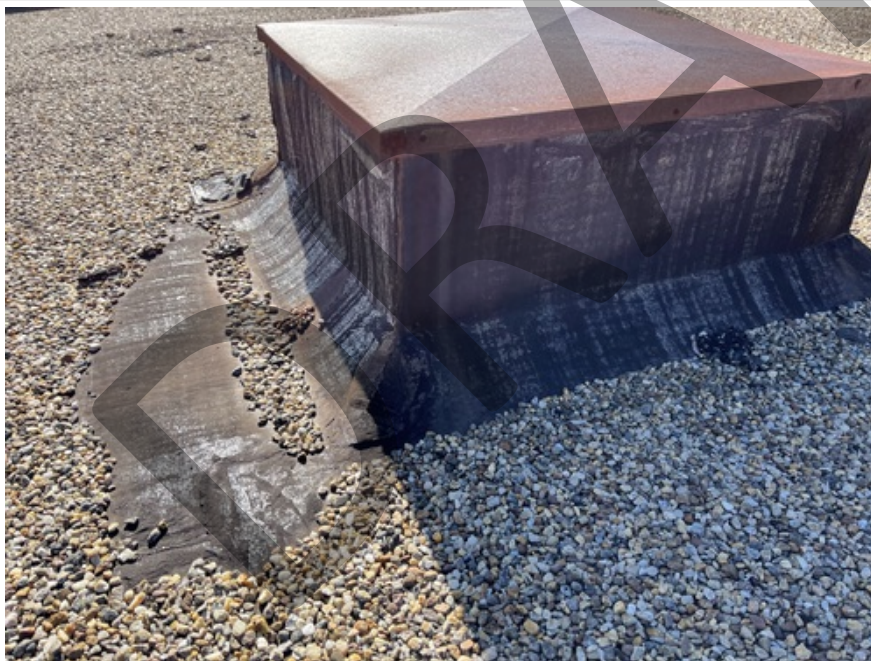
*Photo 9*

**Vertical flashings failing-  
Consistent throughout-  
Failed seam mastic**

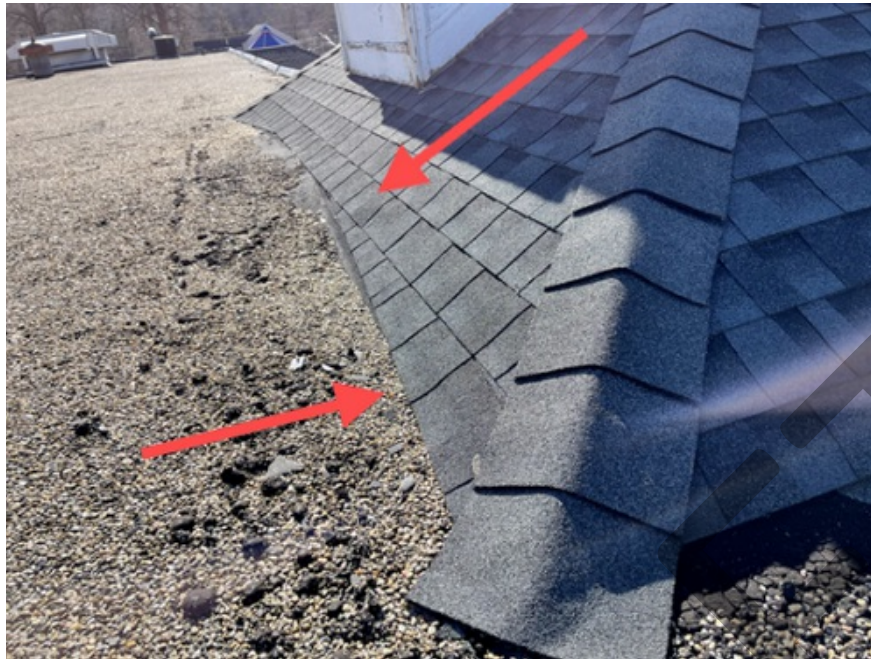
*Photo 10*

**Obsolete curbs- Removal  
recommended when next  
reroof happens**

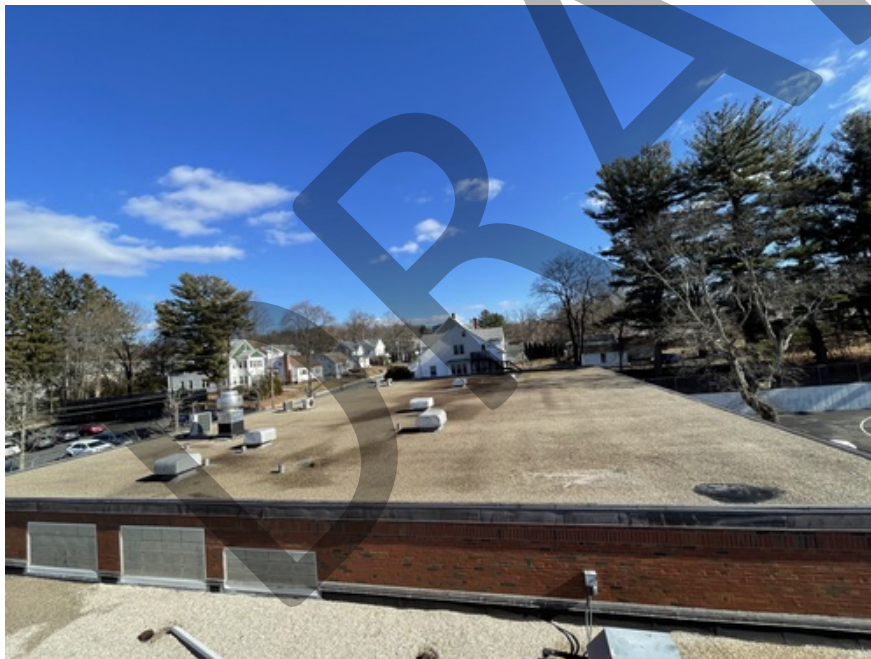
*Photo 11*

**Improper shingle transition- 30" Minimum for snow drifts**

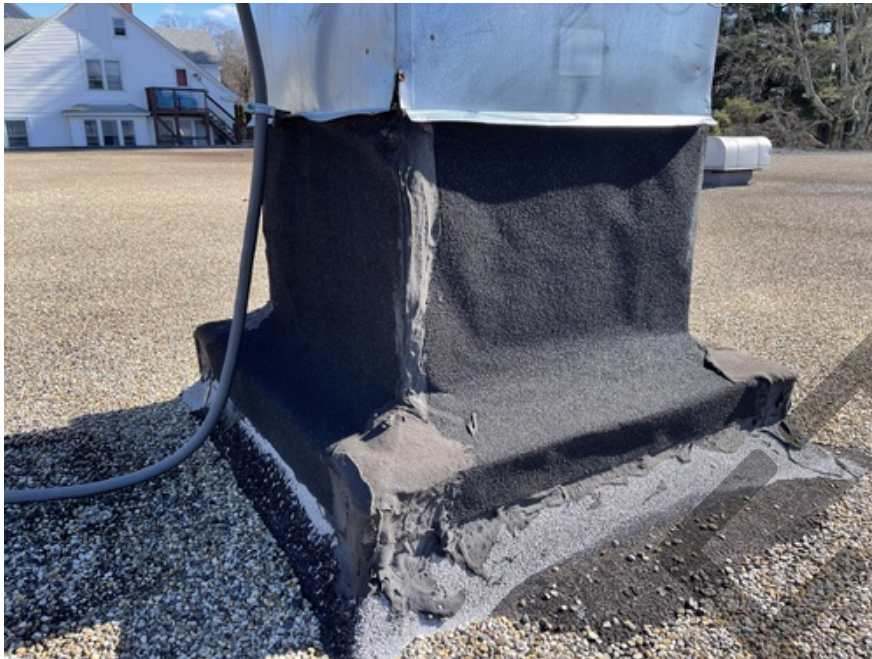
*Photo 18*

**Open condition- Failed and improper previous repairs- Area of reported leaking**

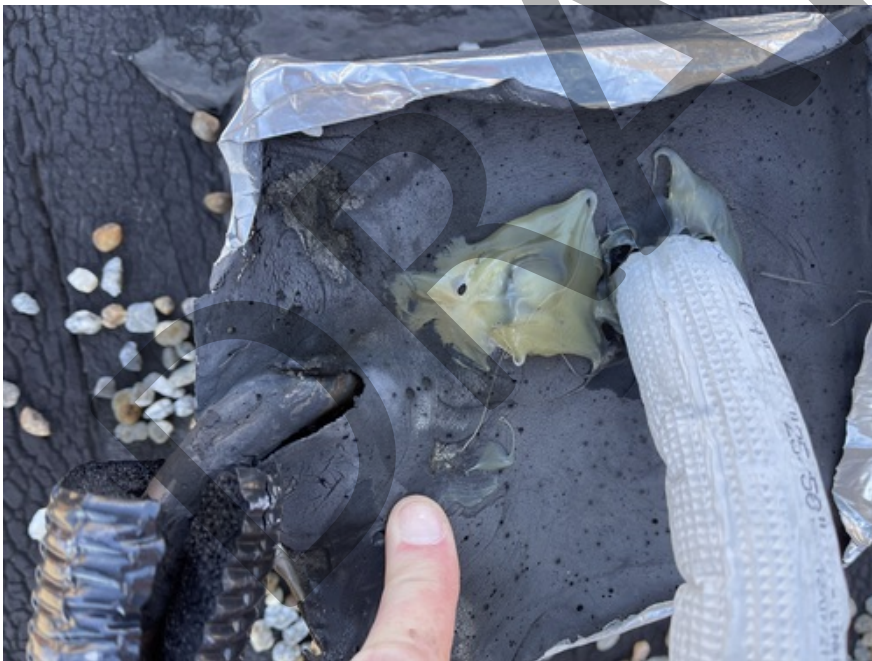
*Photo 19*

**Exposed membrane to UV-  
Non reinforced flashing  
seams**

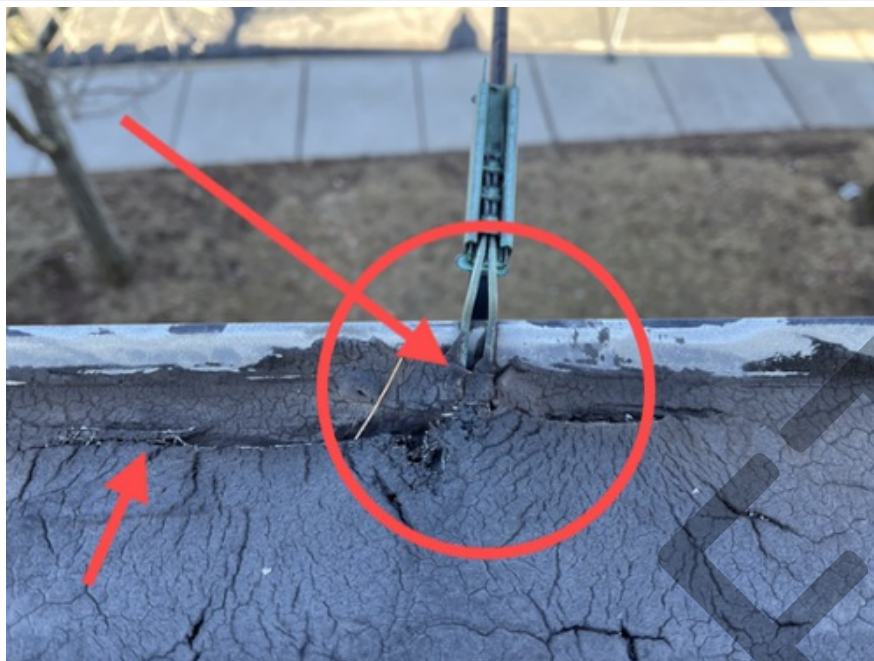
*Photo 20*

**Open condition- Failed  
pitch boxes- Consistent  
throughout**
