Facility Study and Master Plan

Lake Street School

201 Lake Street, Vernon, CT 06066

SUMMER 2023

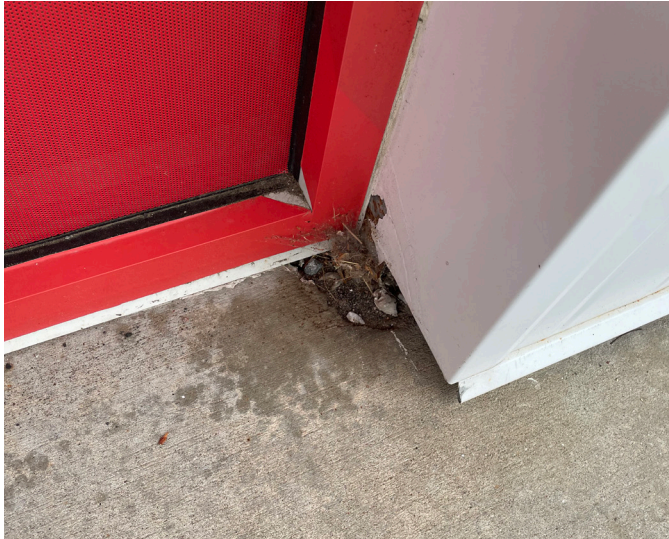
1. Location:

Peeling of the decorative film and rusting at the aluminum entry doors.

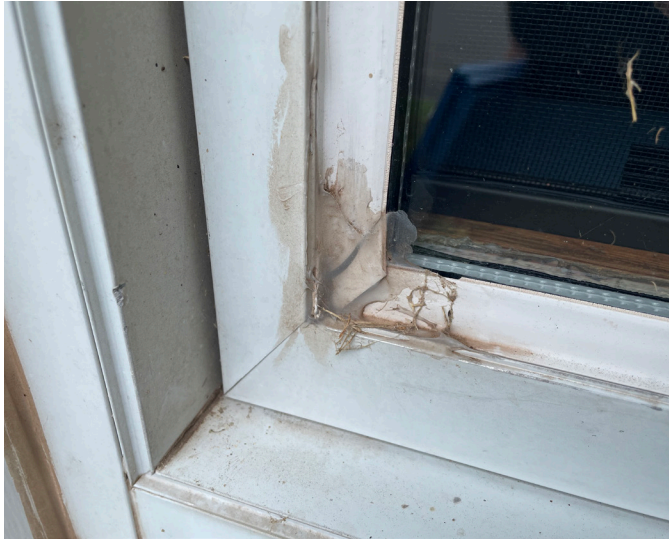
4. Location:

Damaged window glazing

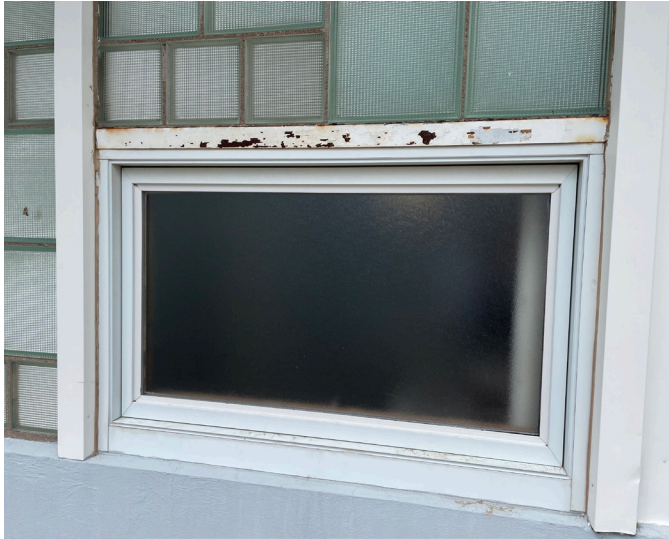
7. Location:

Typical window condition

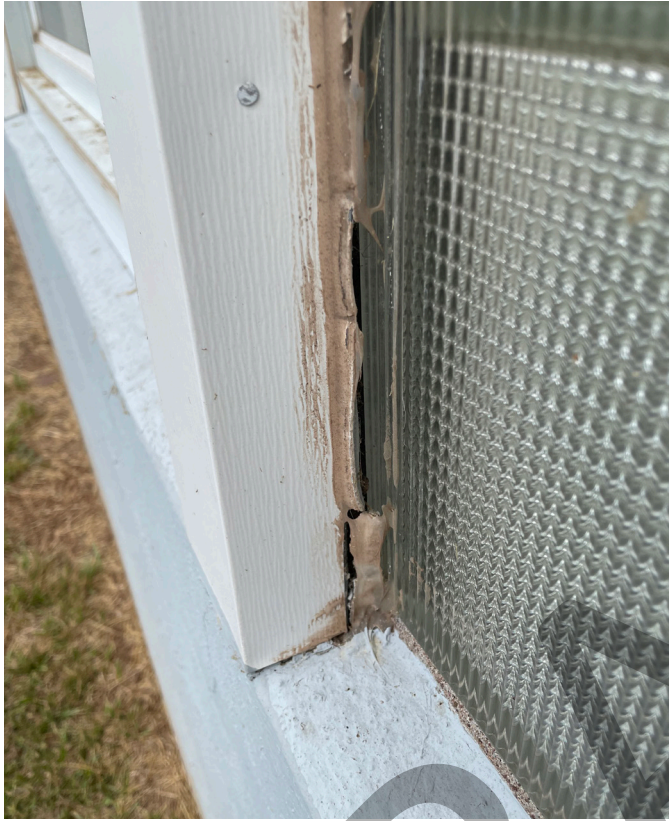
9. Location:

Sealant at glass blocks in poor condition

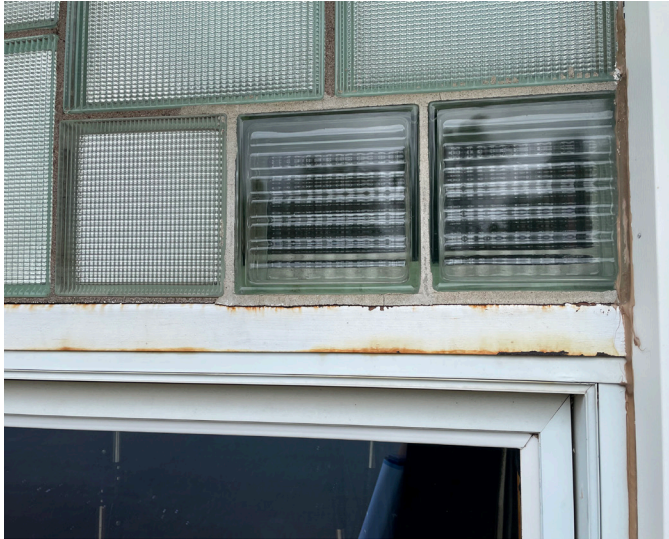
11. Location:

Some glass blocks appear to have been replaced. Window Lintel are rusted

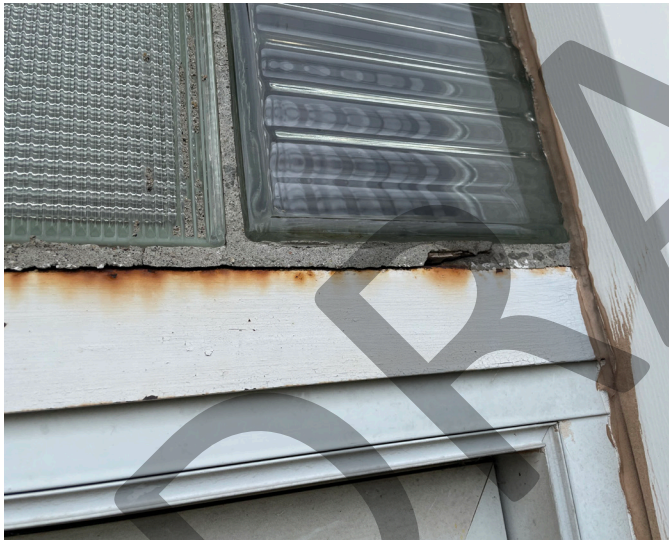
12. Location:

Grout at glass book deteriorating. Window lintel is rusting

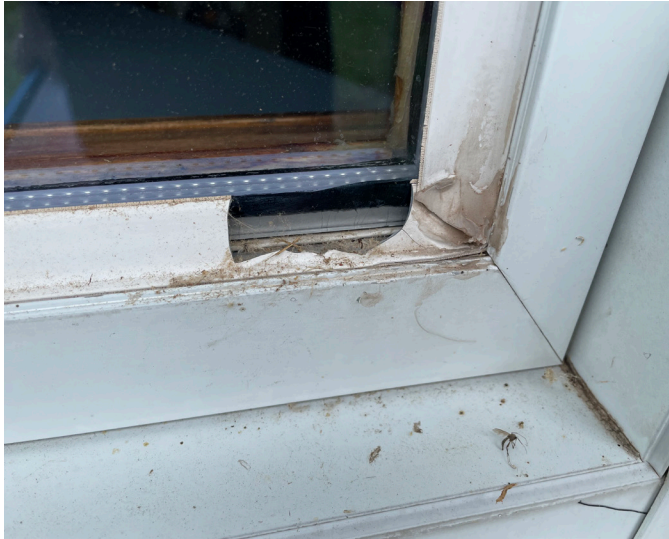
14. Location:

Damaged window frame

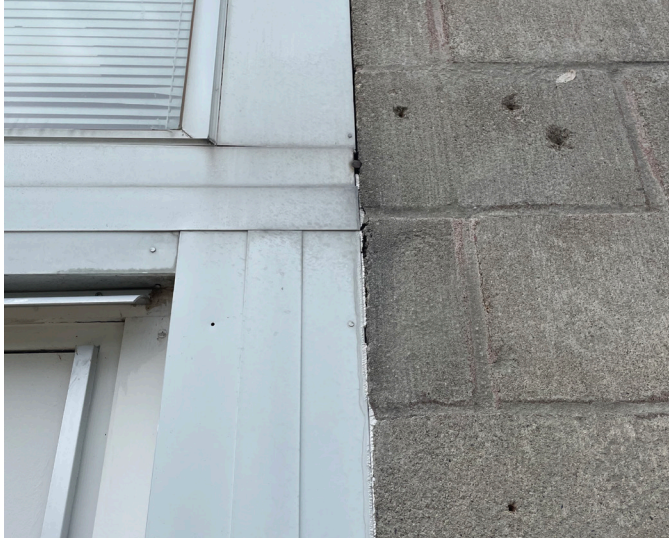
19. Location:

CMU damage and missing sealant between storefront system and CMU

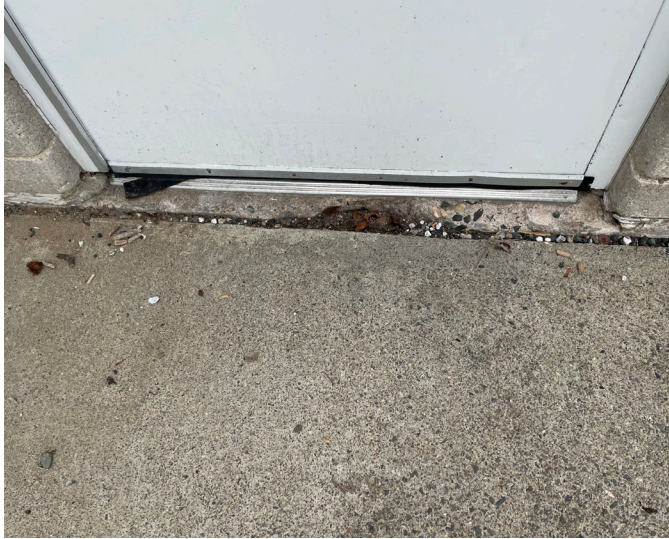
22. Location:

Typical condition of the concrete pad meeting the concrete sill of exterior doors - cracking and debris

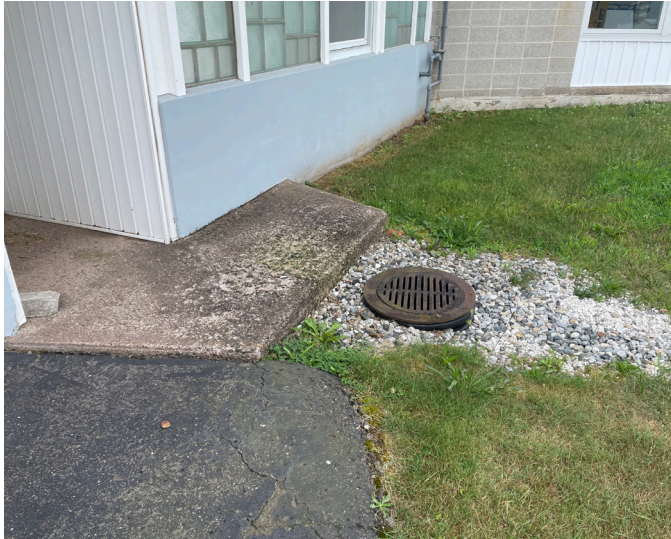
4. Location:

Typical condition of sidewalk and drainage at classroom exit doors.

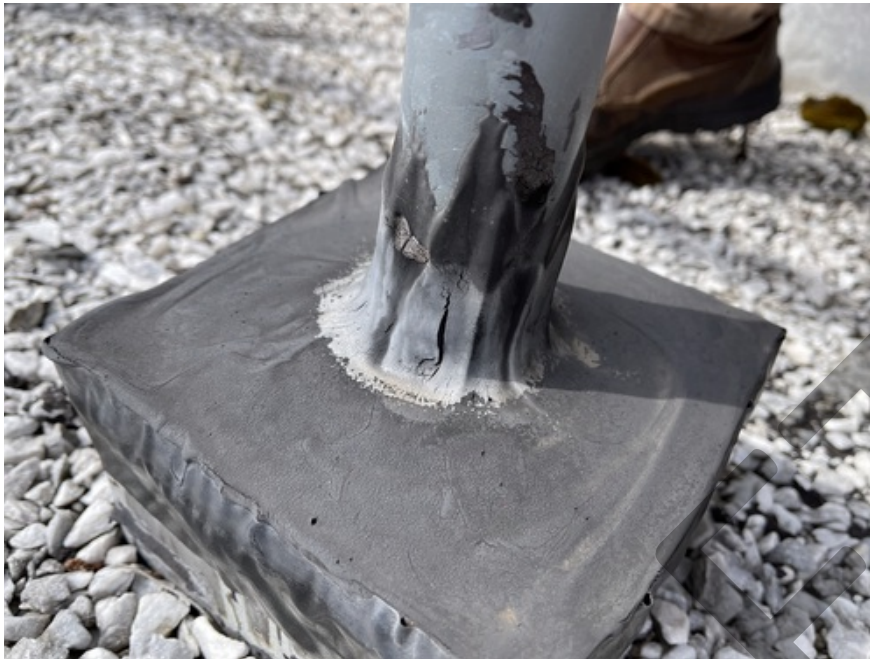
Photo 2

Failing or failed pitch boxes- Consistent throughout inspection

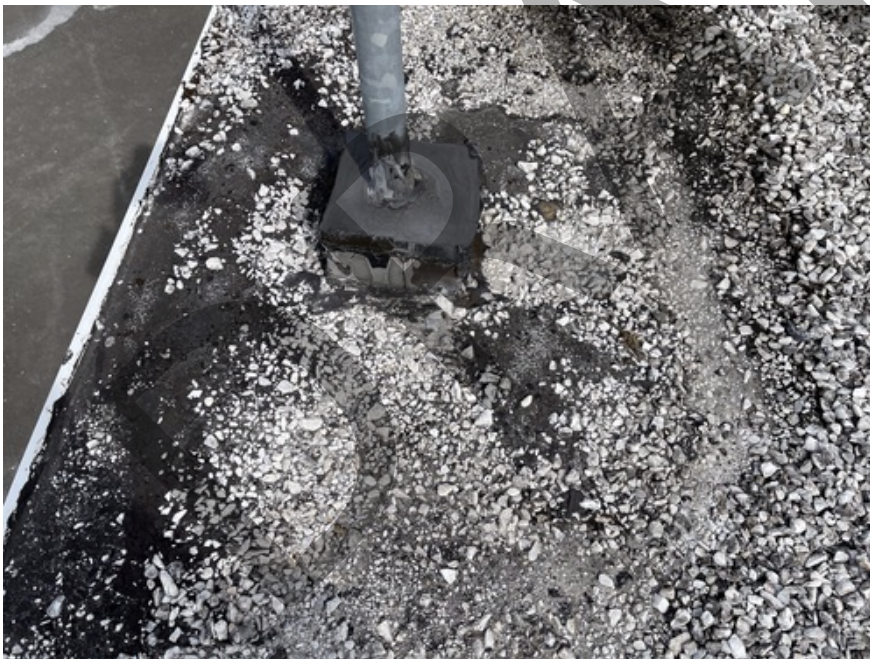
Photo 3

Improper tie-in near perimeter edge- Pitch boxes

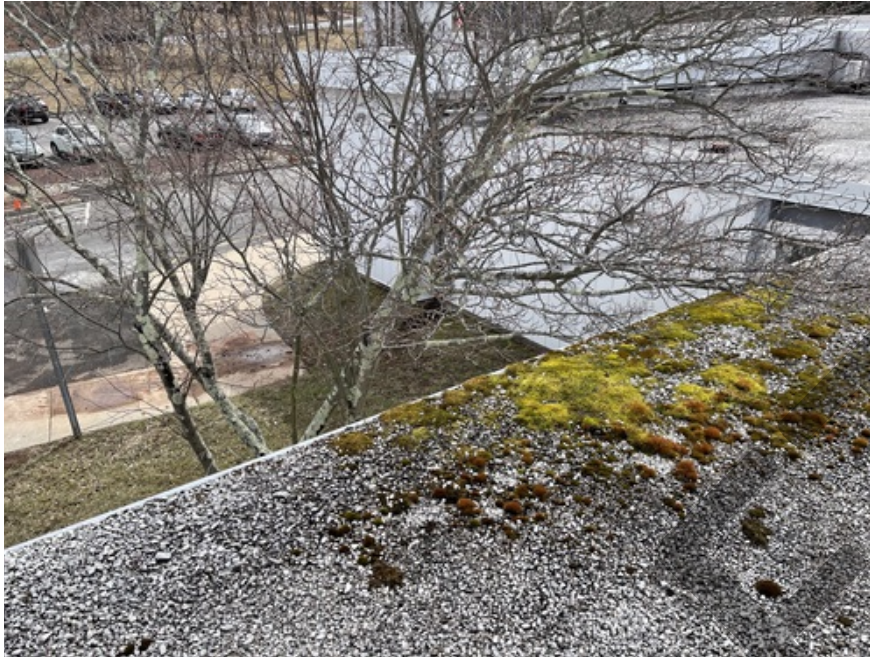
Photo 4

**Excessive organic growth-
Tree removal suggested**

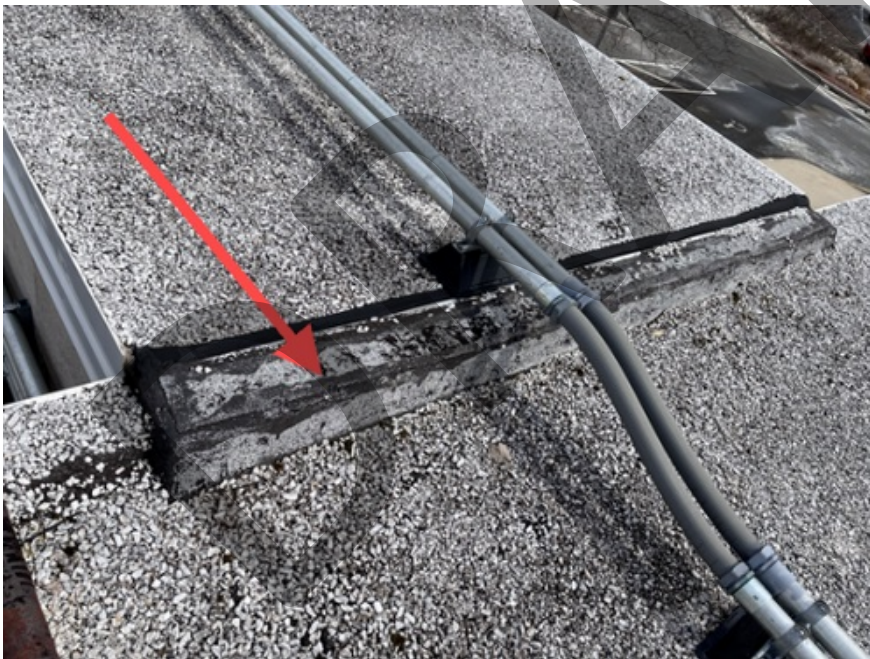
Photo 5

**Failed previous repairs-
Consistent throughout**

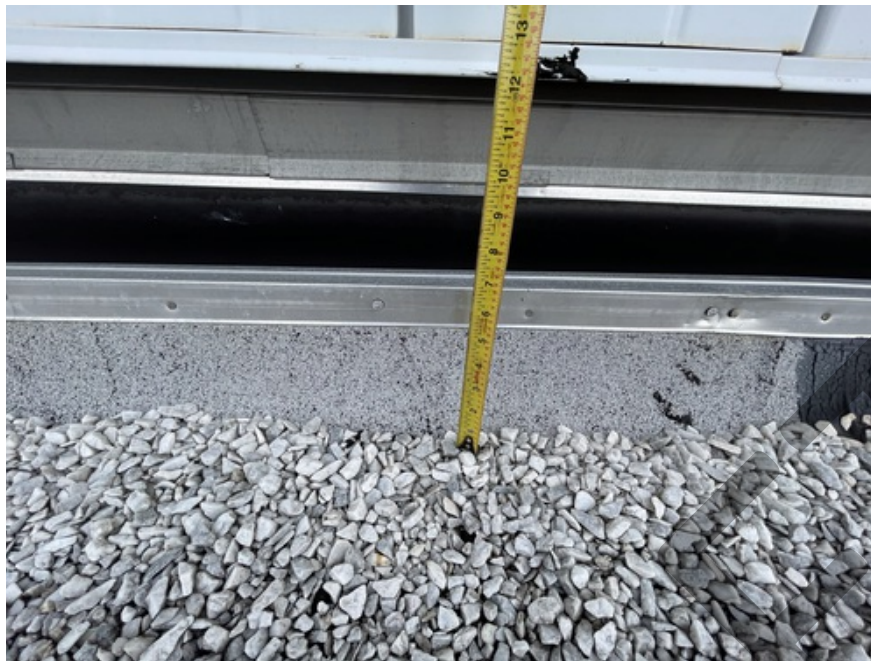
Photo 6

**Low Flashing heights for
perimeter and curbed
units- Consistent
throughout**

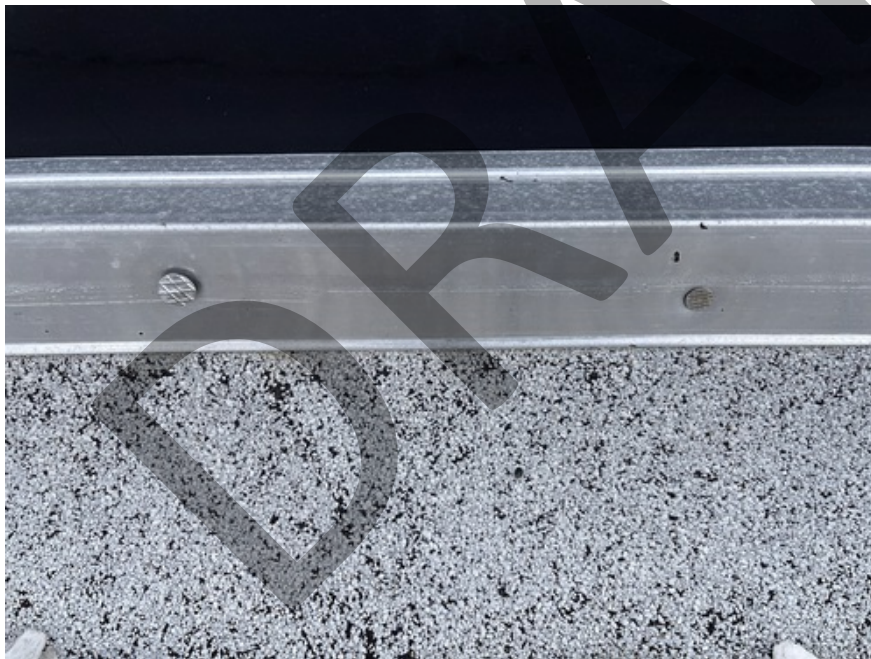
Photo 7

**Open condition- No
membrane termination
bar- Through fastened**

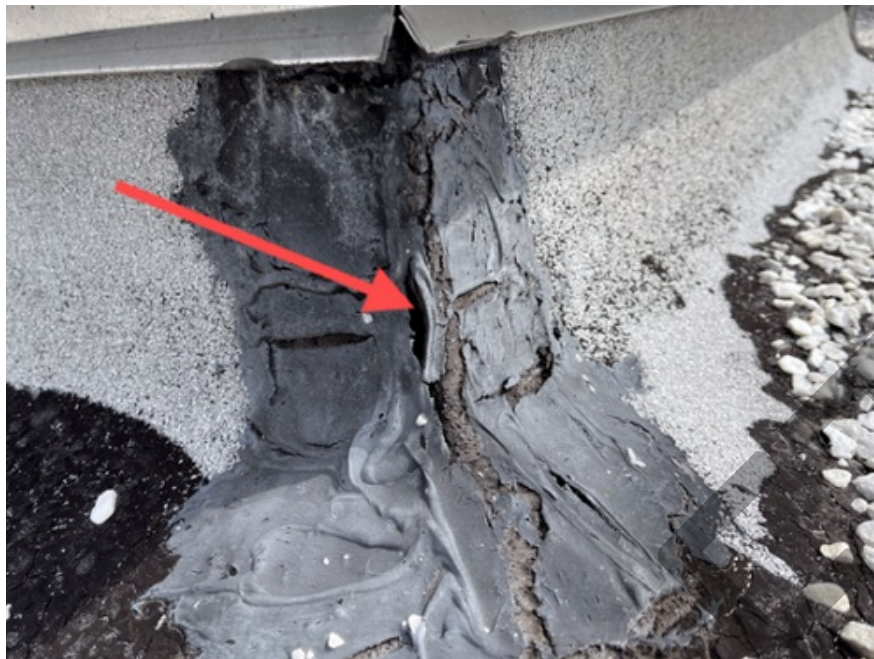
Photo 8

Open condition- No reinforcement used on flashing repair- Failed previous repairs

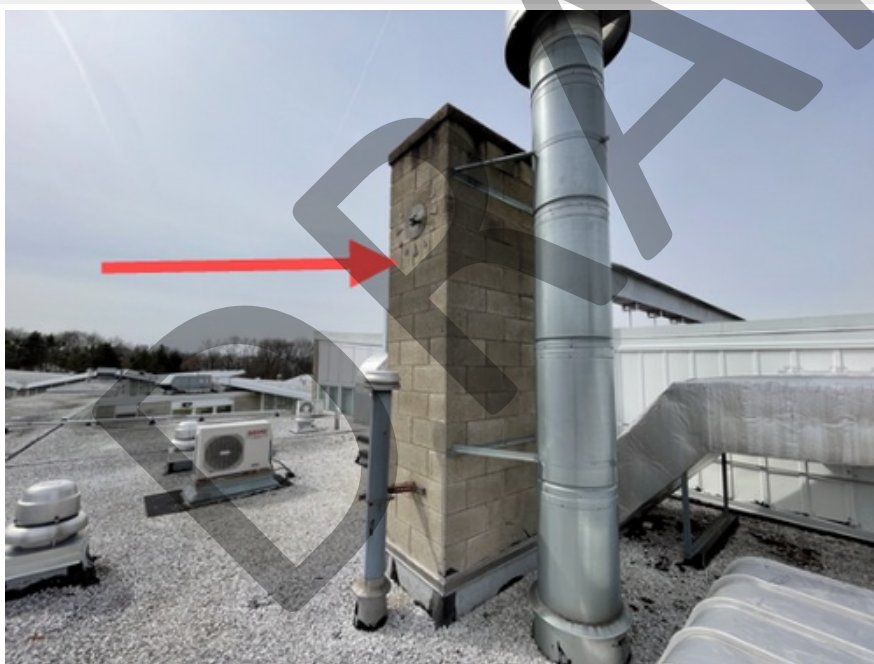
Photo 9

Exposed porous masonry block chimney

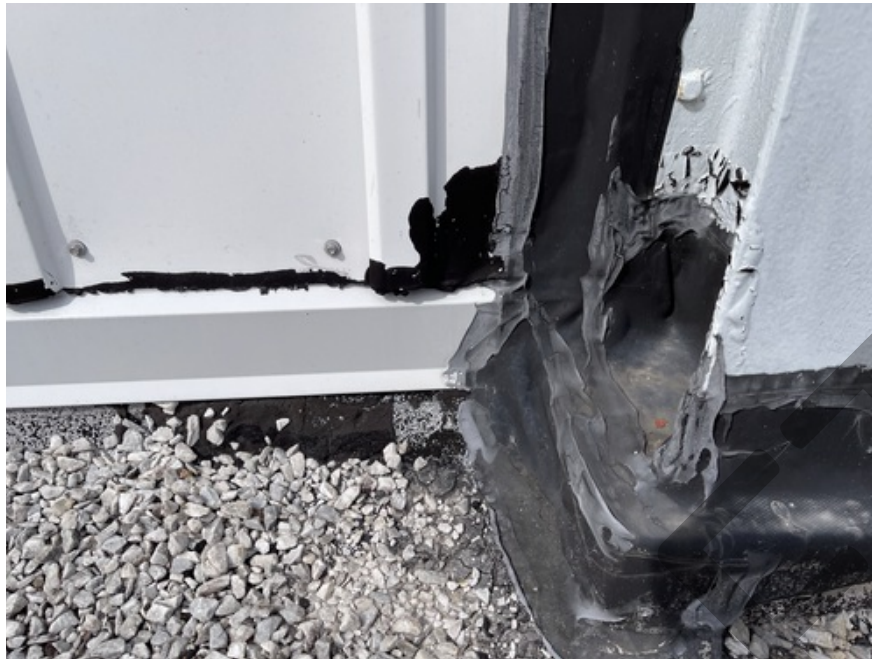
Photo 10

Improper repairs- Poor system design

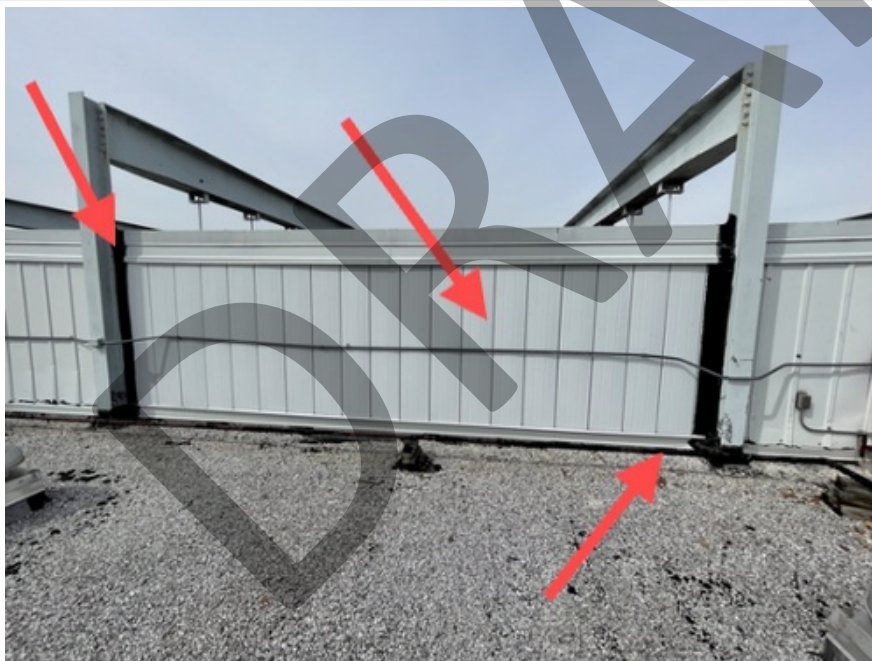
Photo 11

Poor system design- Previous problems were evident through the attempt to stop leaking

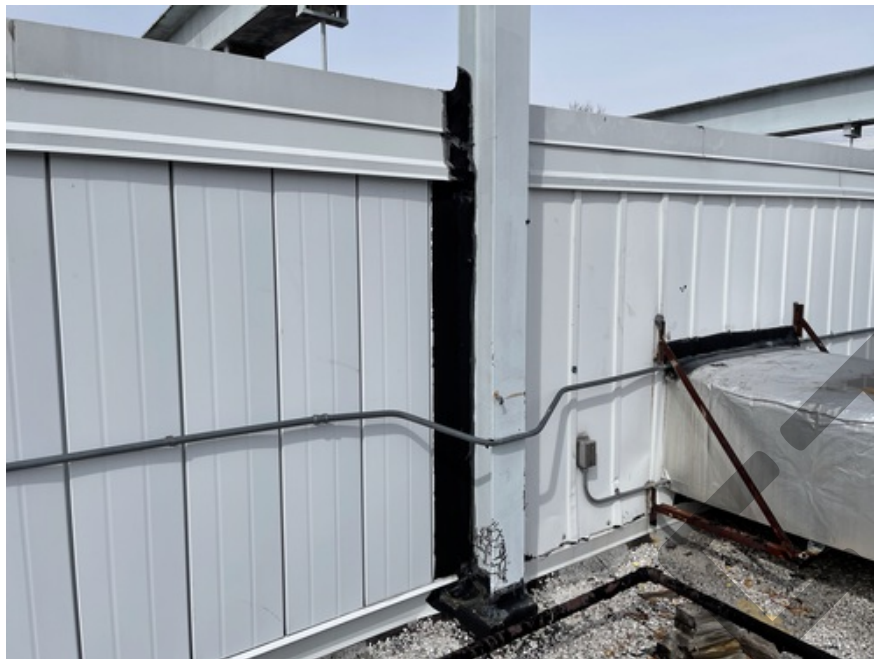
Photo 12

Wall panel system is letting water in

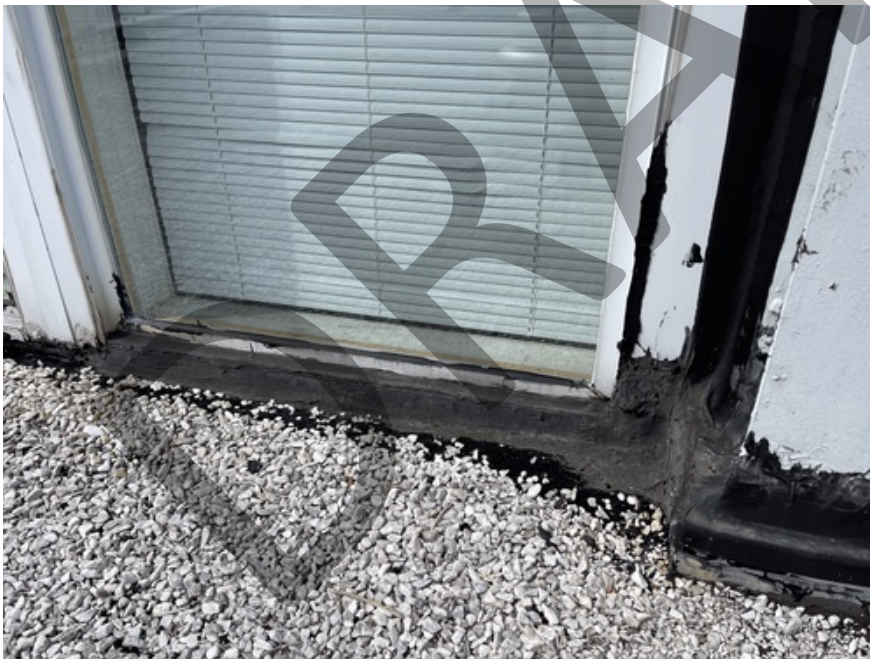
Photo 15

**Previous improper repairs-
Window flashing failure**

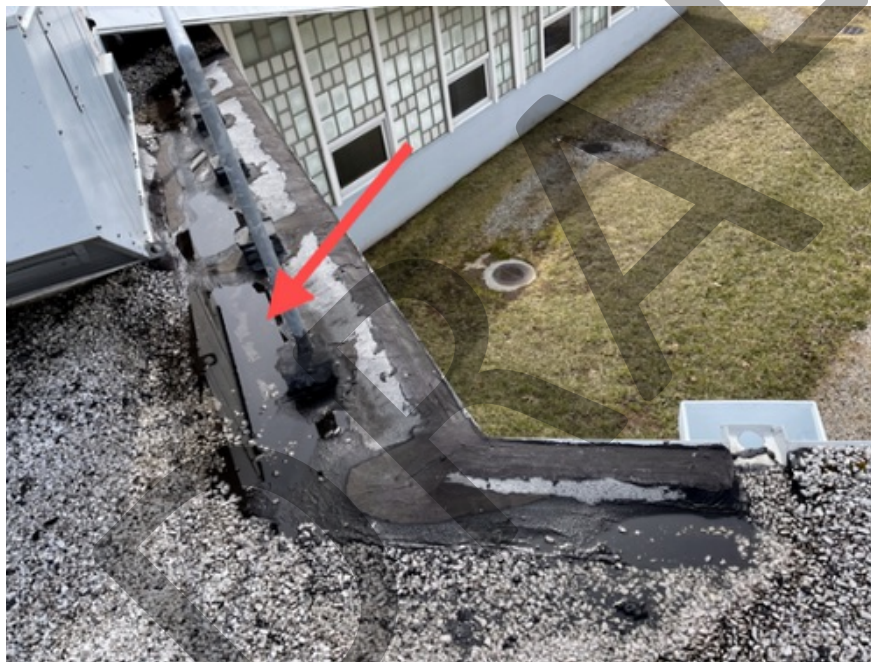
Photo 17

Ponding water on failing repairs- Action recommended

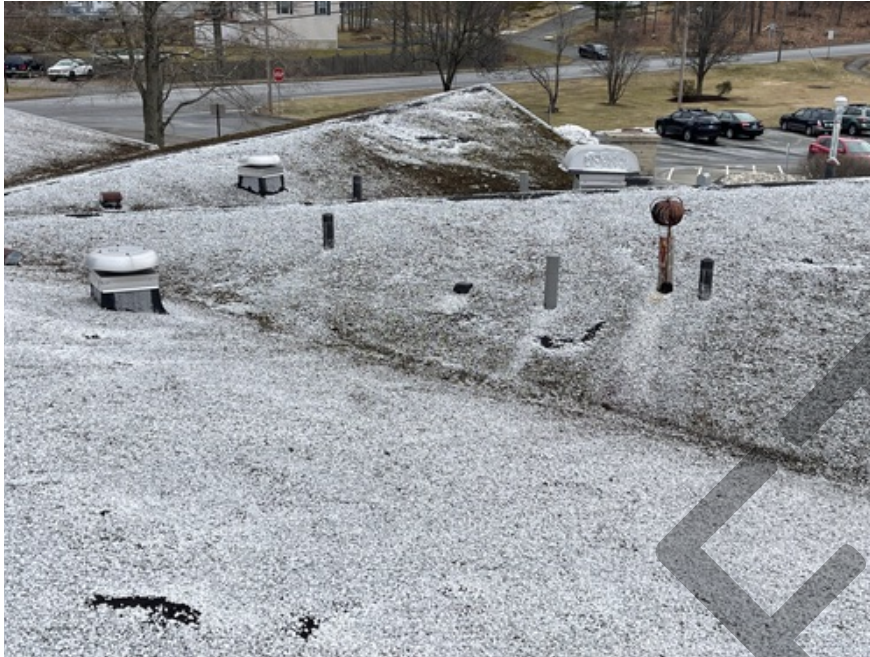
Photo 2

Penetrations near valley

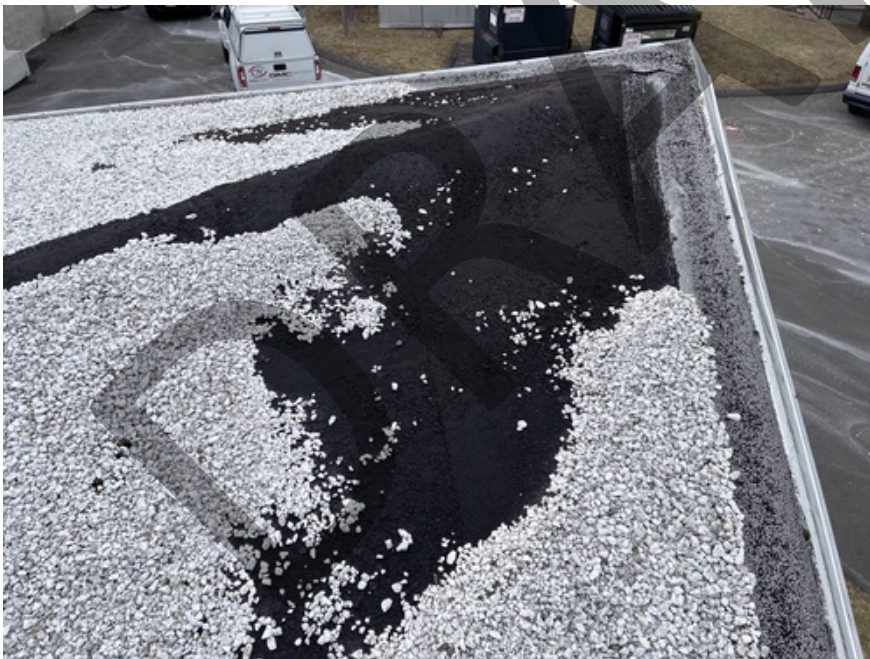
Photo 3

**Wind-scor was found
throughout- Exposed
membrane**

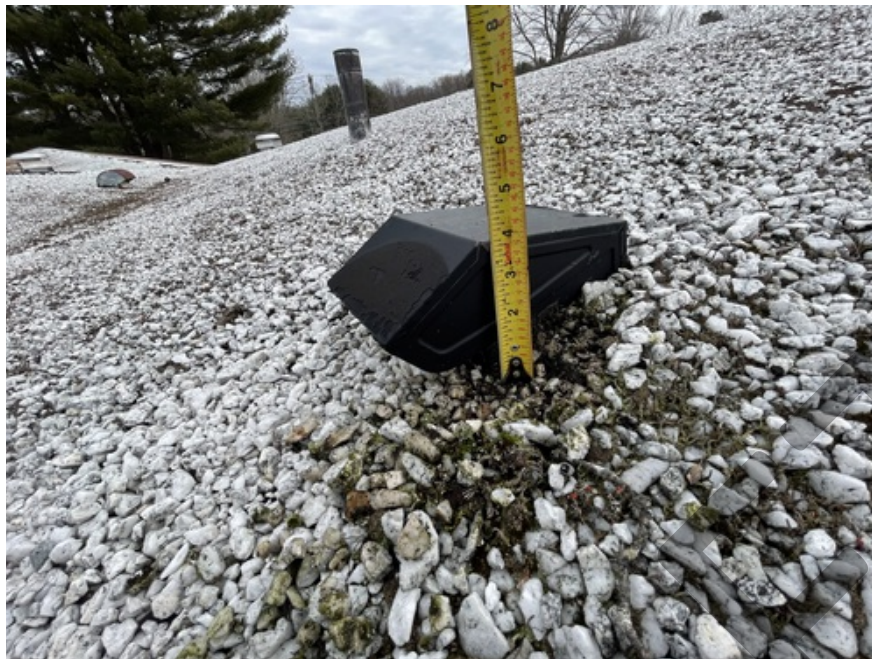
Photo 4

Improper vent fan flashings- No height

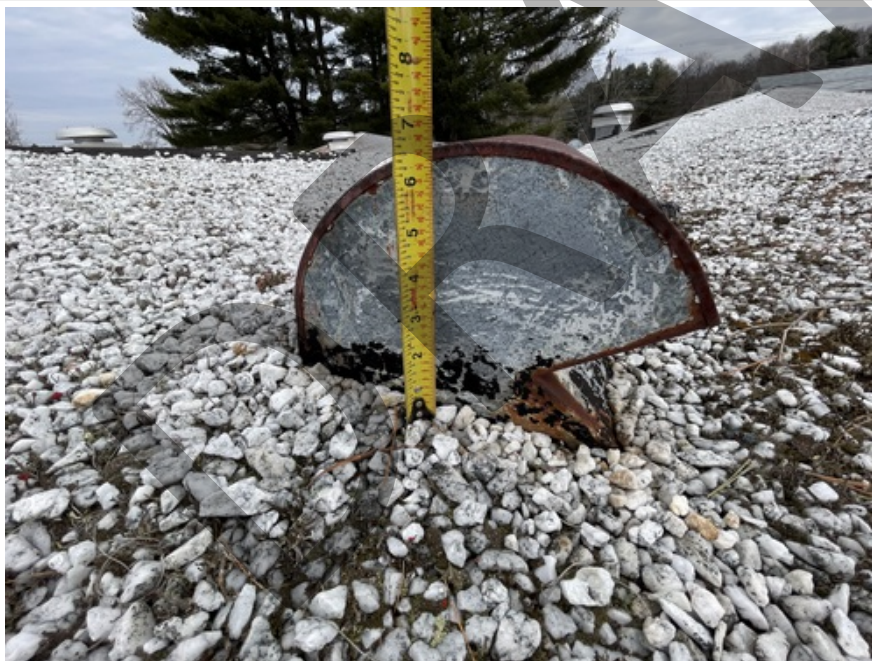
Photo 5

Improper vent fan flashings- No height directly in the valley

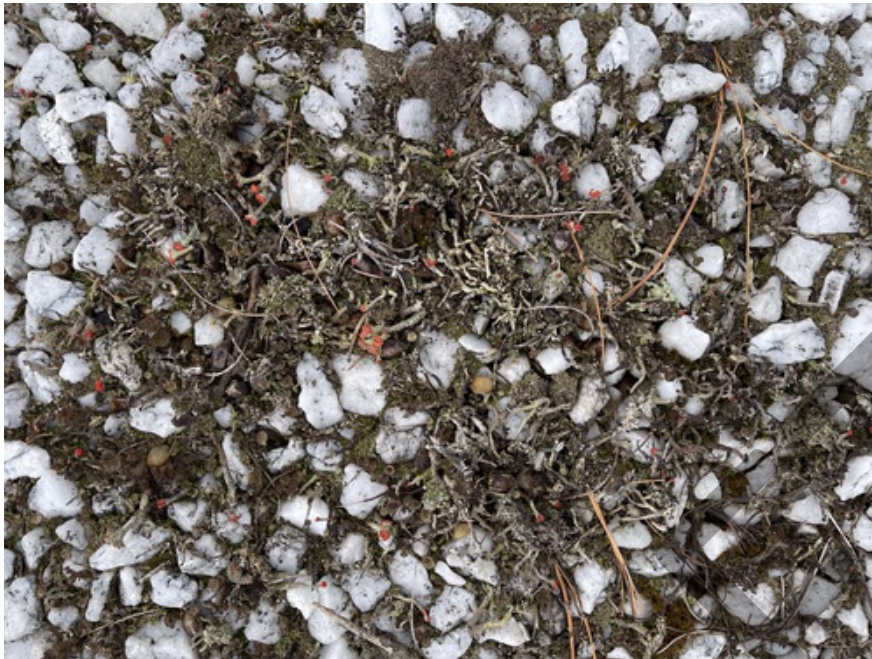
Photo 6

Organic growth throughout- Evidence of improper moisture mitigation

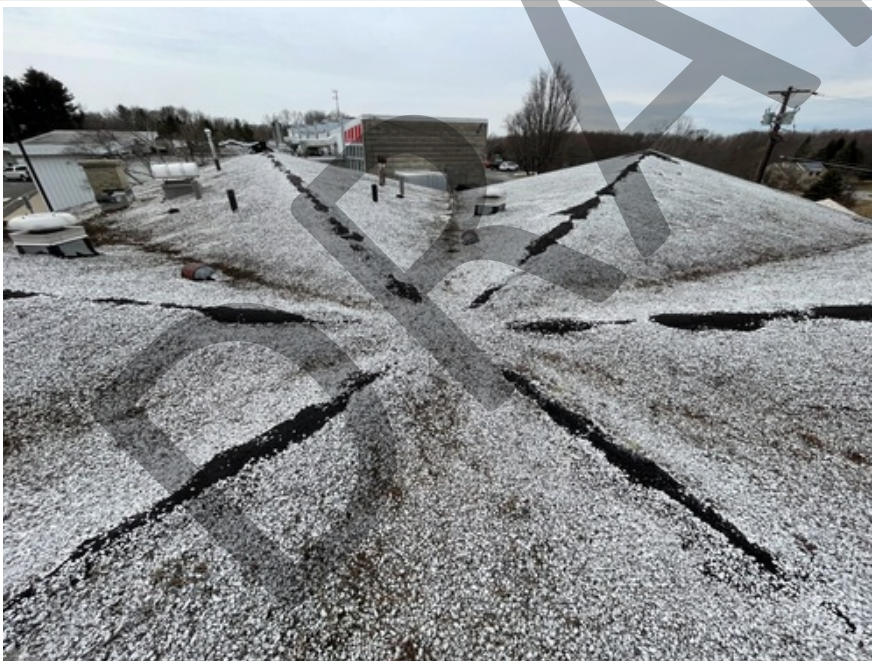
Photo 7

Overview- All ridges were exposed- Consistent throughout

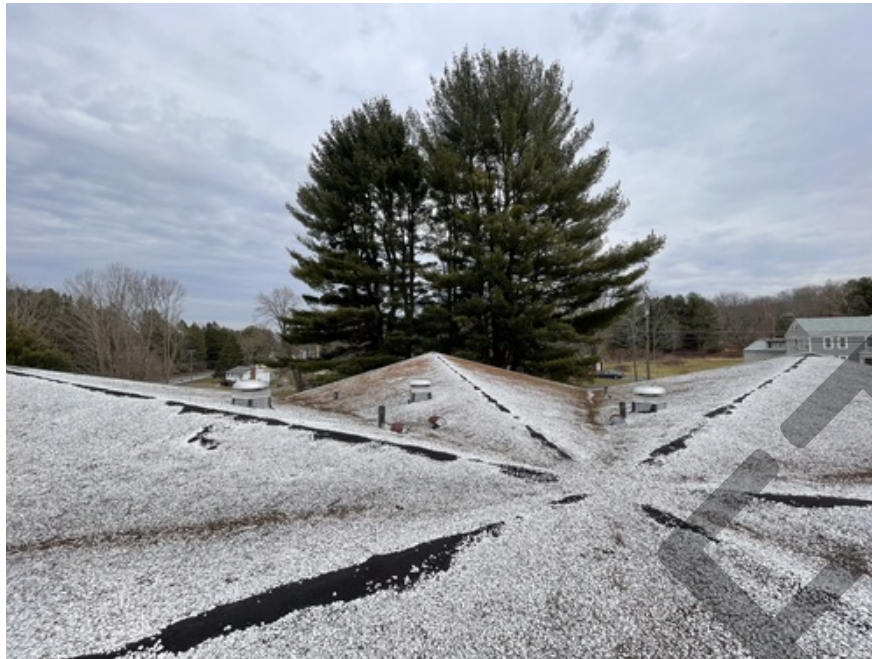
Photo 8

**Trees within 25ft of roof-
Removal recommended**

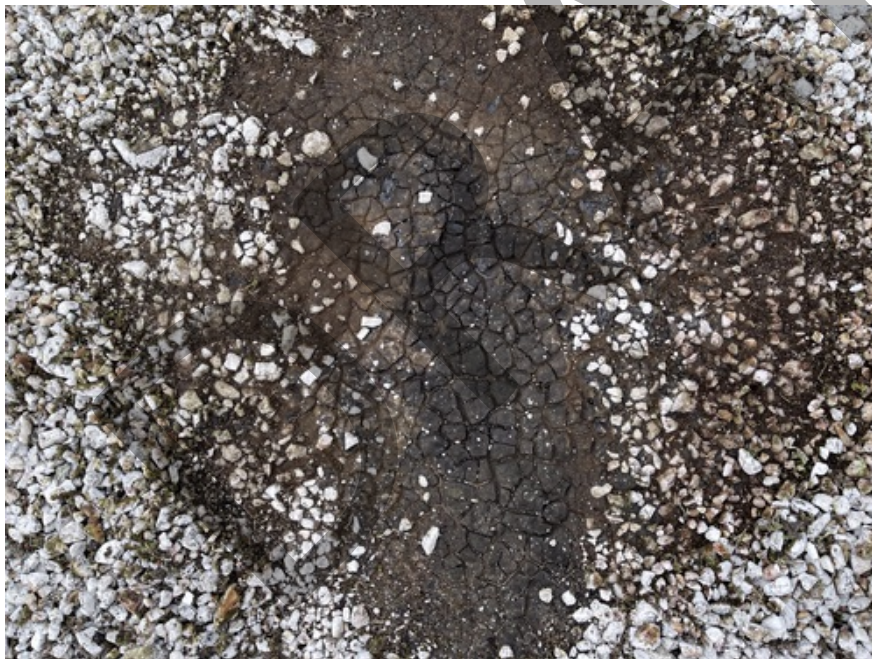
Photo 9

**Aged and Failing flood
coat- Exposed to UV**
