FACILITY CONDITION ASSESSMENT

NORTH MIDDLESEX REGIONAL SCHOOL DISTRICT

Hawthorne Brook Middle School

August 6, 2020
H&A JN 1919.02

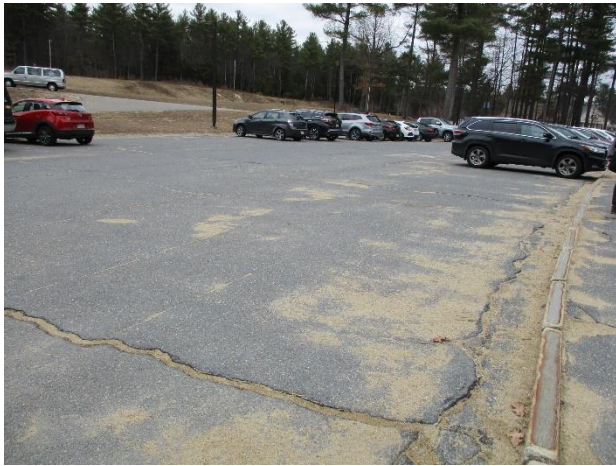
| Work Item Description | Qty | Unit | Unit Cost | Total | ¹ Total w/ Soft Costs | Scope 1 | Scope 2 | Scope 3 | Totals |
|--|---|---|---|---|---|---|---|---|---|
| 1.1 Replace Bituminous Paving at Parking Lot: Paving is cracked and deteriorated. | 5,830 | SY | 30.00 | 174,900 | 227,370 | 227,370 | | | 227,370 |

1.1 Bituminous paving at parking lot.

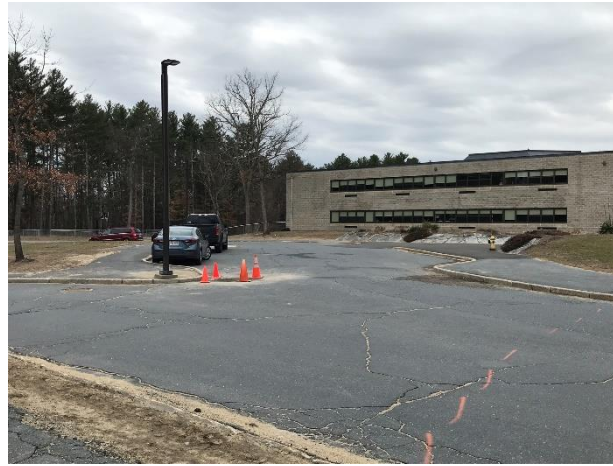
| Work Item Description | Qty | Unit | Unit Cost | Total | ¹ Total w/ Soft Costs | Scope 1 | Scope 2 | Scope 3 | Totals |
|--|---|---|---|---|---|---|---|---|---|
| 1.2 Replace Bituminous Paving at Bus Drop-Off and Around School Building: Paving is cracked and deteriorated. Several areas of the walkway have settled and filled with sand. | 7,000 | SY | 30.00 | 210,000 | 273,000 | 273,000 | | | 273,000 |

1.2 Bituminous paving at bus drop off.

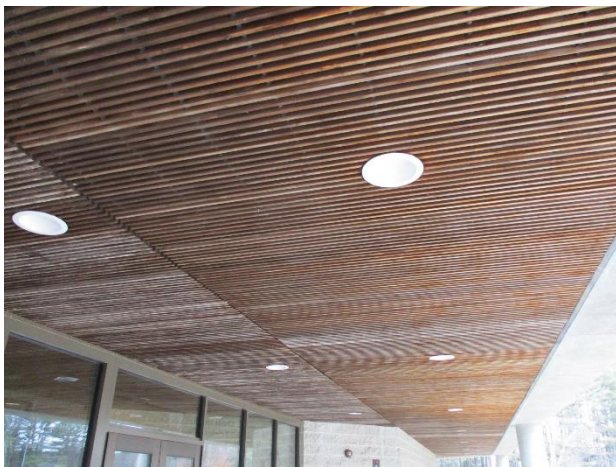
| Work Item Description | Qty | Unit | Unit Cost | Total | ¹ Total w/ Soft Costs | Scope 1 | Scope 2 | Scope 3 | Totals |
|--|---|---|---|---|---|---|---|---|---|
| 1.4 Paint Overhang Ceiling at the Main Entrance: Paint / stain overhand ceiling at the main entrance. | 1,800 | SF | 15.00 | 27,000 | 35,100 | | 35,100 | | 35,100 |

1.4 Overhang ceiling at main entrance.

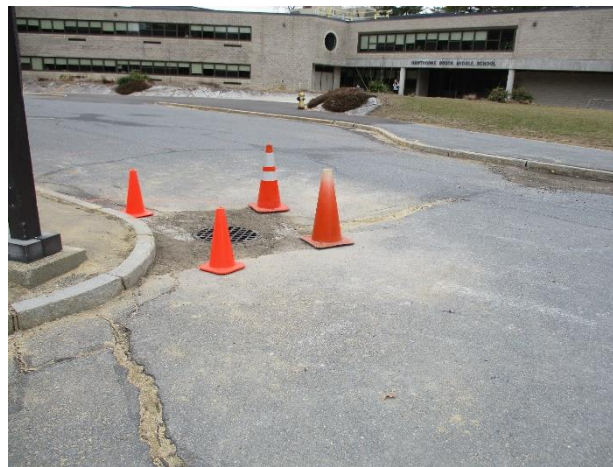
| Work Item Description | Qty | Unit | Unit Cost | Total | ¹ Total w/ Soft Costs | Scope 1 | Scope 2 | Scope 3 | Totals |
|--|---|---|---|---|---|---|---|---|---|
| 1.5 Replace Old Catch Basins: Some catch basins had been replaced by the school. | 10 | EA | 10,000.00 | 100,000 | 130,000 | 130,000 | | | 130,000 |

1.5 Newly replaced catch basin.

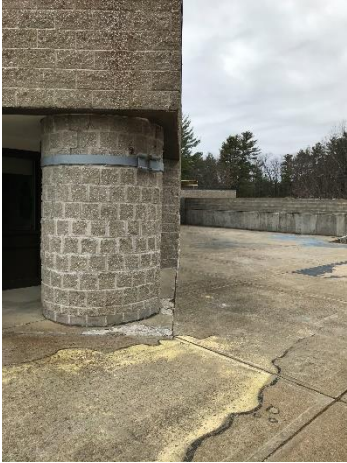
| Work Item Description | Qty | Unit | Unit Cost | Total | ¹ Total w/ Soft Costs | Scope 1 | Scope 2 | Scope 3 | Totals |
|--|---|---|---|---|---|---|---|---|---|
| 1.7 Patch / Repair Concrete Patio: Patch / repair spalled and cracked areas of concrete surface - approx. 10% of the surface area. | 626 | SF | 40.00 | 25,040 | 32,552 | 32,552 | | | 32,552 |

1.7 Concrete patio play area.

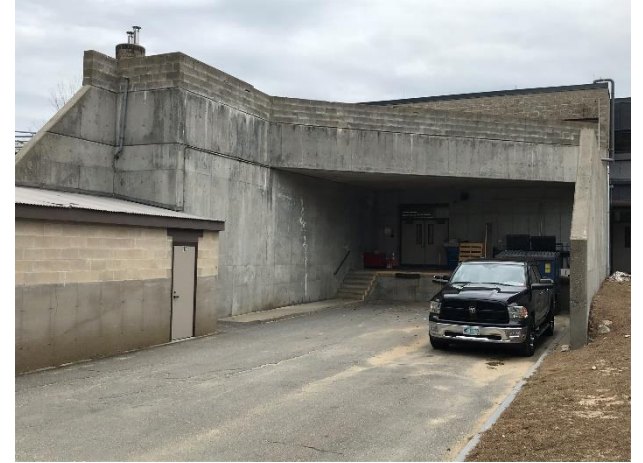
| Work Item Description | Qty | Unit | Unit Cost | Total | ¹ Total w/ Soft Costs | Scope 1 | Scope 2 | Scope 3 | Totals |
|--|---|---|---|---|---|---|---|---|---|
| 1.9 Replace CMU Wall Between Patio and Loading Dock: The exposed CMU blocks on top of the concrete wall are deteriorated and spalling. Concrete caps are missing in some areas. | 260 | SF | 50.00 | 13,000 | 16,900 | | 16,900 | | 16,900 |

1.9 CMU wall at concrete patio and loading dock area.

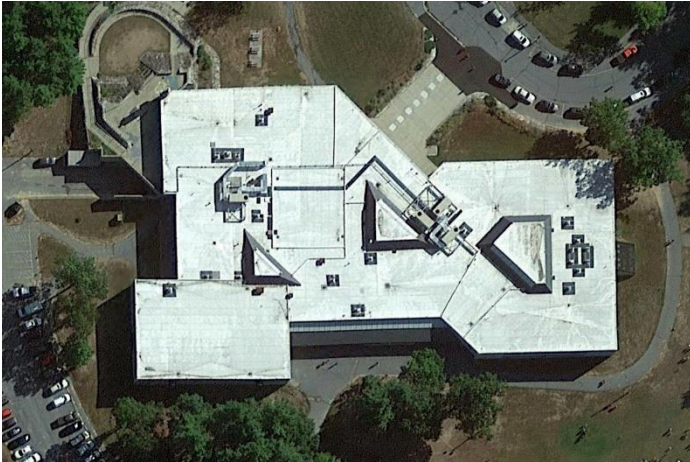
| Work Item Description | Qty | Unit | Unit Cost | Total | ¹ Total w/ Soft Costs | Scope 1 | Scope 2 | Scope 3 | Totals |
|---|---|---|---|---|---|---|---|---|---|
| 2.1 Replace 20 Years Old PVC Roof: The existing PVC roofing membrane is at the end of its life expectancy. Provide new PVC roof assembly and metal gravel stop roof edge fascia. Consider making provision for future PV installation. | 50,000 | SF | 50.00 | 2,500,000 | 3,250,000 | 3,250,000 | | | 3,250,000 |

2.1 Aerial photo of the roof.

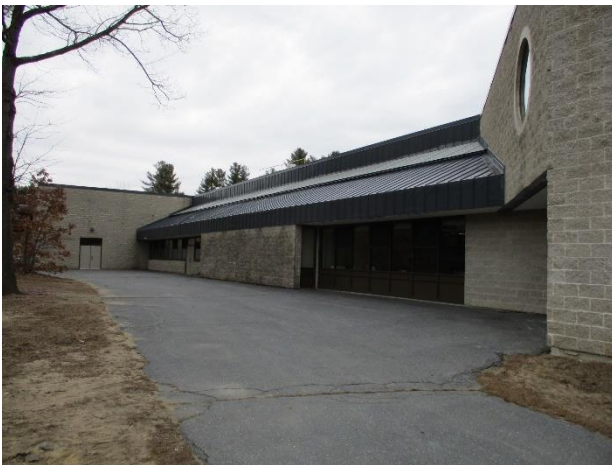
| Work Item Description | Qty | Unit | Unit Cost | Total | ¹ Total w/ Soft Costs | Scope 1 | Scope 2 | Scope 3 | Totals |
|---|---|---|---|---|---|---|---|---|---|
| 2.4 Staining and efflorescence on masonry walls: Power wash and clean split face block wall by the Electrical Room. | 1,660 | SF | 5.00 | 8,300 | 10,790 | | 10,790 | | 10,790 |

2.4 Staining on masonry wall.

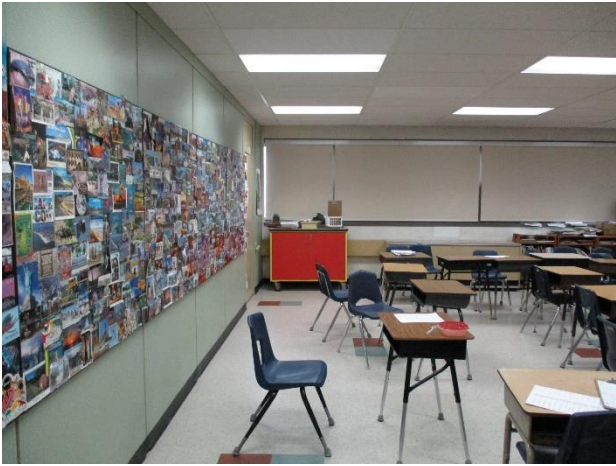
| Work Item Description | Qty | Unit | Unit Cost | Total | ¹ Total w/ Soft Costs | Scope 1 | Scope 2 | Scope 3 | Totals |
|---|---|---|---|---|---|---|---|---|---|
| 3.1 Demountable Wall Panels Partition Between Classrooms: Replace demountable wall panels partition between classrooms with metal stud and drywall and sound attenuation insulation full height to bottom of deck. | 7,344 | SF | 9.00 | 66,096 | 85,925 | | 85,925 | | 85,925 |

3.1 Demountable partition between classrooms.

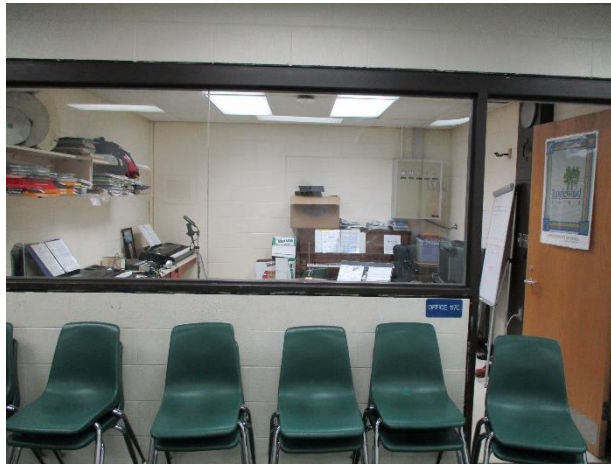
| Work Item Description | Qty | Unit | Unit Cost | Total | ¹ Total w/ Soft Costs | Scope 1 | Scope 2 | Scope 3 | Totals |
|---|---|---|---|---|---|---|---|---|---|
| 3.6 Band Room Door: Replace with acoustical door with gasket. | 1 | LS | 2,500.00 | 2,500 | 3,250 | 3,250 | | | 3,250 |

3.6 Band room office.

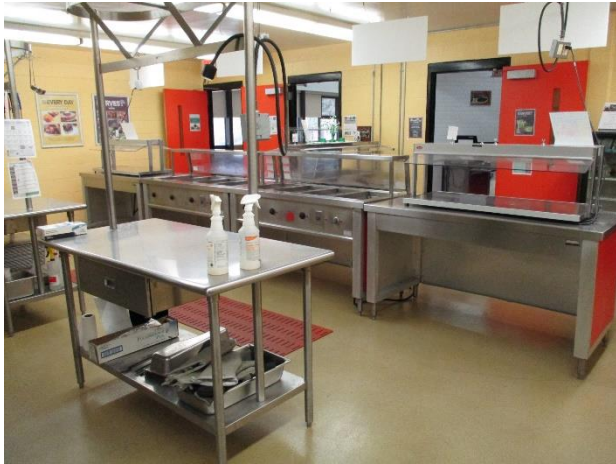
| Work Item Description | Qty | Unit | Unit Cost | Total | ¹ Total w/ Soft Costs | Scope 1 | Scope 2 | Scope 3 | Totals |
|---|---|---|---|---|---|---|---|---|---|
| 3.8 Replace Kitchen Equipment: Kitchen food service equipment is outdated. Replace with new equipment. | 1 | LS | 300,000.00 | 300,000 | 390,000 | | | 390,000 | 390,000 |

3.8 Kitchen equipment.

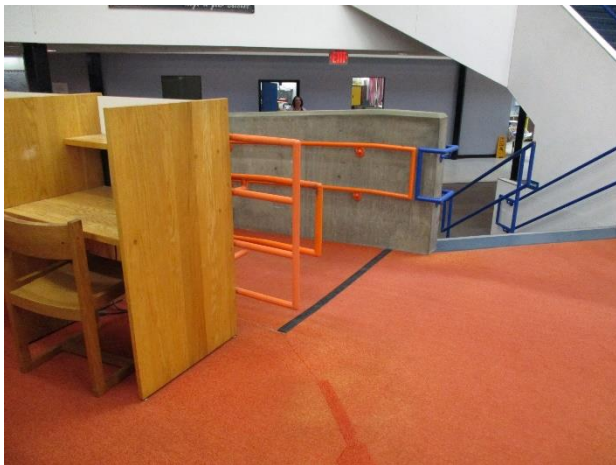
| Work Item Description | Qty | Unit | Unit Cost | Total | ¹ Total w/ Soft Costs | Scope 1 | Scope 2 | Scope 3 | Totals |
|---|---|---|---|---|---|---|---|---|---|
| 3.11 Replace the Original Carpet: The original broadloom carpet from 1978 is worn and torn in many areas. Replace with new carpet. | 16,612 | SF | 10.00 | 166,120 | 215,956 | 215,956 | | | 215,956 |

3.11 Original carpet in the Library.

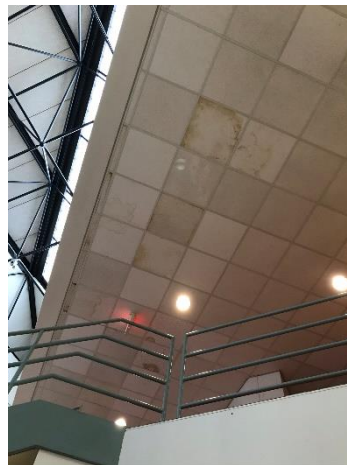
| Work Item Description | Qty | Unit | Unit Cost | Total | ¹ Total w/ Soft Costs | Scope 1 | Scope 2 | Scope 3 | Totals |
|---|---|---|---|---|---|---|---|---|---|
| 3.12 Replace Sagging / Stained ceiling tiles: Replace sagging / stained ceiling tiles throughout the school, assuming 25% of the ceiling tiles need to be replaced. | 26,650 | SF | 8.00 | 213,200 | 277,160 | | 277,160 | | 277,160 |

3.12 Stained ceiling tile.

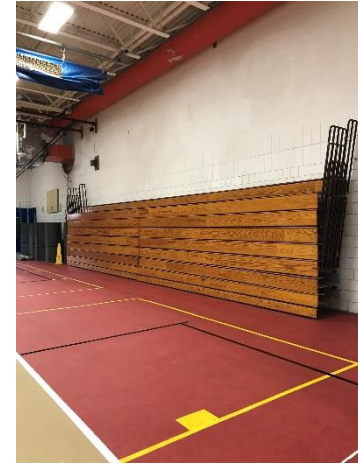
| Work Item Description | Qty | Unit | Unit Cost | Total | ¹ Total w/ Soft Costs | Scope 1 | Scope 2 | Scope 3 | Totals |
|---|---|---|---|---|---|---|---|---|---|
| 3.16 Gymnasium Bleacher Seating is Non-accessible: We recommend that the Owner applies for a variance since the existing bleacher can not be modified to accommodate ADA seatings. | 1 | LS | 750.00 | 750 | 975 | | | 975 | 975 |

3.16 Bleacher seating.

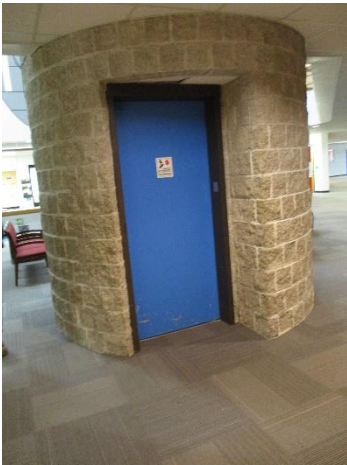
| Work Item Description | Qty | Unit | Unit Cost | Total | ¹ Total w/ Soft Costs | Scope 1 | Scope 2 | Scope 3 | Totals |
|---|---|---|---|---|---|---|---|---|---|
| 3.17 Existing Elevator Does Not Meet Accessibility Requirements: Completely Remove and replace the elevator including elevator shaft and foundation. | 1 | LS | 300,000.00 | 300,000 | 390,000 | | | 390,000 | 390,000 |

| Work Item Description | Qty | Unit | Unit Cost | Total | ¹ Total w/ Soft Costs | Scope 1 | Scope 2 | Scope 3 | Totals |
|--|---|---|---|---|---|---|---|---|---|
| 3.36 Existing Elevator Does Not Meet Accessibility Requirements: Remove and replace the elevator control system. | 1 | LS | 50,000.00 | 50,000 | 65,000 | | | 65,000 | 65,000 |

3.17 Elevator.

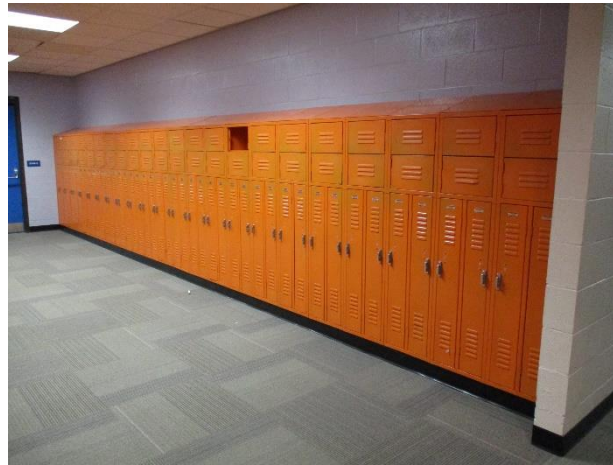
| Work Item Description | Qty | Unit | Unit Cost | Total | ¹ Total w/ Soft Costs | Scope 1 | Scope 2 | Scope 3 | Totals |
|---|---|---|---|---|---|---|---|---|---|
| 3.18 Replace Old Lockers Throughout the building: The existing lockers are too small and not functional. Preferred lockers are 12"x15"x60" on 4" high base. | 625 | EA | 114.00 | 71,250 | 92,625 | | 92,625 | | 92,625 |

3.18 Student lockers.

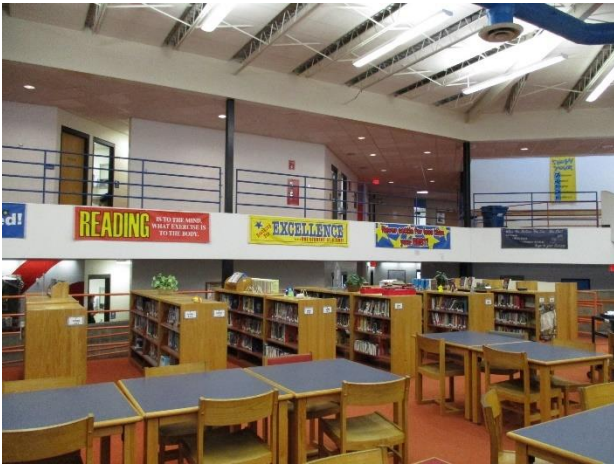
| Work Item Description | Qty | Unit | Unit Cost | Total | ¹ Total w/ Soft Costs | Scope 1 | Scope 2 | Scope 3 | Totals |
|--|---|---|---|---|---|---|---|---|---|
| 3.20 Library Guardrails are not Code Compliant: Replace non-compliant guardrails. | 158 | LF | 45.00 | 7,110 | 9,243 | | | 9,243 | 9,243 |

3.20 Library guardrails.

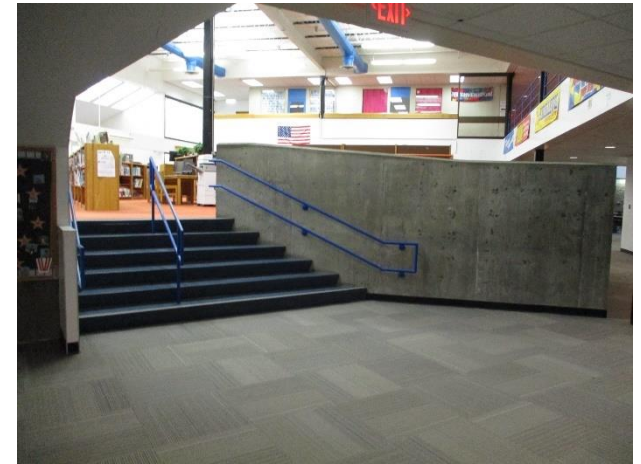
| Work Item Description | Qty | Unit | Unit Cost | Total | ¹ Total w/ Soft Costs | Scope 1 | Scope 2 | Scope 3 | Totals |
|--|---|---|---|---|---|---|---|---|---|
| 3.23 Replace Non-compliant Intermediate Handrail on stair between Library and First Floor: Replace non-compliant railing. | 13 | LF | 45.00 | 585 | 761 | | | 761 | 761 |

3.23 Stair from first floor to library.

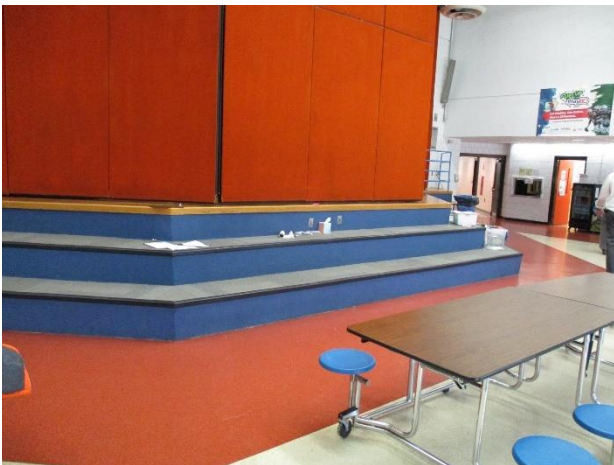
| Work Item Description | Qty | Unit | Unit Cost | Total | ¹ Total w/ Soft Costs | Scope 1 | Scope 2 | Scope 3 | Totals |
|--|---|---|---|---|---|---|---|---|---|
| 3.24 Original 1978 Sheet Vinyl Floor in the Cafetorium: Replace existing sheet vinyl floor with new sheet vinyl. | 2,622 | SF | 10.00 | 26,220 | 34,086 | | 34,086 | | 34,086 |

3.24 Sheet vinyl floor at cafetorium.

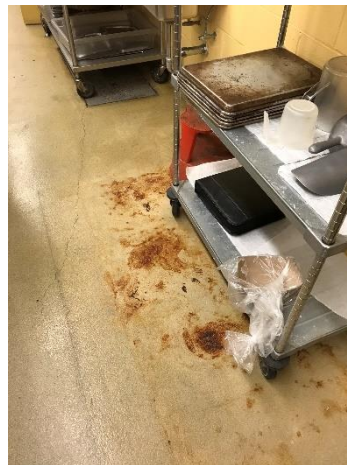
| Work Item Description | Qty | Unit | Unit Cost | Total | ¹ Total w/ Soft Costs | Scope 1 | Scope 2 | Scope 3 | Totals |
|--|---|---|---|---|---|---|---|---|---|
| 3.25 Existing Kitchen Epoxy Floor is cracked and Stained: Replace the old kitchen floor. | 1,490 | SF | 32.00 | 47,680 | 61,984 | | 61,984 | | 61,984 |

3.25 Kitchen epoxy floor.

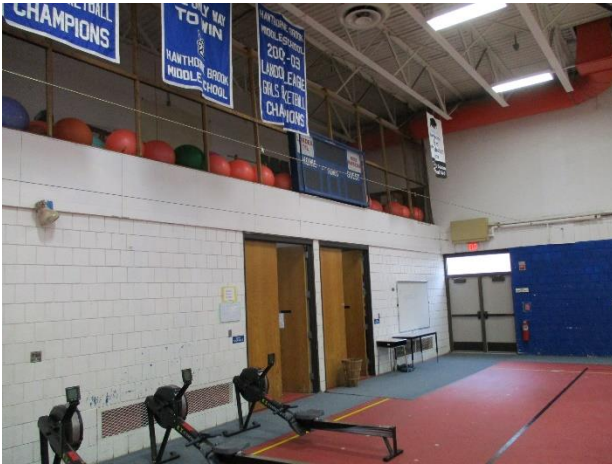
| Work Item Description | Qty | Unit | Unit Cost | Total | ¹ Total w/ Soft Costs | Scope 1 | Scope 2 | Scope 3 | Totals |
|--|---|---|---|---|---|---|---|---|---|
| 3.27 Reconfigure Gymnasium Storage Area: Redesign this area to create exercise room. Remove and replace existing wood stair to the mezzanine level. | 1,500 | SF | 200.00 | 300,000 | 390,000 | | | 390,000 | 390,000 |

3.27 Gymnasium storage area.

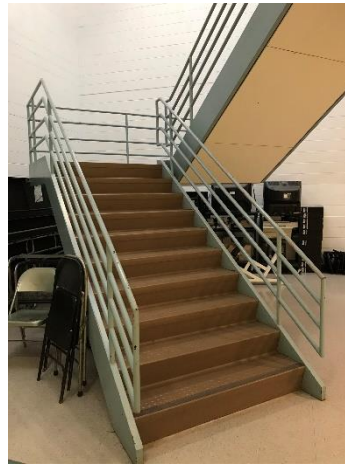
| Work Item Description | Qty | Unit | Unit Cost | Total | ¹ Total w/ Soft Costs | Scope 1 | Scope 2 | Scope 3 | Totals |
|--|---|---|---|---|---|---|---|---|---|
| 3.28 Non-compliant Handrails / Guardrails: Open Stair Outside Gymnasium has Non-compliant Handrails / Guardrails. Replace the non-compliant railings. Includes cane detection railing underneath. | 149 | LF | 45.00 | 6,705 | 8,717 | | | 8,717 | 8,717 |

3.28 Non-compliant handrails / guardrails.

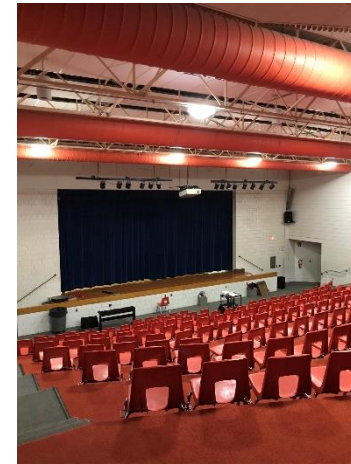
| Work Item Description | Qty | Unit | Unit Cost | Total | ¹ Total w/ Soft Costs | Scope 1 | Scope 2 | Scope 3 | Totals |
|--|---|---|---|---|---|---|---|---|---|
| 3.29 Auditorium Theatrical Lighting and Loudspeakers: Replace the outdated theatrical lighting and loudspeakers system. | 1 | LS | 100,000.00 | 100,000 | 130,000 | | 130,000 | | 130,000 |

3.29 Auditorium stage lighting.

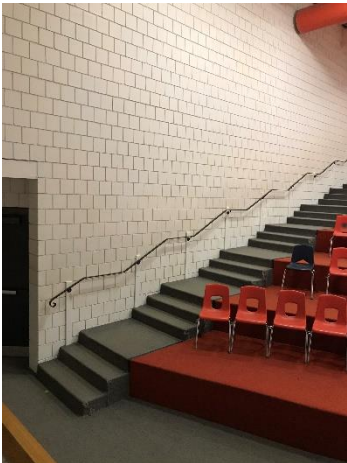
| Work Item Description | Qty | Unit | Unit Cost | Total | ¹ Total w/ Soft Costs | Scope 1 | Scope 2 | Scope 3 | Totals |
|--|---|---|---|---|---|---|---|---|---|
| 3.30 Non-compliant Handrails: Wall mounted handrails in the auditorium are not code compliant. Remove and replace. | 66 | LF | 45.00 | 2,970 | 3,861 | | | 3,861 | 3,861 |

3.30 Handrail in the auditorium.

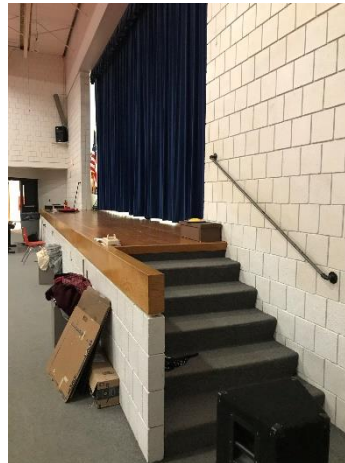
| Work Item Description | Qty | Unit | Unit Cost | Total | ¹ Total w/ Soft Costs | Scope 1 | Scope 2 | Scope 3 | Totals |
|--|---|---|---|---|---|---|---|---|---|
| 3.31 Non-compliant Handrails to Stage: Replace the non-compliant handrails. | 28 | LF | 45.00 | 1,260 | 1,638 | | | 1,638 | 1,638 |

3.31 Handrail to the stage.

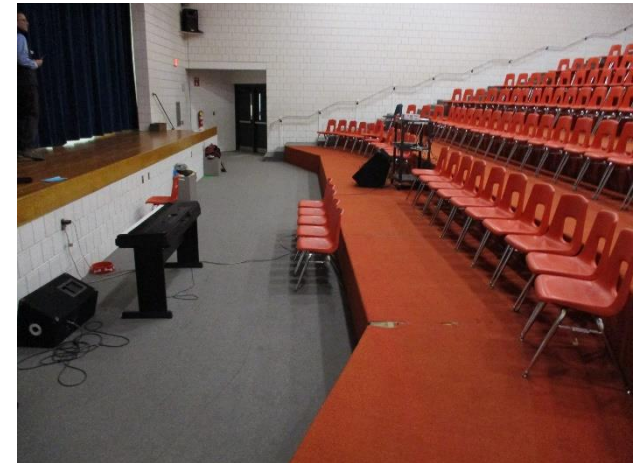
| Work Item Description | Qty | Unit | Unit Cost | Total | ¹ Total w/ Soft Costs | Scope 1 | Scope 2 | Scope 3 | Totals |
|--|---|---|---|---|---|---|---|---|---|
| 3.32 Replace Auditorium Carpet: Auditorium carpet is worn and detached. Replace with new carpet. | 2,500 | SF | 10.00 | 25,000 | 32,500 | | 32,500 | | 32,500 |

3.32 Auditorium carpet.

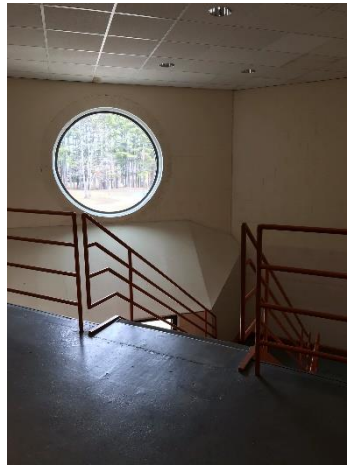
| Work Item Description | Qty | Unit | Unit Cost | Total | ¹ Total w/ Soft Costs | Scope 1 | Scope 2 | Scope 3 | Totals |
|--|---|---|---|---|---|---|---|---|---|
| 3.34 Non-compliant Handrails / Guardrails: Replace non-compliant railings on Stair B. | 76 | LF | 45.00 | 3,420 | 4,446 | | | 4,446 | 4,446 |

3.34 Handrails at Stair B.

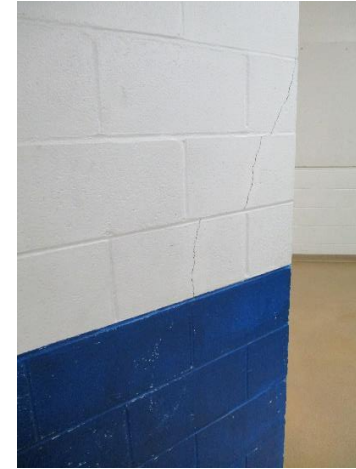
| Work Item Description | Qty | Unit | Unit Cost | Total | ¹ Total w/ Soft Costs | Scope 1 | Scope 2 | Scope 3 | Totals |
|--|---|---|---|---|---|---|---|---|---|
| 3.35 Stress cracks on interior masonry walls throughout the building: Repair / rebuild masonry walls. It is unknown what is causing the stress crack, further investigation is recommended. | 200 | EA | 180.00 | 36,000 | 46,800 | | 46,800 | | 46,800 |

3.35 Stress cracks on masonry wall.

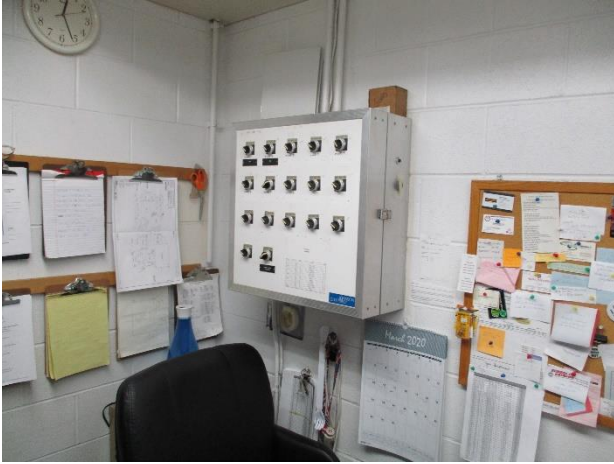
| Work Item Description | Qty | Unit | Unit Cost | Total | ¹ Total w/ Soft Costs | Scope 1 | Scope 2 | Scope 3 | Totals |
|--|---|---|---|---|---|---|---|---|---|
| 4.1 Replace Pneumatic Control: The building HVAC system utilizes a combination of DDC and pneumatic controls. The pneumatic system is obsolete and is not reliable. Replace the remaining pneumatic controls and upgrade to DDC system. Assuming 75% of the existing control system is pneumatic. | 75,000 | SF | 5.00 | 375,000 | 487,500 | | 487,500 | | 487,500 |

4.1 Pneumatic control panel

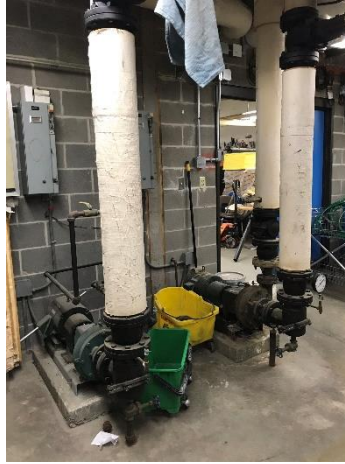
| Work Item Description | Qty | Unit | Unit Cost | Total | ¹ Total w/ Soft Costs | Scope 1 | Scope 2 | Scope 3 | Totals |
|--|---|---|---|---|---|---|---|---|---|
| 4.2 Replace Pumps in Boiler Room: Replace old pumps in the boiler room. | 2 | EA | 12,000.00 | 24,000 | 31,200 | | 31,200 | | 31,200 |

4.2 Boiler pumps

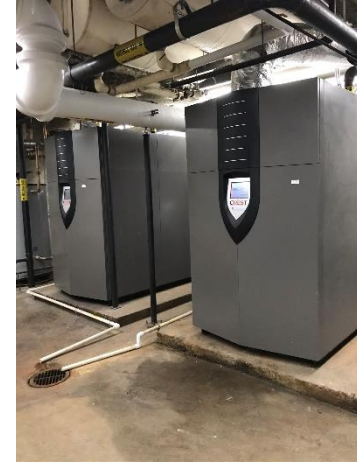
| Work Item Description | Qty | Unit | Unit Cost | Total | ¹ Total w/ Soft Costs | Scope 1 | Scope 2 | Scope 3 | Totals |
|--|---|---|---|---|---|---|---|---|---|
| 4.3 Replace VFD Controller in the Boiler Room: Remove old VFD in the boiler room. | 1 | EA | 25,000.00 | 25,000 | 32,500 | | 32,500 | | 32,500 |

4.3 Boiler room

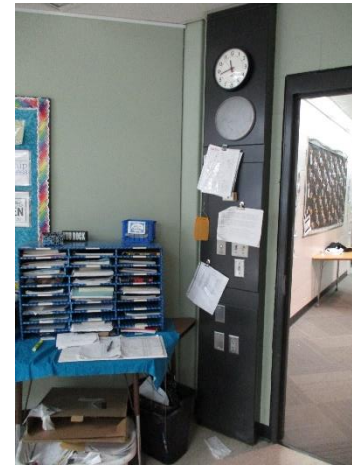
| Work Item Description | Qty | Unit | Unit Cost | Total | ¹ Total w/ Soft Costs | Scope 1 | Scope 2 | Scope 3 | Totals |
|--|---|---|---|---|---|---|---|---|---|
| 5.3 Upgrade Communication/Clock System: The system has reached life expectancy. A new wireless clock and VOIP system should be installed to replace the existing system. | 106,600 | SF | 3.00 | 319,800 | 415,740 | | 415,740 | | 415,740 |

5.3 Intercom System.

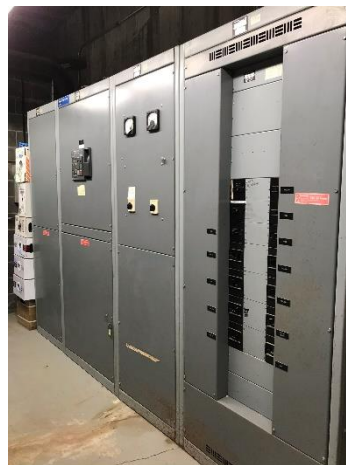
| Work Item Description | Qty | Unit | Unit Cost | Total | ¹ Total w/ Soft Costs | Scope 1 | Scope 2 | Scope 3 | Totals |
|--|---|---|---|---|---|---|---|---|---|
| 5.5 Replace the Existing Switchgear: The existing 1978 switchgear is in fair to poor condition. We recommend replacing the switchgear under a renovation. | 106,600 | SF | 6.00 | 639,600 | 831,480 | | 831,480 | | 831,480 |

5.5 Electrical room.

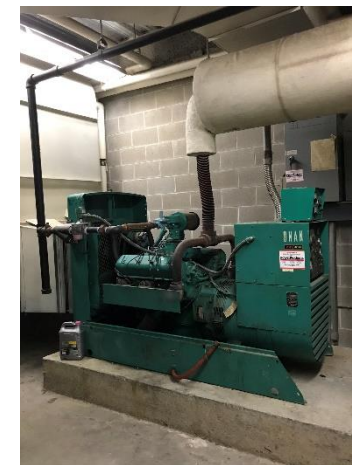
| Work Item Description | Qty | Unit | Unit Cost | Total | ¹ Total w/ Soft Costs | Scope 1 | Scope 2 | Scope 3 | Totals |
|--|---|---|---|---|---|---|---|---|---|
| 5.6 Replace Emergency Generator and Transfer Switch: The existing gas-fired generator is 44 years old. Replace the outdated generator. | 1 | LS | 125,000.00 | 125,000 | 162,500 | | 162,500 | | 162,500 |

5.6 Emergency generator.
