MOLD AND MOISTURE ASSESSMENT REPORT

ALBERT HILL MIDDLE SCHOOL

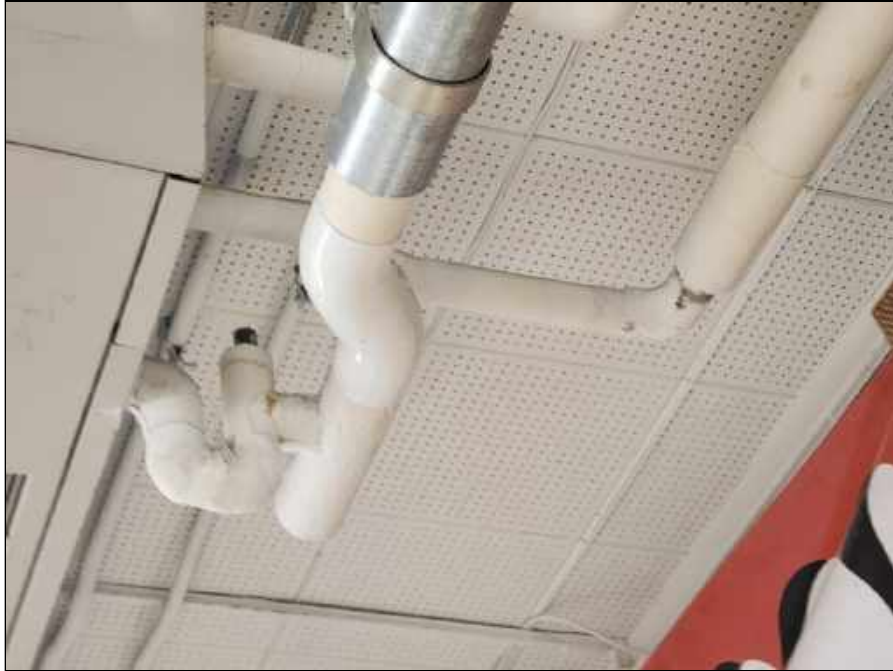
1 - Mold on hydronic plumbing insulation in the cafeteria

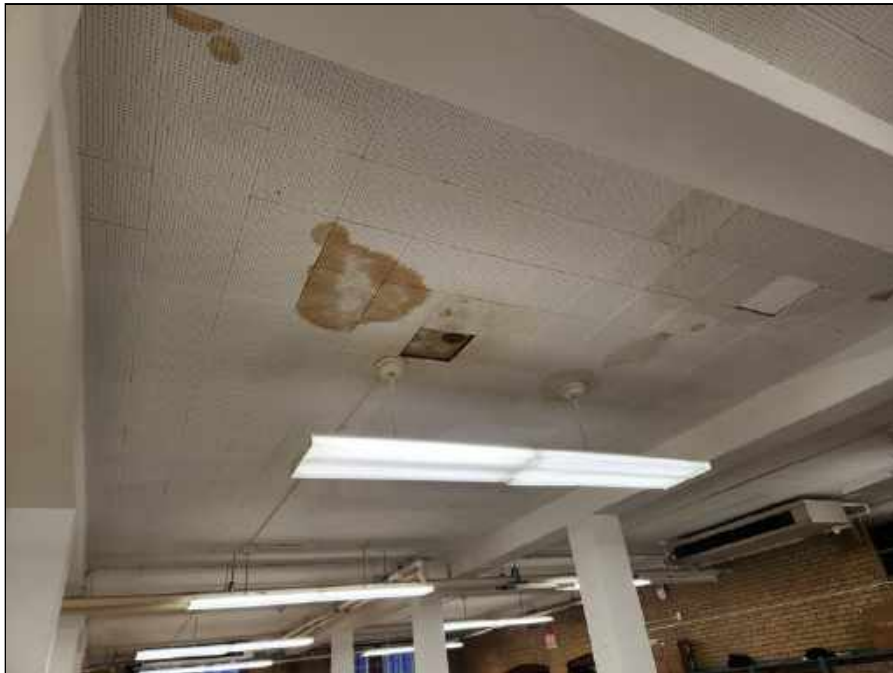
2 - Moisture damaged ceiling tiles in the cafeteria

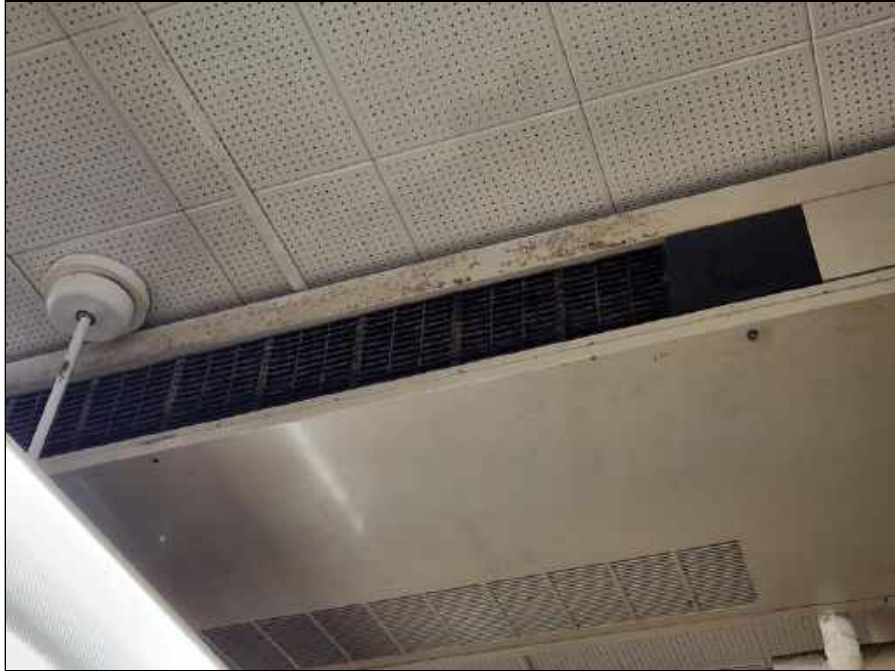
3 - Mold on the ceiling mounted fan coil in the cafeteria

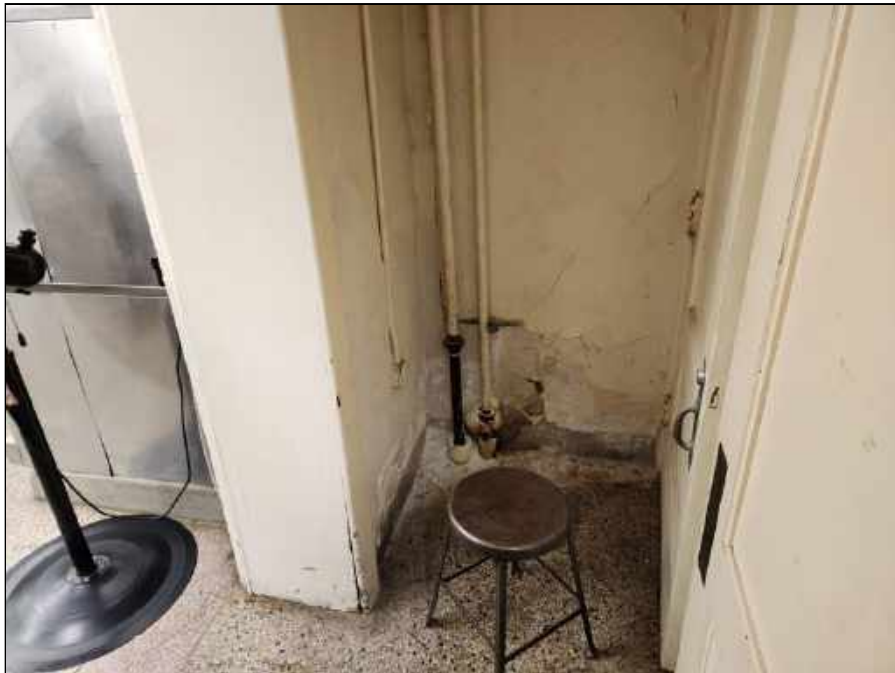
4 - Moisture damaged plaster wall in the kitchen

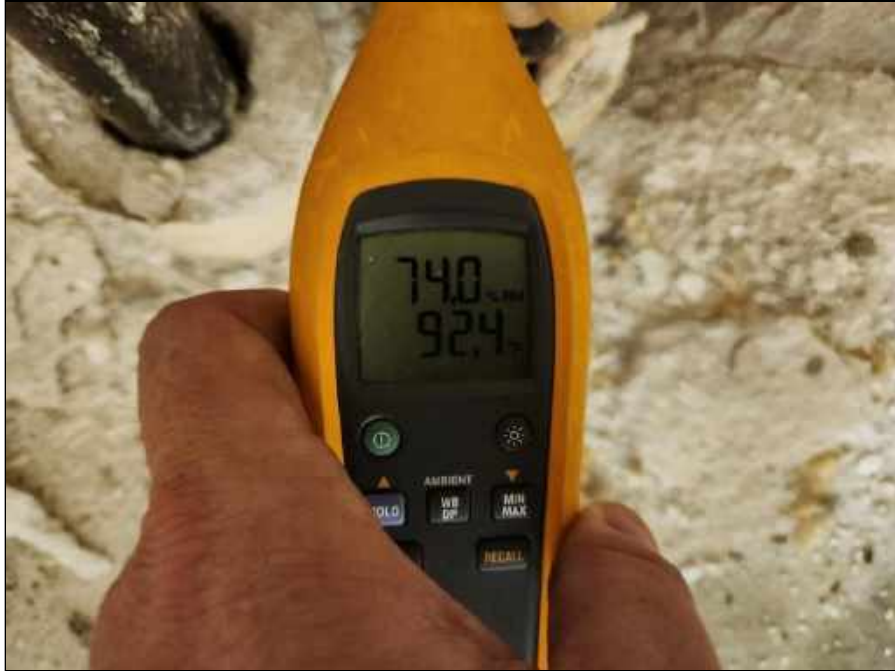
5 - Elevated relative humidity near the moisture damaged plaster wall

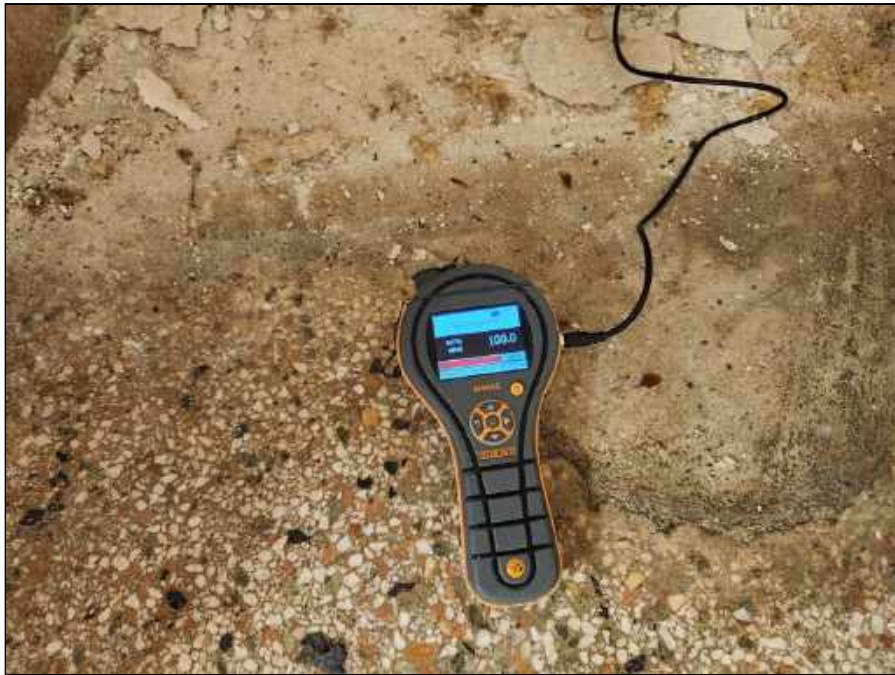
6 - Moisture meter reading indicating a portion of the damaged plaster wall is wet

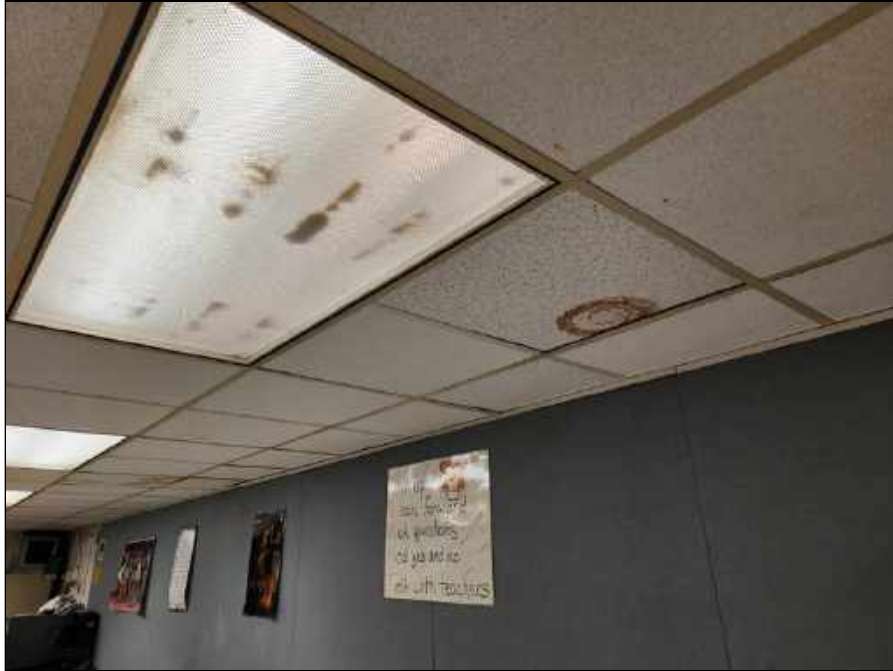
7 - Moisture stained ceiling tiles in the band room

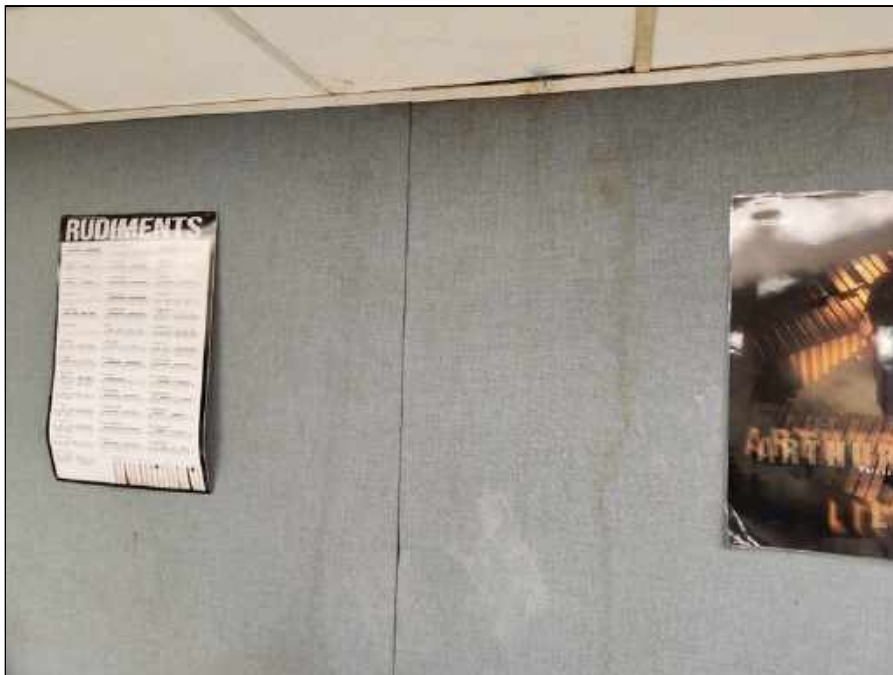
8 - Moisture stained wall panels in the band room

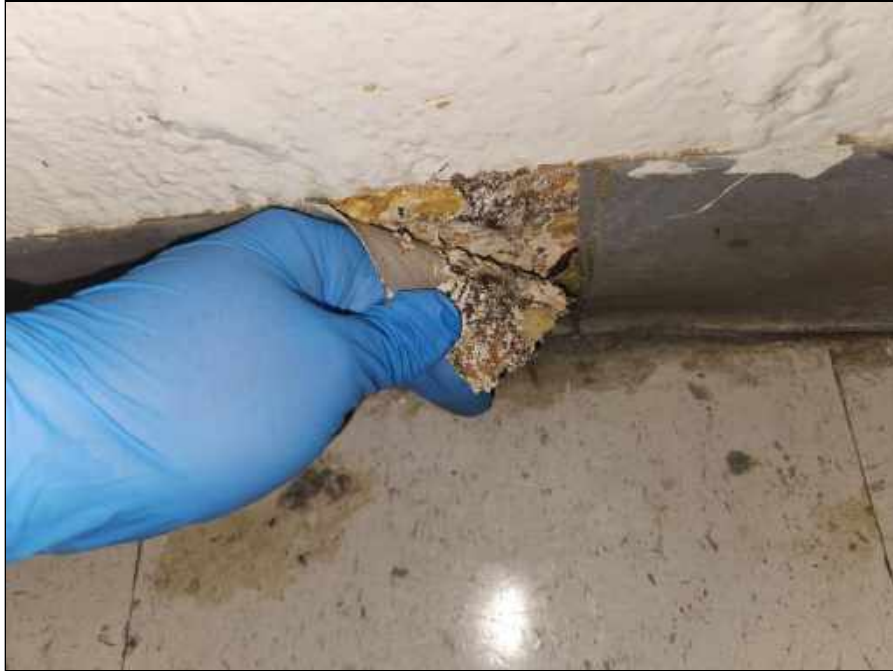
9 - Mold behind vinyl cove baseboard in the band room

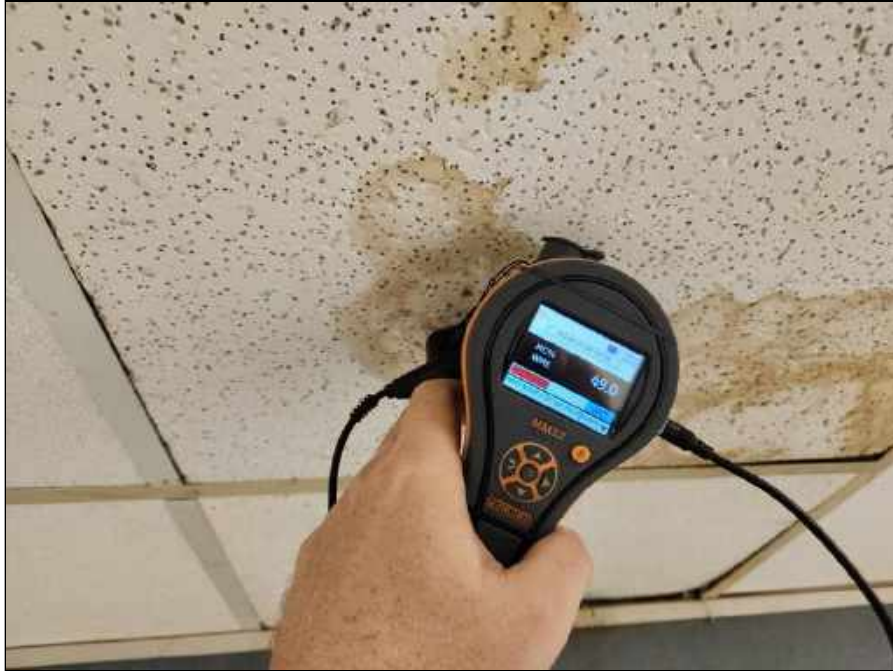
11 - Elevated moisture meter reading collected from ceiling tile in the band room

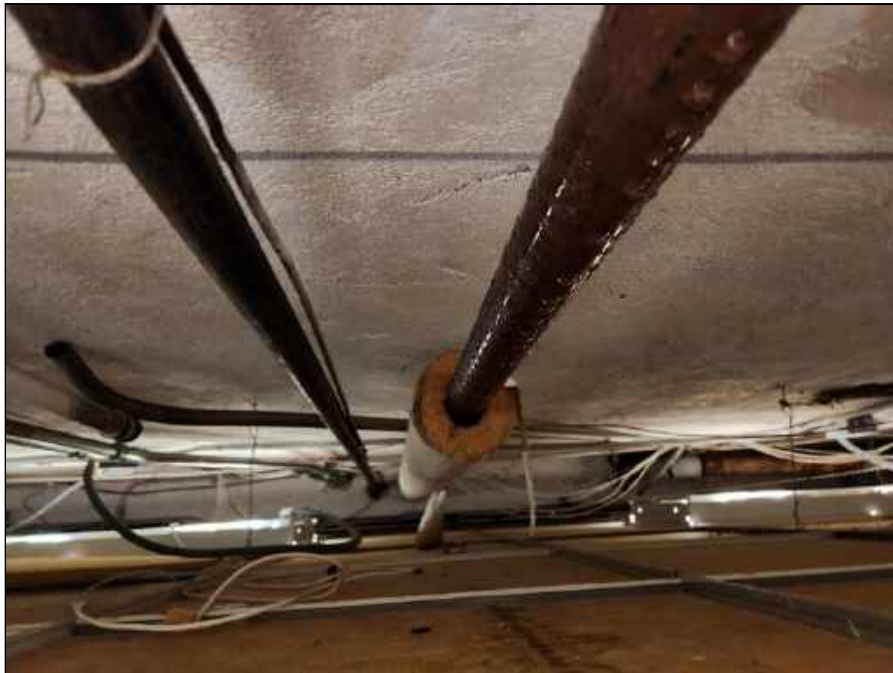
12 - Un-insulated condensating pipe above the ceiling in the band room

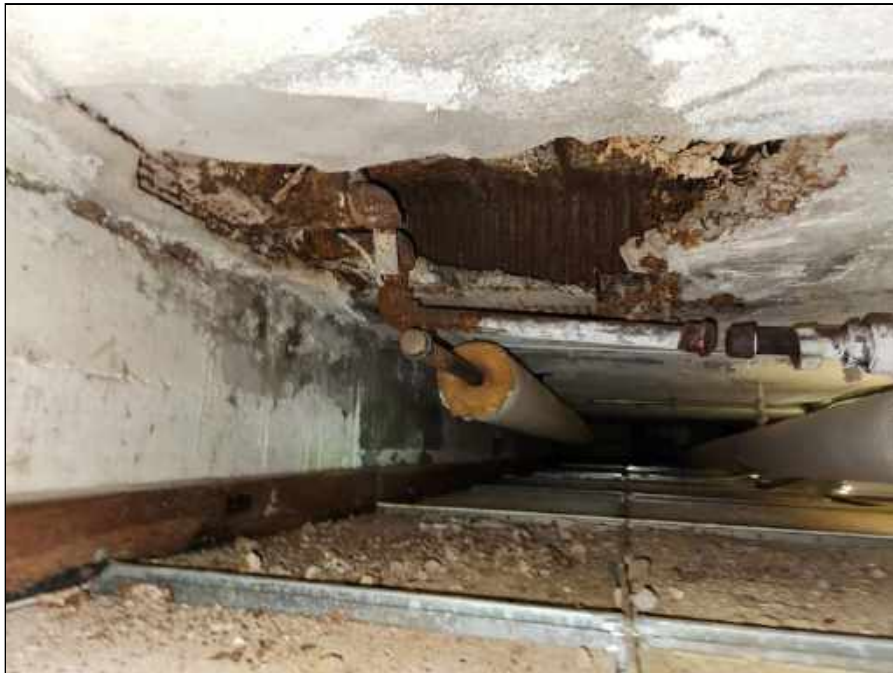
14 - Moisture damaged plaster ceiling in the basement outside of the boiler room

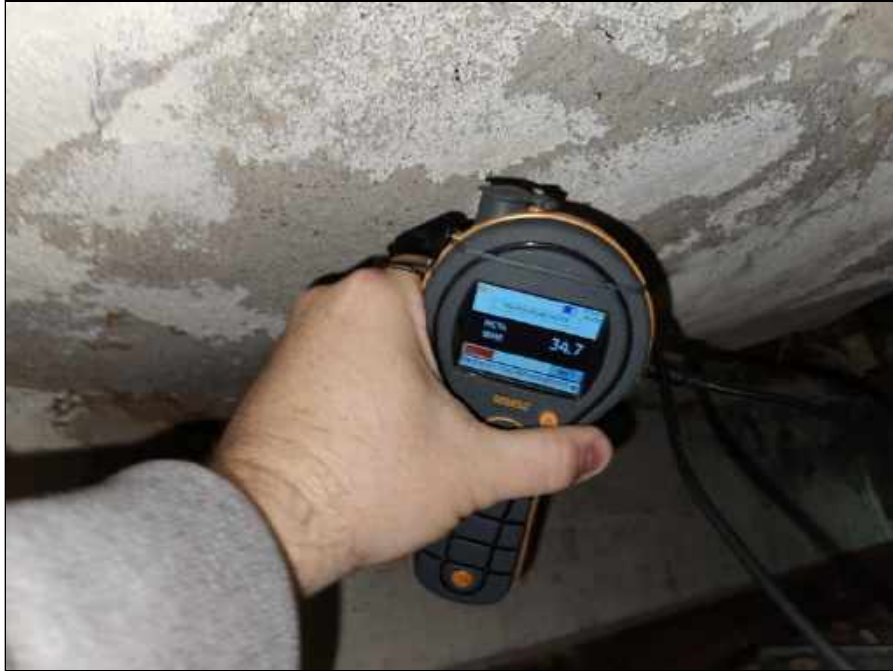
15 - Elevated moisture meter reading associated with the plaster ceiling outside of the boiler room

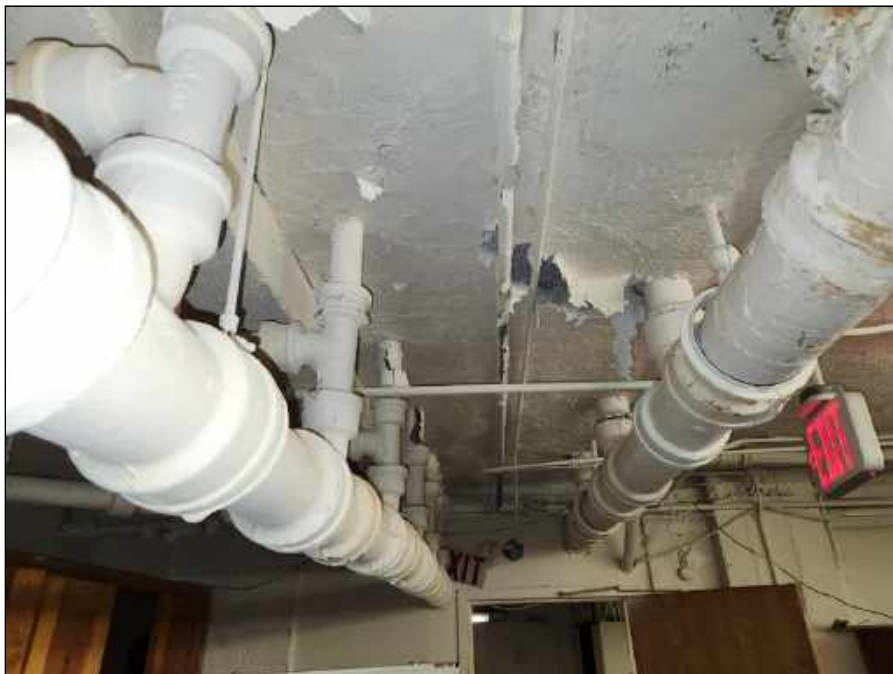
16 - Moisture damaged plaster ceiling in the Harp Room

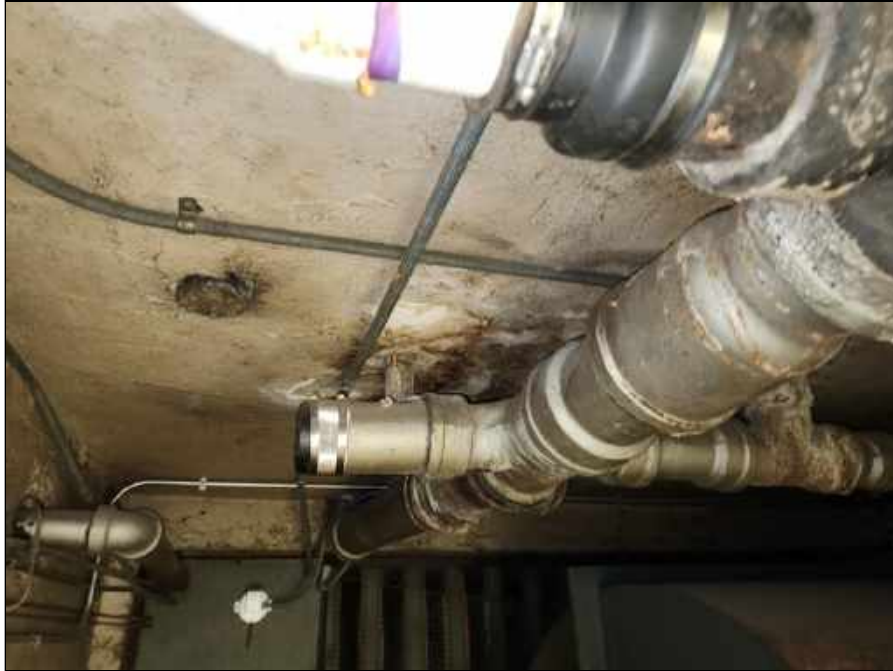
17 - Mold and moisture impacted plaster ceiling in the basement fan room

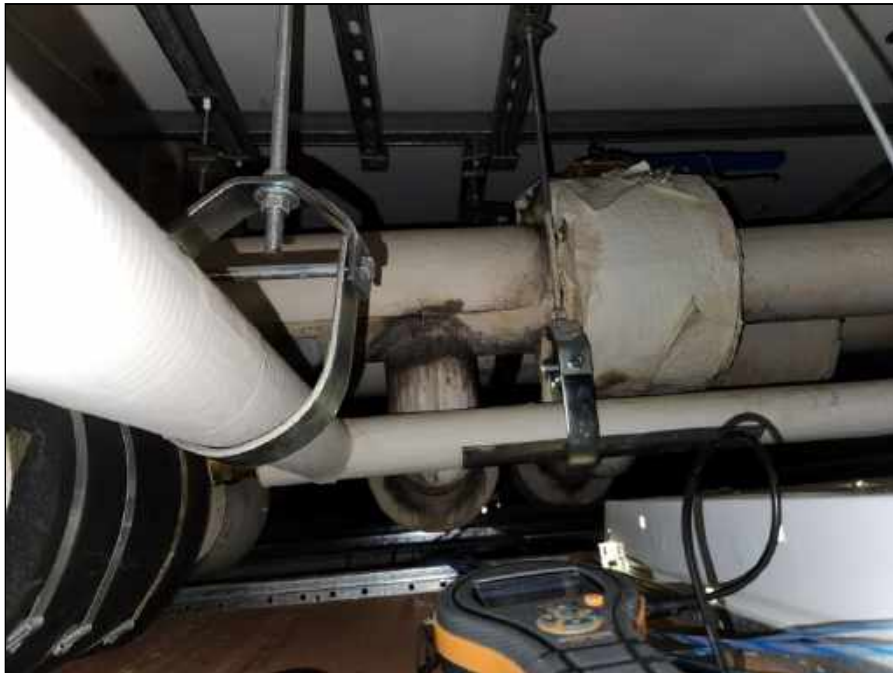
18 - Mold on pipe insulation above the 2nd floor ceiling

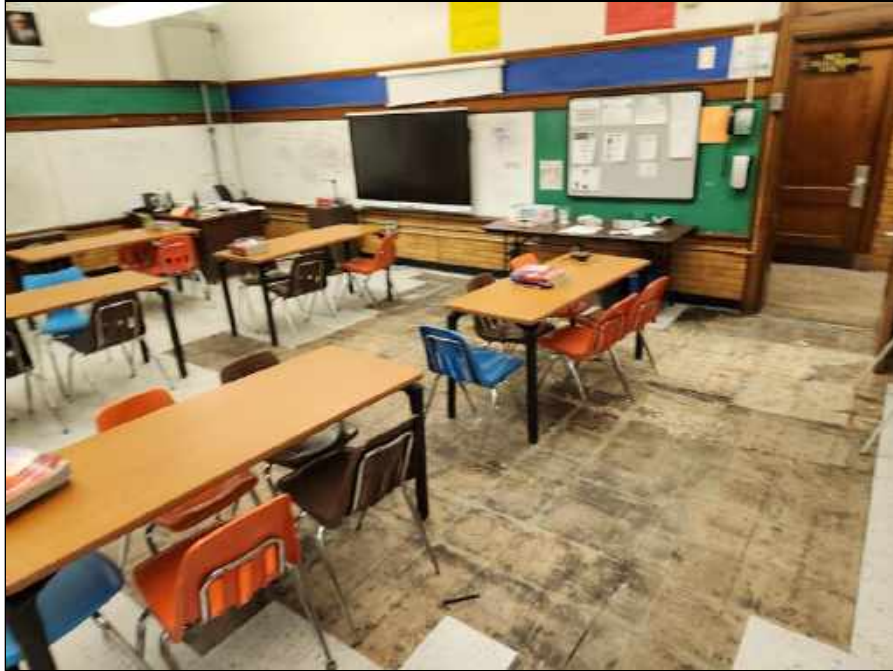
19 - Moisture impacted sub-floor in Room 212

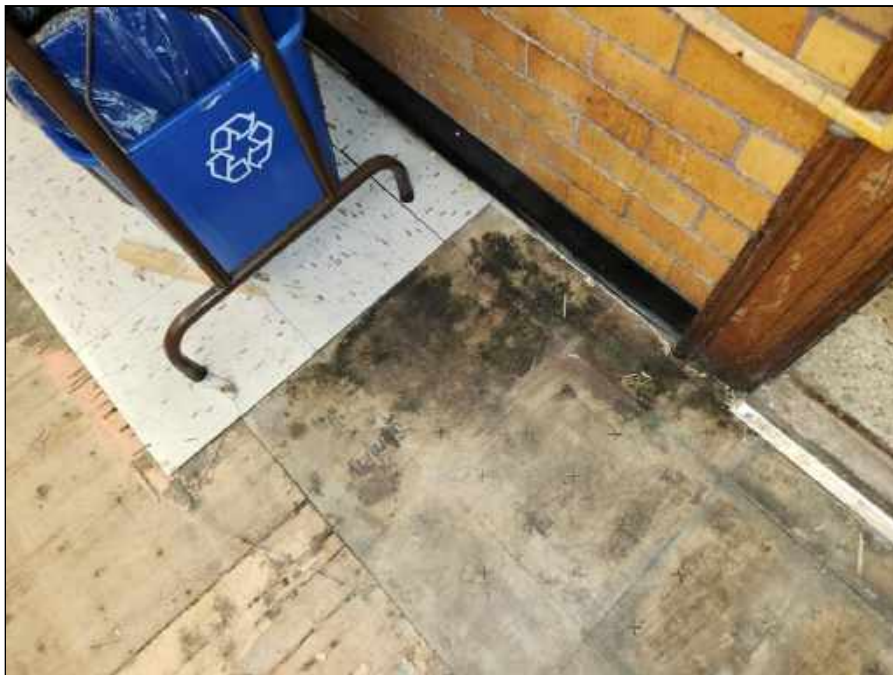
20 - Mold impacted sub-floor in Room 212

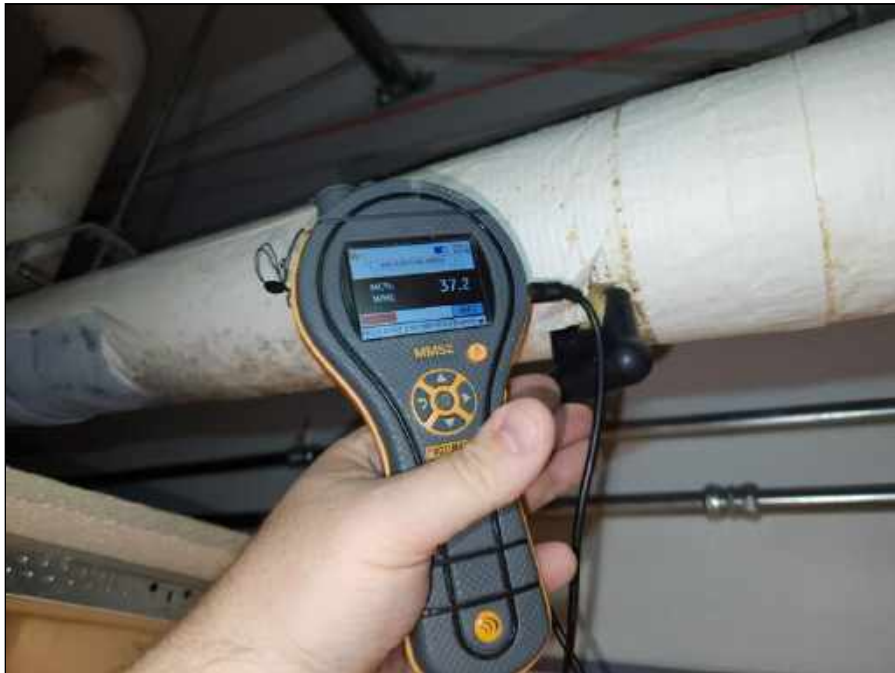
24 - Elevated moisture meter reading associated with the mold impacted pipe insulation

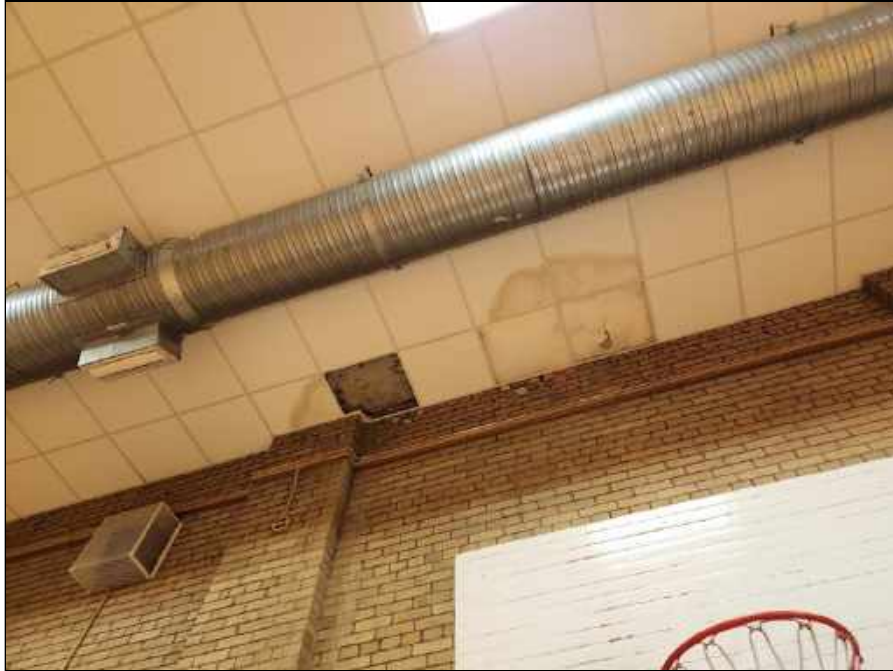
25 - Moisture damaged drop ceiling and plaster ceiling in the gym

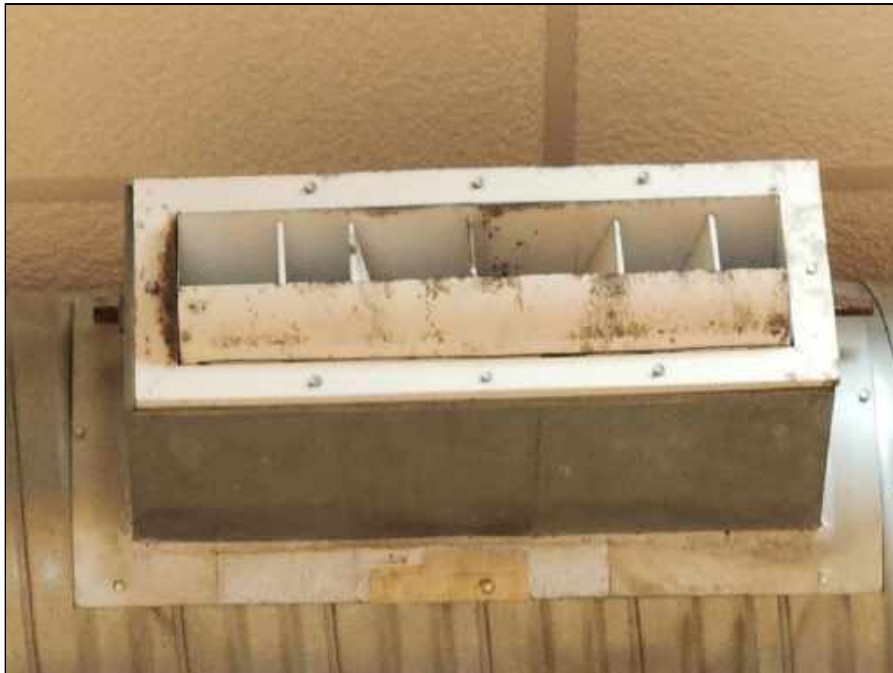
26 - Suspect mold on the HVAC supply ducts in the gym

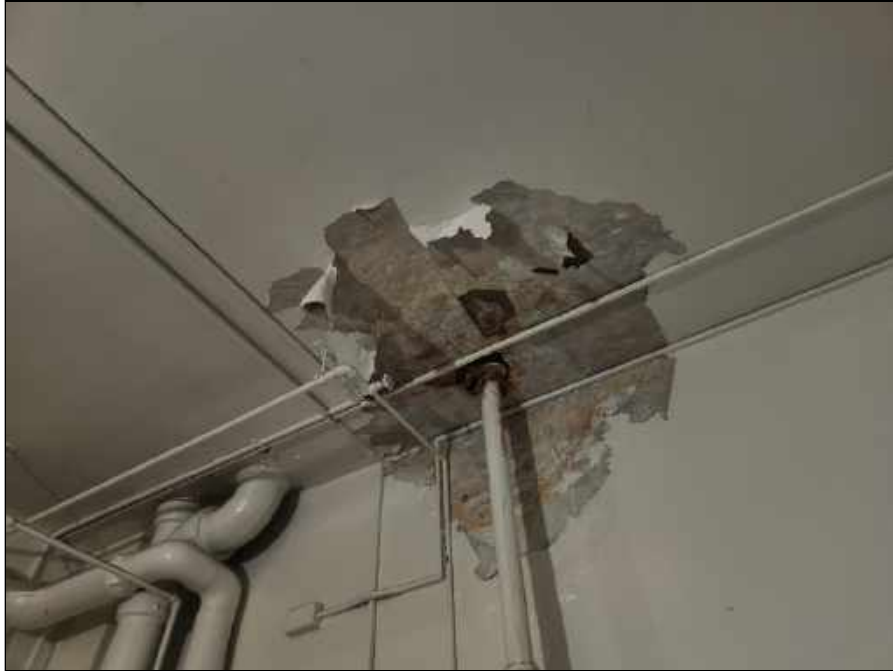
27 - Moisture damaged plaster ceiling in the girl's locker room

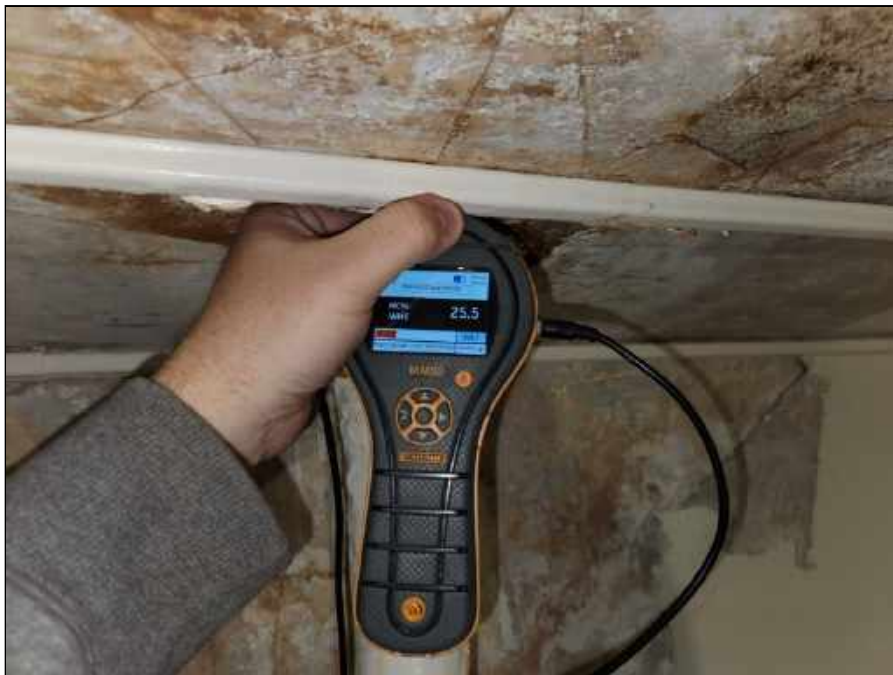
28 - Elevated moisture meter reading associated with the damaged plaster ceiling

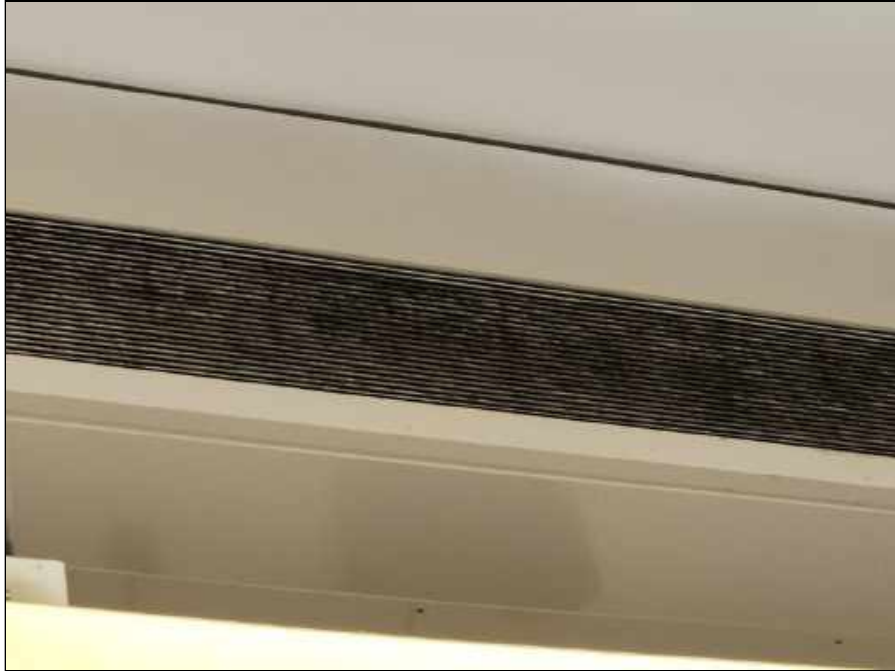
29 - Mold on the ceiling mounted fan coil in Room 301

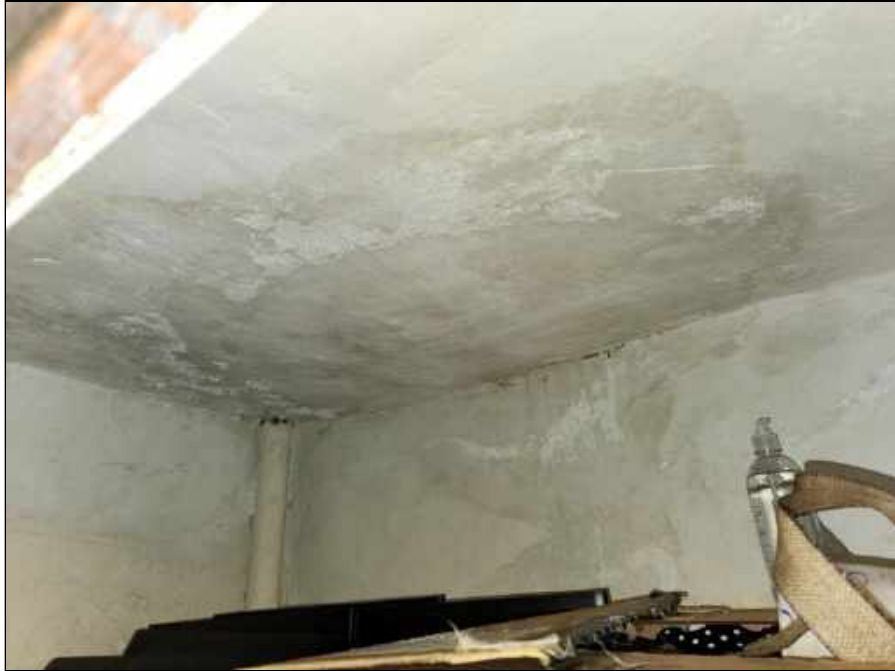
31 - Moisture stained plaster ceiling in the closet in Room 301

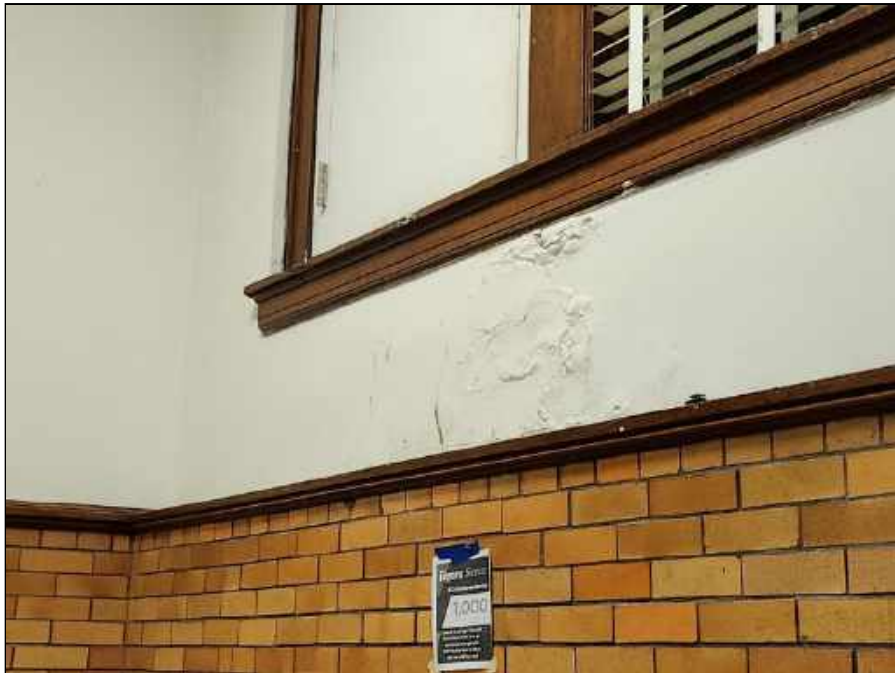
32 - Moisture damaged plaster wall in the 3rd floor hallway

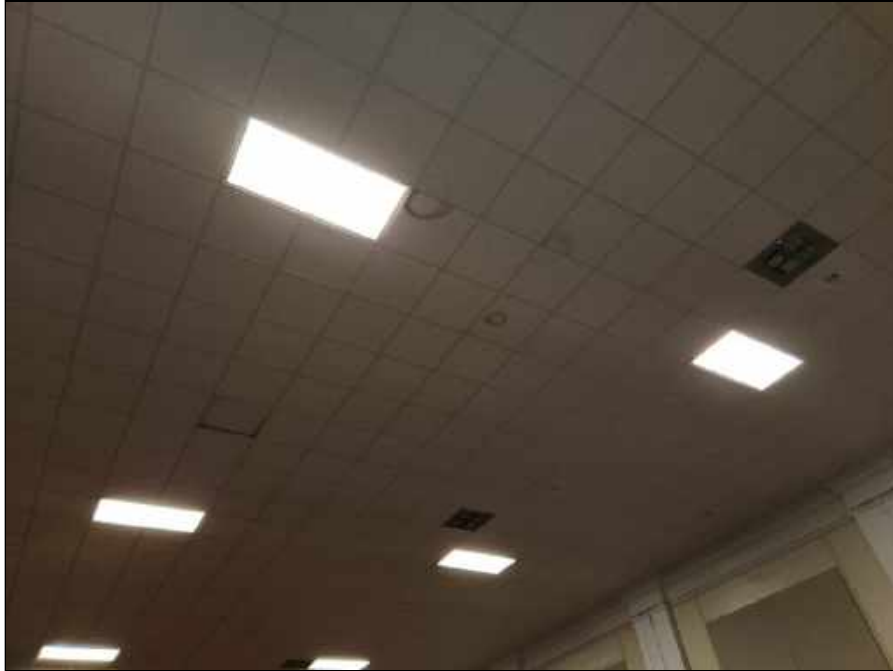
33 - Moisture stained ceiling tiles in the auditorium

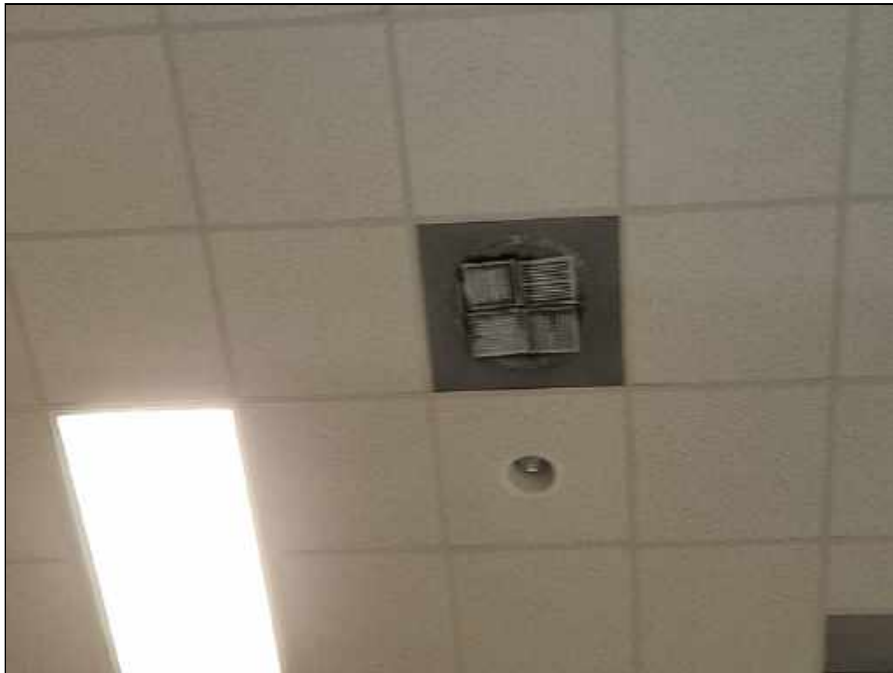
34 - Suspect mold on HVAC supplies in the Auditorium

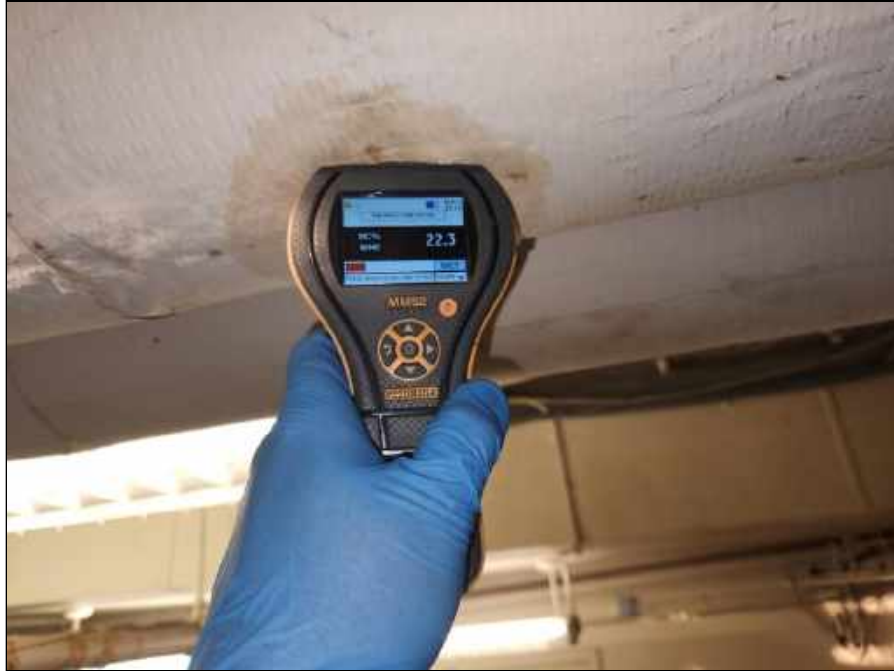
39 - Elevated moisture meter reading from pipe insulation in Ms. Macklin's office in the basement
