MOLD AND MOISTURE ASSESSMENT REPORT

FOX AT CLARK SPRINGS ELEMENTARY SCHOOL

1101 DANCE STREET
RICHMOND, VIRGINIA 23220

ECS PROJECT NO. 47:14153-A

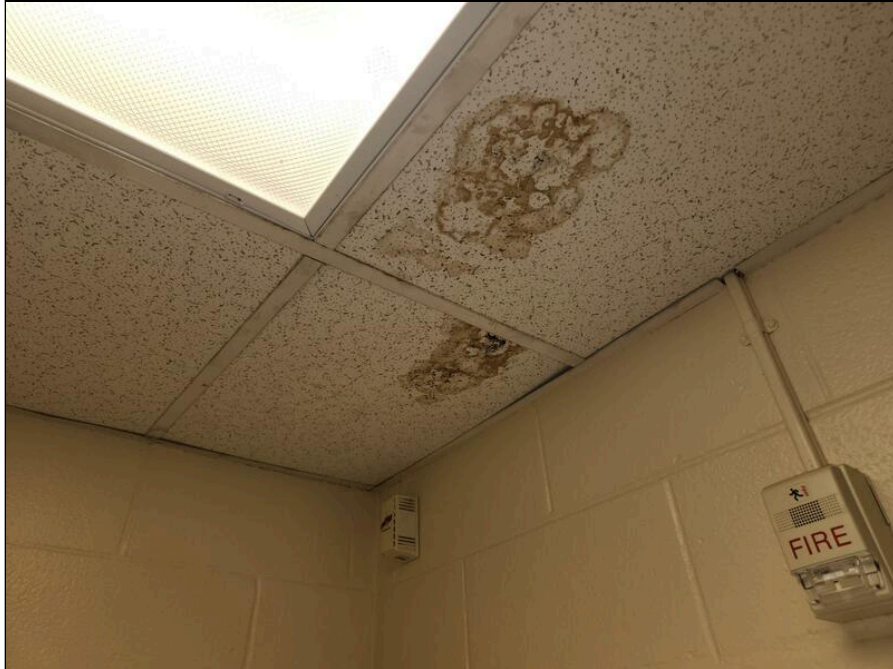
11 - Water and mold impacted ceiling tile in the Room 108 bathroom
