MOLD AND MOISTURE ASSESSMENT REPORT

LOIS HARRISON-JONES ELEMENTARY SCHOOL

ECS PROJECT NO. 47:14153-J

FEBRUARY 26, 2024

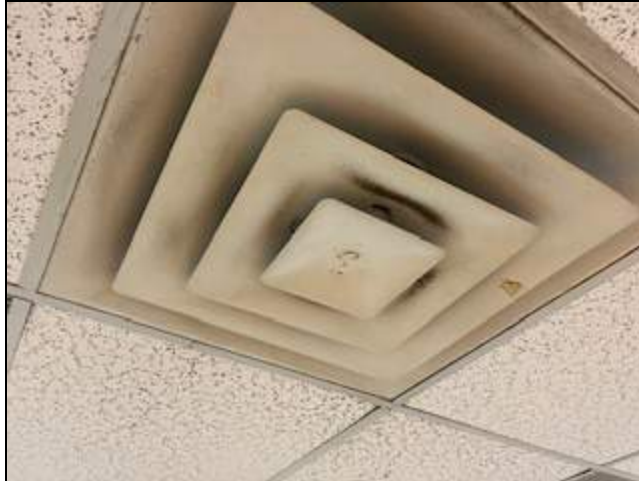
1 - General view of supply vent showing heavy dust accumulation.

- A heavy build-up of dust and dirt was observed associated with the ceiling supply vents throughout the building. Perform localized cleaning of the HVAC system and review the cleaning and maintenance schedule for the units; Use a mold remediation contractor or qualified school maintenance staff. Perform any mold remediation as described in this protocol above this section; Note: Having dust accumulation and suspect mold at the diffusers is not uncommon and is a normal preventive maintenance measure to monitor and correct.

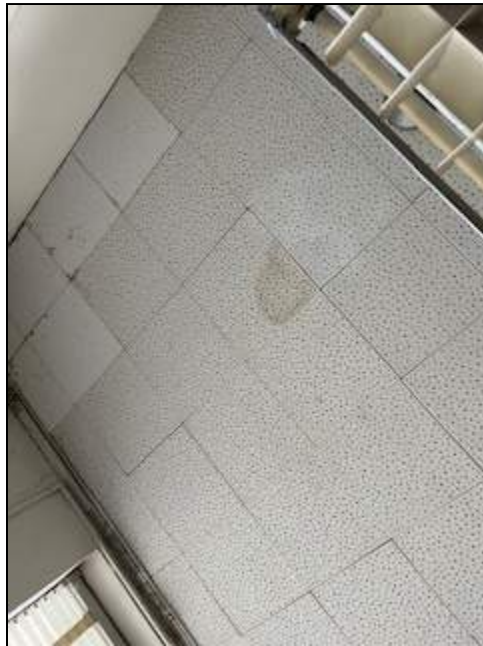
- Moisture stained ceiling tiles were observed sporadically in areas throughout the hallways, classrooms, and cafeteria in areas where drop ceiling tiles are present. None of the areas tested were determined to have elevated moisture content. In general much of the staining observed on ceiling tiles was likely caused by old roof leaks, pipe or HVAC condensation leaks or general leaking pipes;

2 - General view of ceiling tiles with water staining.

- Moisture stained ceiling tiles were observed sporadically in areas throughout the hallways, offices, cafeteria/auditorium, and kitchen in areas where drop ceiling tiles are present. None of the areas tested were determined to have elevated moisture content. In general much of the staining observed on ceiling tiles was likely caused by old roof leaks, pipe condensation or leaking pipes. Have a qualified mold remediation contractor or qualified maintenance staff remove and replace all moisture impacted ceiling tiles. Perform any mold remediation as described in this protocol above this section if needed;

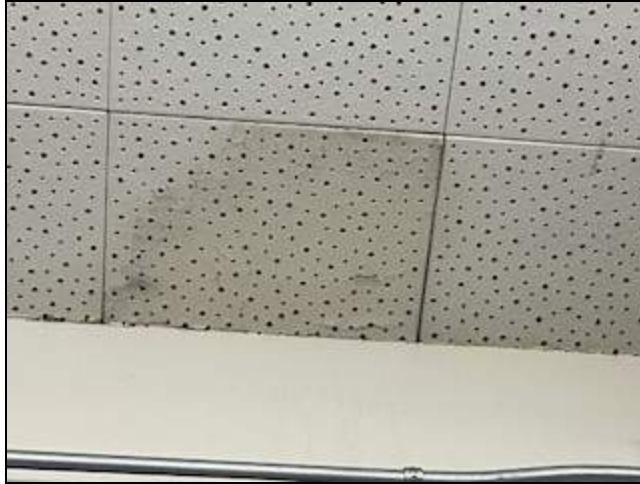
3 - General view of 1' x 1' ceiling tile with water staining observed.

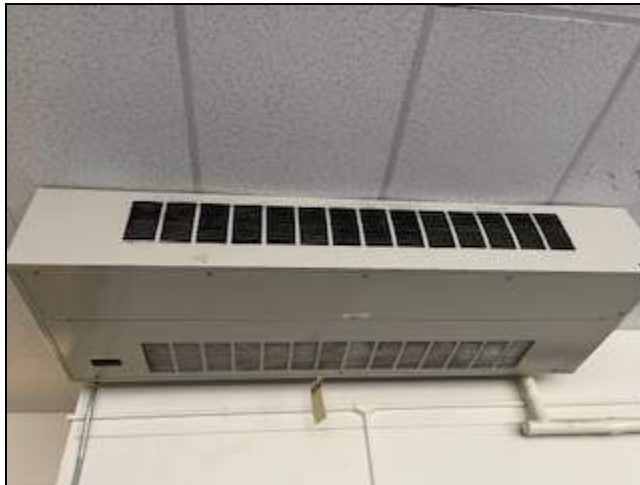
- Suspect mold was observed on the ceiling mounted fan coil units throughout the school. ECS observed heavy dust on the face of the units and suspect mold was growing from the accumulated dust.

4 - General view of ceiling mounted HVAC unit with suspect mold on supply diffuser.

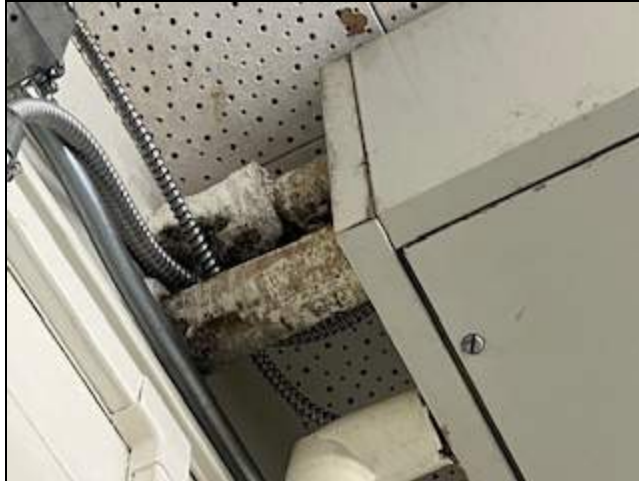
- ECS also observe heavy mold growth on the fiberglass pipe insulation associated with the ceiling mounted fan coil units throughout the school;
- During the site visit an active water leak was occurring in the Cafeteria. Three ceiling tiles were impacted by the water leak.

5 - General view of pipe with suspect mold associated with a ceiling mounted HVAC unit.

- ECS also observed heavy mold growth on the fiberglass pipe insulation associated with the ceiling mounted fan coil units throughout the school. Have a qualified mold remediation contractor or qualified maintenance staff remove and replace all mold and moisture impacted fiberglass pipe insulation. Perform any mold remediation as described in this protocol above this section, as needed;

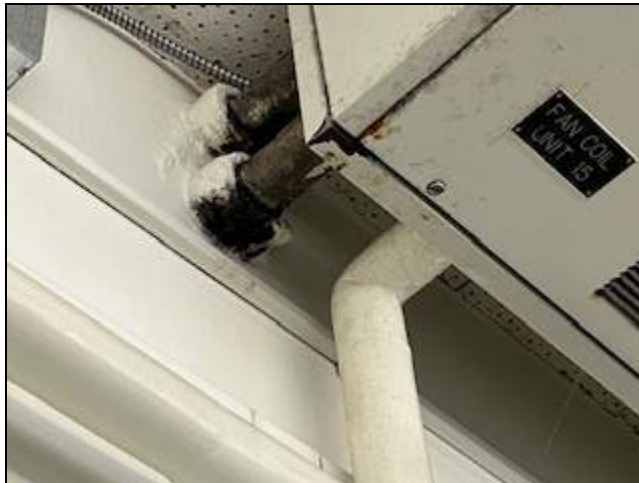
6 - General view of pipe with suspect mold associated with a ceiling mounted HVAC unit.

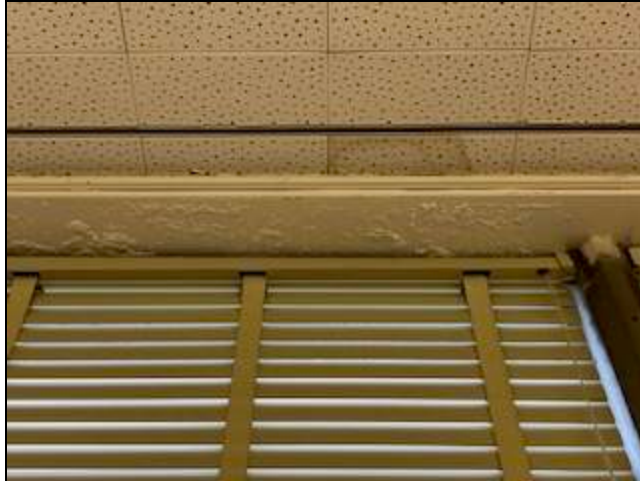
- ECS observed a window in room 112 having water damage possibly from a caulk failure on the exterior portion of the building;
- ECS observed the window lintel in room 203 with water damage possibly from caulk failure or a roof leak.

7 - View of the window lintel having signs of water intrusion within room 203.

- ECS observed the window lintel in room 203 with water damage possibly from caulk failure or a roof leak. Further review by a maintenance staff is recommended;

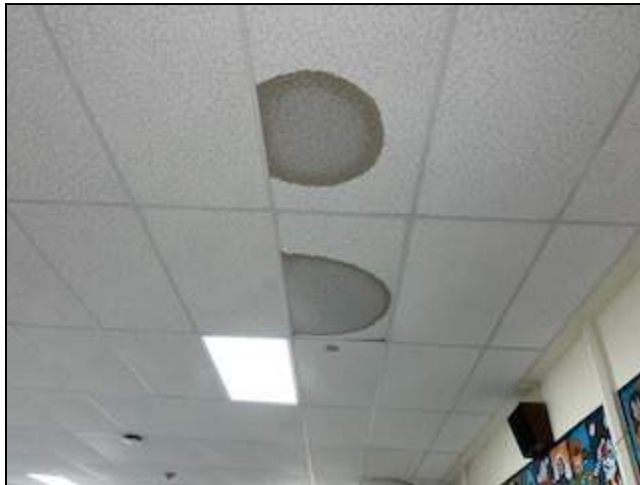
8 - Cafeteria - stained /water impacted ceiling tile showing active water leak from roof.

- During the site visit an active water leak was occurring in the Cafeteria. Three ceiling tiles were impacted by the water leak. Have a maintenance staff removed any water impacted ceiling tiles, and have a roofing contractor inspect the roof above the cafeteria for any leaks; Dry any remaining materials.

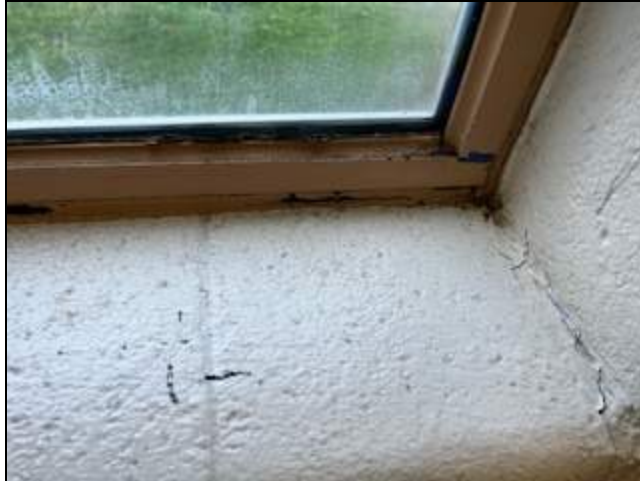
9 - Window in room 112 showing peeling paint possibly from water intrusion from caulk failure.

- ECS observed a window in room 112 having water damage (showing peeling/rust) possibly from caulk failure on the exterior portion of the building; Repair the window casing as well as the exterior caulk/glaze failure (by an asbestos abatement contractor) to prevent further water intrusion from occurring;

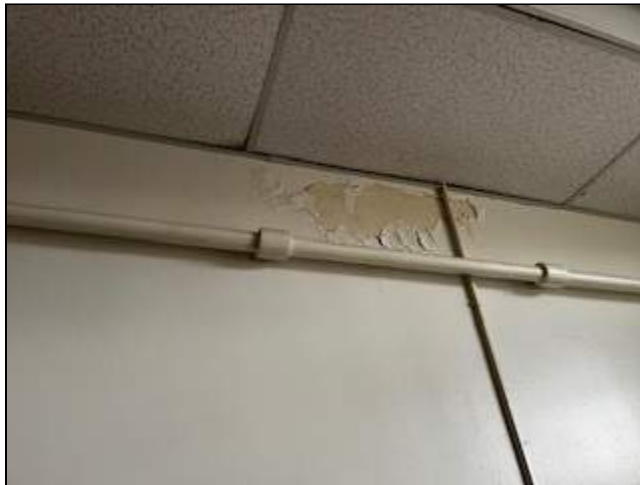
- The exterior wall in room 208 was observed to have bubbling/paint peeling from a previous water intrusion. Moisture reading taken from plaster was in the dry range.

Location	Building Component	Substrate Material	Moisture Content (%)
Room 109	Wall	Plaster	45.5
Room 208	Wall	Plaster	53.2

Moisture readings were taken within the wall plaster within rooms 109 and 208 where ECS observed water impacted plaster. ECS is unable to determine the source of moisture, therefore, further investigation of the source of the water intrusion is recommended. ECS speculates that the source is through exterior walls or roof leaks.

10 - View of wall bubbling/peeling paint from possible water intrusion in room 208.

- The wall in room 208 was observed to have bubbling/paint peeling from a previous water intrusion occurring. Moisture reading taken from plaster was in the dry range. Repair the plaster wall and verify the area is dry and suspect mold is not present. Perform any mold remediation as described in this protocol, above this section;

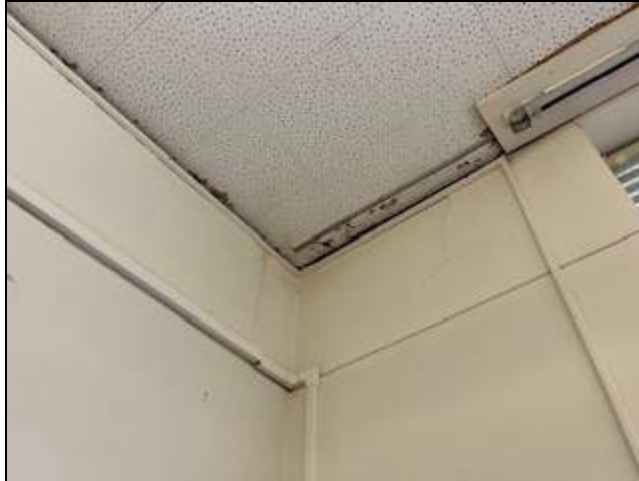
11 - View of damaged ceiling tile and wall showing staining from a previous leak.

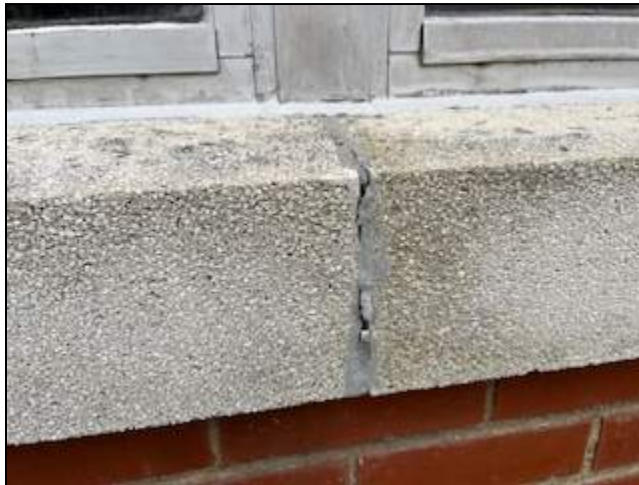
- ECS observed areas of failed asbestos containing caulk and window glaze throughout the exterior of the building. from normal age and weathering.

12 - View of exterior window sill with damaged caulk/sealant.

- Repair and replace the damaged asbestos exterior window caulk/glaze and exterior vent caulk throughout the building. Any disturbance or the removal of the material will need to be performed by a Virginia licensed Asbestos Abatement Contractor. If these windows will be removed and replaced then the windows and associated caulking should be disposed of as Category II Non-Friable ACM by a licensed abatement contractor.

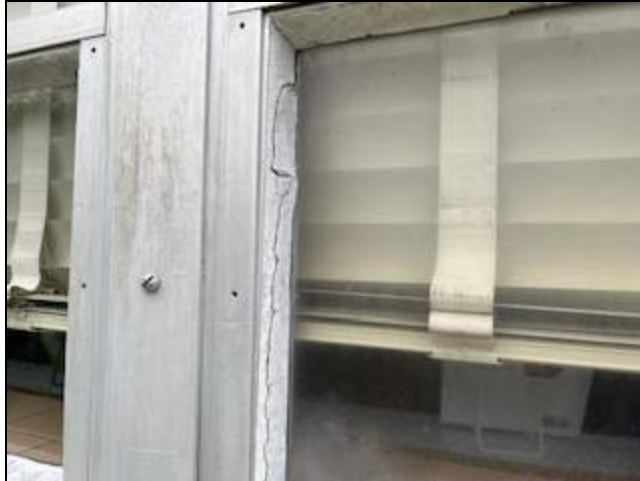
13 - View of degraded window glazing from weathering.

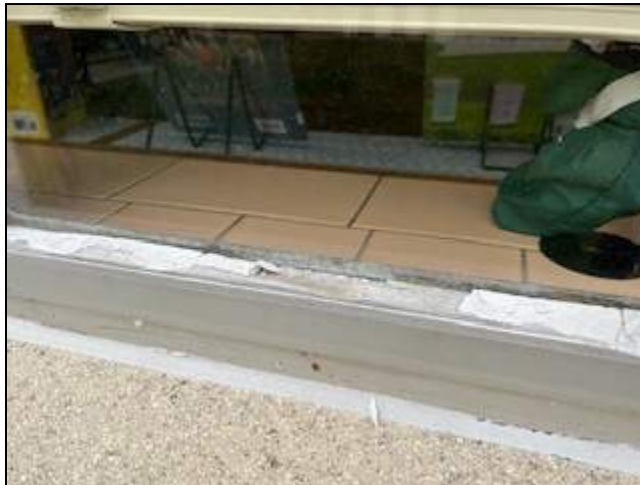
14 - View of damaged window glazing from weathering.

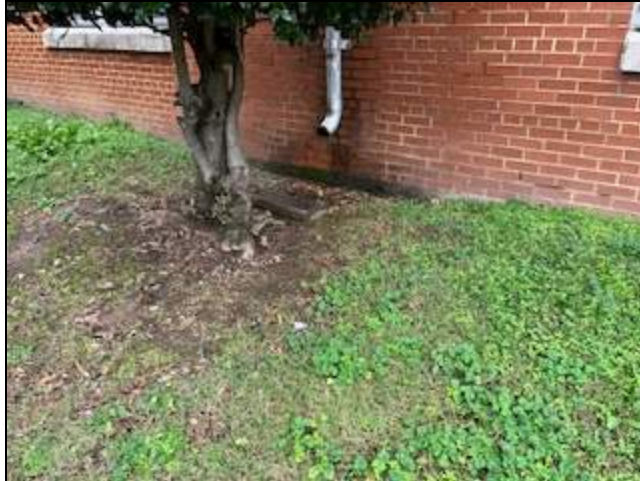
15 - View of roof drain draining against the foundation.

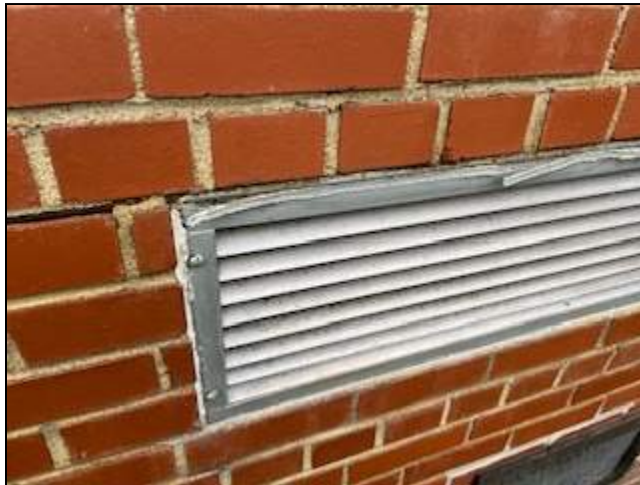
16 - View of exterior wall vent with caulk peeling and falling out.
