MOLD AND MOISTURE ASSESSMENT REPORT

MARY SCOTT PRESCHOOL

ECS PROJECT NO. 47:14153-E

FEBRUARY 26, 2024

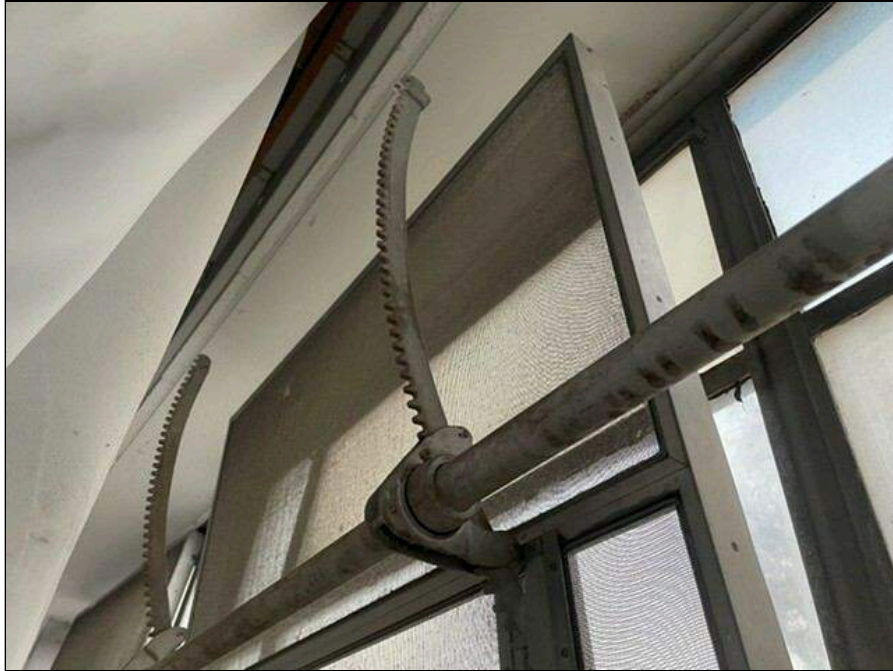
- One of the high windows in the Cafeteria appeared to be mechanically stuck open and inoperable. This may introduce moisture into the building;
- Mold was observed on CMU walls behind vinyl cove baseboard in the cafeteria;

1 - Window apparently stuck open in the Cafeteria

- One of the high windows in the Cafeteria appeared to be mechanically stuck open and inoperable. This may introduce moisture into the building; Close this window if it is not supposed to remain open;

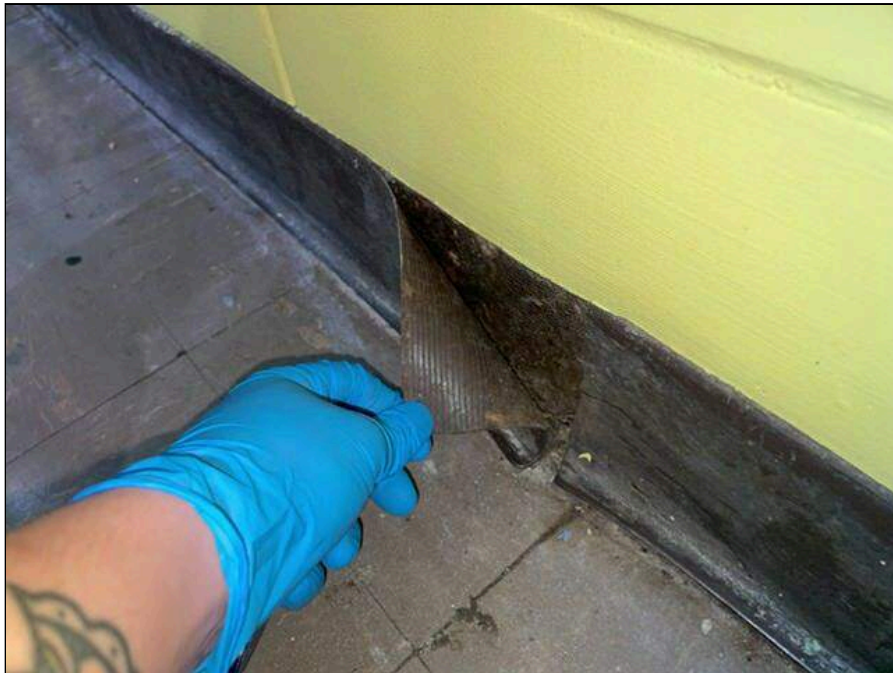
2 - Mold observed behind vinyl cove baseboard in the Cafeteria

- Mold was observed on CMU walls behind vinyl cove baseboard in the cafeteria. ECS recommends that mold be assumed to be present concealed behind vinyl cove baseboard throughout the school. Perform further investigation and determine if mold is concealed behind vinyl cove baseboard in other areas of the school and determine the cause. In the cafeteria and other areas where mold is observed concealed behind vinyl cove baseboard, remove and dispose of the vinyl cove baseboard, perform localized cleaning of these areas and apply an antimicrobial encapsulant to the cleaned areas. Use a mold remediation contractor and perform any mold remediation as described in this protocol, above this section;

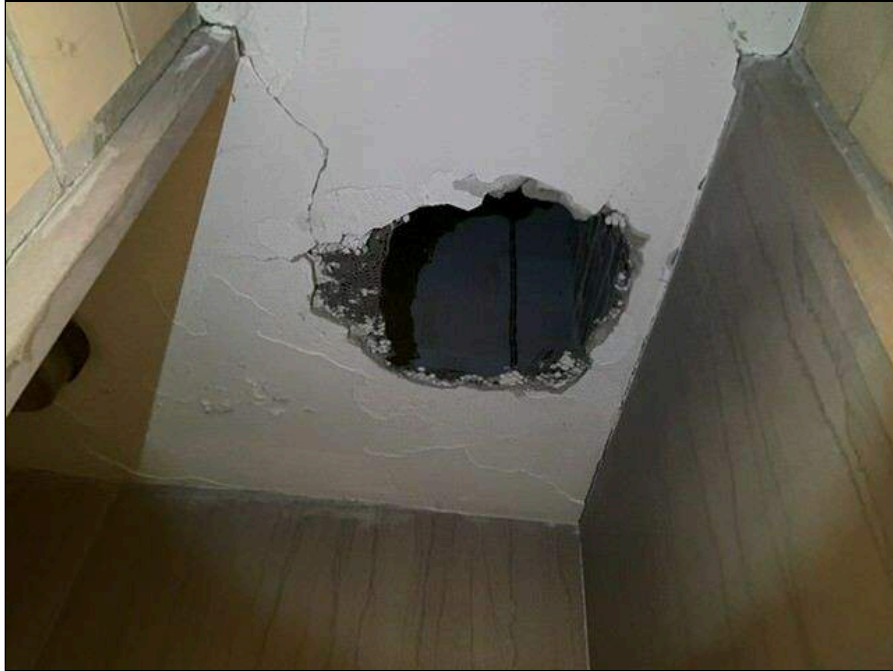
3 - Damaged plaster ceiling in the shower in the Boy's Room

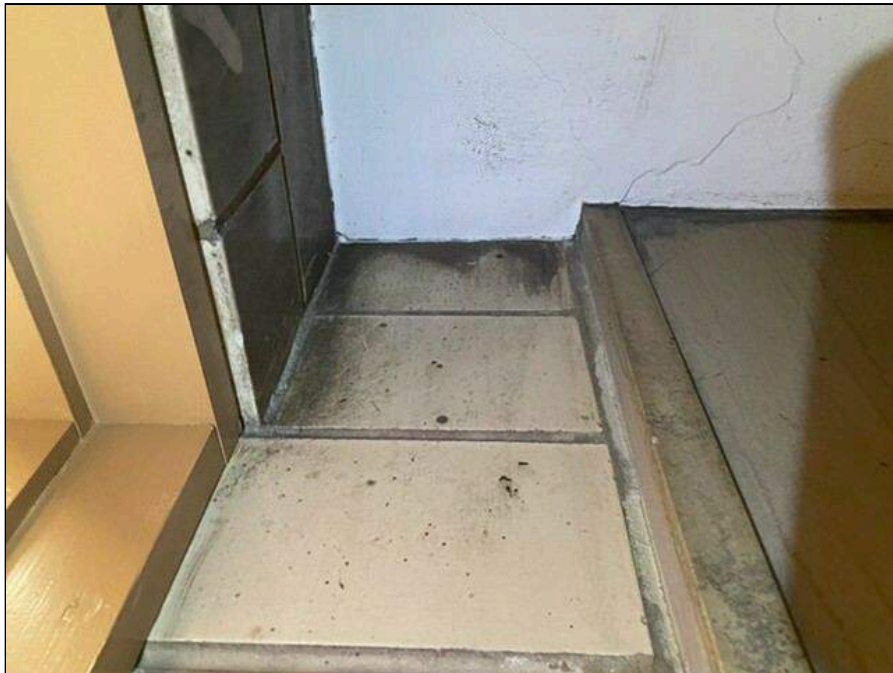
- Mold was also observed on the interior of the caulking surrounding many of the windows in the east wing;
- Visible moisture was observed in the main "boys" student bathroom where the ceramic tile walls appeared damp, the wall shared with the wet wall mechanical chase showed signs of moisture intrusion along the floor where sealants appeared visibly wet. Suspect mold on the walls and damaged plaster ceilings were observed in the shower area currently being used for storage;

4 - Mold observed on the walls in the shower in the Boy's Room

- Visible moisture was observed in the hallway boy's bathroom where the ceramic tile walls appeared damp; The wall shared with the wet wall mechanical chase showed signs of moisture intrusion along the floor where sealants appeared visibly wet. Suspect mold on the walls and damaged plaster ceilings were observed in the shower area currently being used for storage. Inspect the plumbing fixtures associated with this wall in the bathroom and in the wet wall chase to determine the source of the visible moisture in this area of the hallway boy's bathroom;

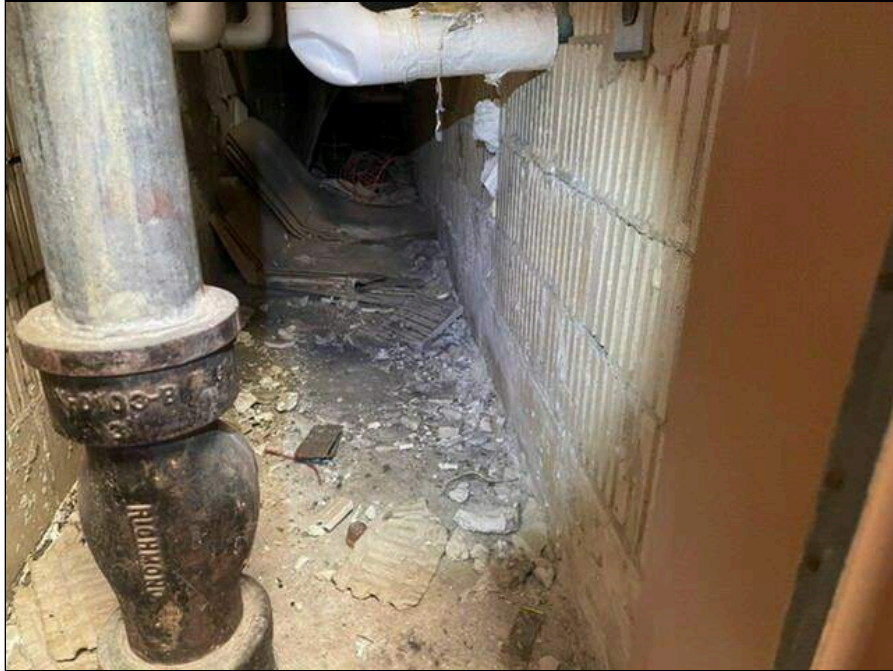
- Suspect mold was observed on debris that has collected on the floor in the wet wall chase between the hallway bathrooms;
- Moisture stained ceiling tiles were observed sporadically in areas in the cafeteria and east wing of the building. In general, the impacted ceiling tiles were determined to be dry at the time of the assessment. Mold impacted ceiling tiles were observed in room 114;

5 - Mold impacted debris on the floor of the wet wall chase between the hall bathrooms

- Suspect mold was observed on debris that has collected on the floor in the wet wall chase between the hallway bathrooms. Pipe insulation from a domestic water line was observed to be failing in this chase, which could lead to condensation leaks associated with the pipe run. Repair the pipe insulation as needed (Note: This material contains asbestos). Perform localized cleaning of the wet wall chase and clean all the debris off of the ground. Use a mold remediation contractor or qualified school maintenance staff. Perform any mold remediation as described in this protocol, above this section, as needed. The pipe insulation and any mudded pipe fittings that are present in this chase should be assumed to be asbestos containing. If any of these materials require cleaning or removal then that work should be done by a Virginia licensed Asbestos Abatement Contractor;

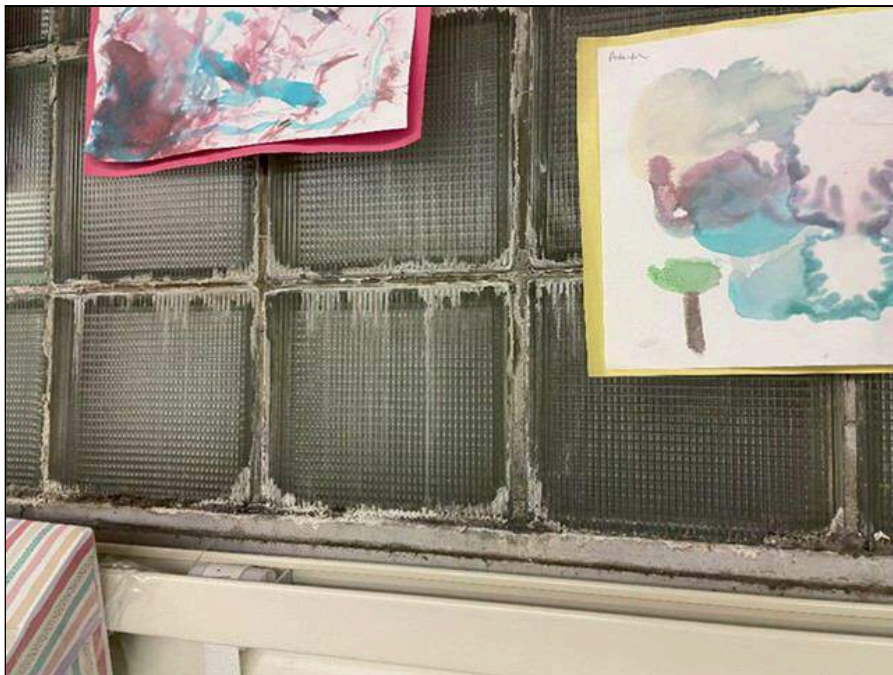
6 - Staining indicating water intrusion through the glass block windows in the main office

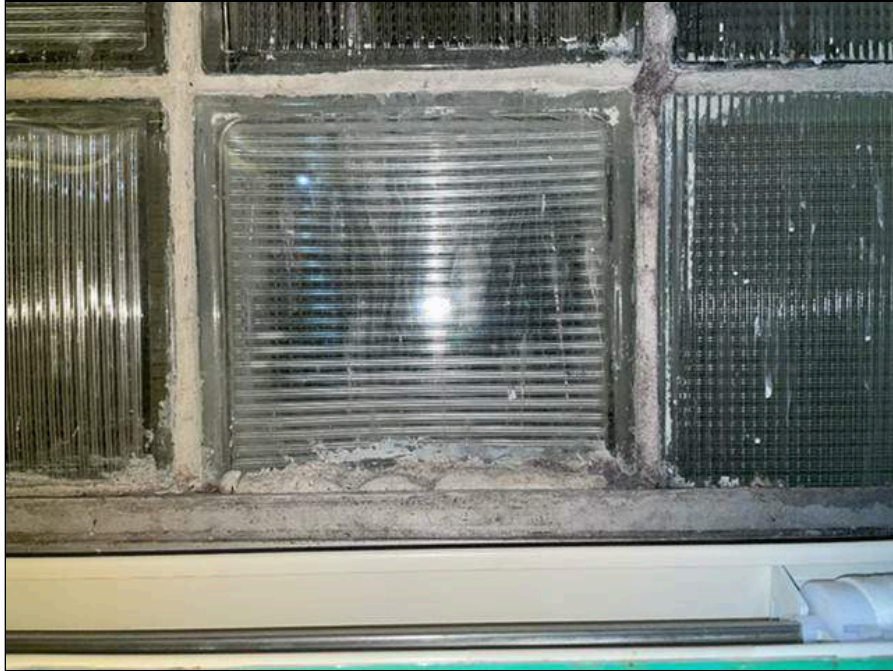
- Moisture staining was observed on the glass block windows in rooms 101 through 108 indicating that moisture is infiltrating the glass block windows in these areas. Mold was observed on some of the mortar joints and caulk associated with the glass block windows;

7 - Mold on the glass block window mortar in Room 105

- Moisture staining was observed on the glass block windows in rooms 101 through 108 indicating that moisture is infiltrating the glass block windows in these areas. Mold was observed on some of the mortar joints and caulk associated with the glass block windows. Perform localized cleaning of all the interior surfaces of the glass block windows in the building. Use a mold remediation contractor and perform any mold remediation as described in this protocol, above this section;

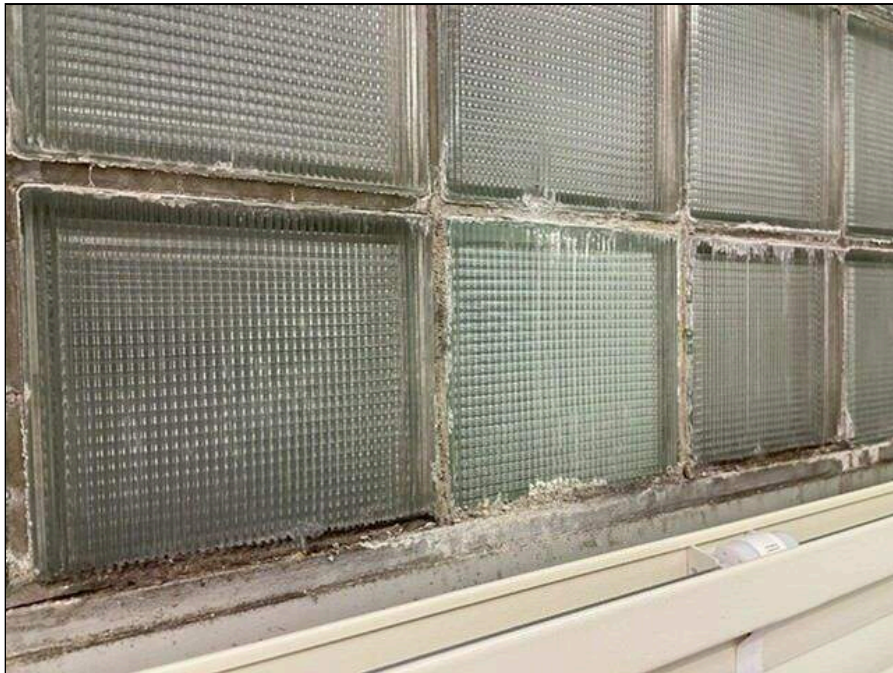
8 - Staining indicating water intrusion through the glass block windows in Room 106

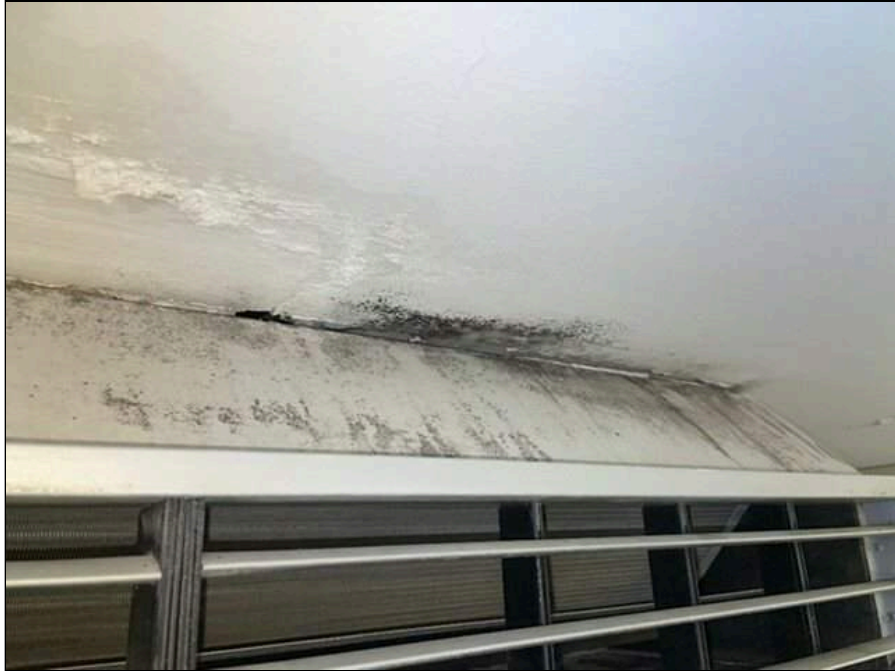
- Mold was observed on and within a majority of the ceiling-mounted fan coil units in the classrooms. Tape lift sampling indicated that significant concentrations of mold exist in these locations;

9 - Mold on and above a ceiling mounted fan coil in Room 15

- Mold was observed on and within a majority of the ceiling-mounted fan coil units in the classrooms. Tape lift sampling indicated that significant concentrations of mold exist in these locations. ECS recommends complete cleaning of the ceiling mounted fan coil units throughout the school by a qualified mold remediation contractor and inspection by a qualified HVAC engineer or technician. Perform any mold remediation as described in this protocol, above this section, as needed. Additionally, ECS recommends a review of the maintenance and service schedule of these fan coil units to determine if they are being maintained and operating per the manufacturer's recommended specifications. Note: it is ECS' understanding after a discussion with RPS Facility Services that the ceiling mounted fan coil units are scheduled to be removed and replaced with a new type of system at this school;

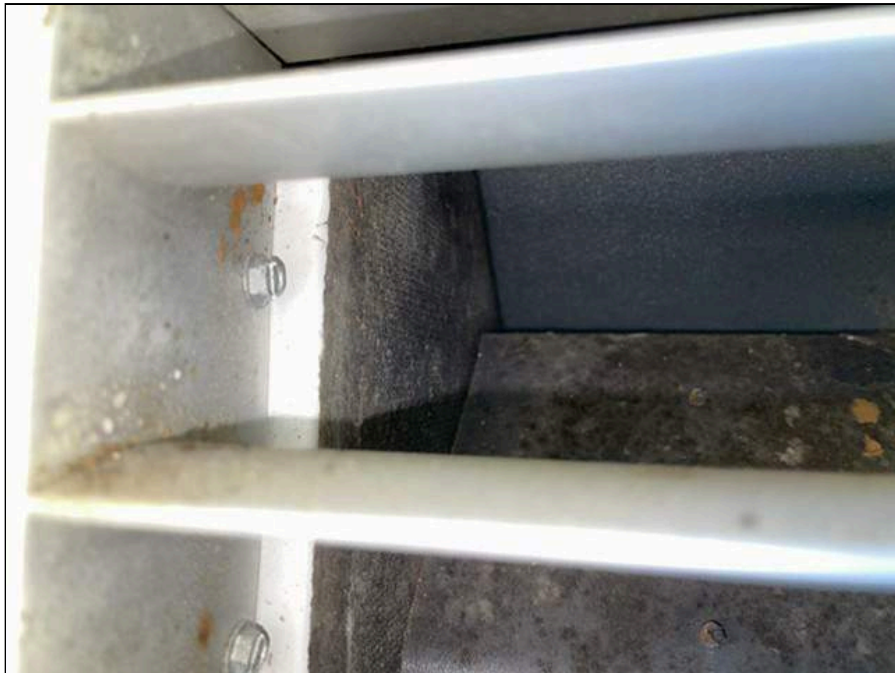
10 - Mold observed within the ceiling mounted fan coil in Room 105

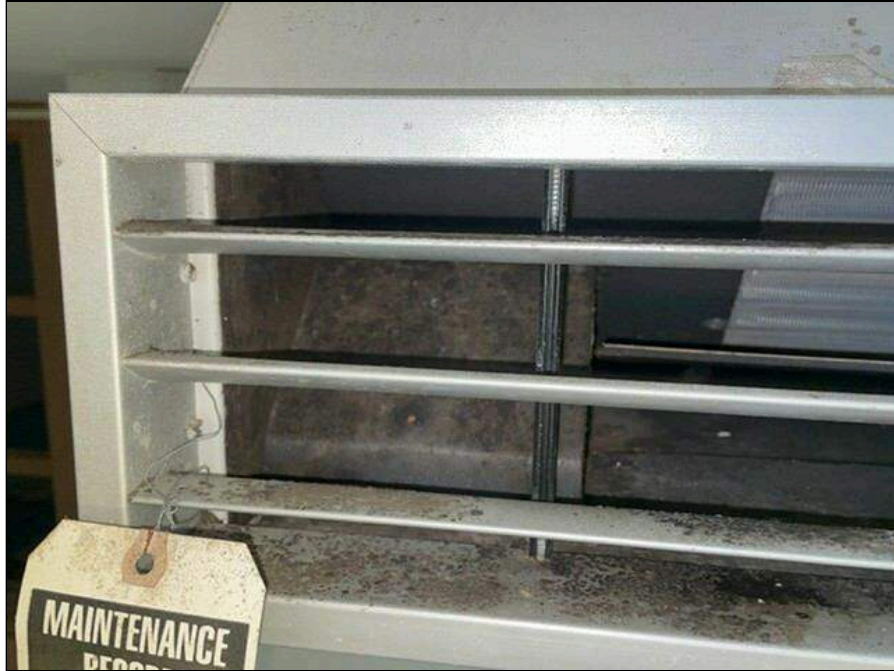
11 - Mold observed within the ceiling mounted fan coil in Room 107

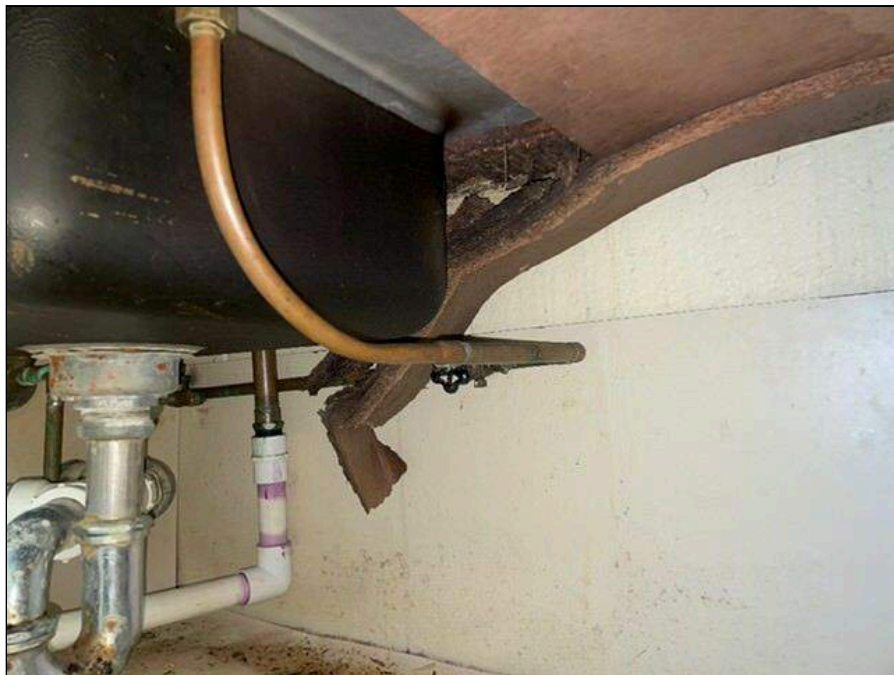
- Suspect mold was observed in the cabinets below the sinks in rooms 104, 106, 112 and 113; ECS was not able to fully access each sink cabinet to inspect for mold or moisture impact because of stored materials in the cabinets. Similar conditions may be present in other sink cabinets in the school.

12 - Moisture damaged sink cabinet countertop in Room 113

- Suspect mold was observed in the cabinets below the sinks in rooms 104, 106, 112 and 113. ECS was not able to fully access each sink cabinet to inspect for mold or moisture impact because of stored materials in the cabinets. Similar conditions may be present in other sink cabinets in the school. Perform further investigation into mold or moisture impact associated with the sink cabinets throughout the school to determine if additional cabinets require remediation. Determine and correct the cause of the mold or moisture staining in these cabinets. Perform localized cleaning of the sink cabinets and apply an antimicrobial encapsulant to the cleaned areas. Use a mold remediation contractor or qualified school maintenance staff. Perform any mold remediation as described in this protocol, above this section, as needed.

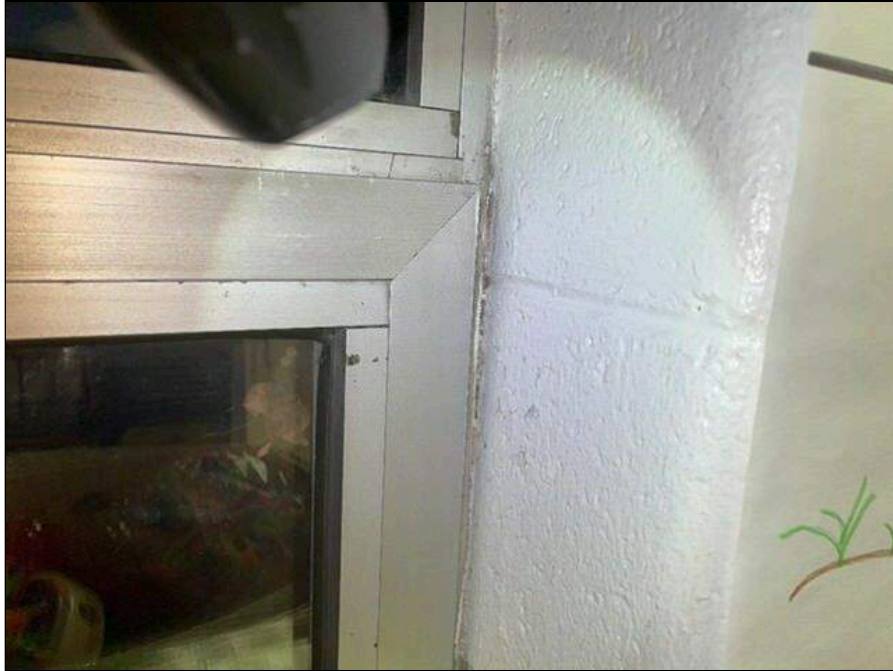
13 - Mold on window frame caulking in an East wing classroom

- Mold was also observed on the interior of the caulking surrounding many of the windows in the east wing. Perform localized cleaning of the window frame and apply an antimicrobial encapsulant to the cleaned areas. Use a mold remediation contractor or qualified school maintenance staff. Perform any mold remediation as described in this protocol, above this section, as needed.

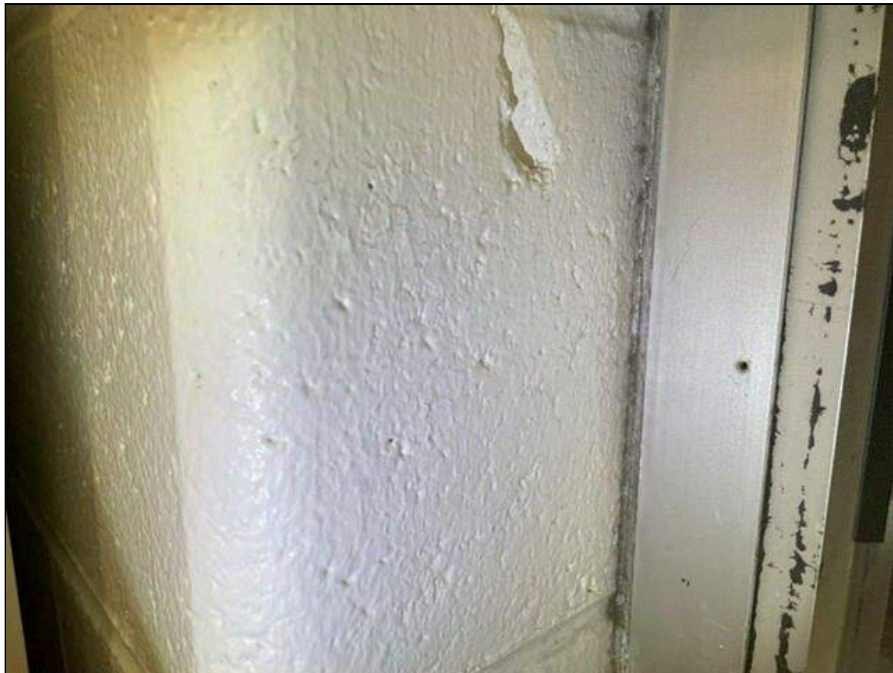
14 - Mold on window frame caulking in an East wing classroom

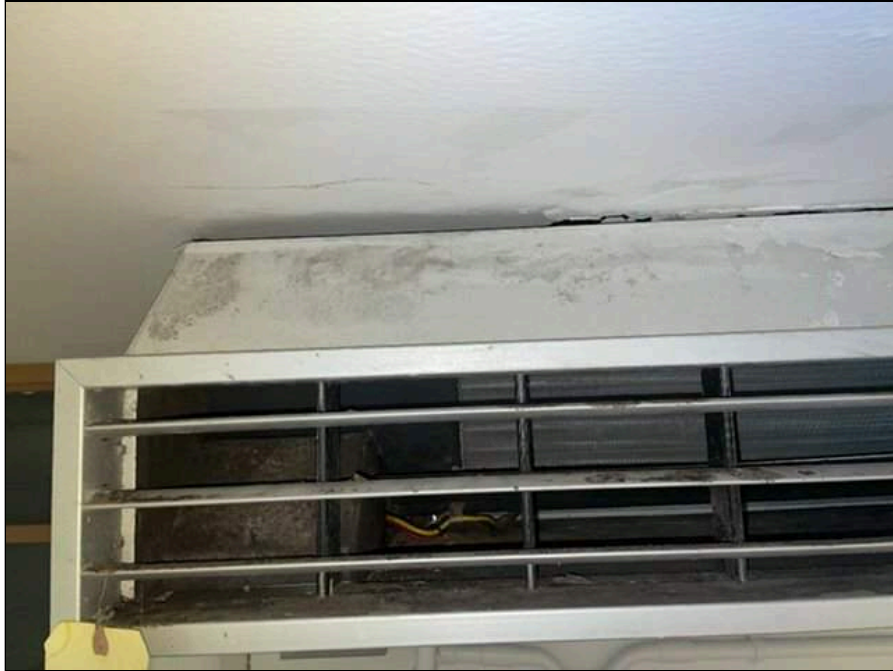
15 - Mold observed on a ceiling mounted fan coil in Room 102

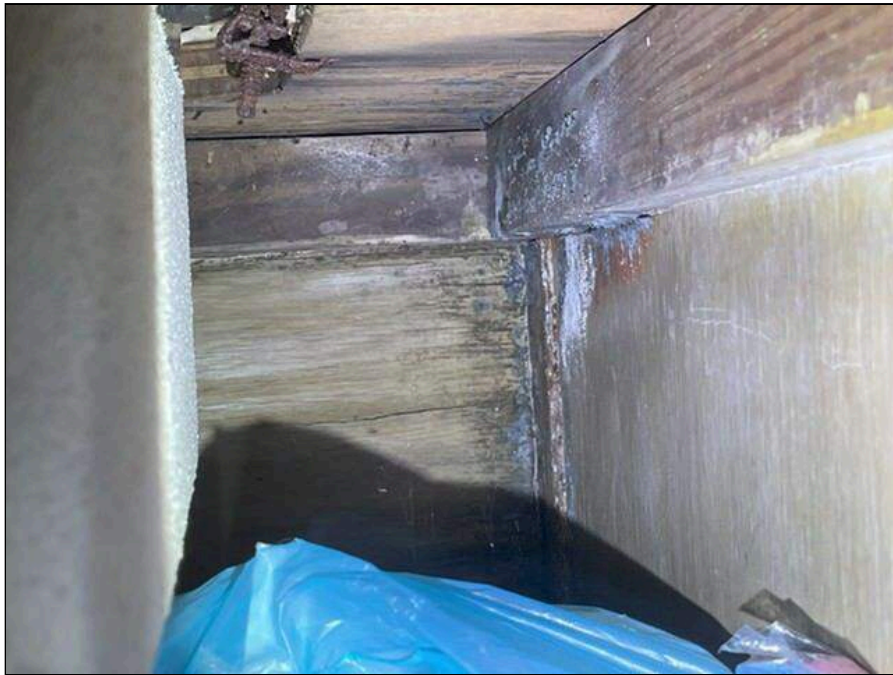
16 - Mold observed in the sink cabinet in Room 104

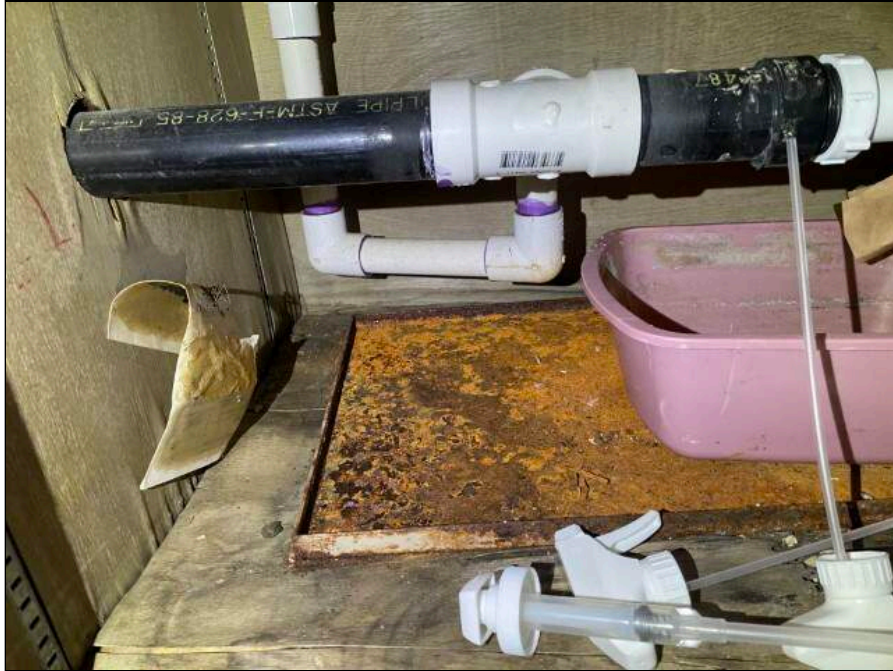
17 - Mold observed in the sink cabinet in Room 106

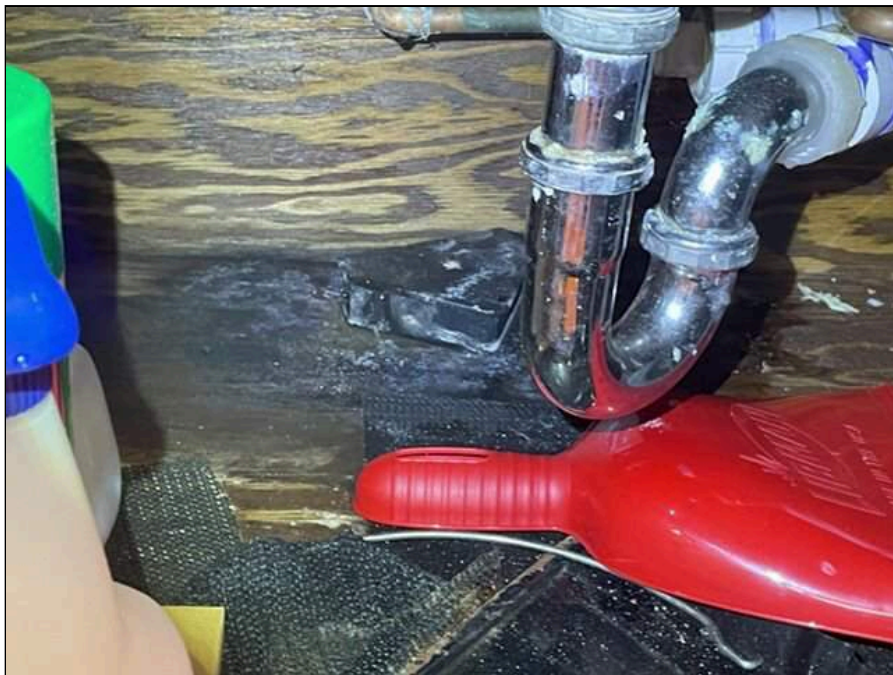
18 - Mold observed in the sink cabinet in Room 112

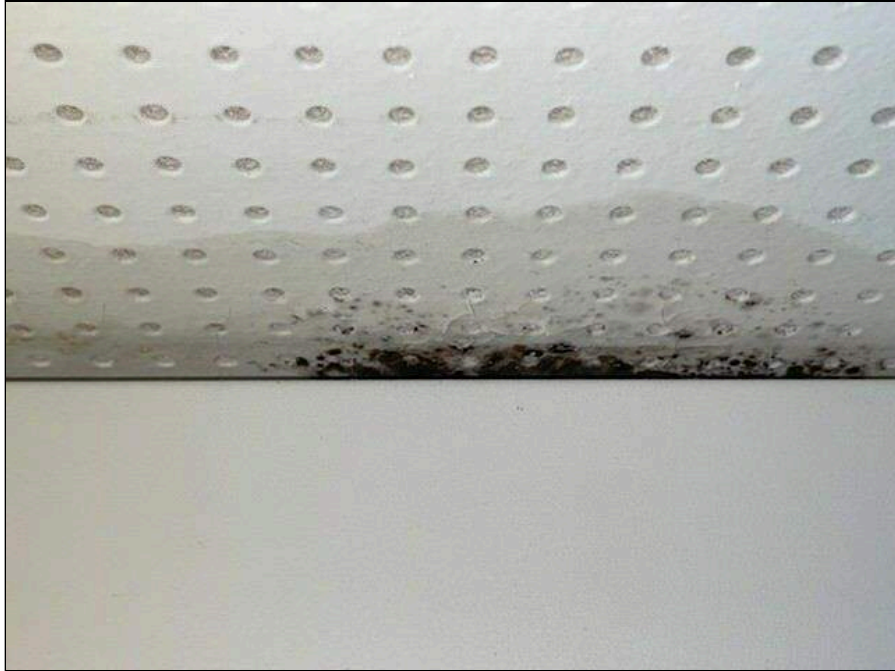
- Mold was also observed on the plaster ceilings surrounding the top of the fan coil units in most areas, with the most significant impact observed in the Library;

19 - Mold on ceiling tiles above the fan coil unit in the Library

- Mold was also observed on the plaster ceilings surrounding the top of the ceiling mounted fan coil units in most rooms of the school with the most significant impact observed in the Library; Determine and correct the cause of mold in these locations (most likely associated with moist air being blown by the fan coil units). Perform localized cleaning of the plaster ceiling these areas and apply an antimicrobial encapsulant to the cleaned areas. Use a mold remediation contractor and perform any mold remediation as described in this protocol, above this section;

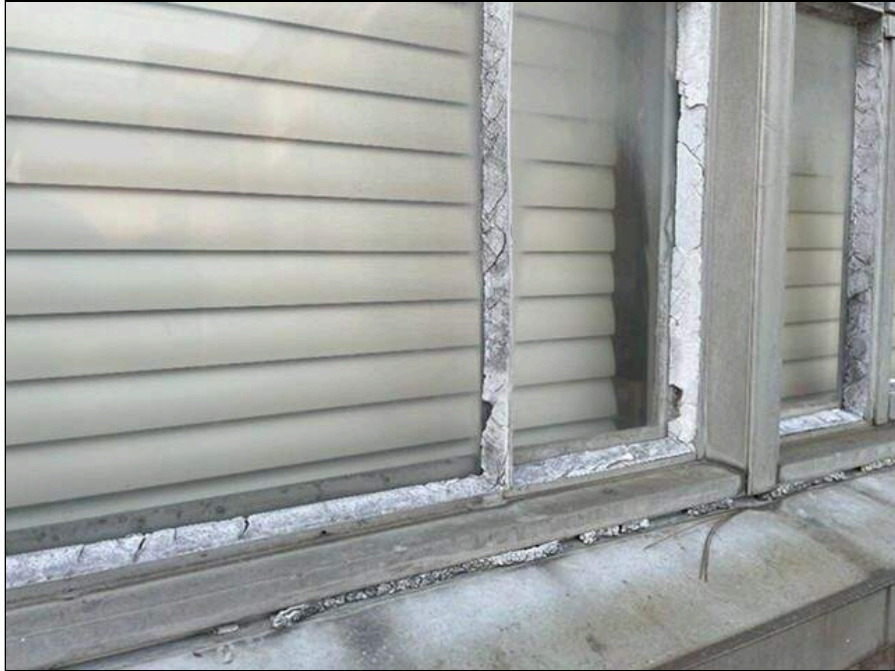
- The sealants and mortar associated with the glass block style windows was observed to be compromised in many area and showed evidence of water intrusion;
- The window sash glazing associated with the split sash style windows was observed to be compromised in many areas.

1 - Damaged asbestos containing window caulk and glazing

The findings of the building envelope assessment should determine the feasibility of the repair of the current window systems in the building versus replacement of them. If the current windows will remain then remove and replace any damaged or mold impacted asbestos containing window caulks or window sash glazing. Any work that impacts the window sealants or glazing should be performed by a Virginia Licensed Asbestos Abatement contractor.
