MOLD AND MOISTURE ASSESSMENT REPORT

BELLEVUE ELEMENTARY SCHOOL

ECS PROJECT NO. 47:14153-K

FEBRUARY 26, 2024

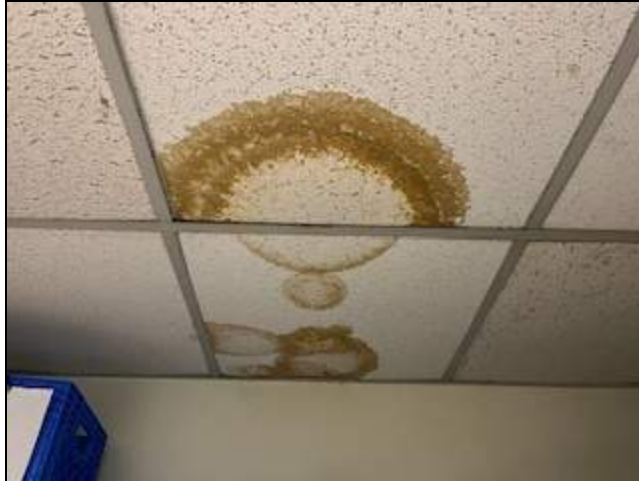
- Moisture stained ceiling tiles were observed sporadically in areas throughout the hallways, classrooms, and cafeteria in areas where drop ceiling tiles are present. None of the areas tested were determined to have elevated moisture content. In general much of the staining observed on ceiling tiles was likely caused by old roof leaks, or pipe or HVAC condensation leaks;

1 - General view of ceiling tile with water intrusion.

- Moisture stained ceiling tiles were observed sporadically in areas throughout the hallways, offices, cafeteria/auditorium, and kitchen in areas where drop ceiling tiles are present. None of the areas tested were determined to have elevated moisture content. In general much of the staining observed on ceiling tiles was likely caused by old roof leaks, pipe condensation or leaking pipes. Have a qualified mold remediation contractor or qualified maintenance staff remove and replace all moisture impacted ceiling tiles. Perform any mold remediation as described in this protocol above this section if needed;

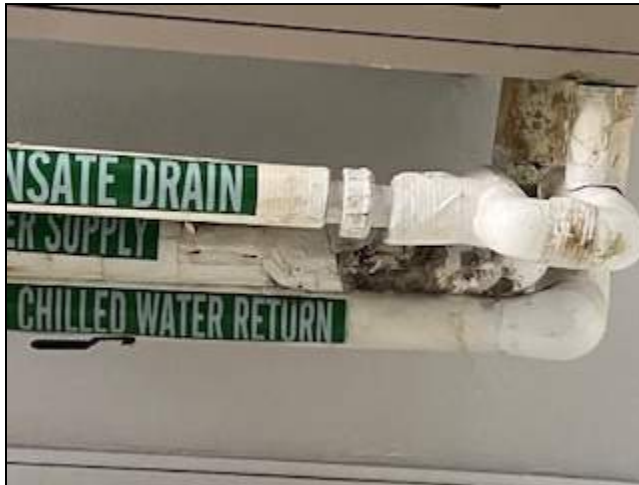
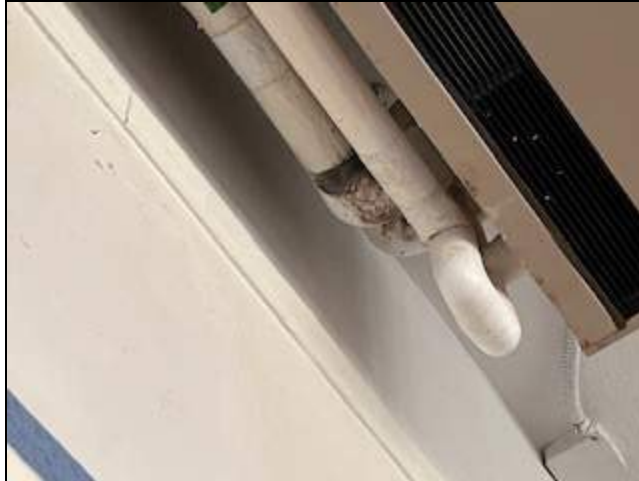
- ECS also observed heavy mold growth on the fiberglass pipe insulation associated with the ceiling mounted fan coil units throughout the school;
- ECS observed the plaster ceiling and wall above the window in room 303 with obvious water damage potentially from a roof leak; Moisture readings collected from these areas were in the dry range;

2 - General view of ceiling mounted fan coil unit pipes with visible mold.

3 - General view of ceiling mounted fan coil unit pipes with visible mold.

- ECS also observed heavy mold growth on the fiberglass pipe insulation associated with the ceiling mounted fan coil units throughout the school. Have a qualified mold remediation contractor or qualified maintenance staff remove and replace all mold and moisture impacted fiberglass pipe insulation. Perform any mold remediation as described in this protocol above this section, as needed;

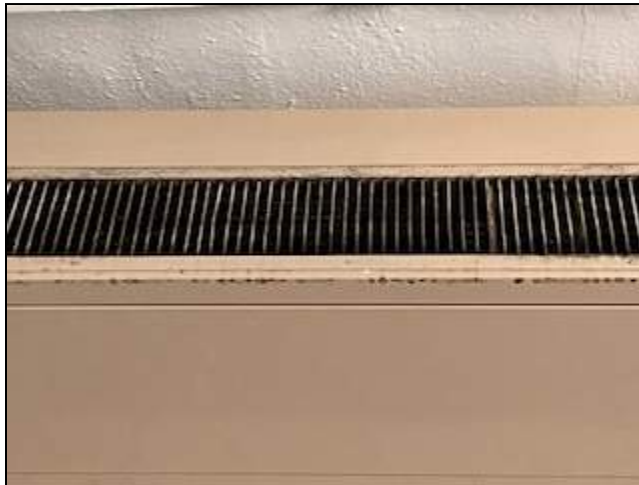
- Suspect mold was observed on the ceiling mounted fan coil units throughout the school. ECS observed heavy dust on the face of the units and suspect mold was growing on the accumulated dust.

4 - General view of ceiling mounted fan coil unit which contains heavy dust and suspect mold.

- A heavy build-up of dust and dirt was observed associated with the ceiling supply vents throughout the building. Perform localized cleaning of the HVAC system and review the cleaning and maintenance schedule for the units; Use a mold remediation contractor or qualified school maintenance staff. Perform any mold remediation as described in this protocol above this section; Note: Having dust accumulation and suspect mold at the diffusers is not uncommon and is a normal preventive maintenance measure to have maintenance staff monitor and correct/clean these areas.

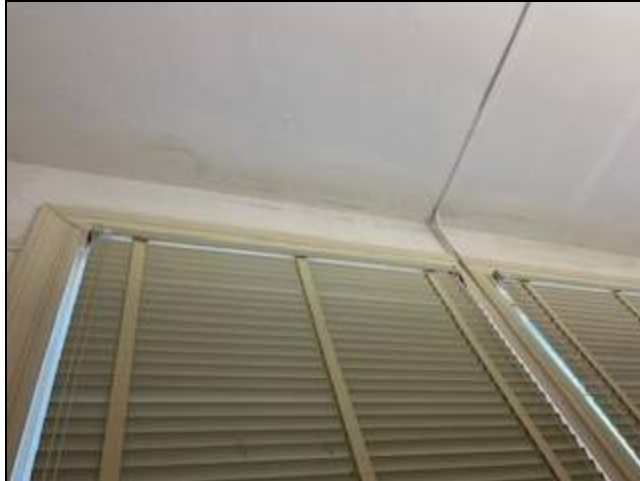
5 - View of plaster ceiling showing water damage from possible roof leaks in room 303.

- ECS observed the plaster ceiling and wall above the window in room 303 with obvious water damage potentially from a roof leak; Moisture readings however were in the dry range. Repair the plaster wall and verify the area is dry and suspect mold is not present. Perform any mold remediation as described in this protocol, above this section, if needed;

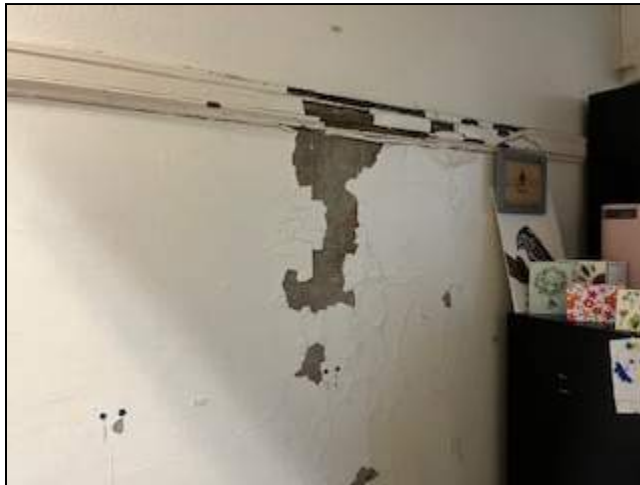
- In a office space beside the media center (room unlabeled), ECS observed heavy damage to the plaster wall; which was below a duct which went through the wall; This area tested dry however with the moisture meter.

6 - View of damaged plaster wall in the office space near the media center on the 3rd floor.

- In a office space beside the media center (room unlabeled), ECS observed heavy damage to the plaster wall which was below a duct which went through the wall. Repair the plaster wall and verify the area is dry and suspect mold is not present. Perform any mold remediation as described in this protocol, above this section, if needed;

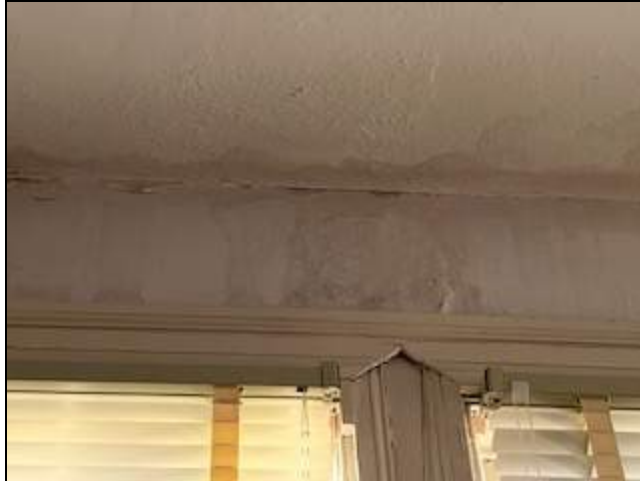
- Heavy plaster damaged was observed from a water intrusion event above the exterior window in room 307; Moisture readings taken from wall measured in the dry range;

Moisture readings were taken from the plaster wall and ceiling in room 307 and 305 where ECS observed water impacted plaster. ECS believes the moisture impacted plaster appears to be from a roof leak since no signs of pipe or HVAC leaks were observed at the time. ECS also collected moisture readings from the brick wall in room 101 where bubbling was observed. This should be further investigated as this area measured damp.

7 - View of damaged plaster from water intrusion in room 307

- Heavy plaster damaged was observed from a water intrusion event above the exterior window in room 30; Moisture readings taken from wall were in the dry range. Repair the plaster wall and verify the area is dry and suspect mold is not present. Perform any mold remediation as described in this protocol, above this section, if needed;

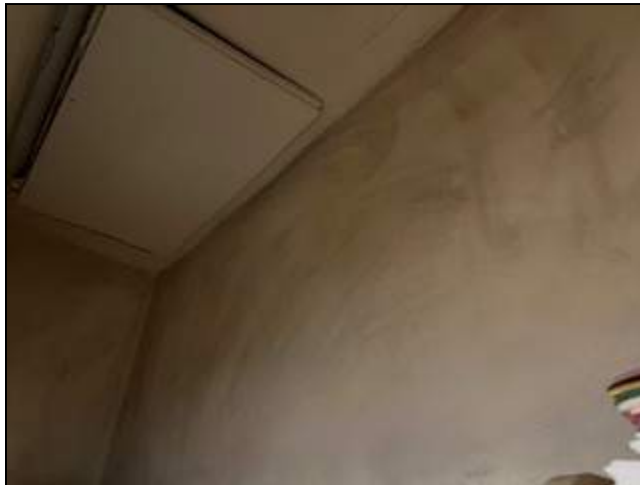
8 - Room 304 closet where it appears cleaning was conducted. Suspect mold was observed on the wall however.

- In room 304 in the closet ECS observed suspect mold were the wall meets the ceiling in the closet. Further cleaning of the plaster wall is recommended; Verify the area is dry and suspect mold is not present. Perform any mold remediation as described in this protocol, above this section, if needed;

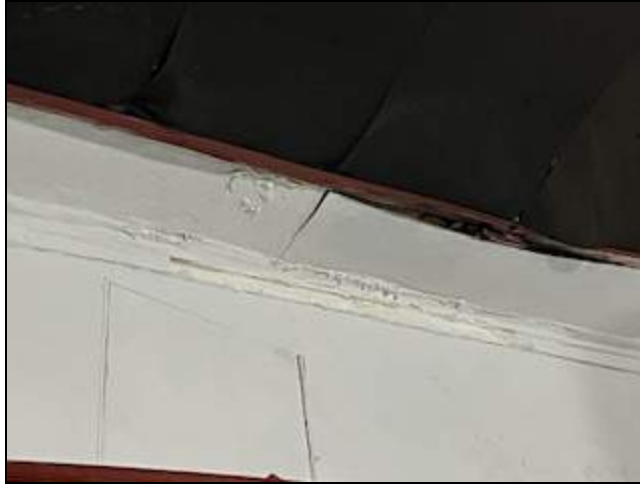
9 - Damaged plaster wall and ceiling from a possible roof leak in the Auditorium.

- ECS observed damaged plaster wall and ceiling within the auditorium in various locations. ECS believes the plaster damage may be caused by a roof leak. Repair the plaster wall and verify the area is dry and suspect mold is not present. Perform any mold remediation as described in this protocol, above this section, if needed;

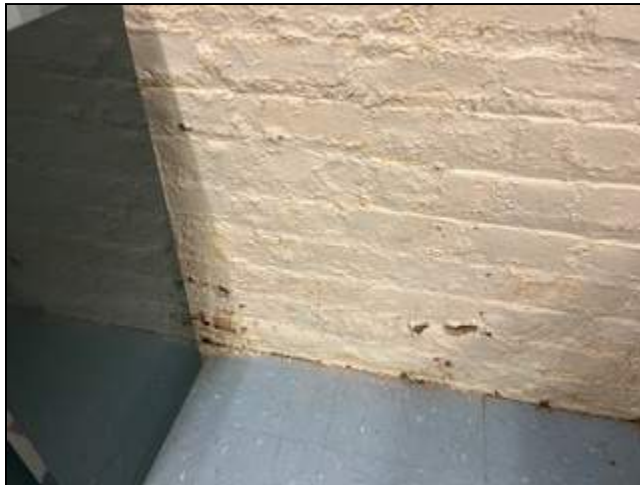
- Water intrusion appeared to be occurring in the basement level in room 101. ECS observed the brick on the exterior wall to be impacted by a water intrusion event; Moisture readings were in the dry range at the time of the site visit.

10 - Brick wall where ECS observed moisture intrusion / damage on the lower half of wall in room 101.

- Water intrusion appeared to be occurring in the basement level in room 101. ECS observed the brick on the exterior wall to be impacted by a water intrusion event; Repair the brick wall and verify the area is dry and suspect mold is not present. Perform any mold remediation as described in this protocol, above this section, if needed;

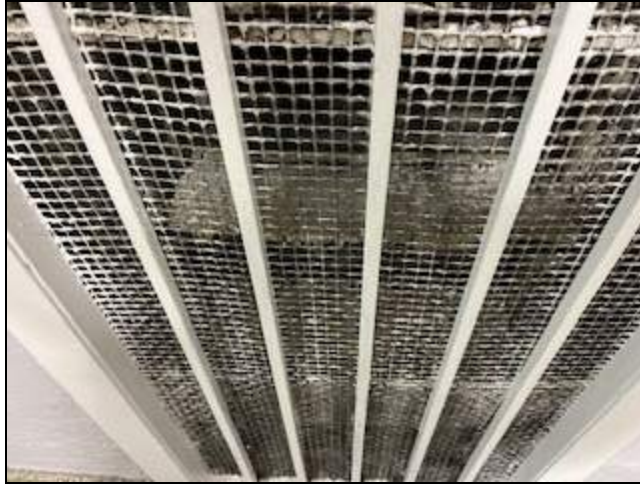
11 - Vent grate near main entrance with heavy dust observed.

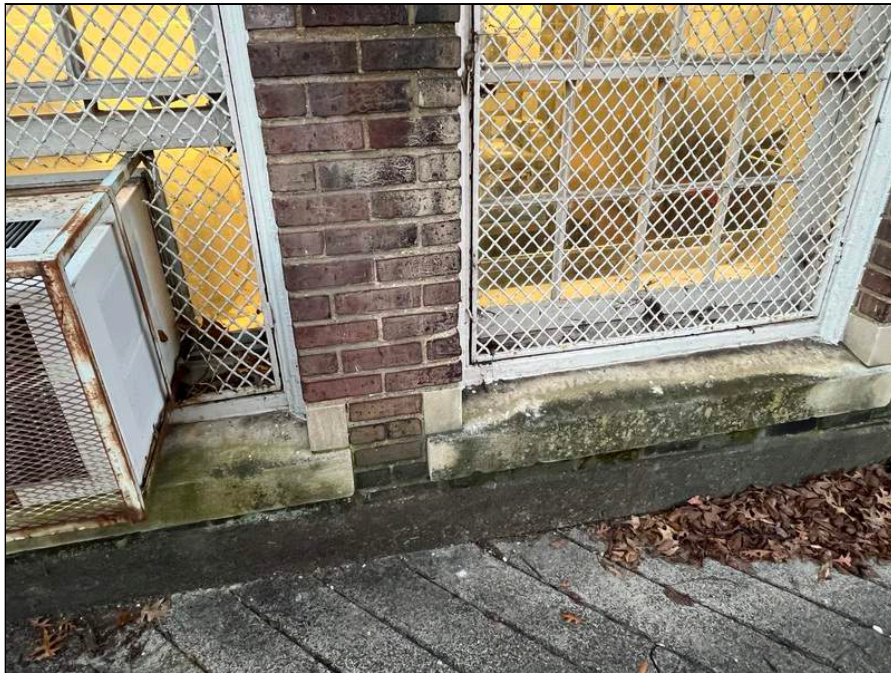
- ECS observed areas of failed caulk and window glaze throughout the exterior of the building from normal age and weathering. However, ECS was unable to test this material due to metal window gate blocking the window from being access and tested for asbestos;
- ECS also observed the window outside room 101 to have heavy staining on the concrete outside of the window; The window sill was also damaged possibly from water intrusion.

12 - View of the window outside room 101 where heavy staining was observed. The windowsill appeared to be damaged from water intrusion.

- ECS observed areas of failed caulk and window glaze throughout the exterior of the building from normal age and weathering; Perform normal repairs.
- ECS also observed the window outside room 101 to have heavy staining on the concrete outside of the window; The window sill was also damaged possibly from water intrusion. Perform normal repairs.
