MOLD AND MOISTURE ASSESSMENT REPORT

ELIZABETH D. REDD ELEMENTARY SCHOOL

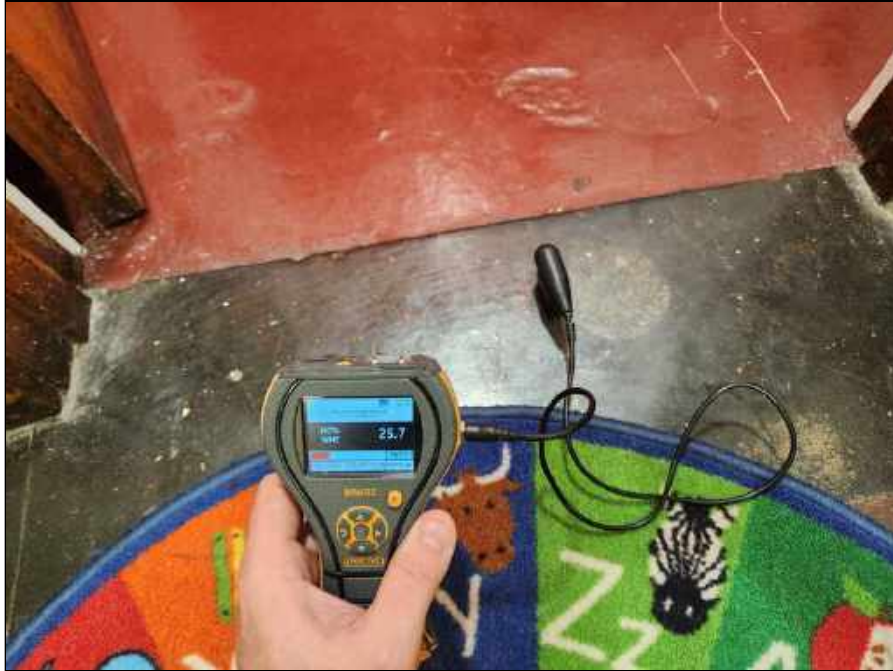
1 - Moisture meter reading collected in the Room 101 bathroom indicating elevated moisture beneath the flooring

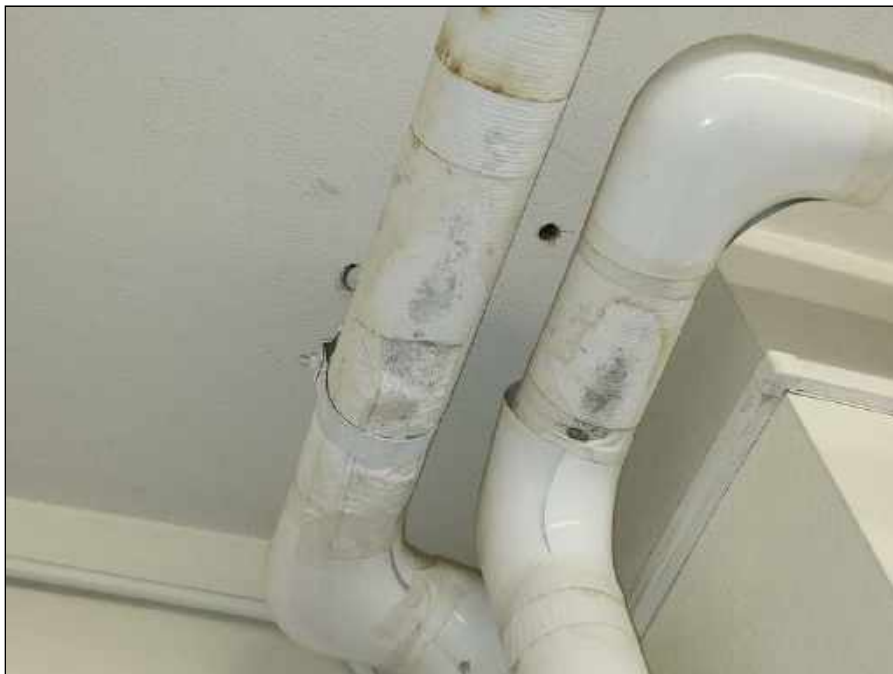
2 - Mold on pipe insulation in Room 101

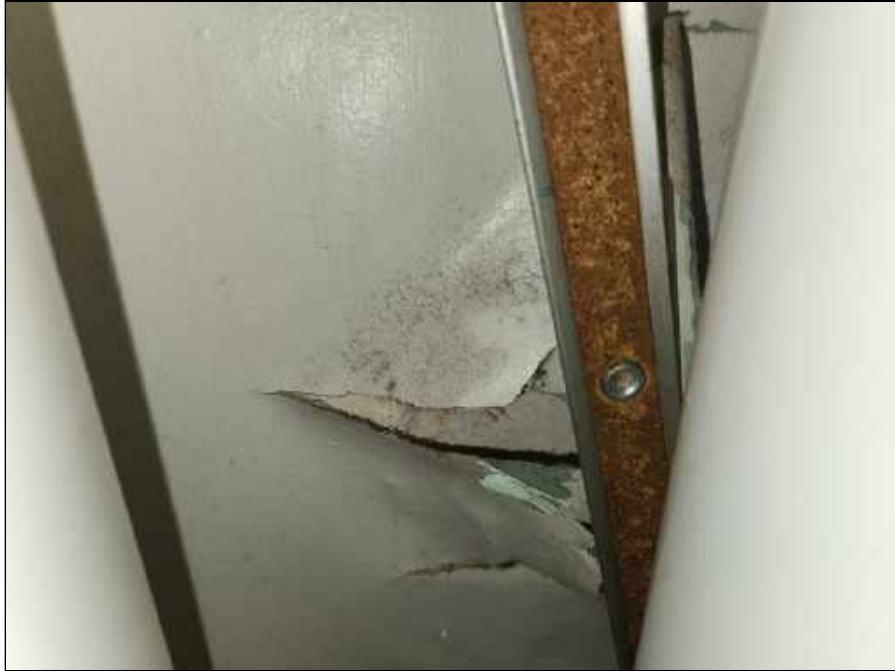
3 - Mold and moisture impacted plaster wall behind piping in Room 101

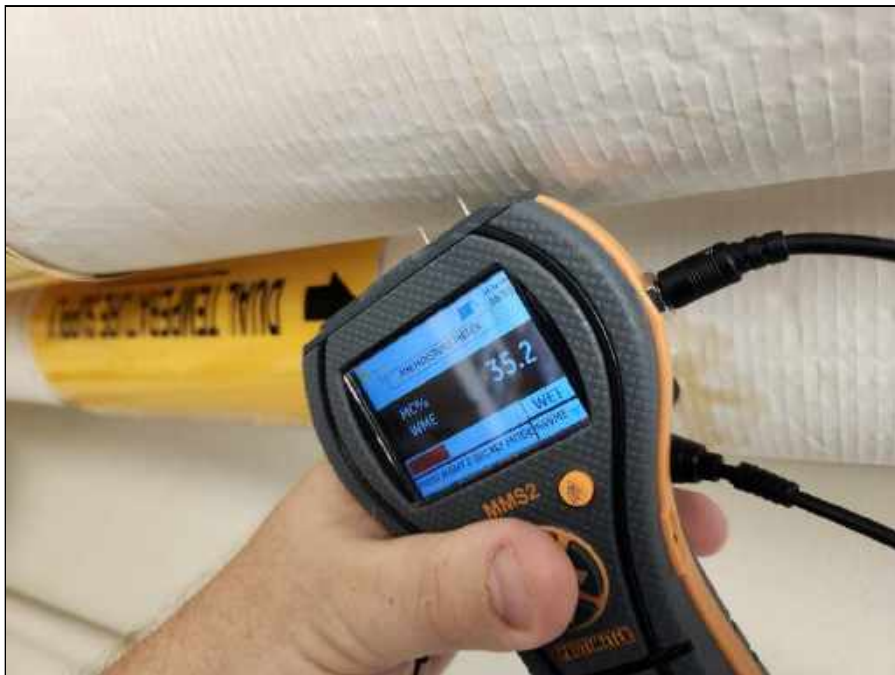
4 - Elevated moisture meter reading collected from impacted pipe insulation in Room 101

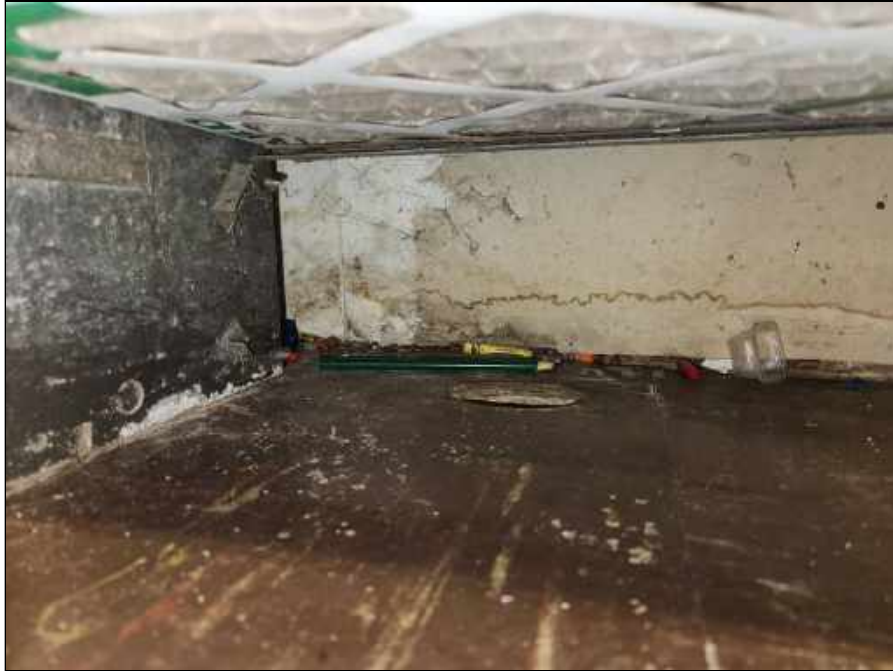
5 - Suspect mold on the plaster wall beneath the fan coil

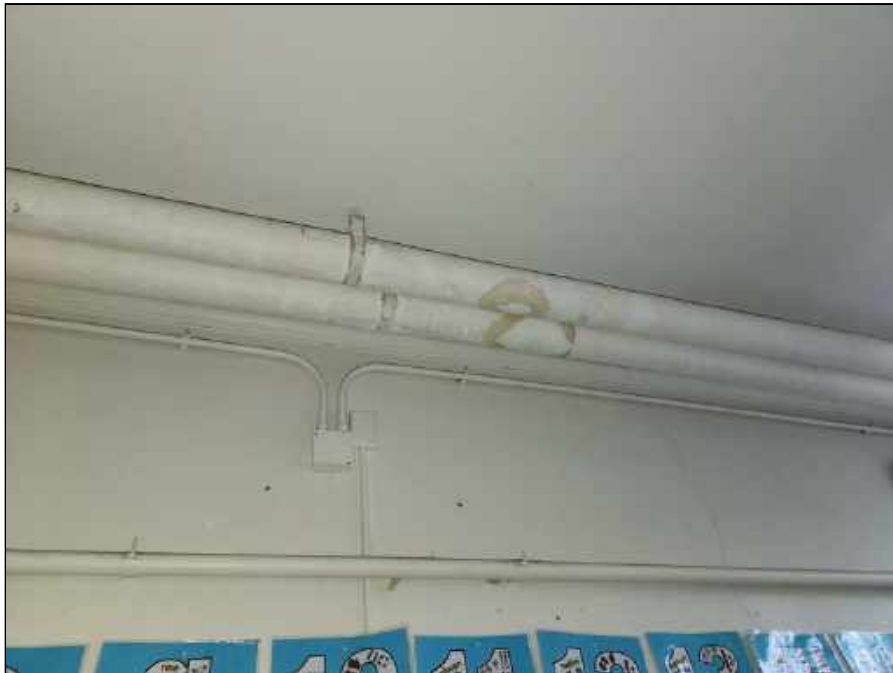
6 - Moisture stained pipe insulation in Room 107

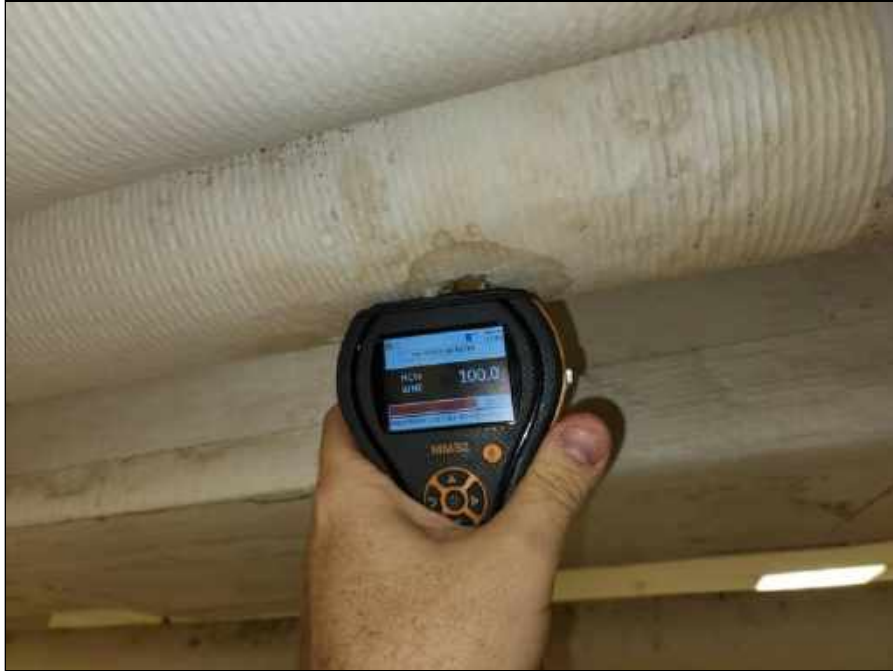
7 - Elevated moisture meter reading collected from pipe insulation in Room 102

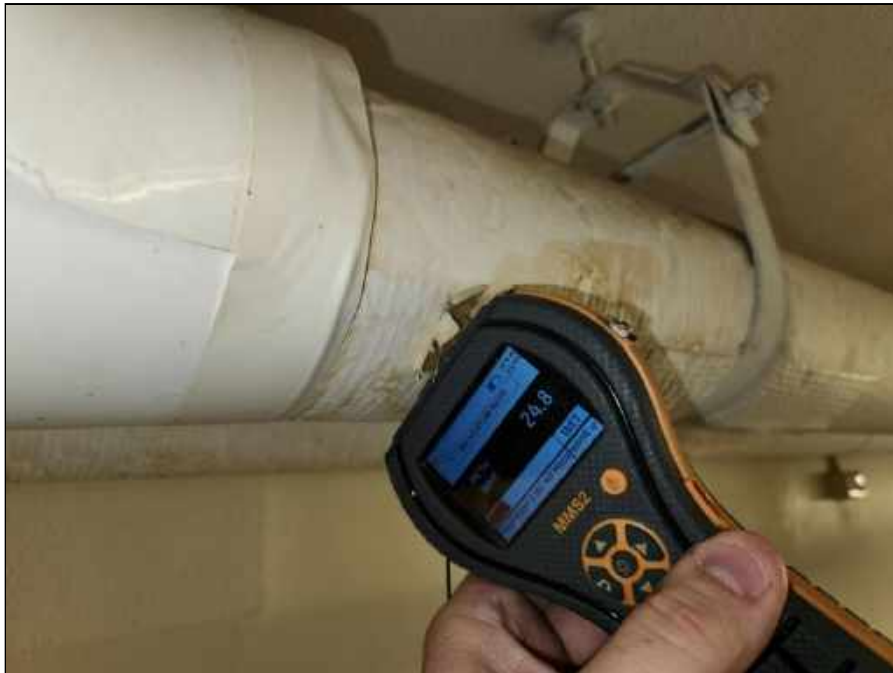
8 - Elevated moisture meter reading collected from pipe insulation in Room 102

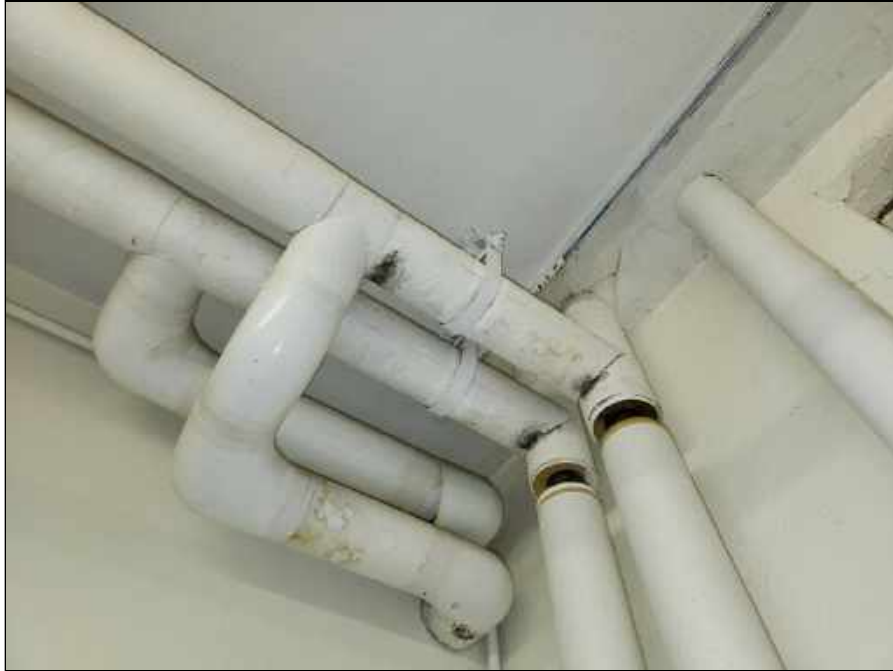
9 - Mold on pipe insulation in Room 102

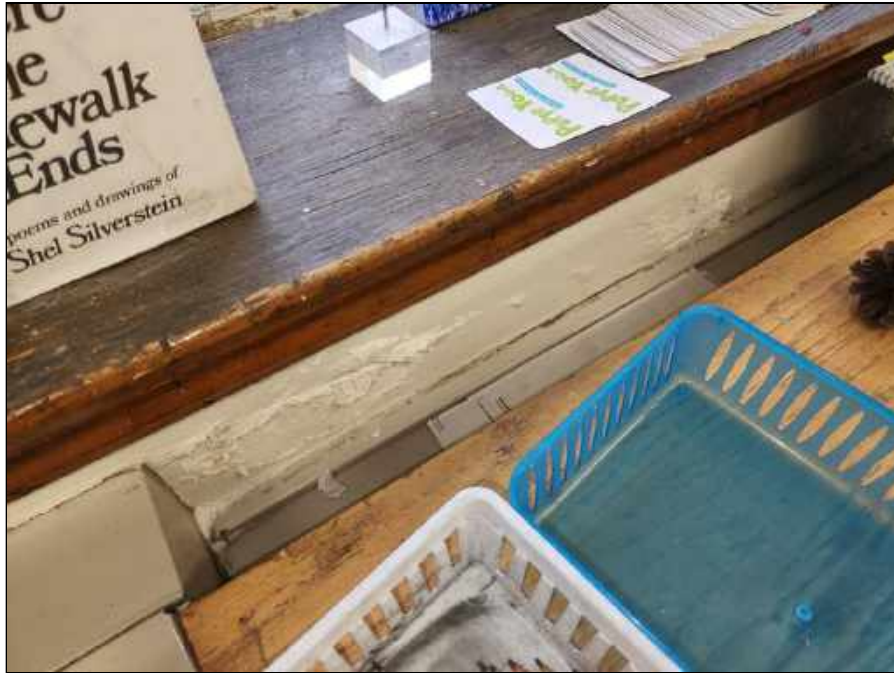
11 - Moisture damaged plaster wall in Room 108

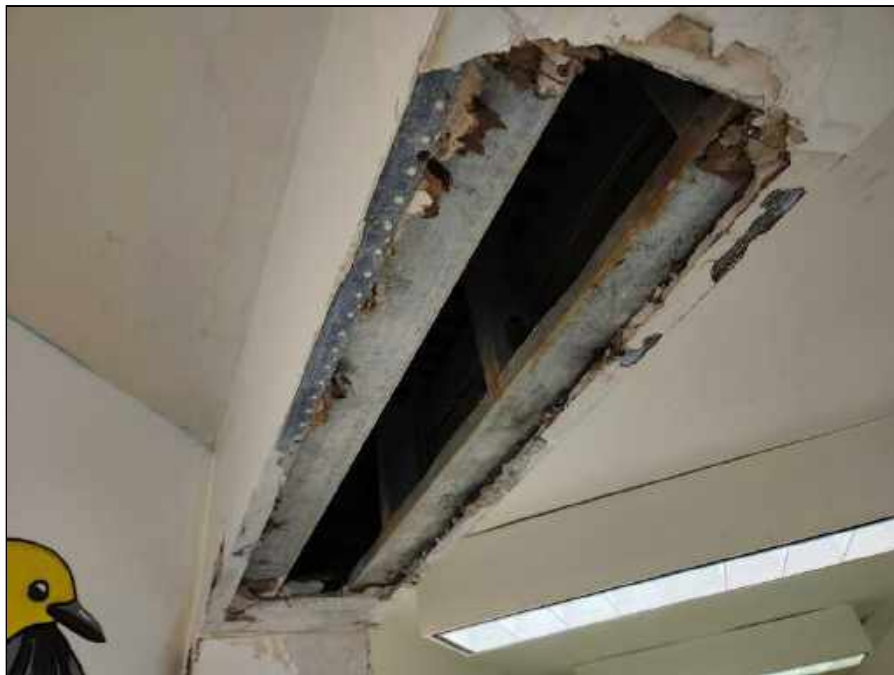
12 - Moisture damaged drywall observed in library hallway on 10-18-23

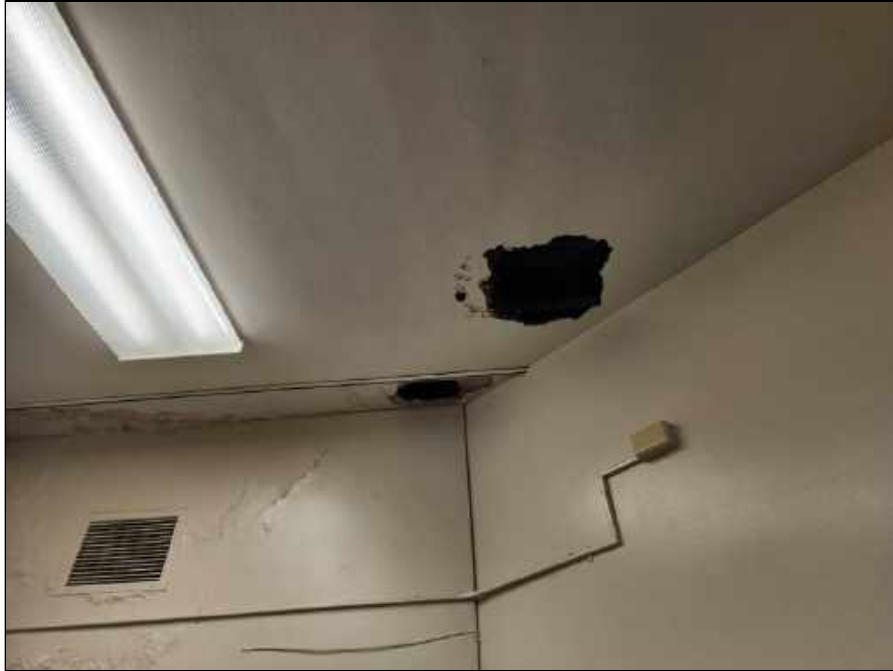
13 - Moisture damaged plaster ceiling observed in Room 111 observed on 10-18-23

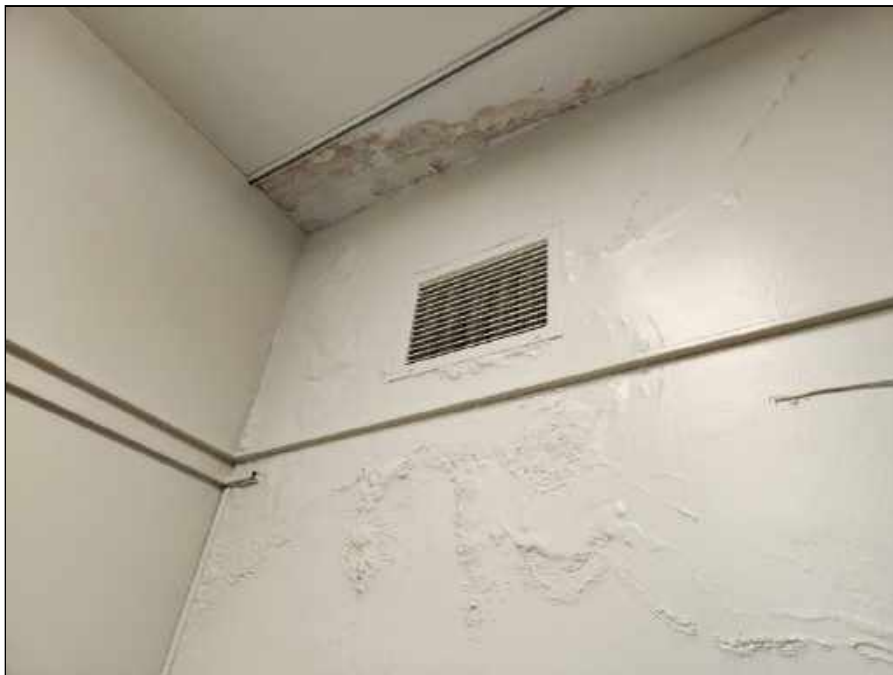
14 - Moisture damaged plaster wall observed in Room 111 on 10-18-23

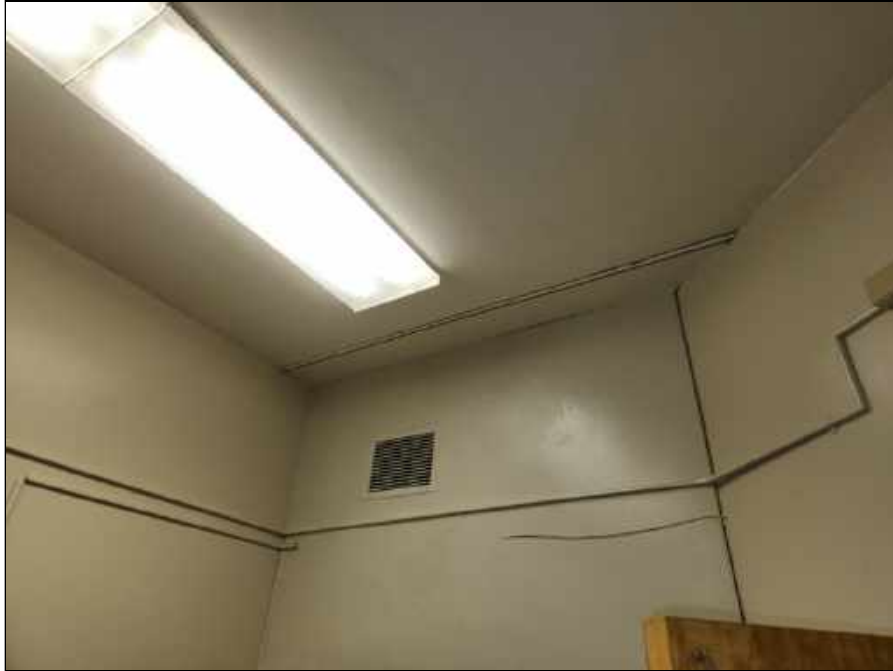
15 - Repaired plaster wall in room 111 observed on 10-30-23

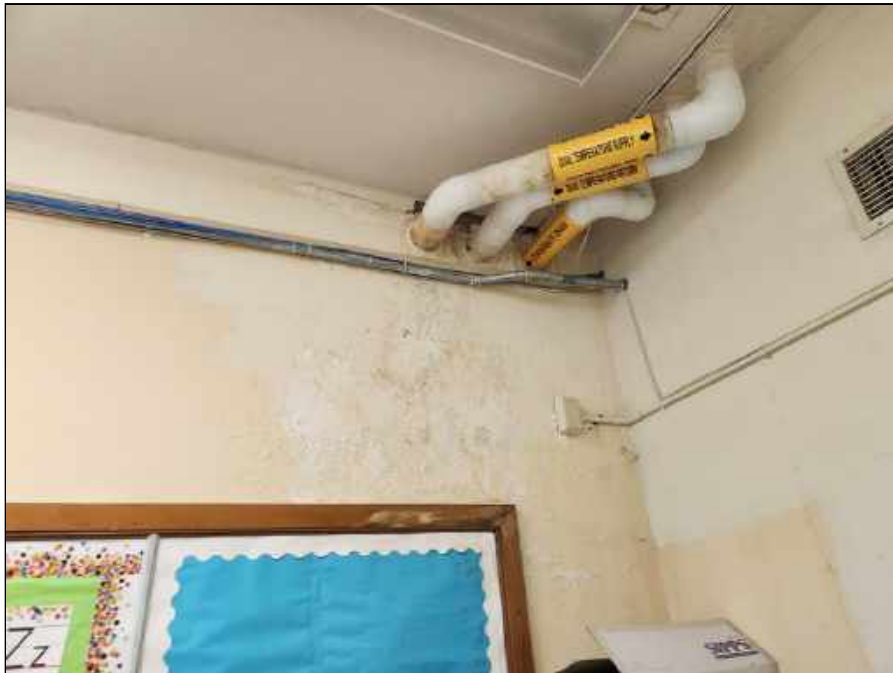
16 - Moisture damaged plaster wall observed in room beside Room 111 on 10-18-23

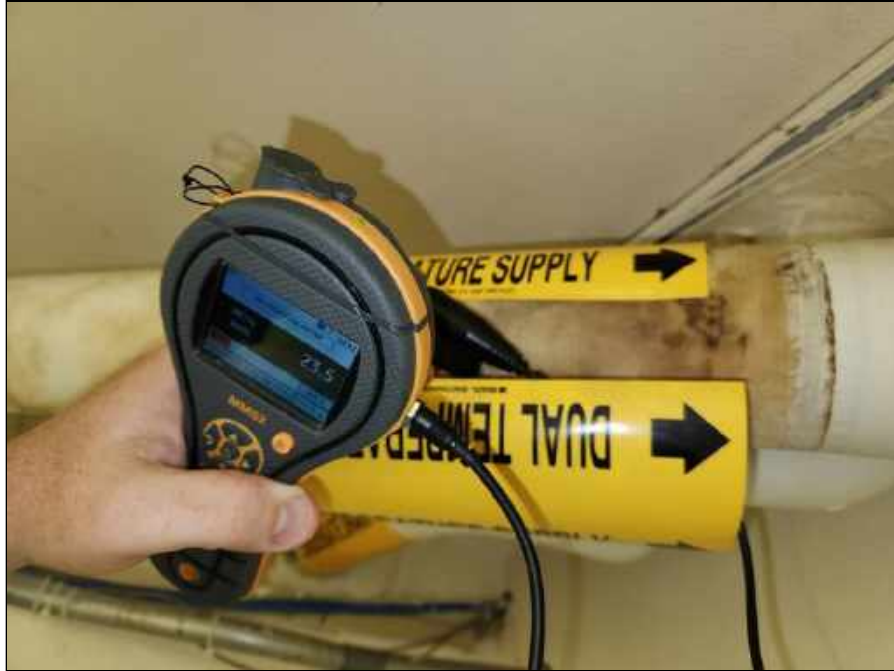
17 - Mold and moisture impacted pipe insulation in the room beside Room 111

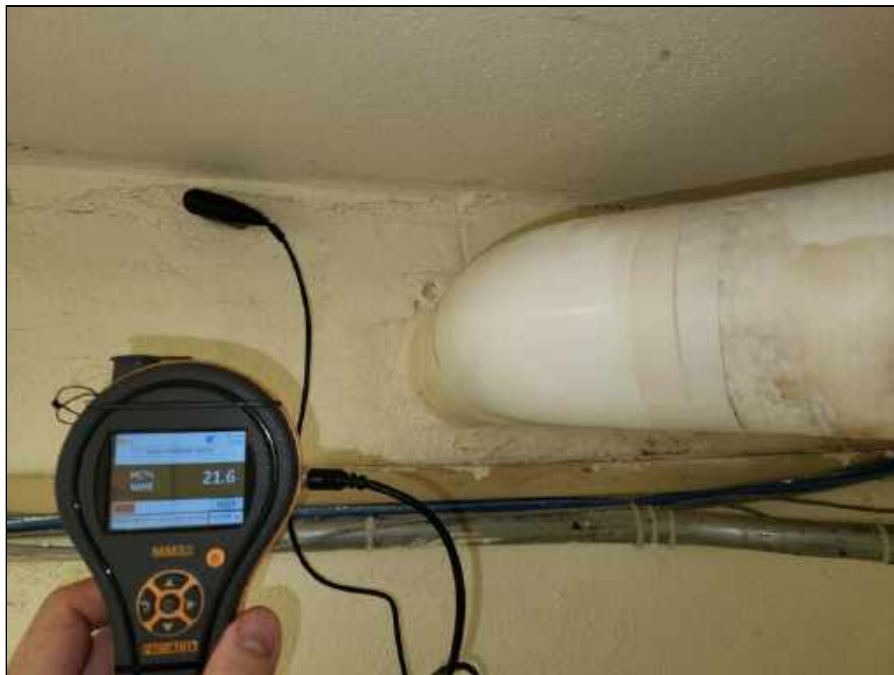
18 - Elevated moisture meter reading collected from the plaster wall around piping in the room beside Room 111

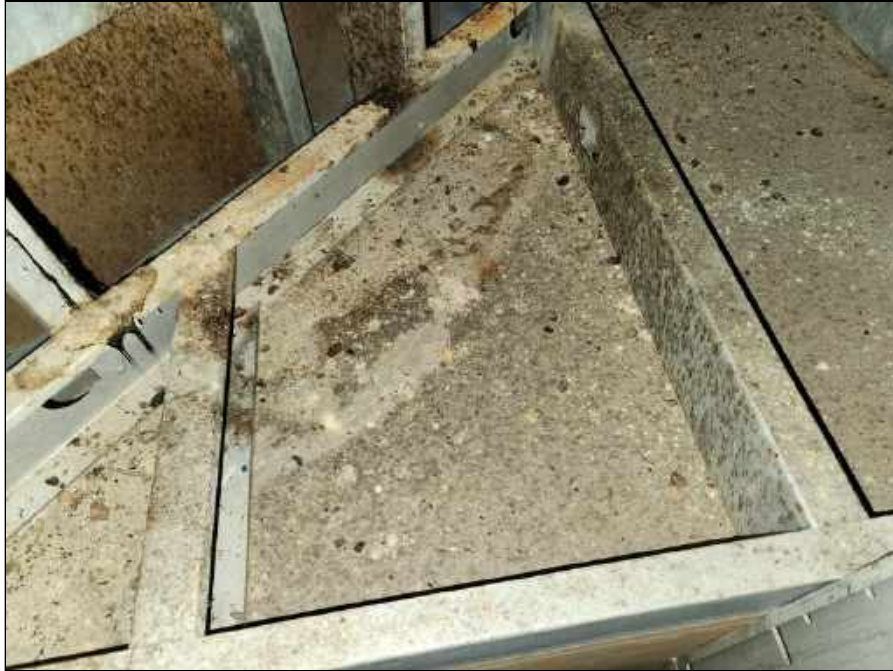
19 - Mold and moisture impacted drywall and framing above the Library hallway

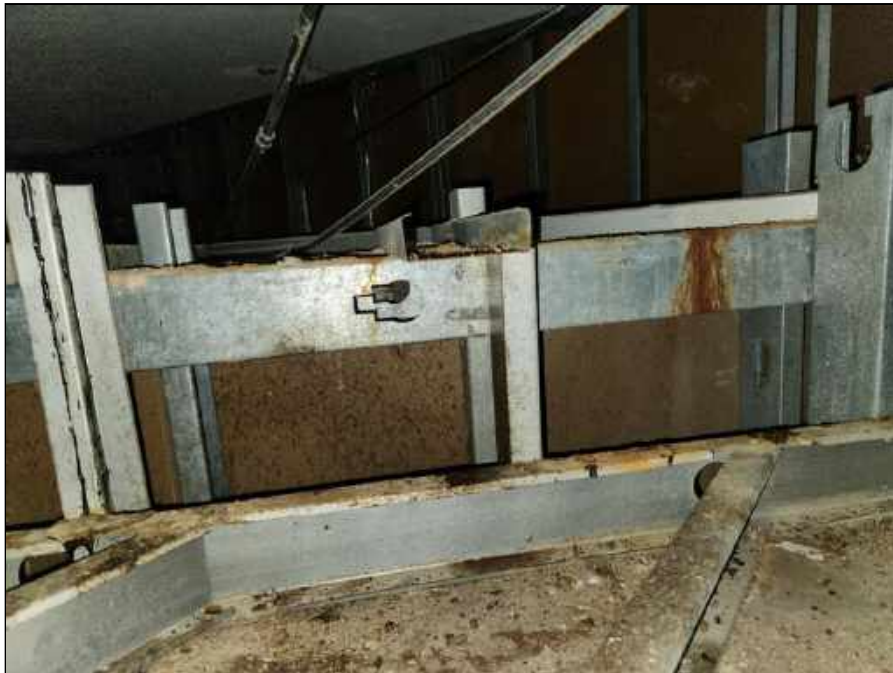
20 - Mold and moisture impacted drywall and framing above the Library hallway

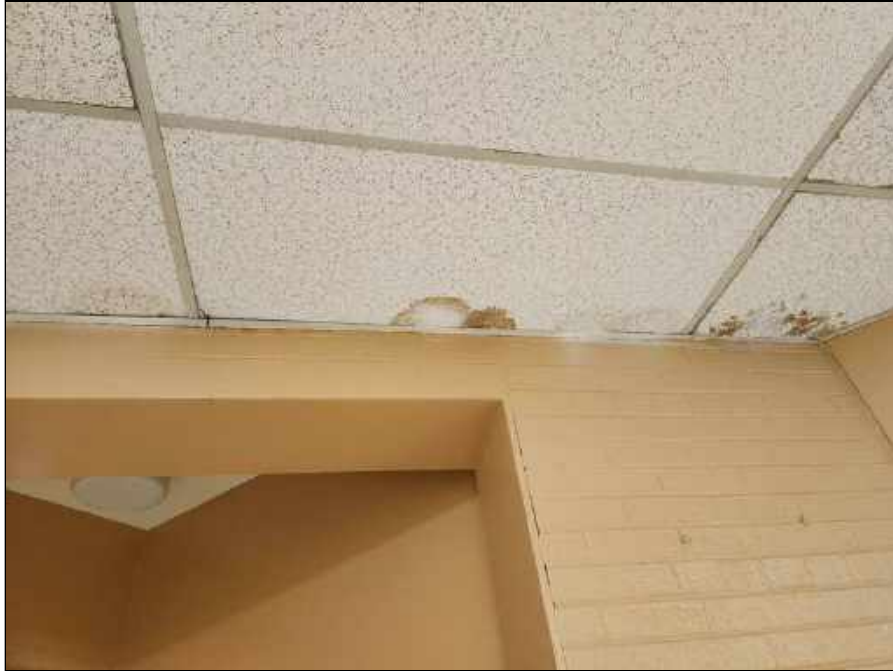
21 - Moisture impacted ceiling tiles in Room 112

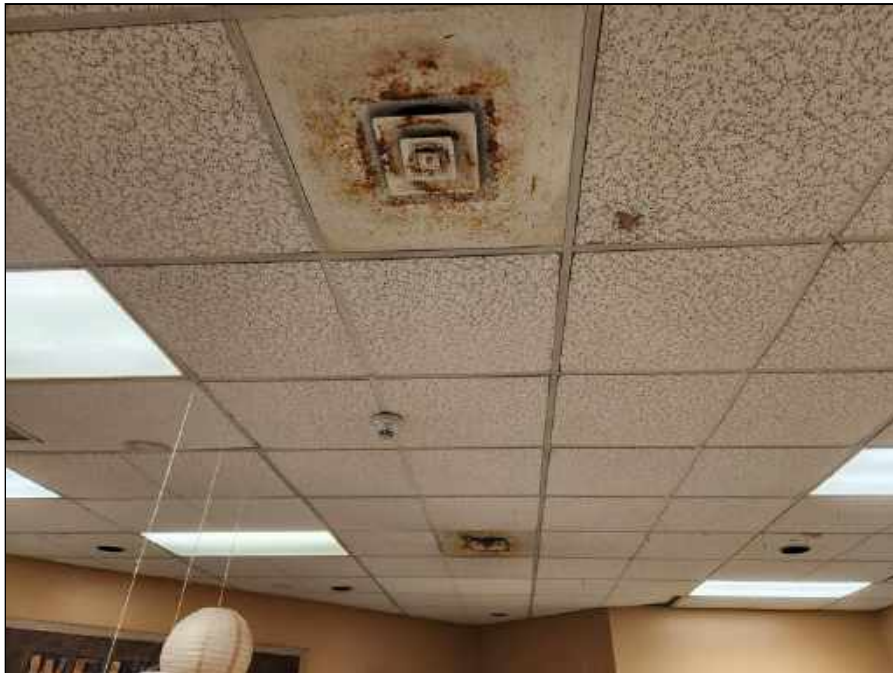
22 - Significant rusting on HVAC diffusers in Room 112

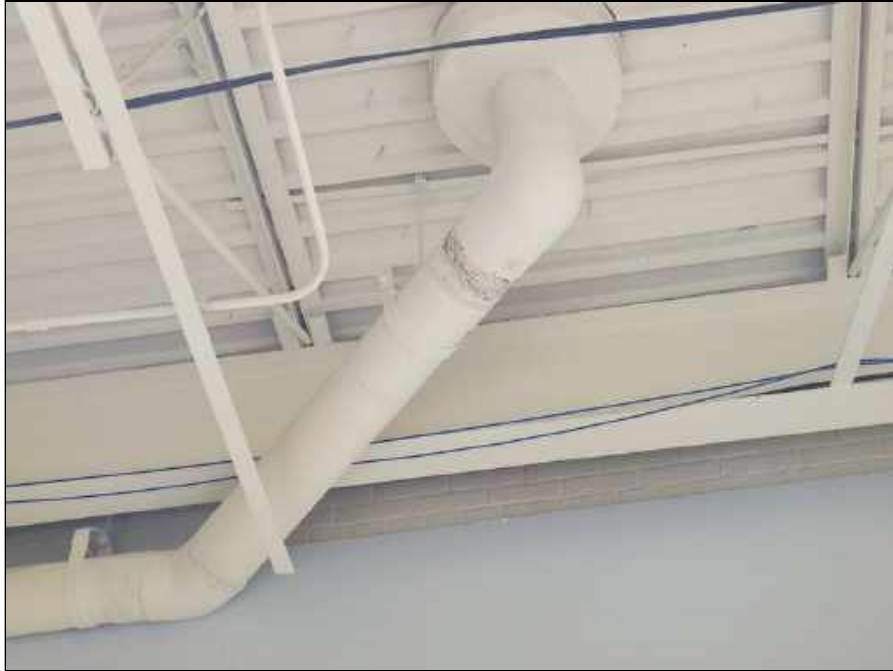
23 - Mold observed on roof drain pipe insulation in the library

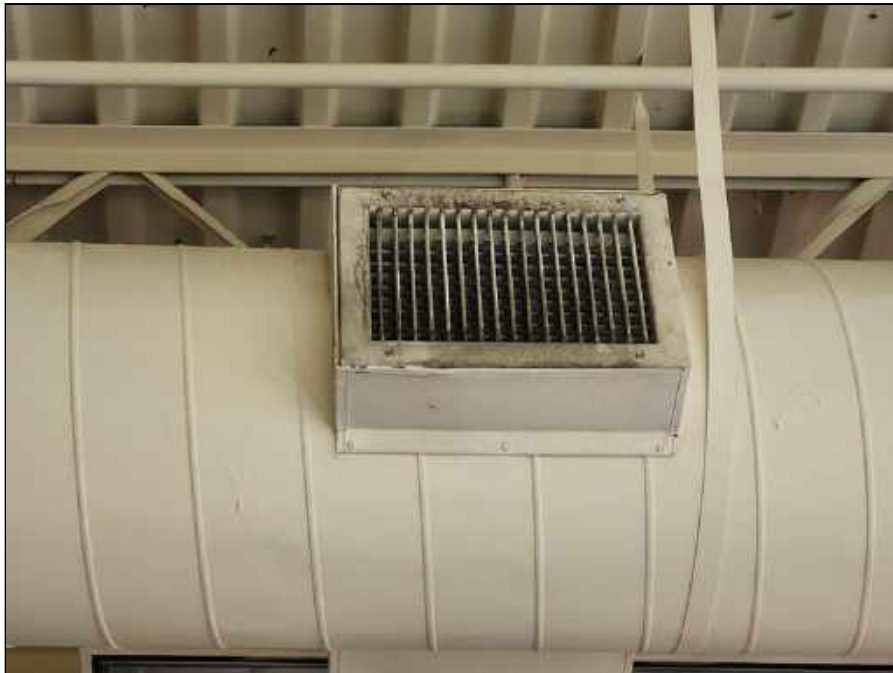
24 - Mold observed on the HVAC supply vents on the main trunk in the library

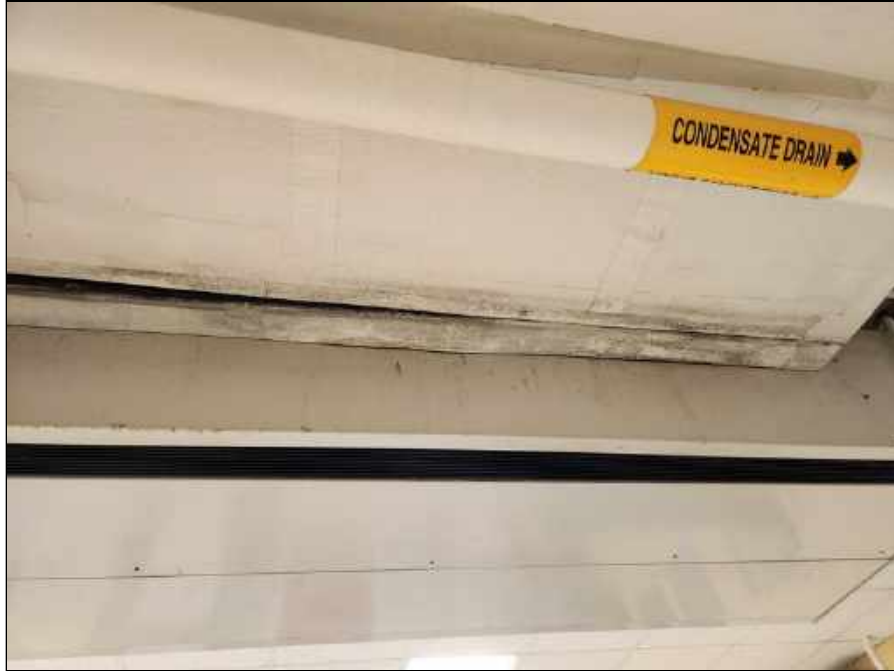
25 - Mold on HVAC duct board in the cafeteria

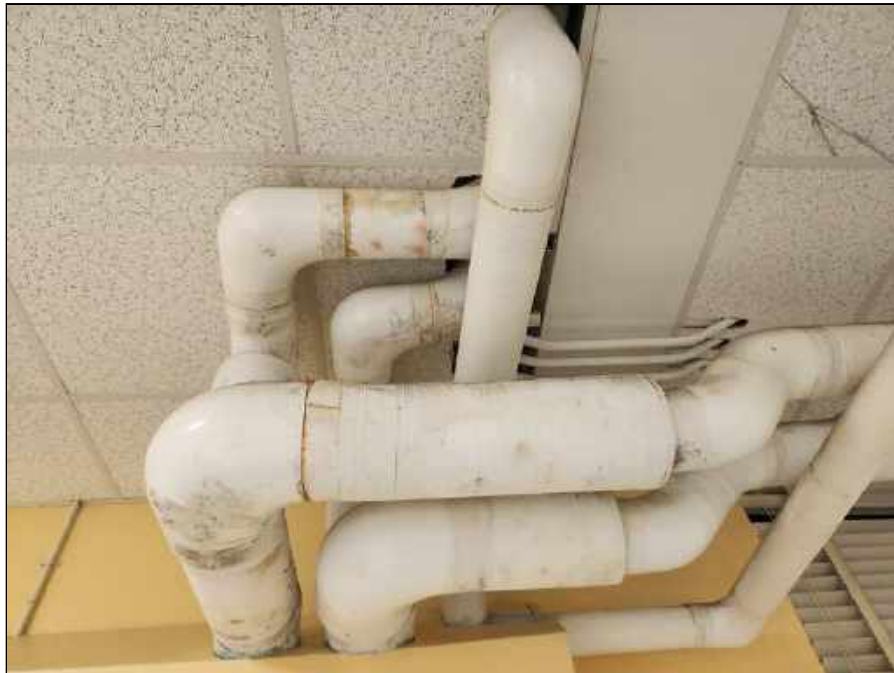
26 - Moisture and mold impacted pipe insulation in the cafeteria

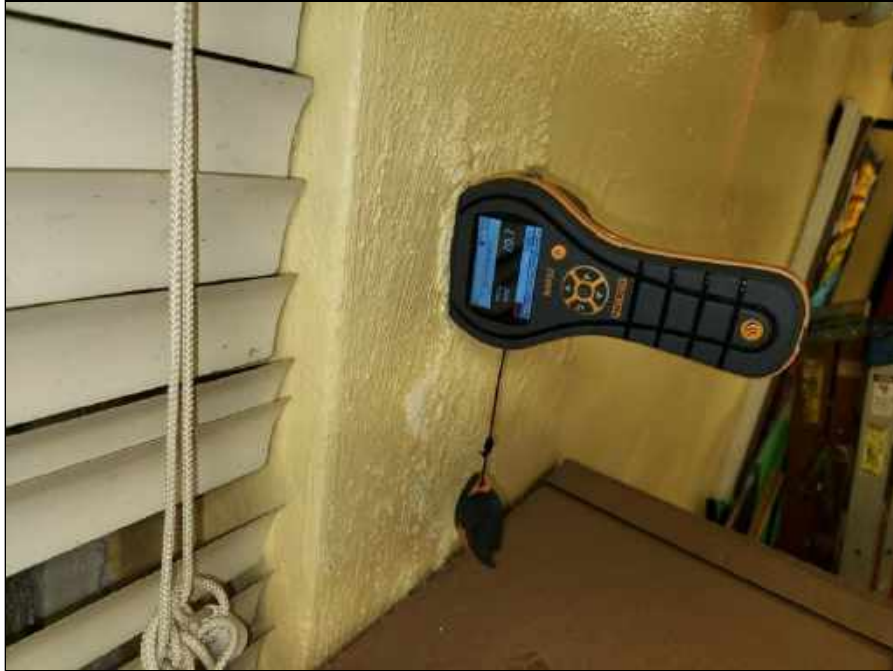
27 - Elevated moisture meter reading collected from a plaster wall in the cafeteria

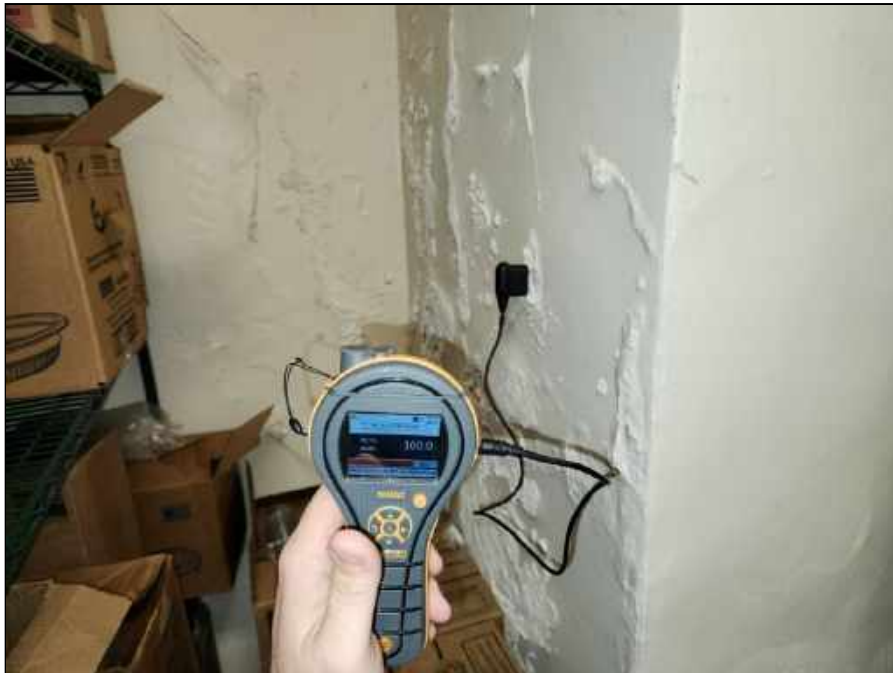
28 - Elevated moisture meter reading collected from the plaster wall in the kitchen by the container storage indicating that the wall is saturated

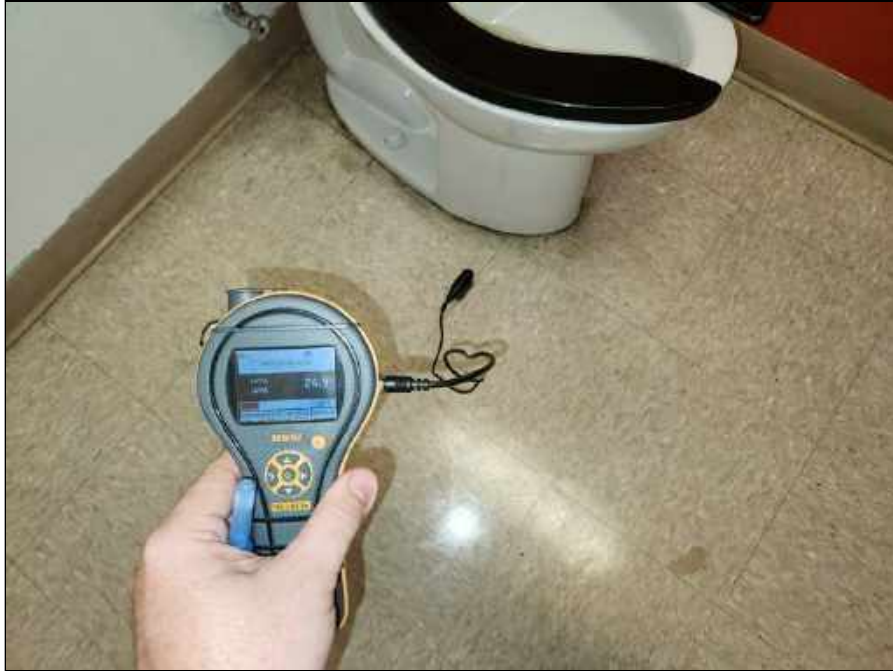
29 - Elevated moisture reading indicating elevated moisture beneath the flooring in the Nurse's bathroom

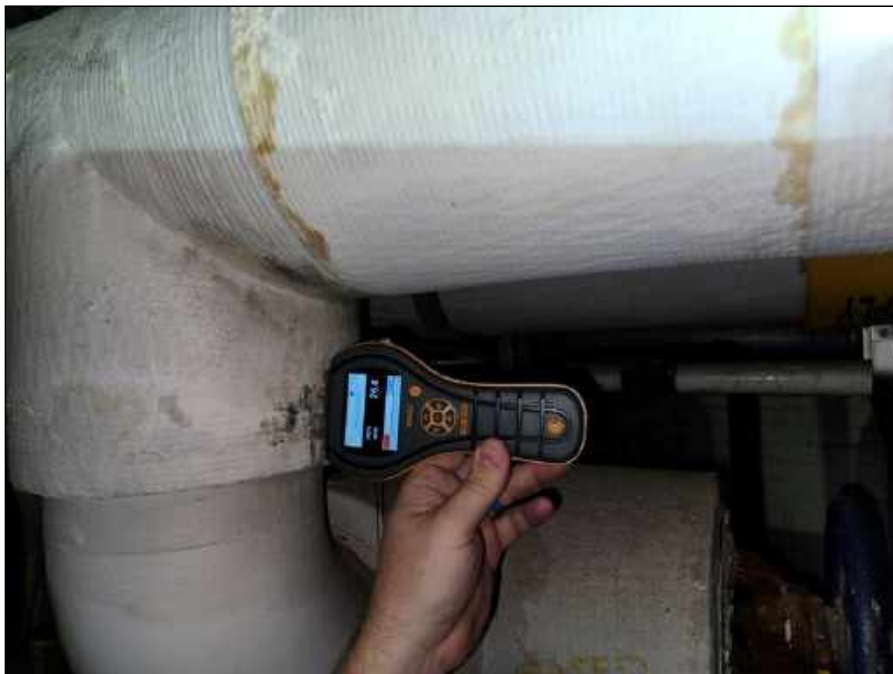
30 - Mold and moisture impacted pipe insulation above the ceiling in the Teacher's Lounge indicating elevated moisture. Elevated moisture readings detected.

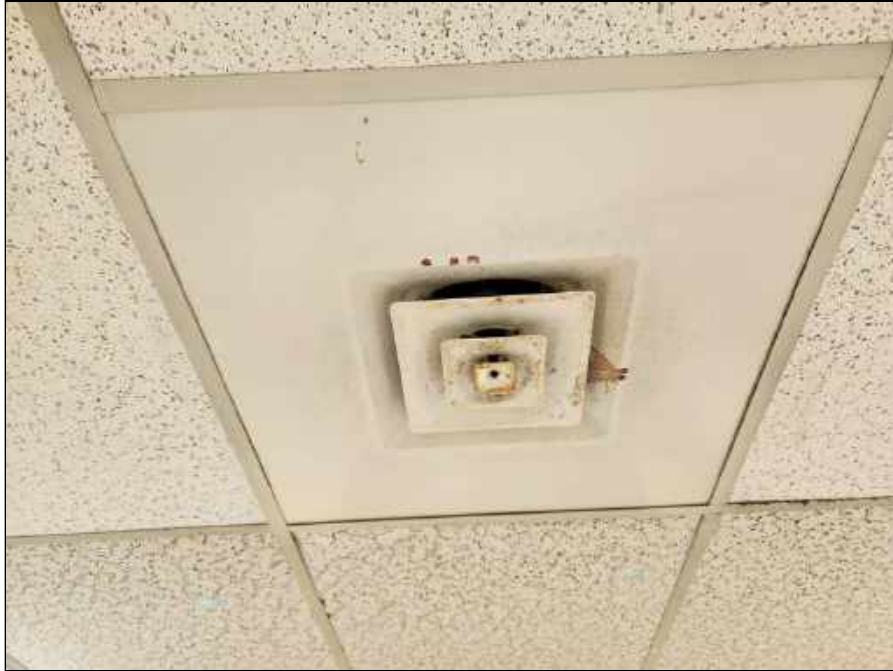
31 - Rusting on HVAC supply diffuser in the Nurse's office

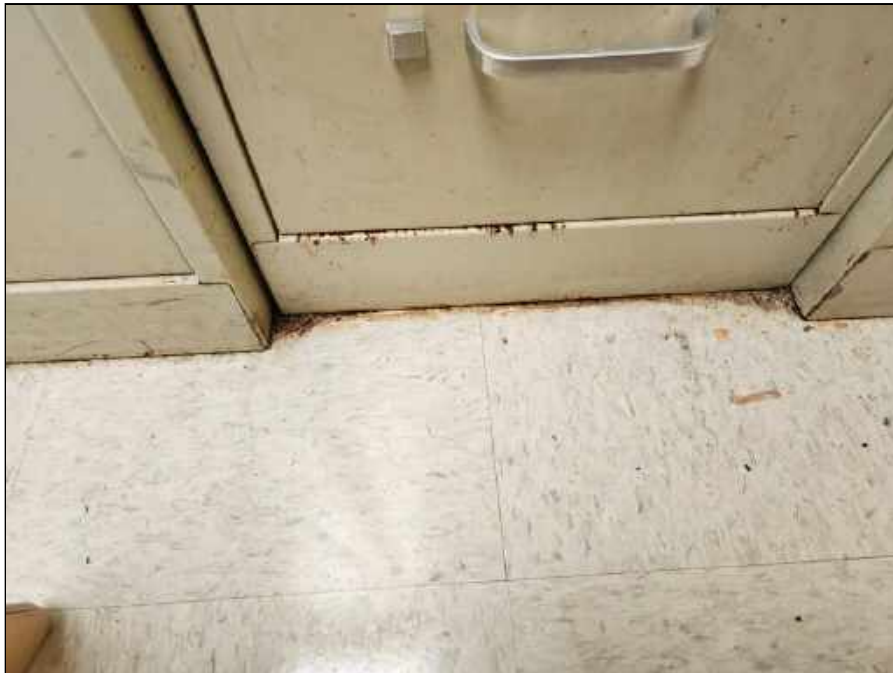
32 - Mold on the floor and rust at the base of a file cabinet in the Nurse's office

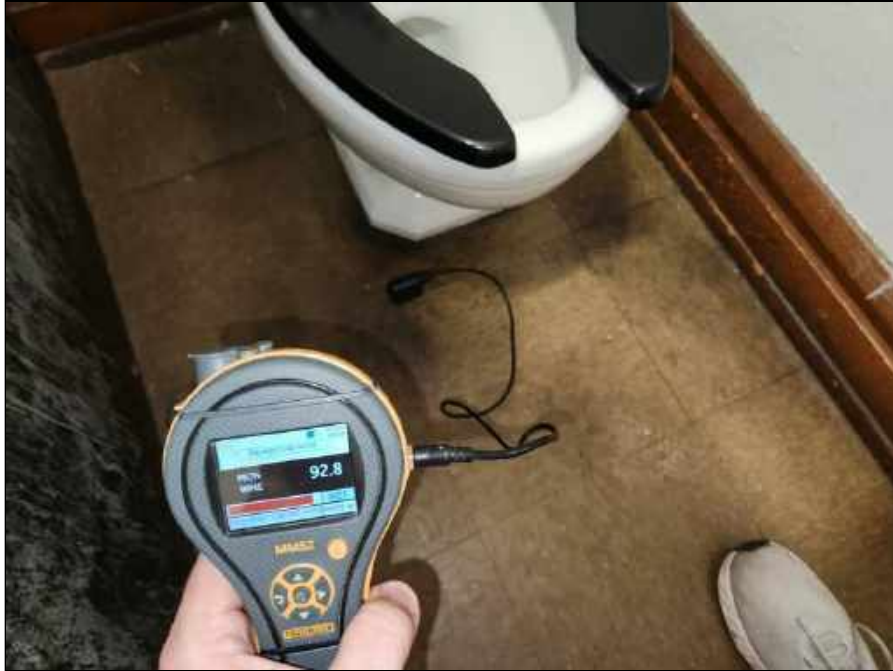
33 - Elevated moisture meter reading in the 2nd floor office between 219 and 220 indicating moisture is trapped beneath the floor tile

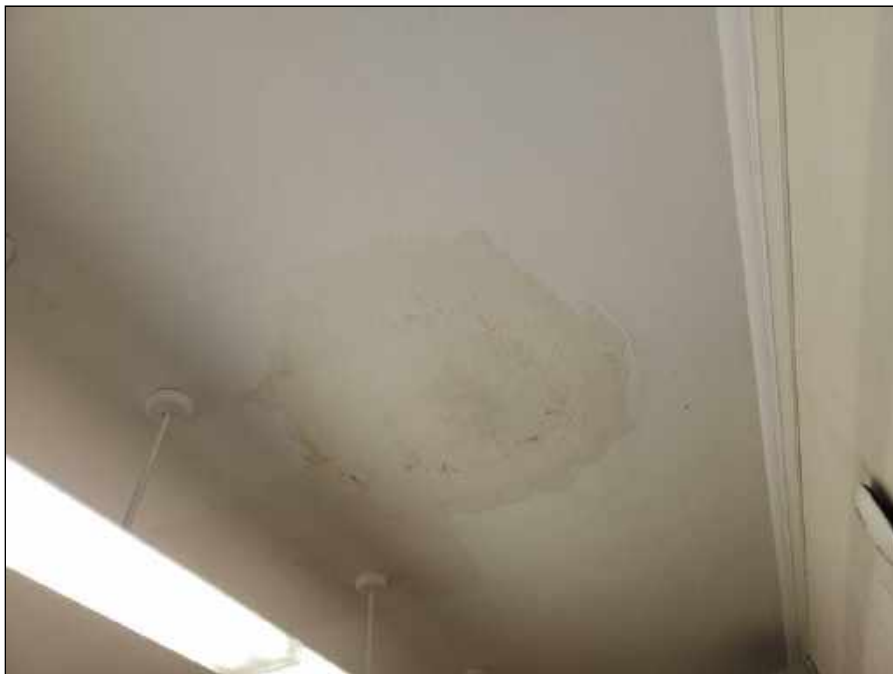
34 - Moisture impacted plaster ceiling in Room 218

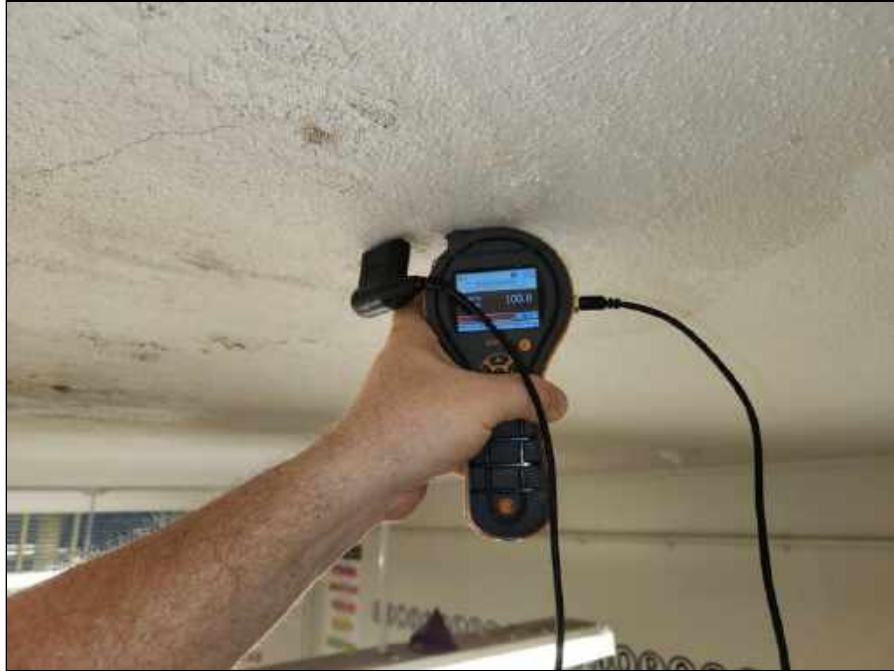
35 - Elevated moisture meter reading indicating that the plaster ceiling is saturated and an active moisture source may be present above the ceiling in Room 218

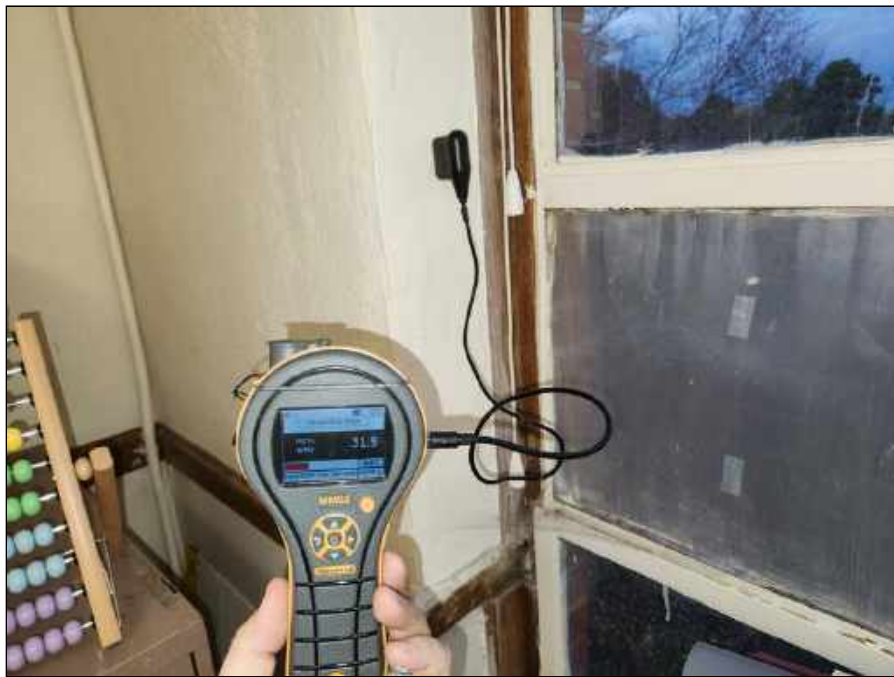
36 - Elevated moisture meter reading collected from the wall in Room 217

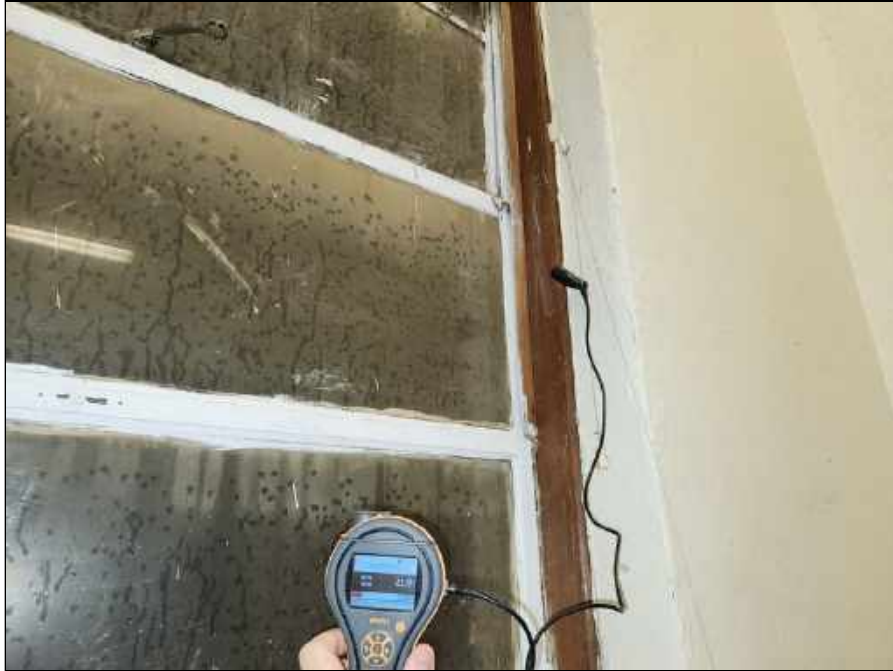
37 - Elevated moisture meter reading collected from the plaster wall in the stairwell by Room 110

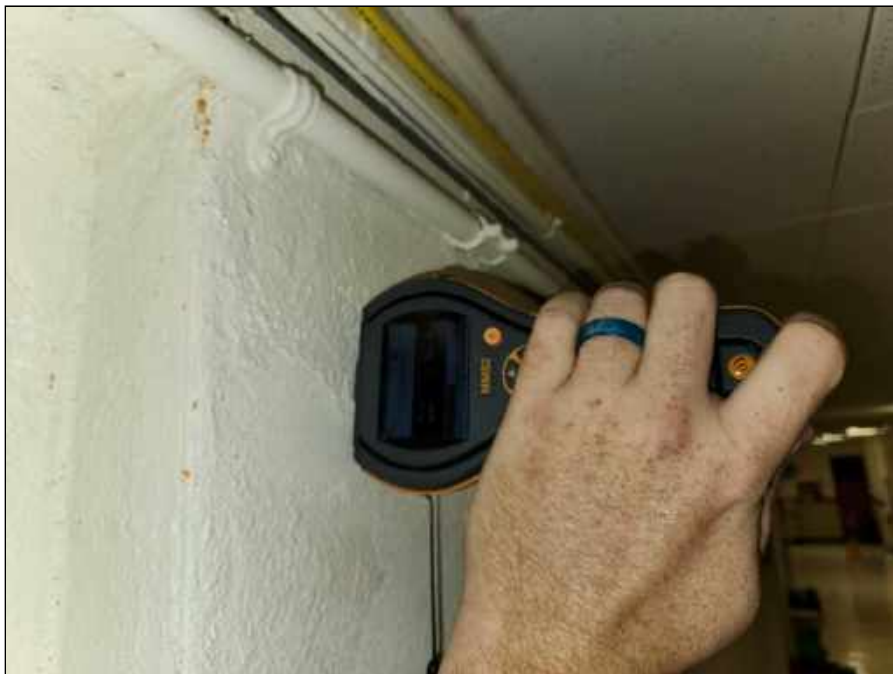
38 - Elevated moisture meter reading collected from a plaster wall in the hallway across from Room 110
