MOLD AND MOISTURE ASSESSMENT REPORT

ELIZABETH D. REDD ELEMENTARY SCHOOL

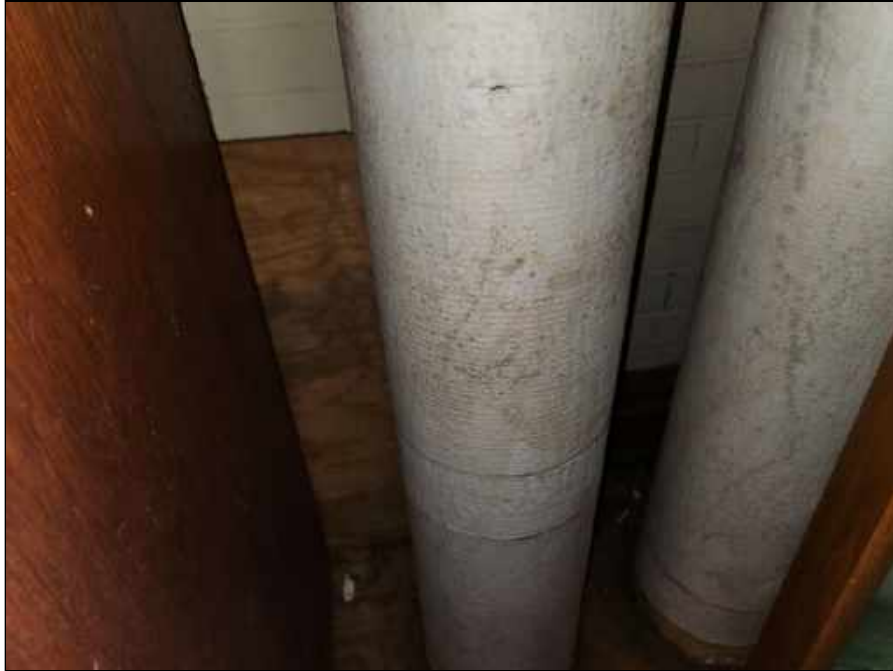
39 - Mold on pipe insulation by the stage (right)

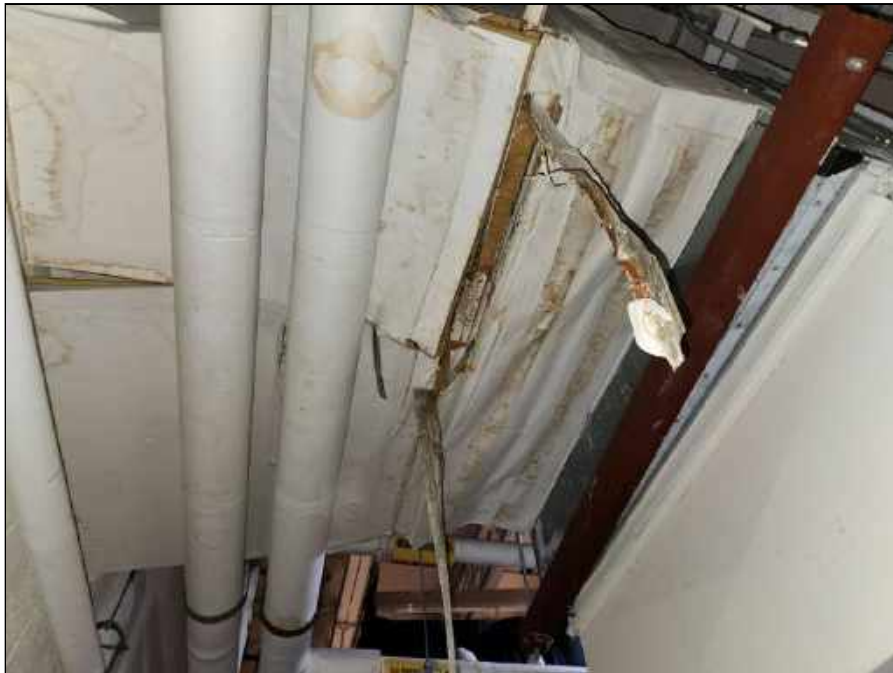
40 - Moisture stained HVAC duct insulation by the stage (right)

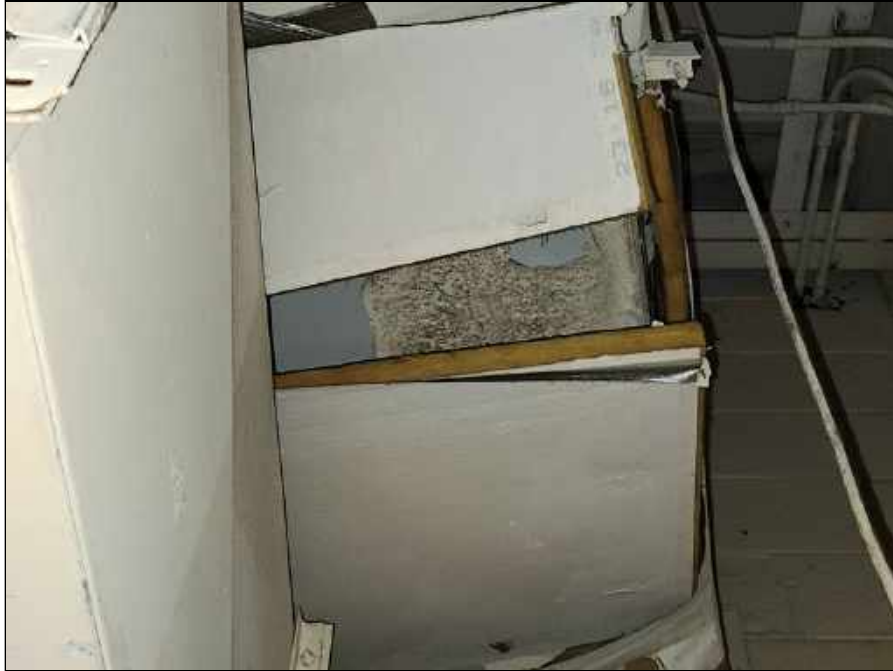
41 - Mold on HVAC duct insulation adhesive by the stage (left)

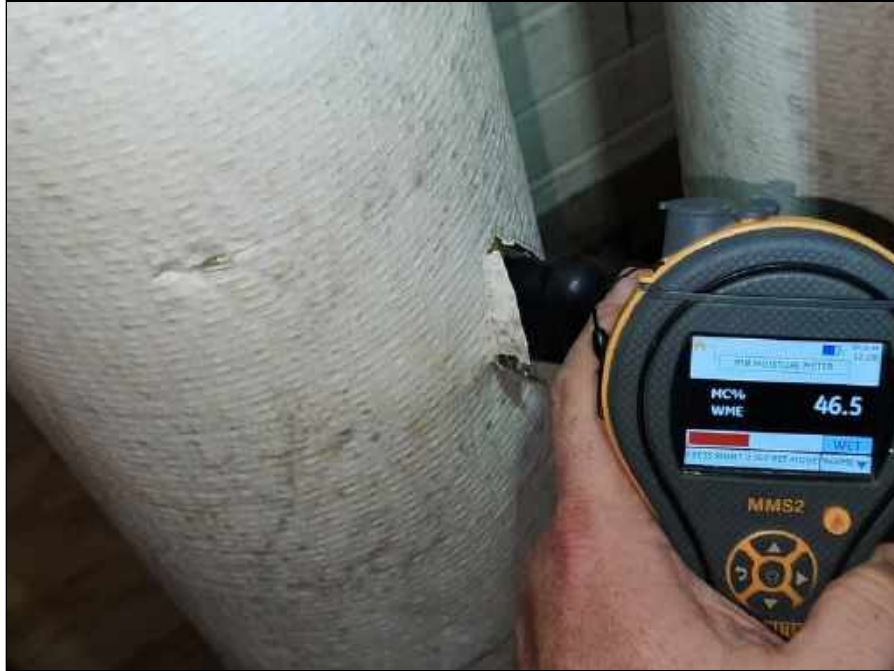
43 - Elevated moisture meter reading collected from pipe insulation - by stage (right)

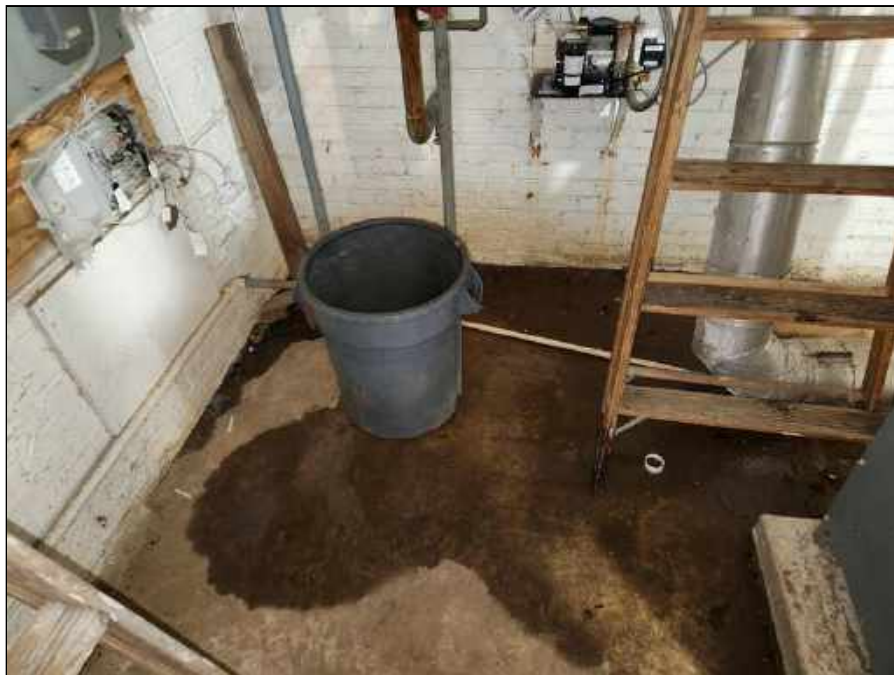
44 - Leaking pipe causing standing water on the floor of the boiler room

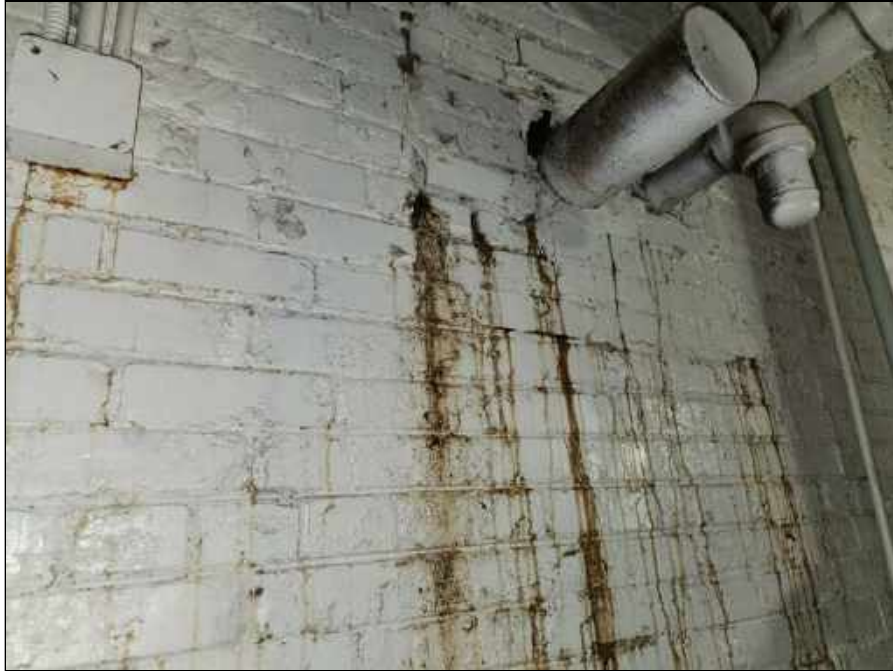
45 - Water leaking from holes in the back wall of the boiler room

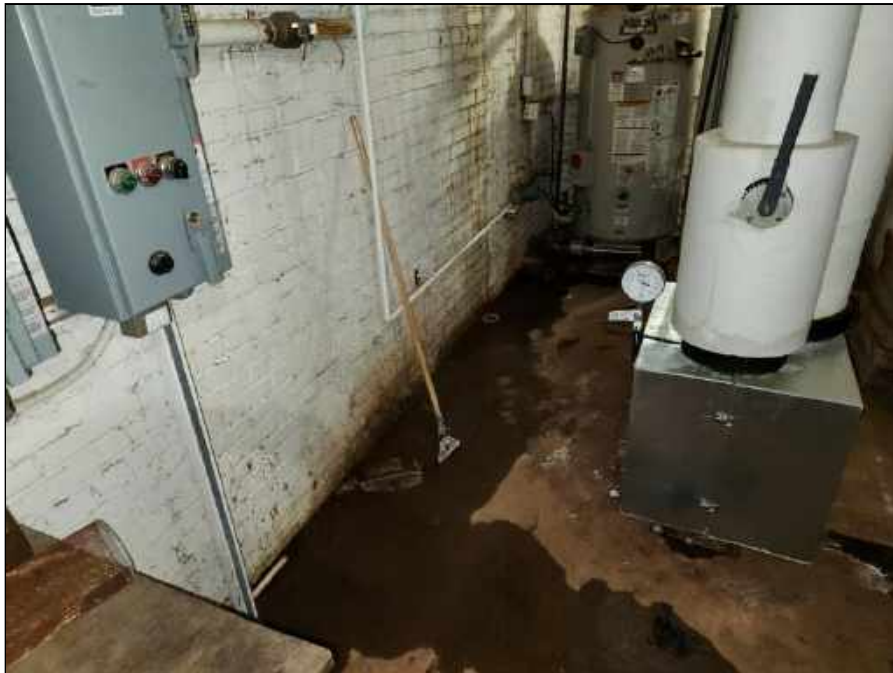
46 - Standing water on the floor of the boiler room caused by water leaking from the wall (exterior)

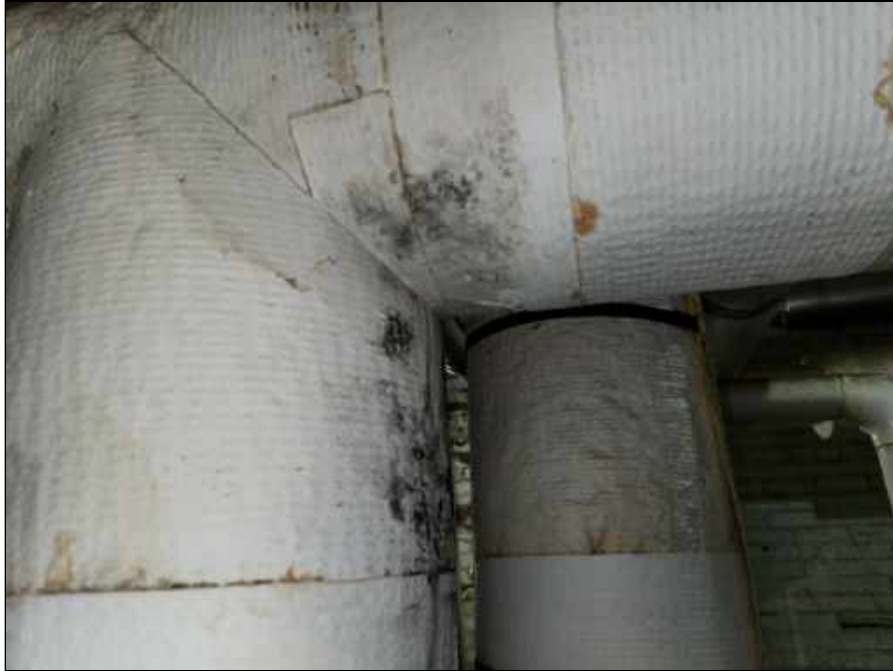
47 - Mold on pipe insulation in the boiler room

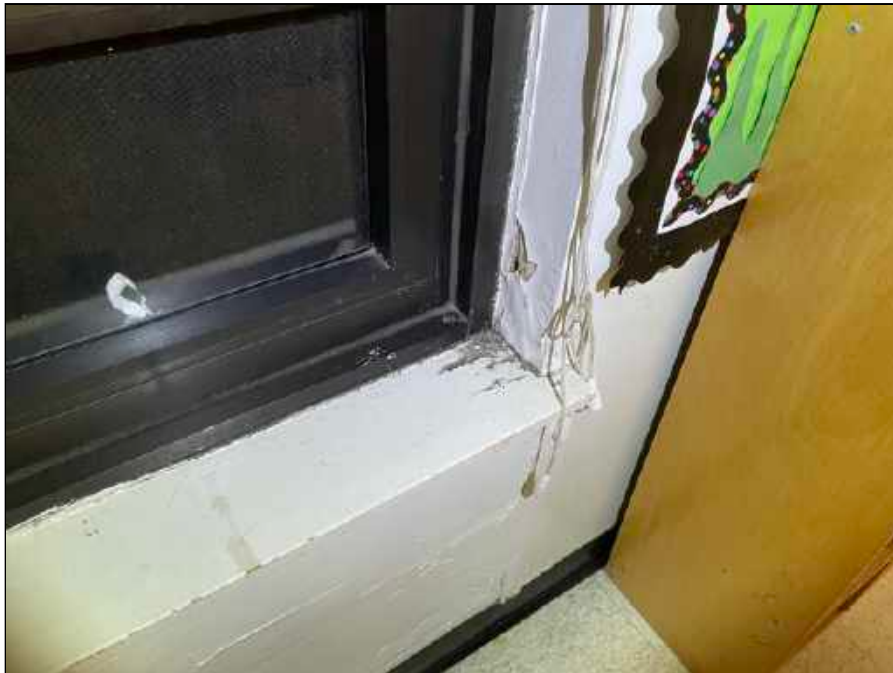
48 - Moisture damaged plaster wall in Room 124 - Activities Room

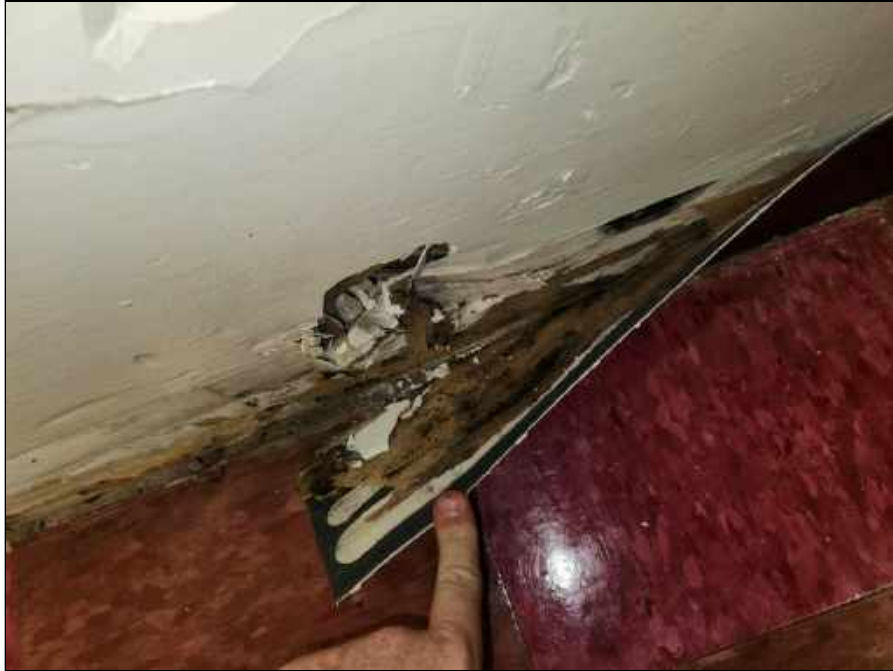
49 - Mold and moisture impacted drywall in Room 126 - the Music Room

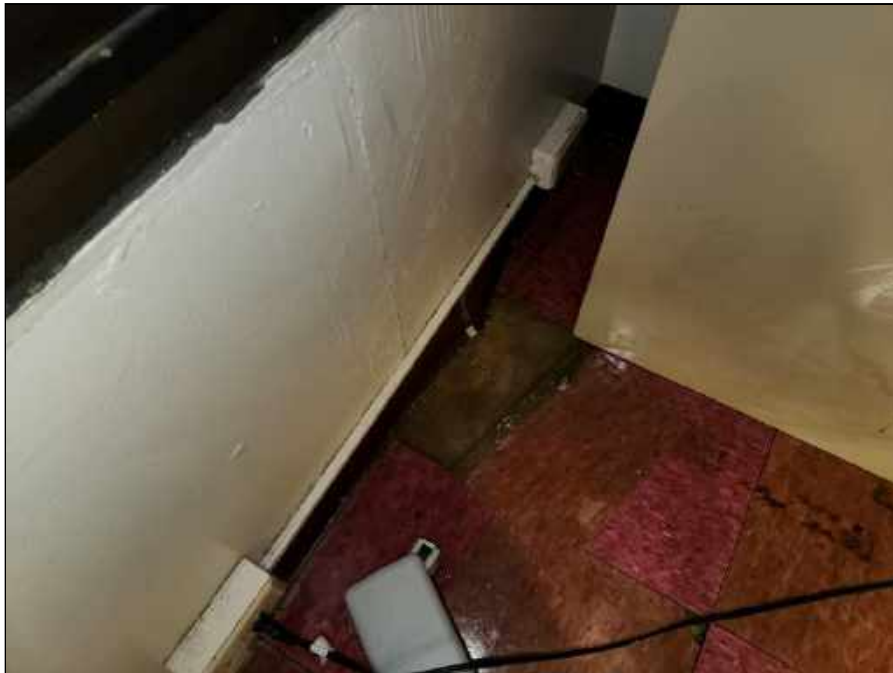
50 - Moisture damaged drywall and water on the floor in Room 126

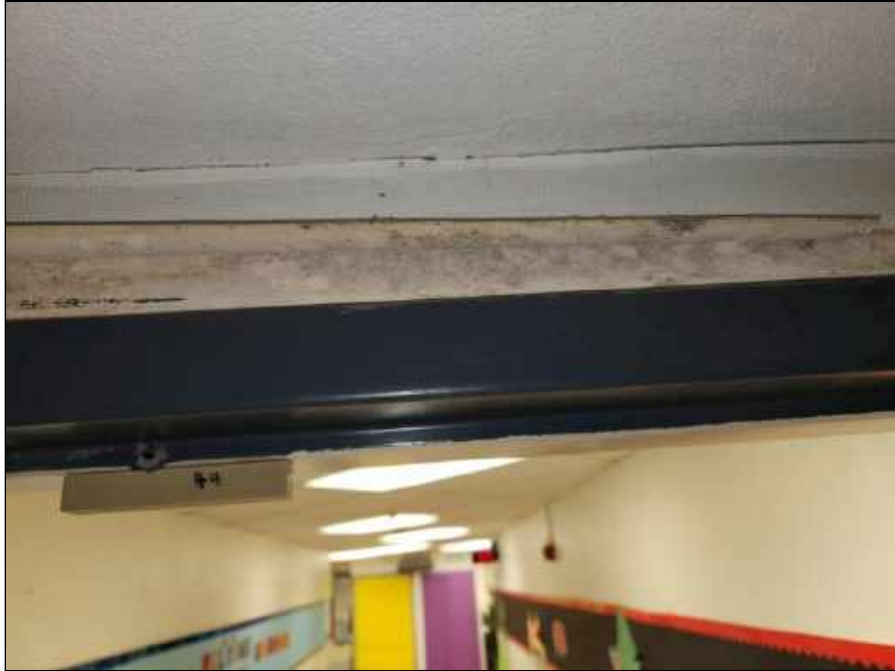
1 - Mold impacted drywall at the entrance to the pod classrooms

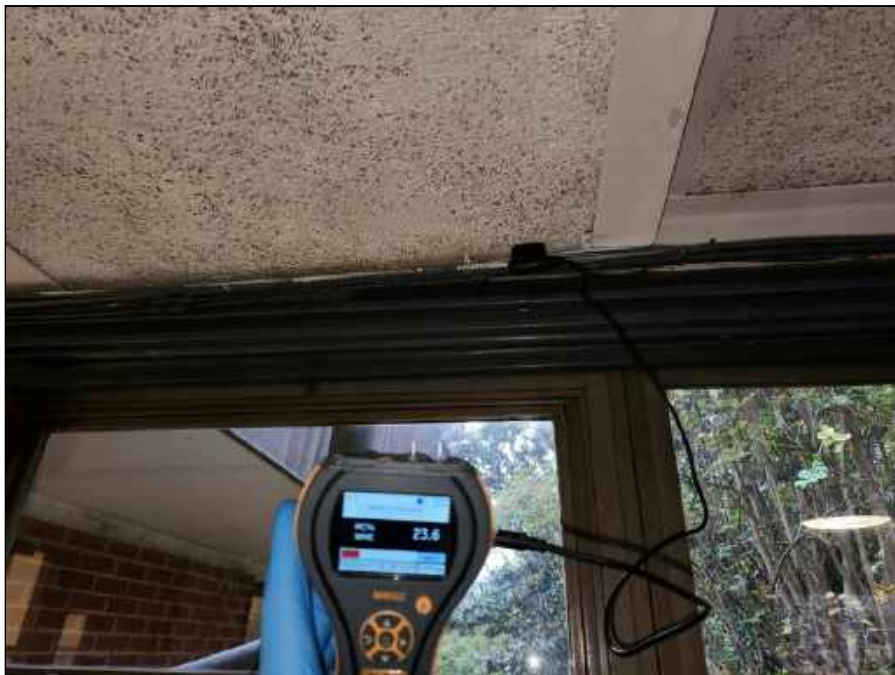
2 - Elevated moisture meter reading collected from the tectum ceiling in the pod connector hall

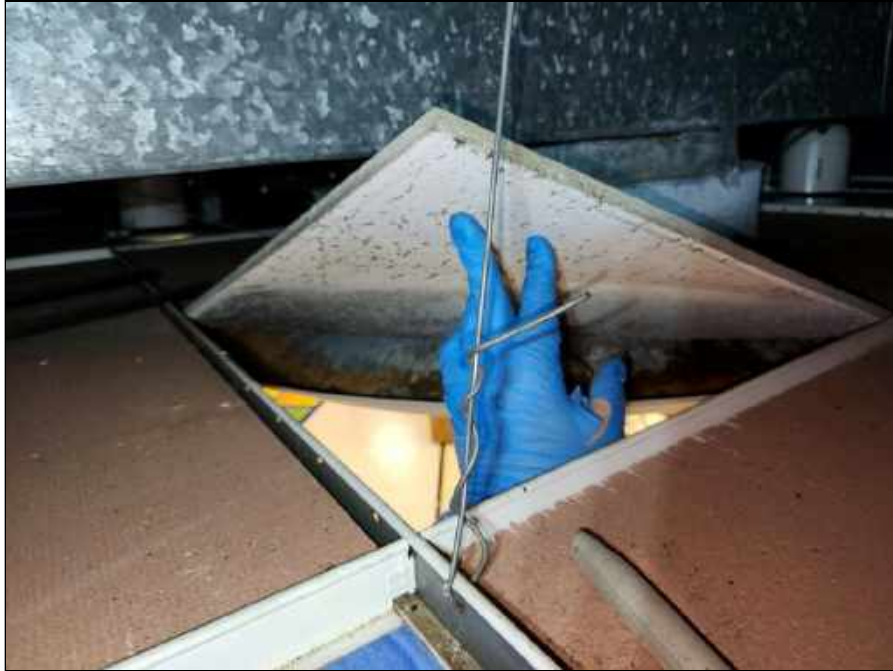
3 - Mold impacted ceiling tiles above the large HVAC supply vent in classroom 103 and evidence of moisture accumulation within the vent

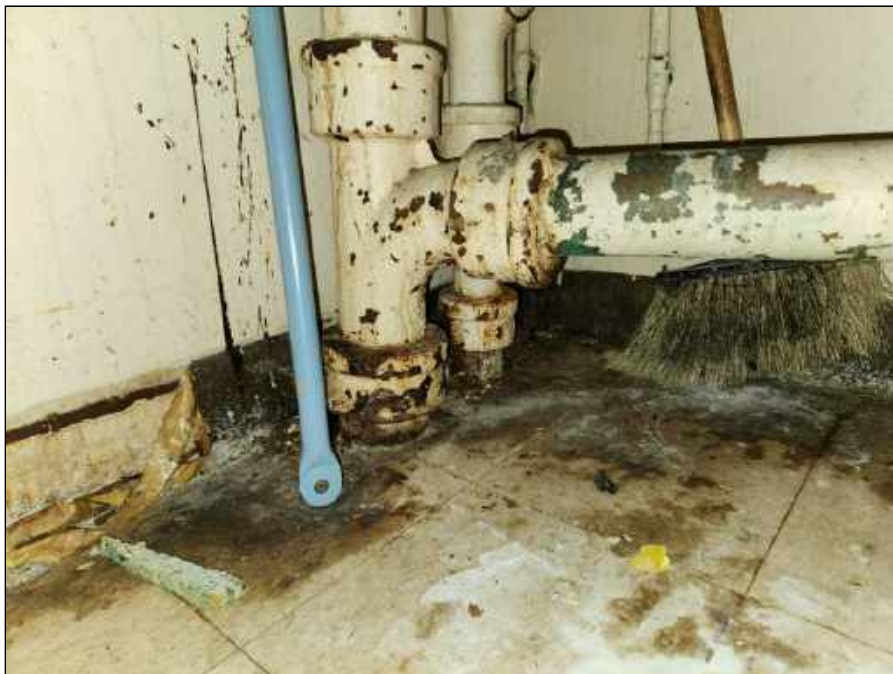
4 - Mold on floor tiles and the base of the plaster wall in the janitor's closet

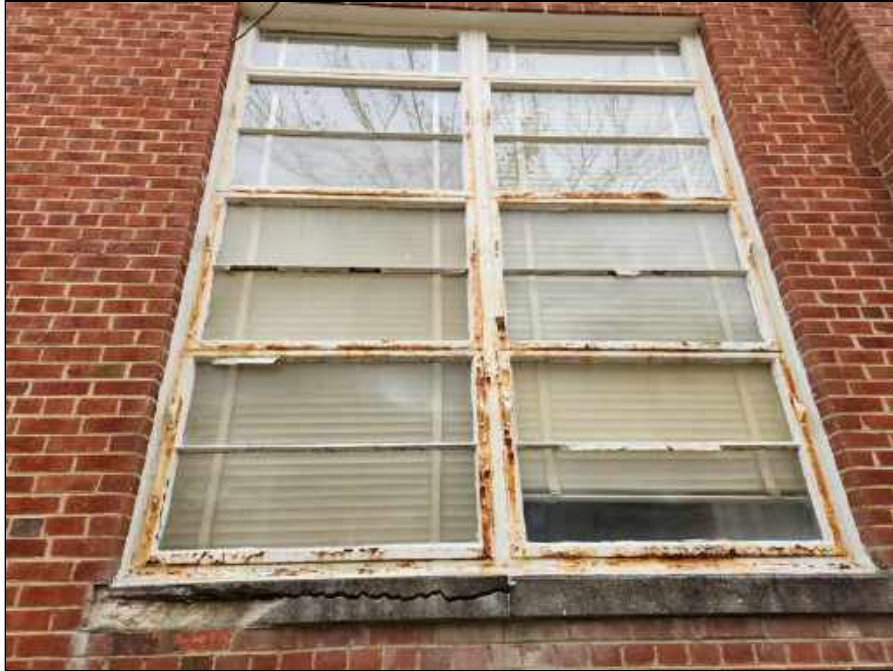
1 - Rusted window frame and damaged window ledge at an Auditorium window

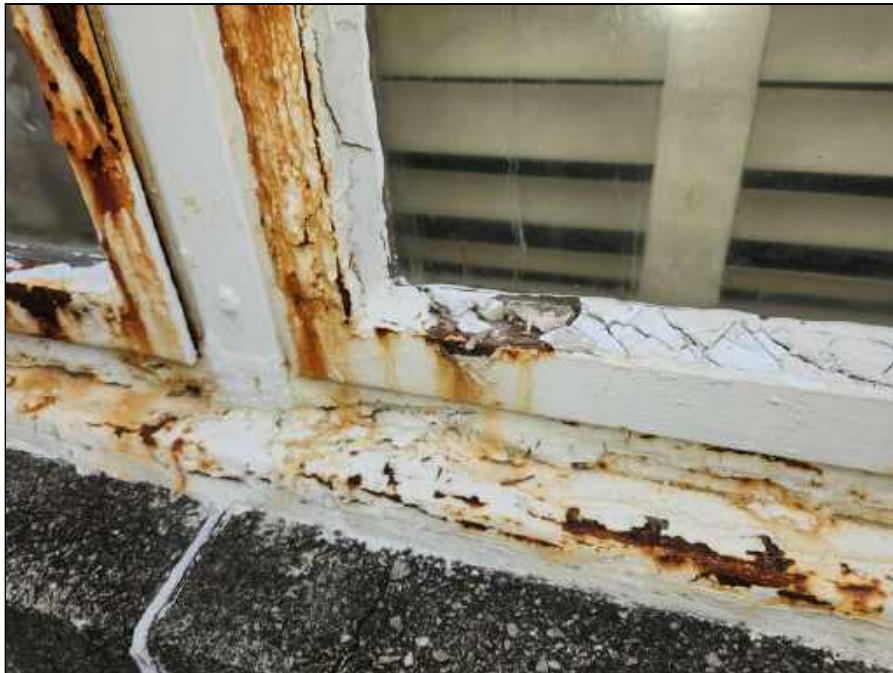
2 - Damaged window glazing at an Auditorium window

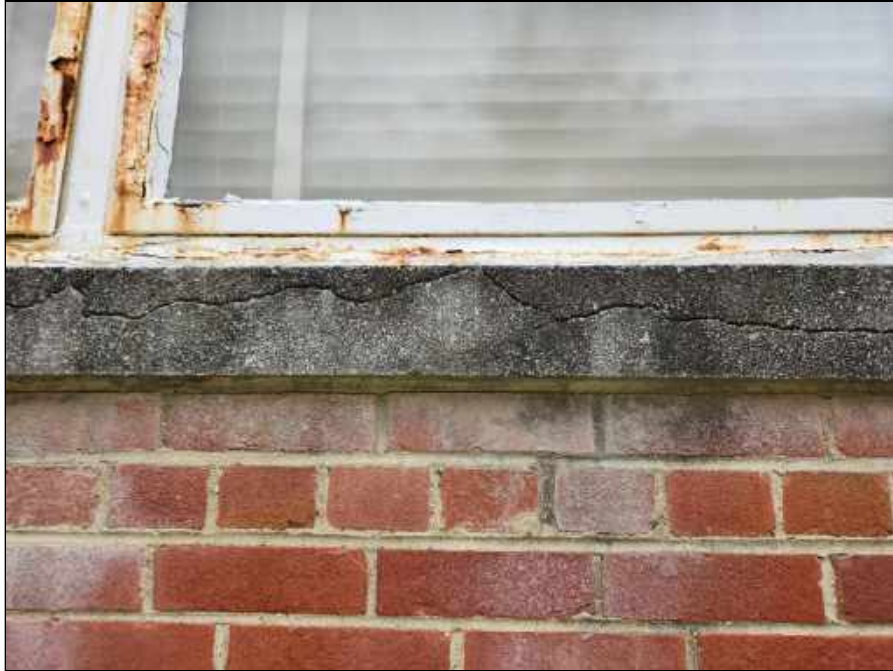
3 - Damaged window ledge at an Auditorium window

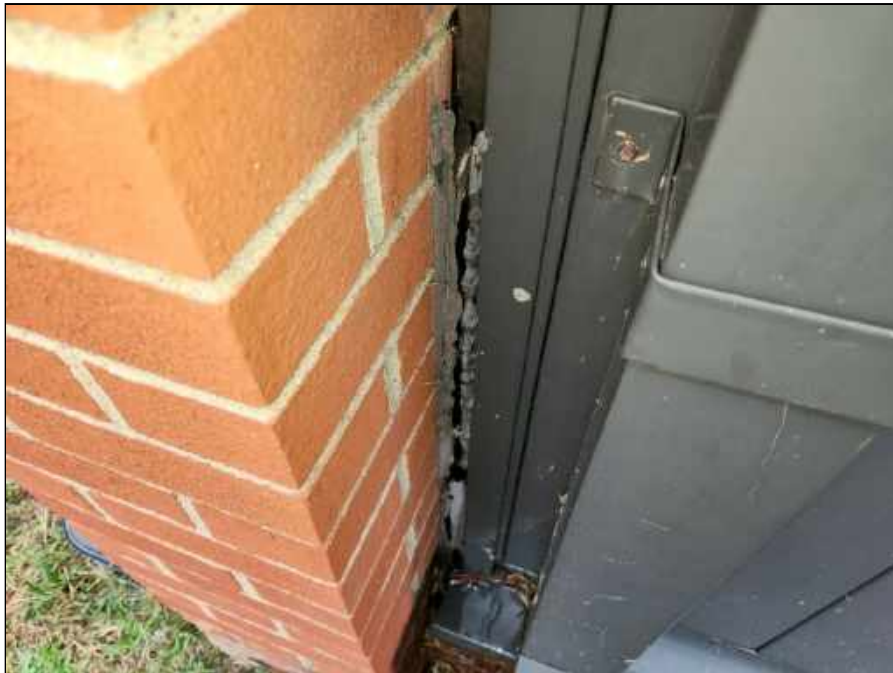
4 - Damaged sealants associated with the exterior metal wall panels outside Room 126

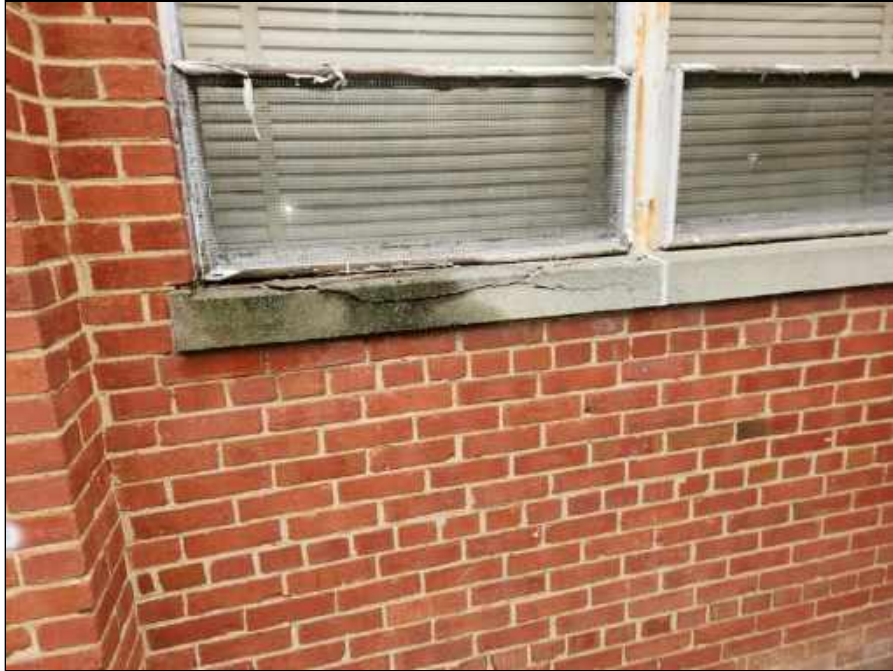
5 - Damaged window ledge at a Cafeteria window

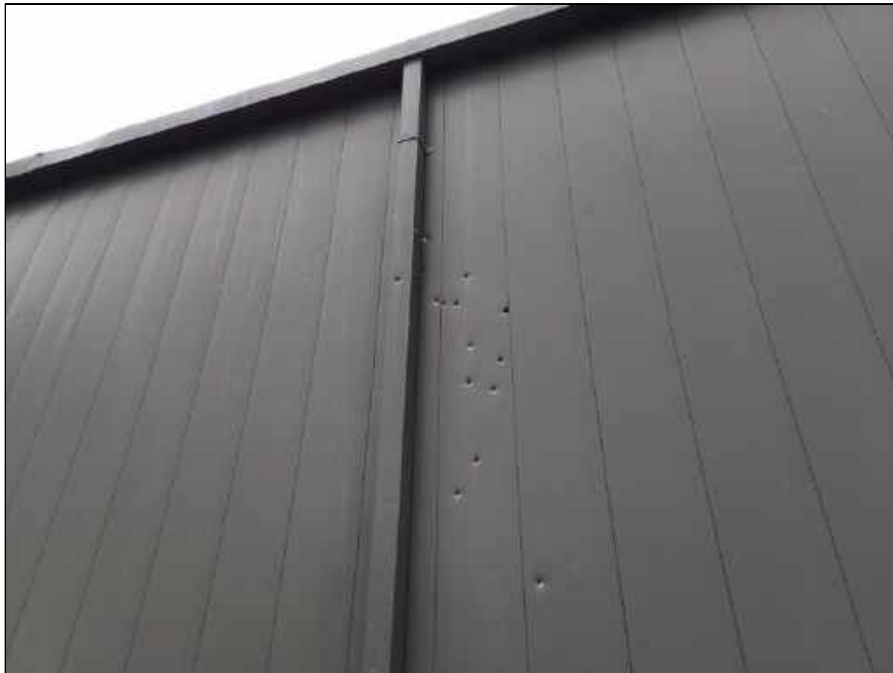
6 - Apparent bullet holes in the exterior metal panels on the Activities portion of the building

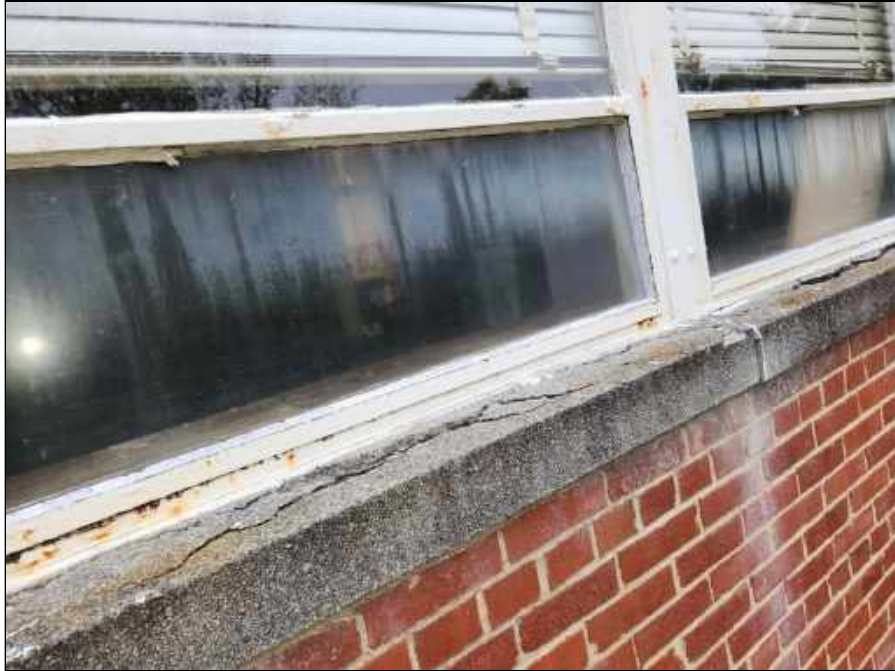
9 - Damaged window ledge on the East side of the building

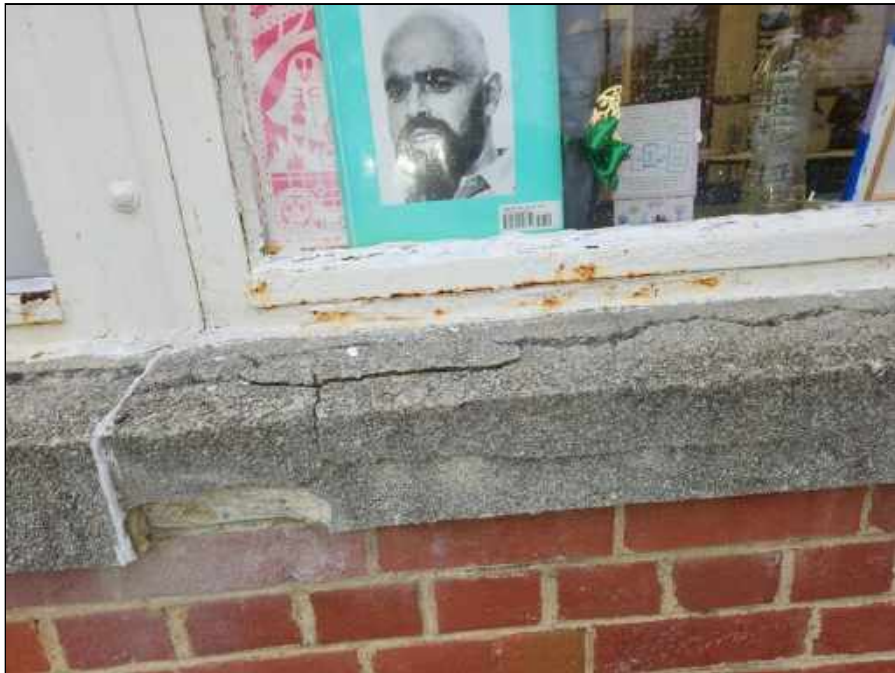
10 - Damaged window ledge on the East side of the building

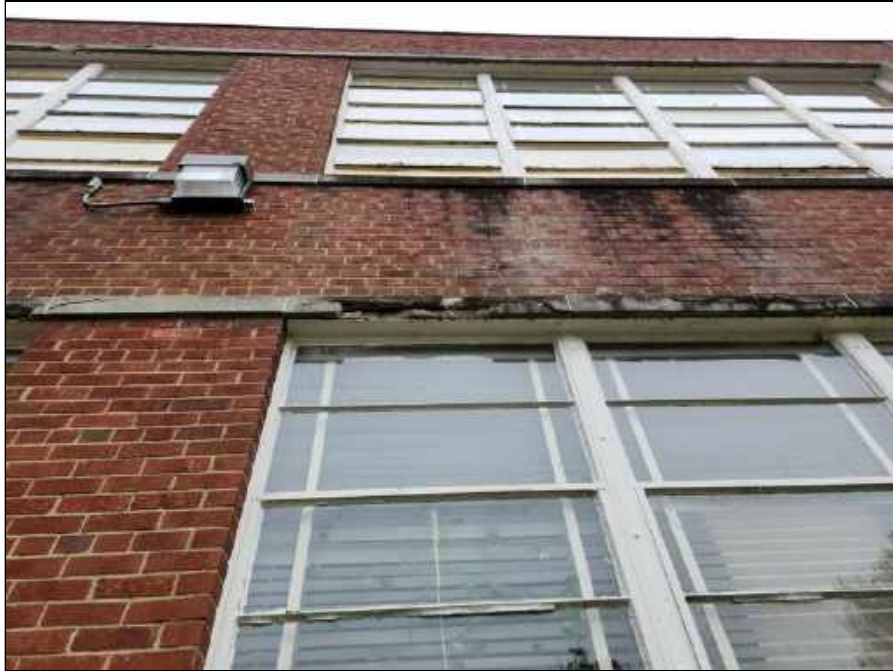
11 - Damaged window ledges on the North side of the building

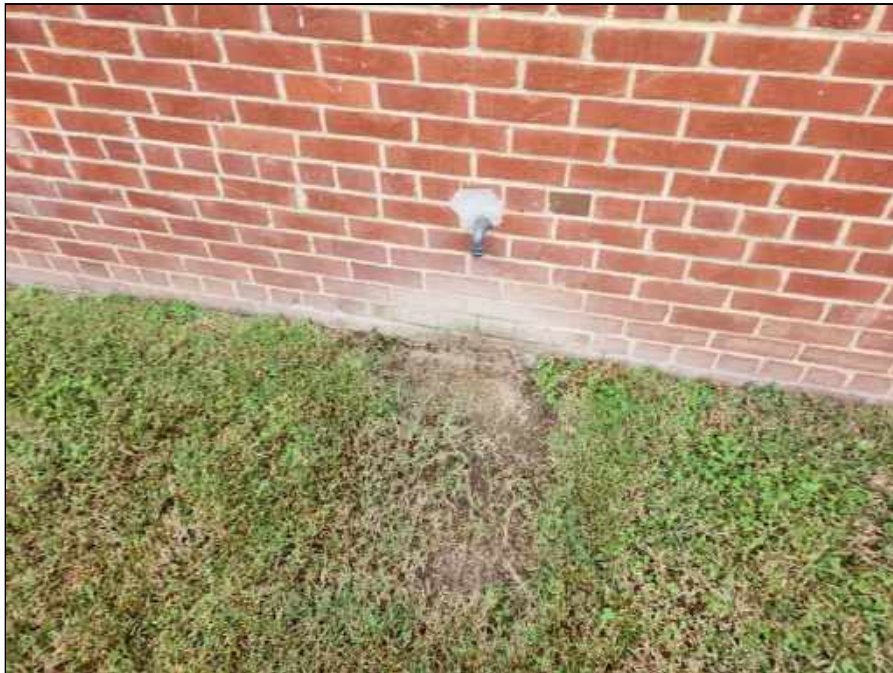
12 - Drain on the East side of the building draining against the foundation

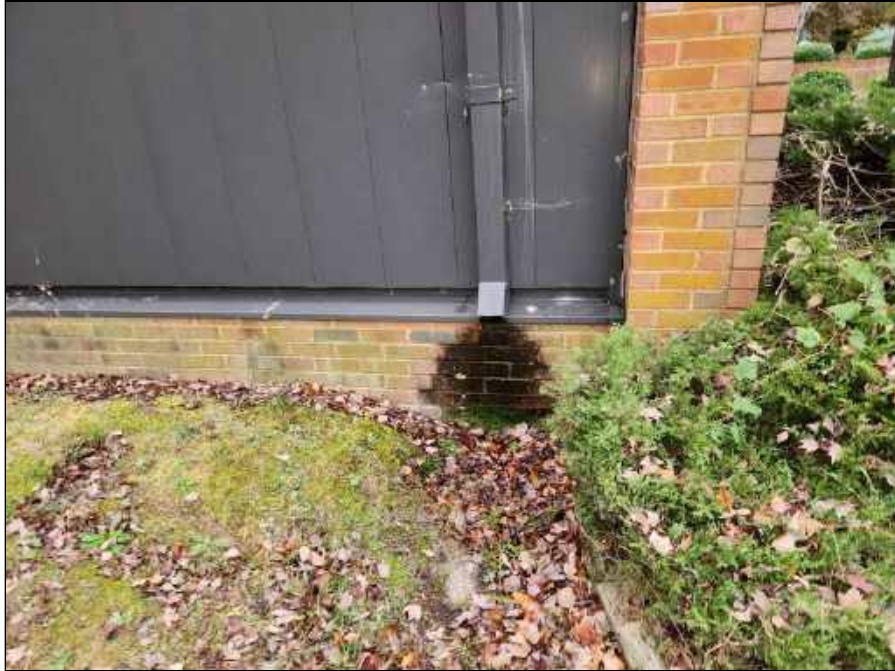
13 - Downspout draining against the foundation outside the main office

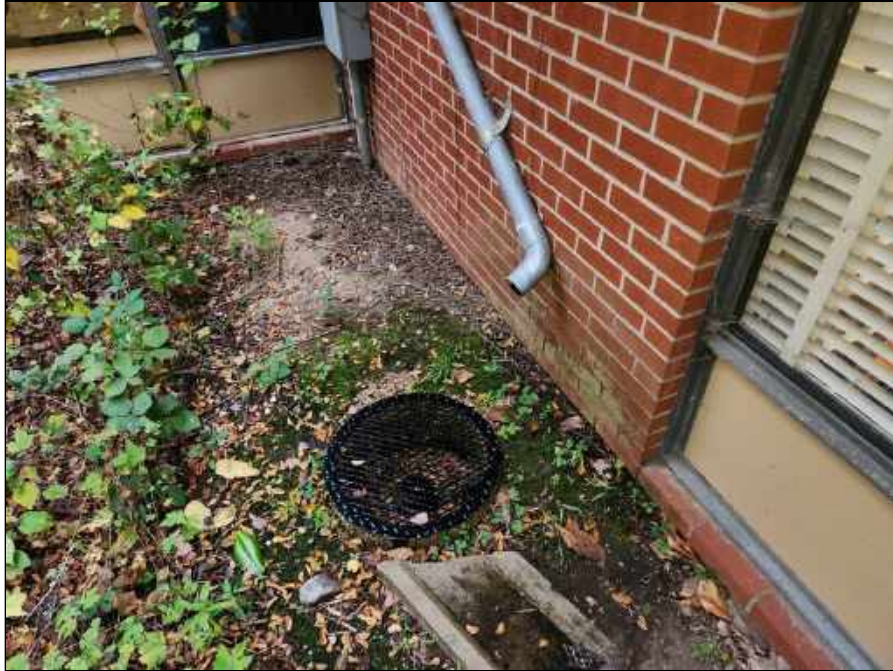
1 - A downspout draining against the foundation

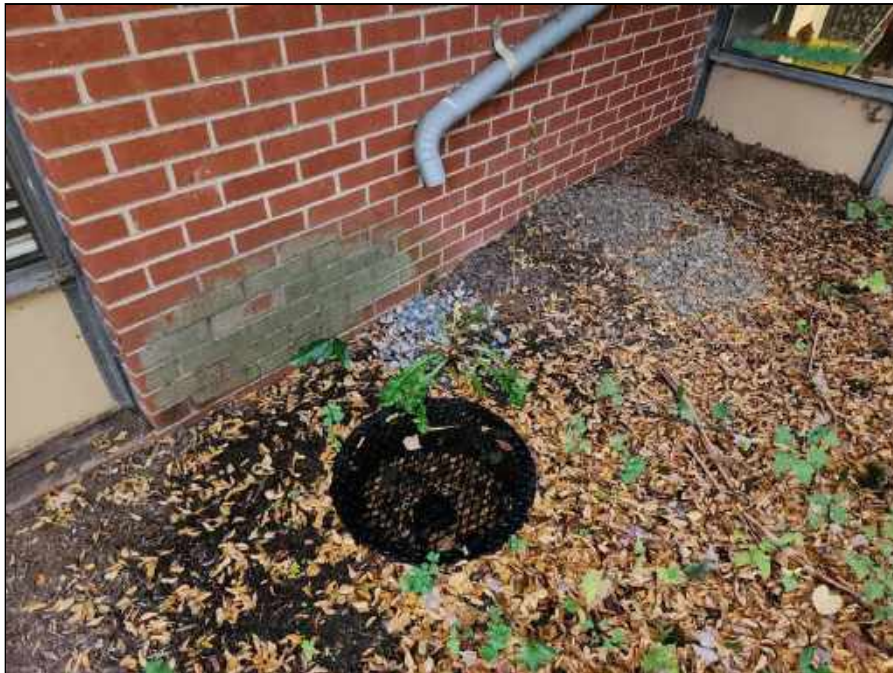
2 - A downspout draining against the foundation

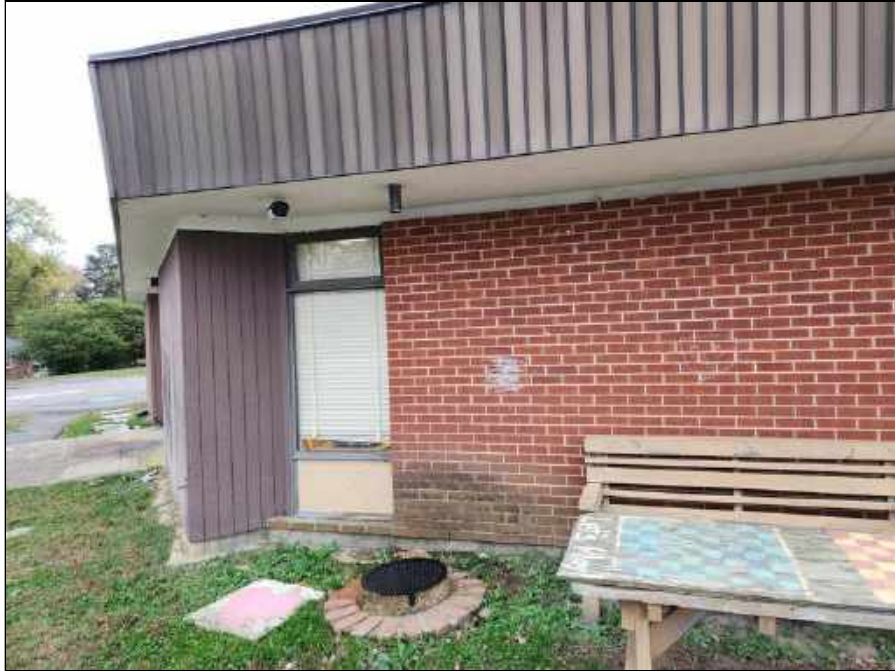
3 - A downspout draining against the foundation

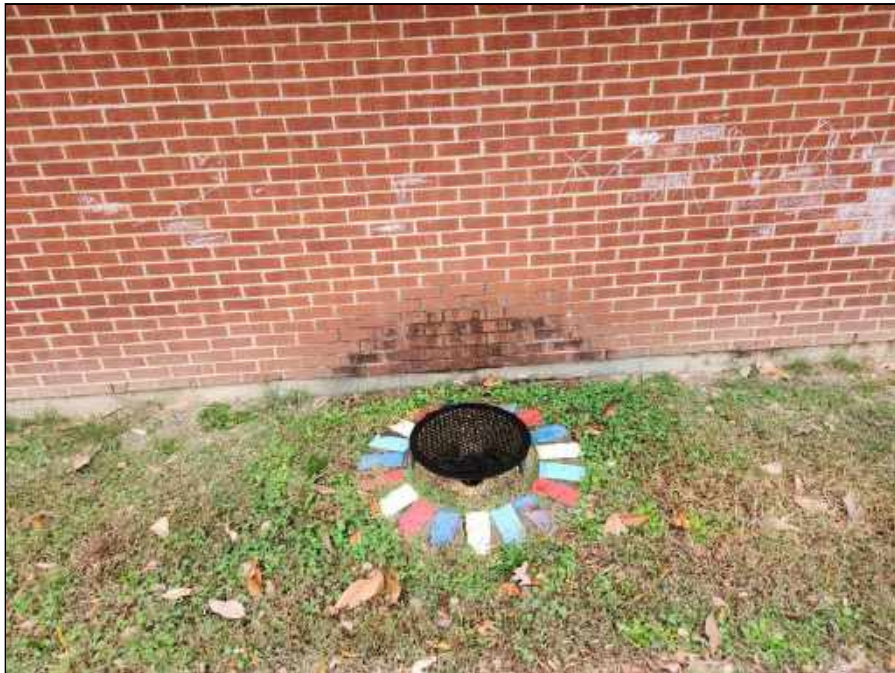
4 - A downspout draining against the foundation

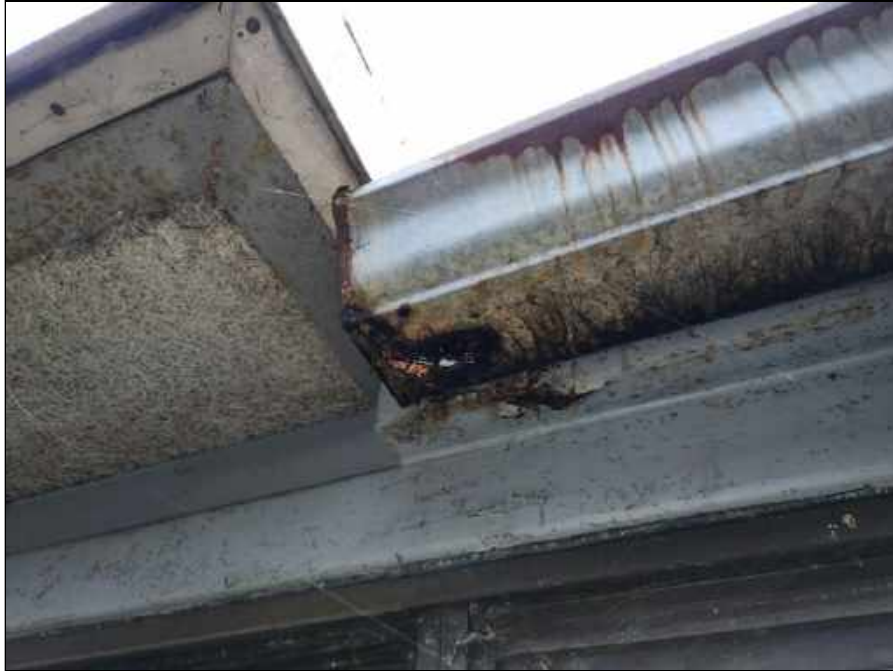
5 - Damaged gutter causing moisture intrusion on the tectum ceiling in the connector hallway

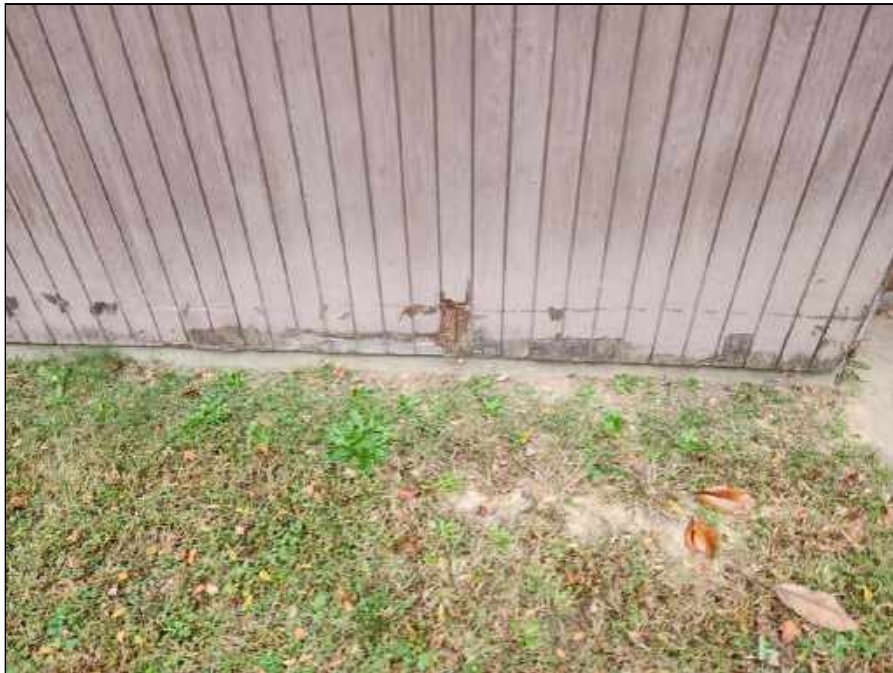
6 - Damaged exterior wood wall panels

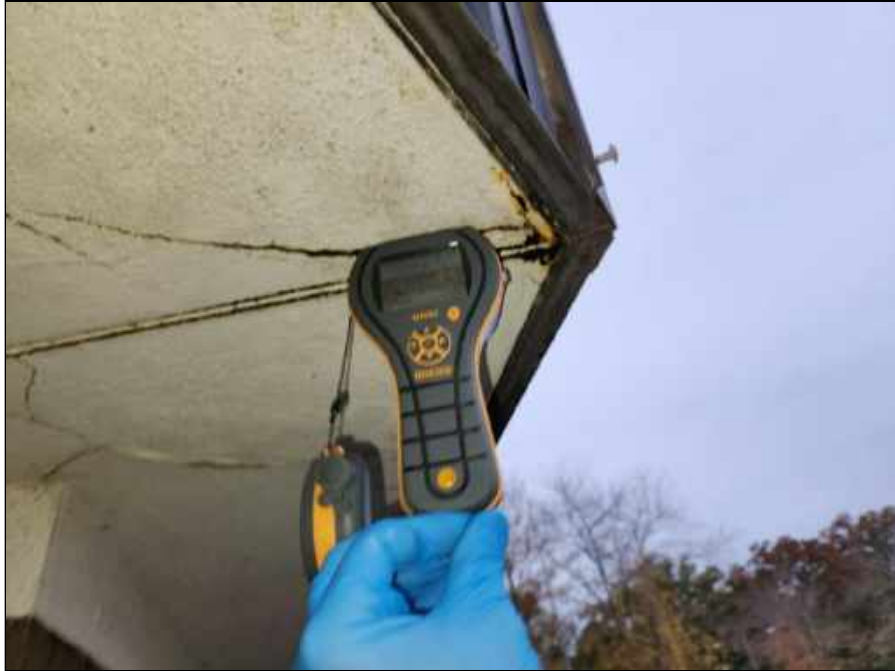
7 - Damaged soffit and elevated moisture meter reading
